| Model: Rmy-P1 | Date: 17-Jul-13 | No.: RM156001e |

| Subject: Firmware Release Note: Main | | Prepared by: Y. Miyamoto | |

| Model: RM-MF | | Date: 20-Nov-14 | No.: RM156003 |
| Subject: ADF part change information | | Prepared by: T. Sakakibara | |

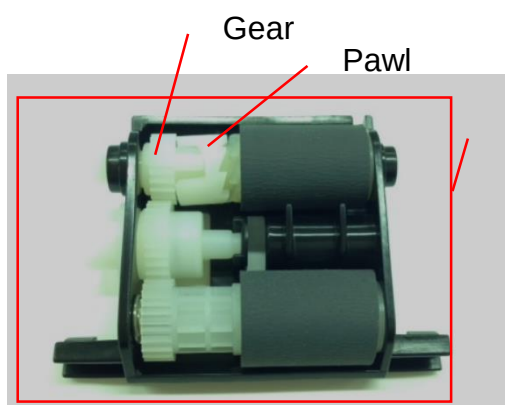
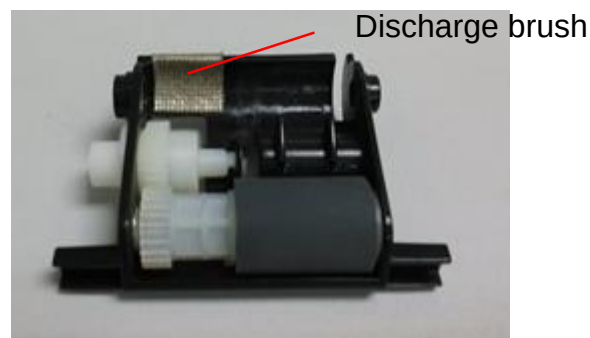
Pick up roller ass'y

1. Material of the gear (M1562825) and the pawl (M2021773) used in the feed roller of the ADF feed unit were changed from nylon to POM (Polyoxymethylene).
2. Discharge brush (M2021779) was newly added.
3. PICKUP ROLLER:ASS'Y was newly available.

Above changes 1 and 2 were made to improve ADF no-feed problems in a low temperature and low humidity environment (LL environment: 10°C, 15% RH).

Both changes were made to neutralize static electricity.

Replace the entire PICKUP ROLLER:ASS'Y or ADF ASS'Y when its sub pieces are damaged.

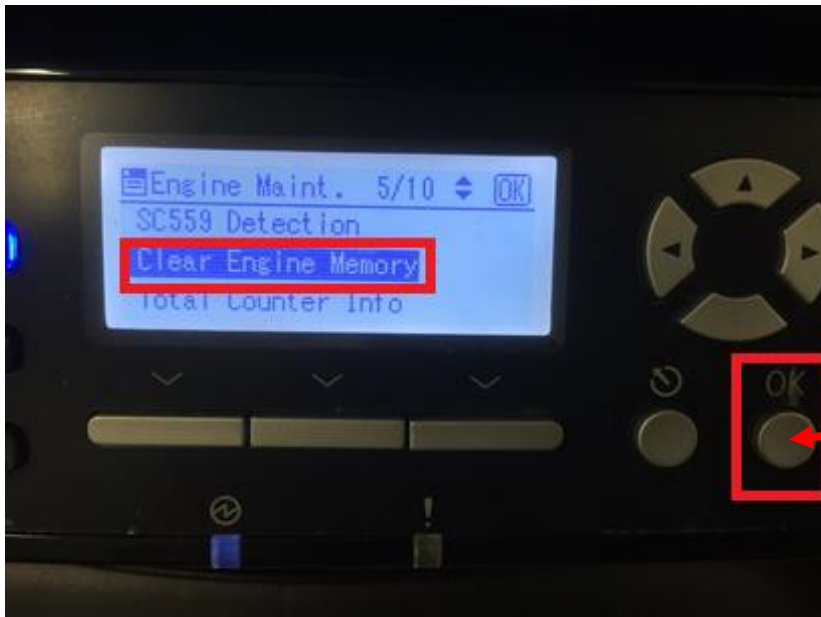
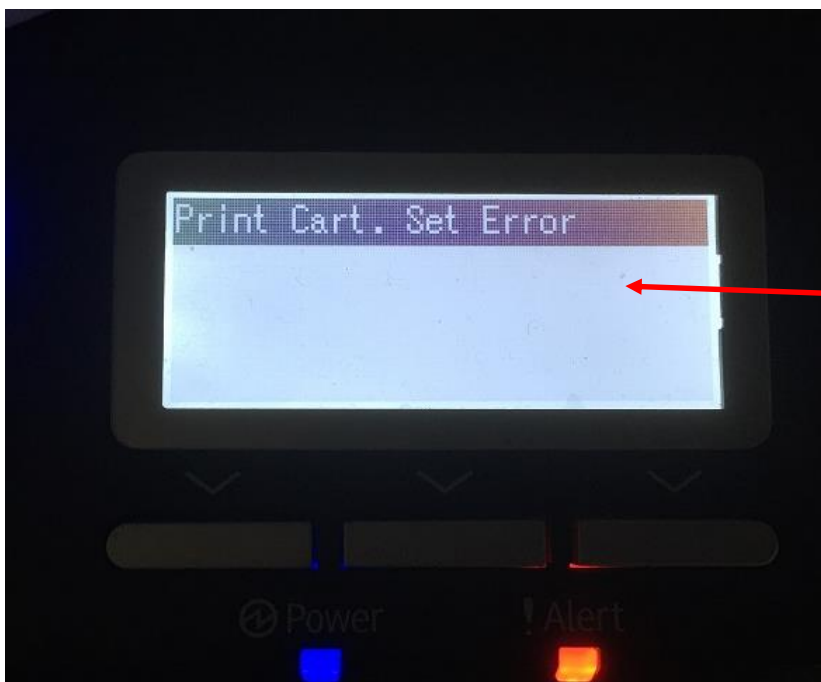
## Copier model SP mode

Clicking the "Clear Engine Memory" button in the SOM (printer configuration screen) or the SP mode will falsely reset all the engine related values stored in the main board, preventing the device from recognizing the AIO.

**DO NOT** select [Clear Engine Memory] and click OK!

Device no longer detects AIO.

***If the Clear Engine Memory button had been pressed, update the Main firmware to "ver.1.04" or later to resolve the situation.***
