Release Notes

Agilent Microarray Scanner Software Versions A.8.4

Agilent G2565CA Microarray Scanner

This document describes the enhancements, defect fixes, and software compatibility issues related to the release of Scan Control V 8.4.

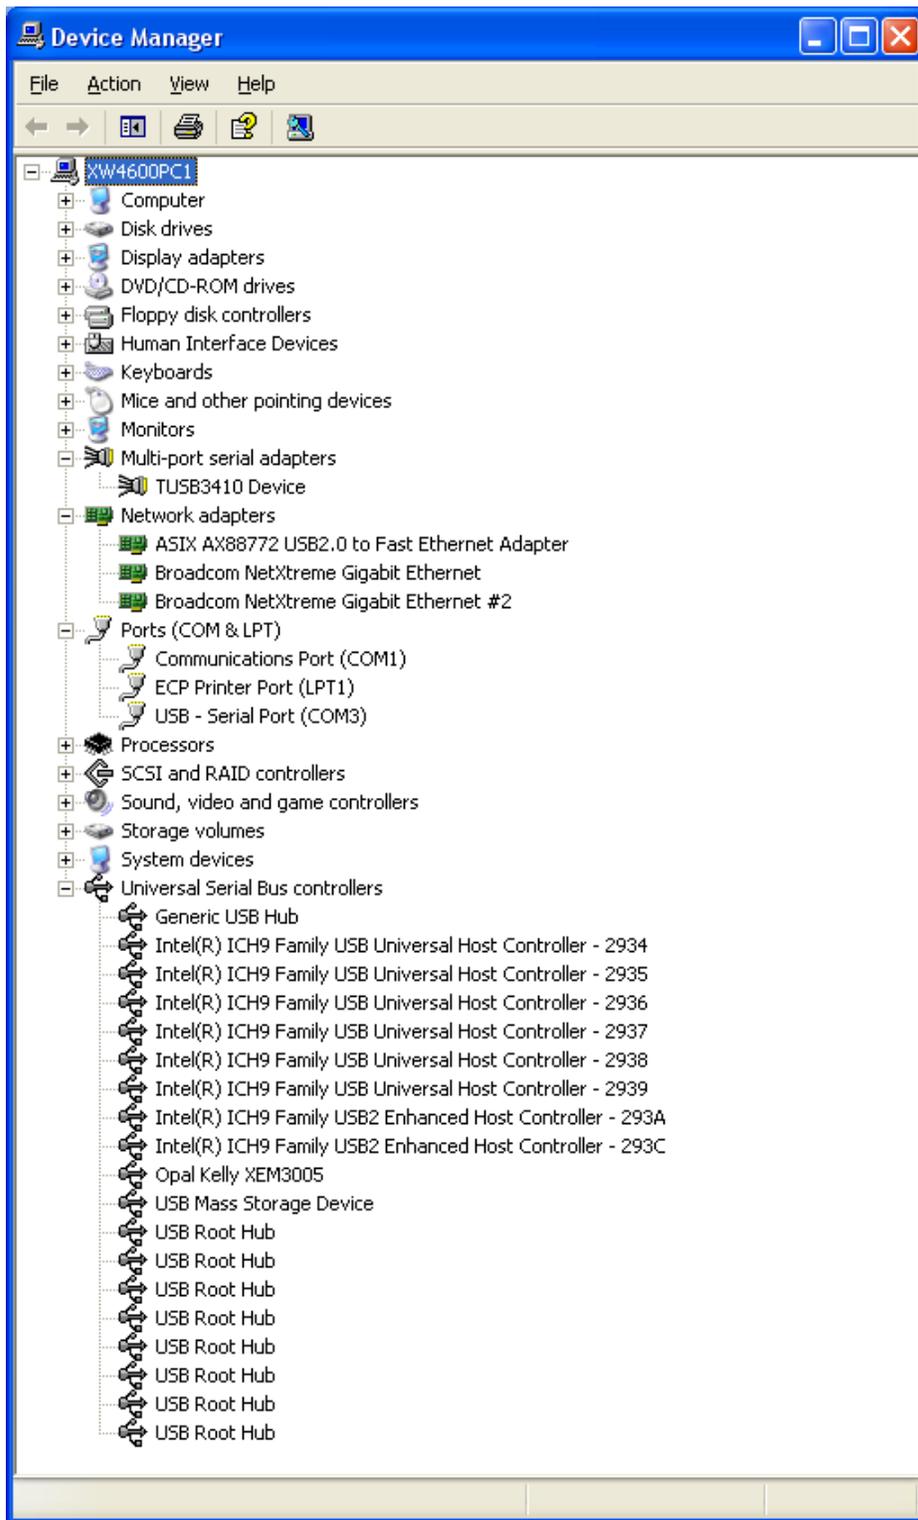
When operating correctly, these connections can all be seen in the Device Manager, as shown below. The hub is visible as "Generic USB Hub"; the data collection system can be seen as "Opal Kelly XEM3005"; the Ethernet as "ASIX AX88772" Ethernet adapter; and the serial as "USB - Serial Port (COM3)".

Use of a high-quality USB2 cable is required for correct operation of the scanner. Using a USB1 cable, or a cable with a ferrite, may result in failure to connect, or loss of data.
