CHRYSLER A604 (41TE) UPDATE HANDBOOK

AUTOMATIC TRANSMISSION SERVICE GROUP 9200 S. DADELAND BLVD. SUITE 720 MIAMI, FLORIDA 33156 (305) 670-4161

CHRYSLER A604 (41TE) "UPDATE HANDBOOK"

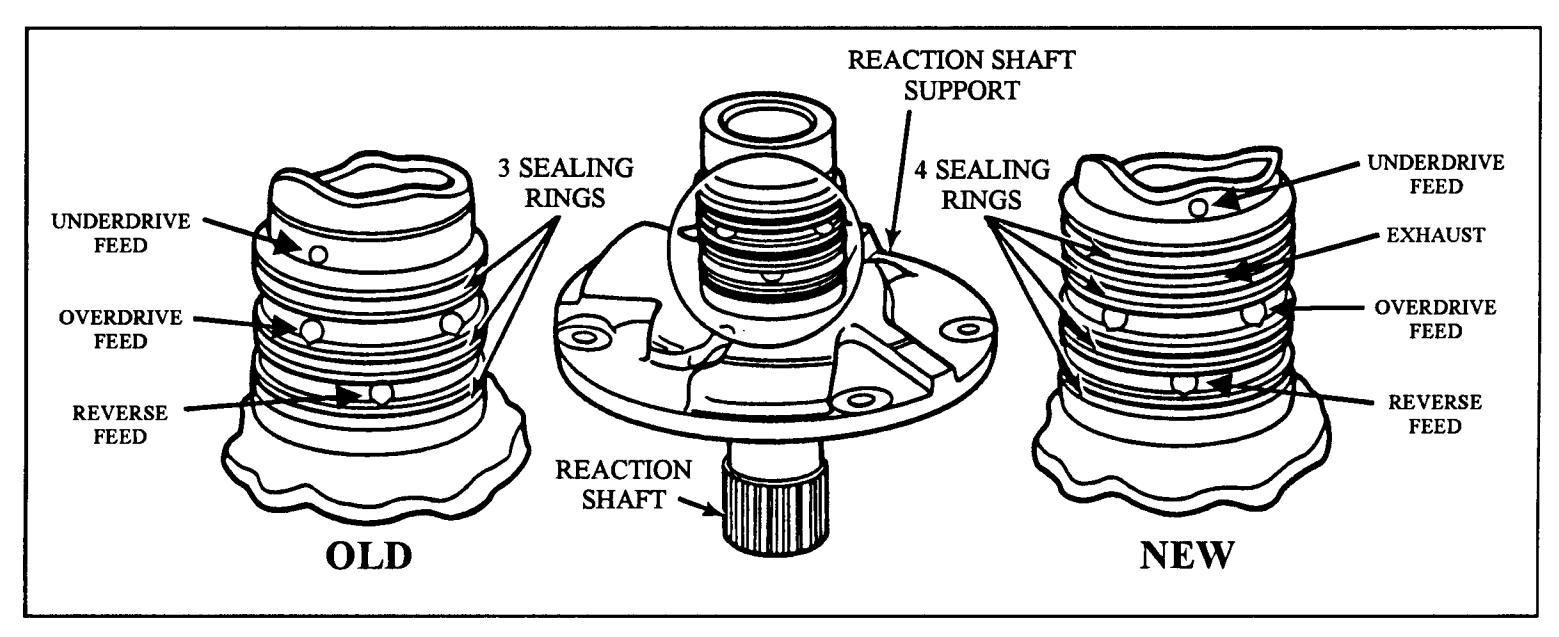
Figure 1

- (1) REACTION SHAFT SUPPORT The new support is longer, and has 4 sealing rings, where the old support only has three (See Figure 1).
- (2) INPUT SHAFT/CLUTCH HUB The new Input Clutch Hub bore is machined deeper to accommodate the additional length of the reaction shaft, created by the added sealing ring (See Figure 2). The "O" Ring grooves are also cut shallower than the old input clutch hub, which increases the groove diameter, and provides improved compression or "Crush", between the "O" rings and the input clutch retainer. (See Figure 3).

ALWAYS UPDATE to the four ring reaction shaft support. There is now available a repair package, OEM part number 4549248, that includes the following:

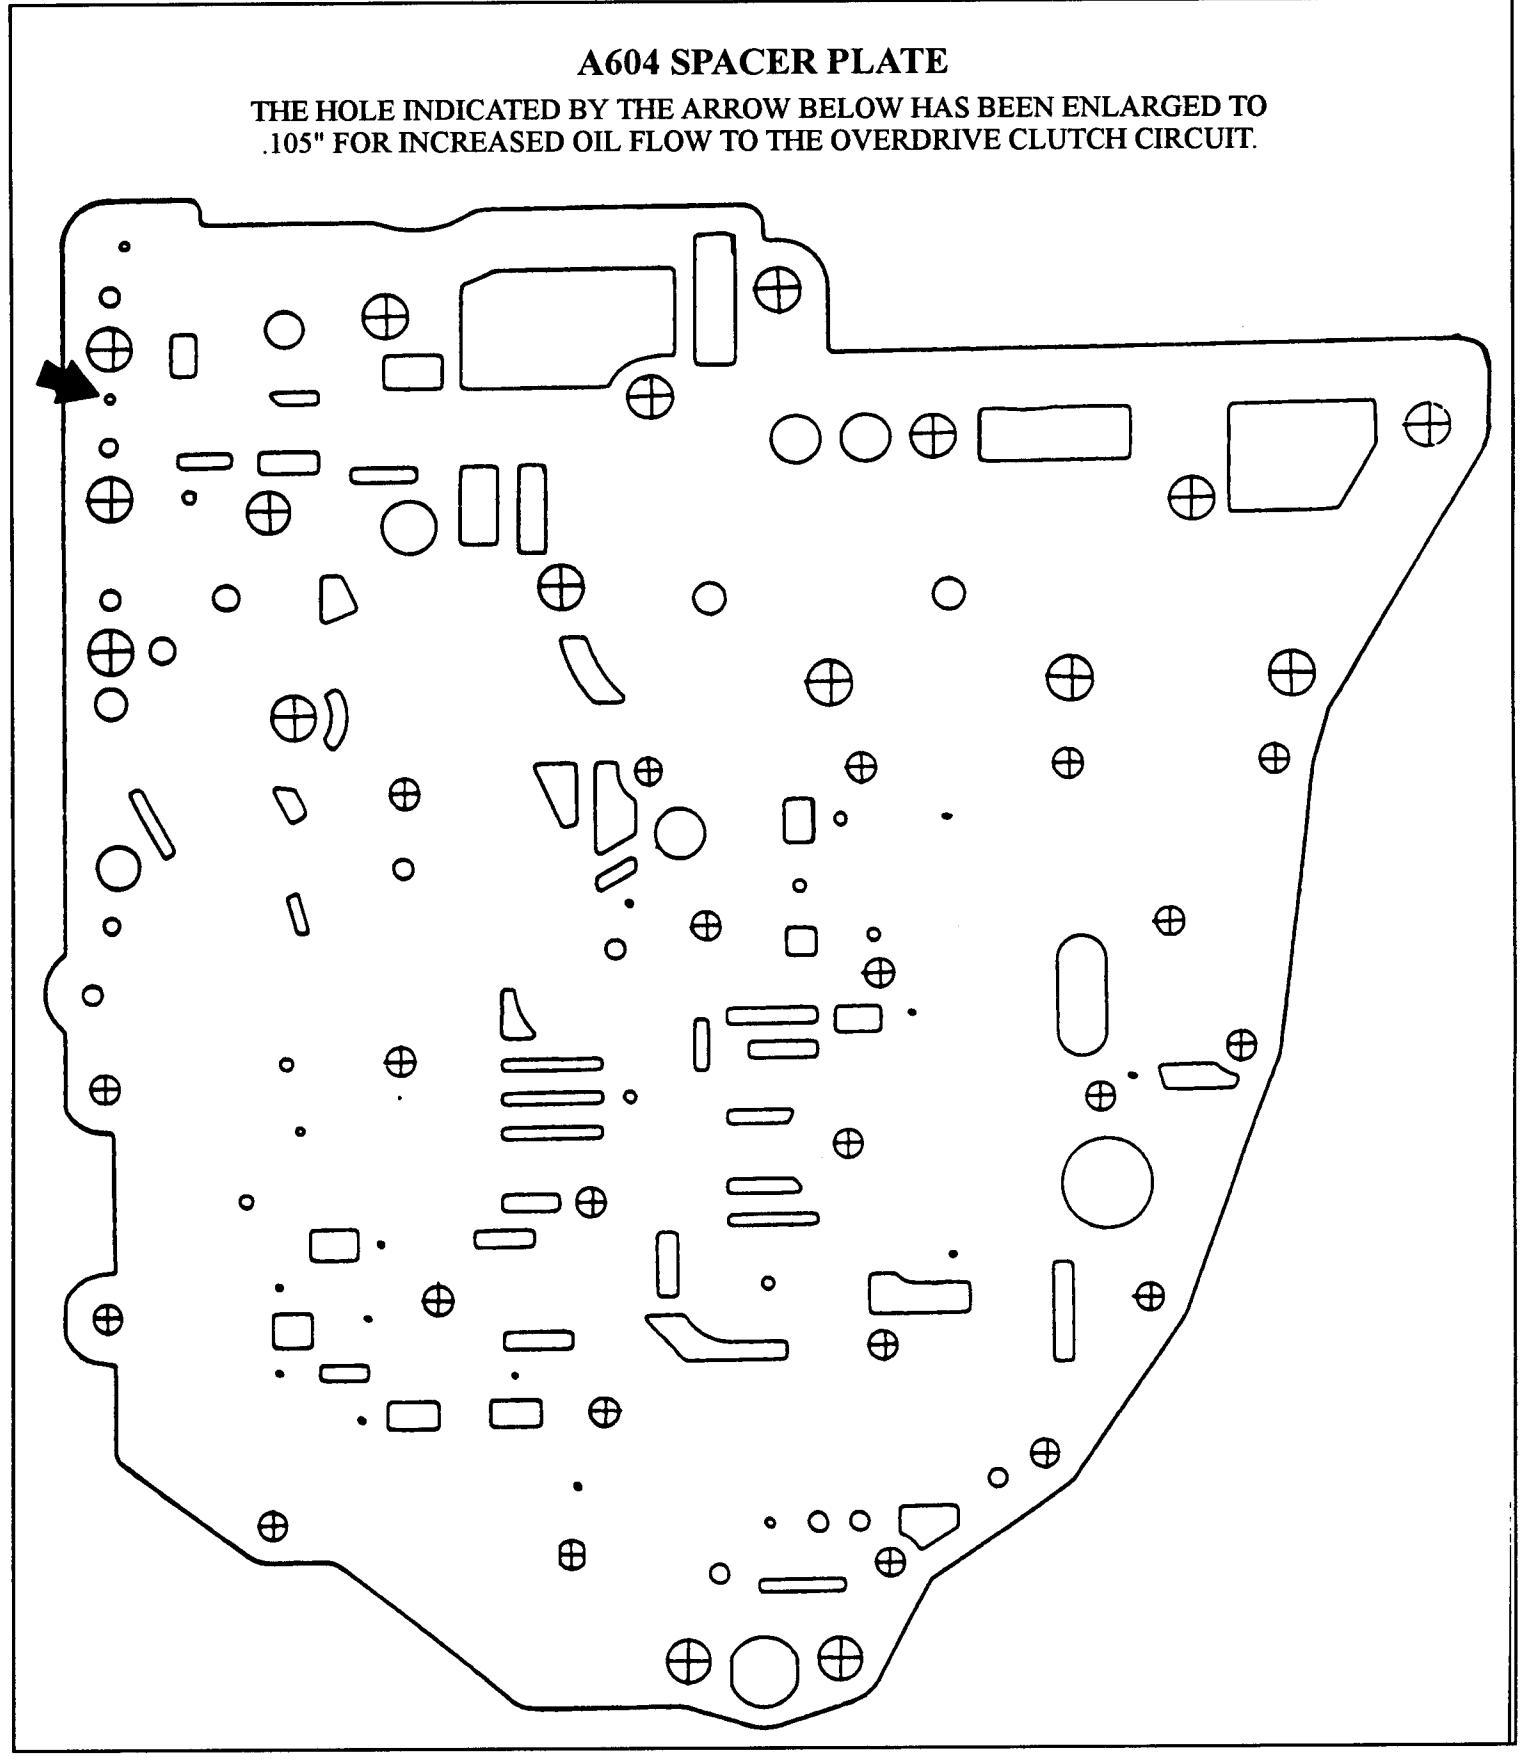
Figure 5

- (5) SPACER PLATE The new Spacer Plate has a larger (.105") overdrive clutch feed orifice to provide increased oil flow to the overdrive clutch circuit (See Figure 5).

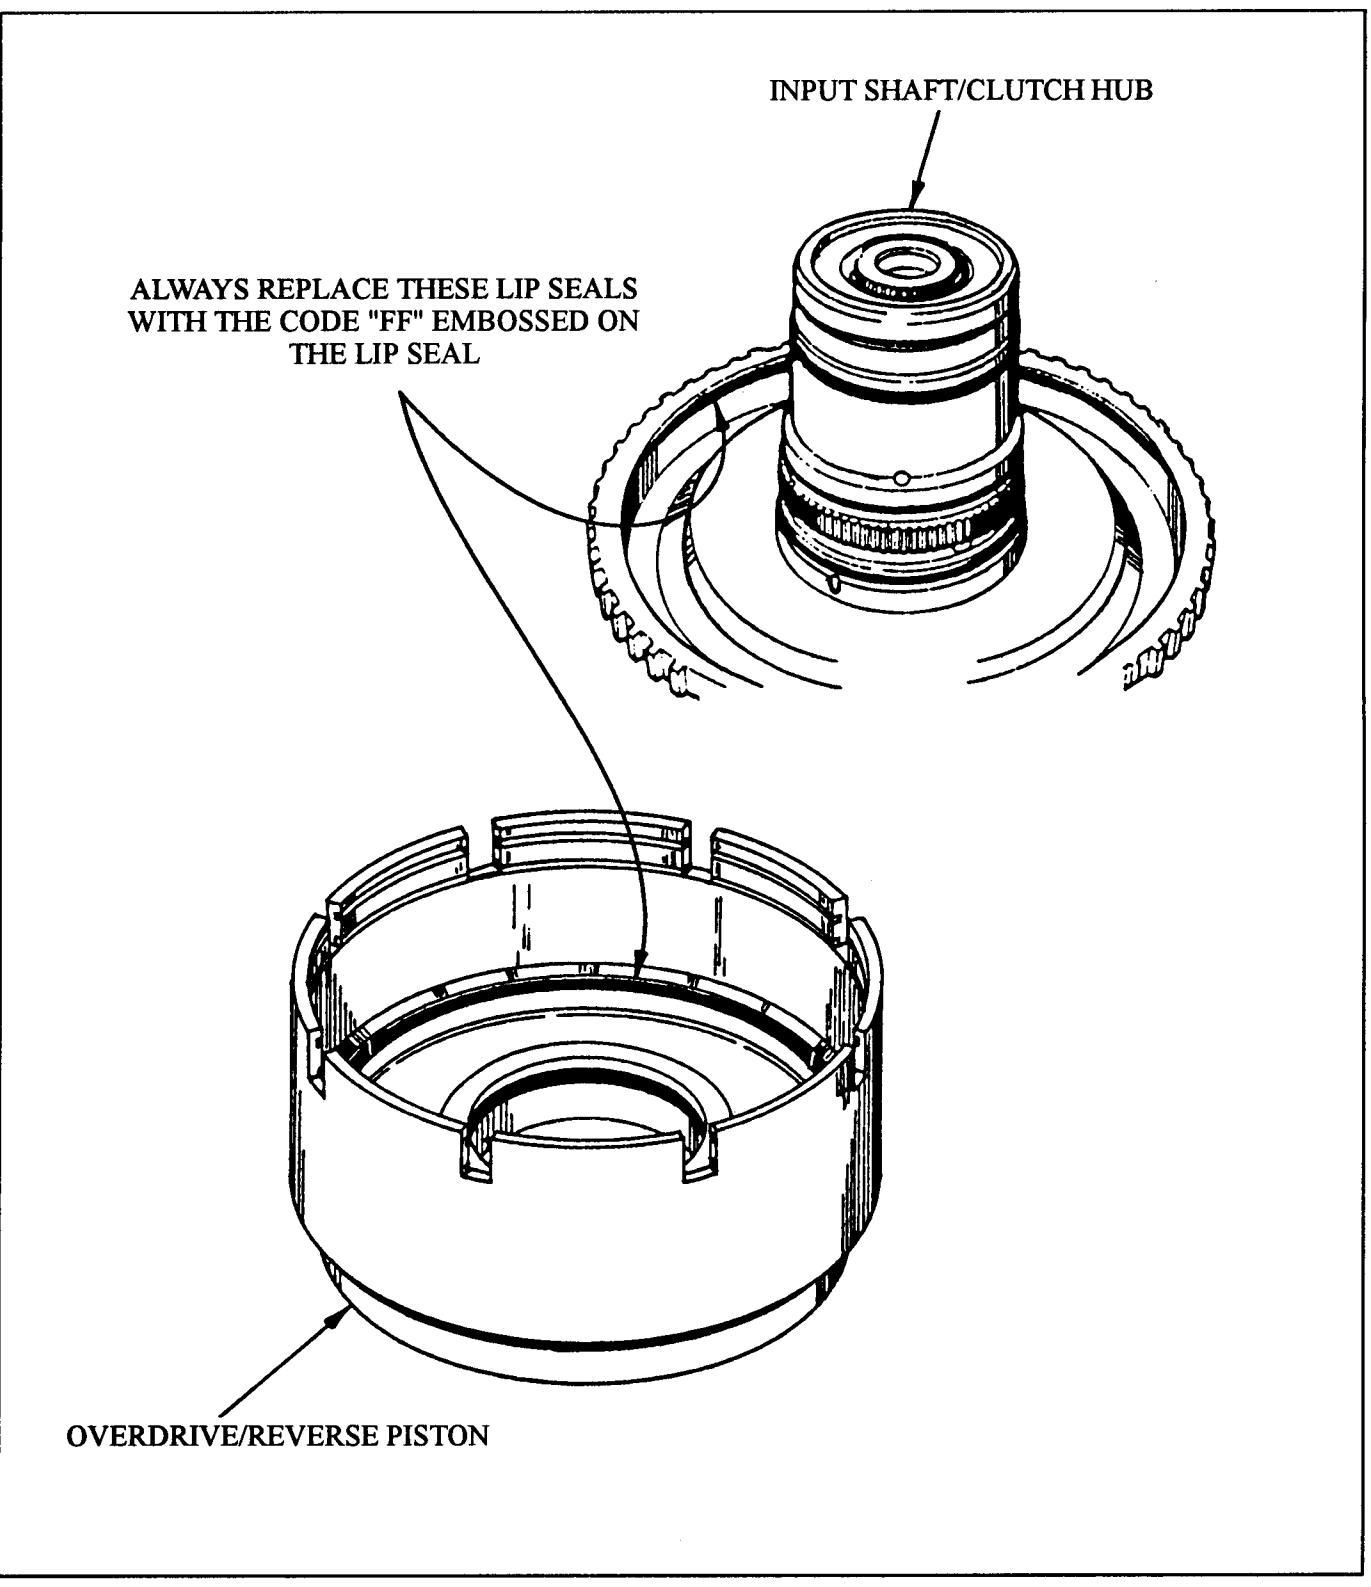
Figure 6

CHANGE: The lip seals in the Overdrive/Reverse Clutch Piston and the Input Shaft/Clutch Hub are now replaced with lip seals made of different material (See Figure 6).

- (1) OD/REVERSE PISTON LIP SEAL No dimensional changes, but the material changes, and the new lip seals can be identified by the code "FF" embossed into the seal. The old lip seal is embossed with the code "IPC", and should not be used (See Figure 6).
- (2) INPUT CLUTCH HUB OUTER LIP SEAL No dimensional changes, but the material changes, and the new lip seals can be identified by the code "FF" embossed into the seal. The old lip seal is embossed with the code "IPC", and should not be used (See Figure 6).

THE NEW LIP SEALS EMBOSSED WITH THE CODE "FF" WILL RETROFIT BACK TO ALL PREVIOUS MODELS, AND SHOULD BE USED DURING OVERHAUL.

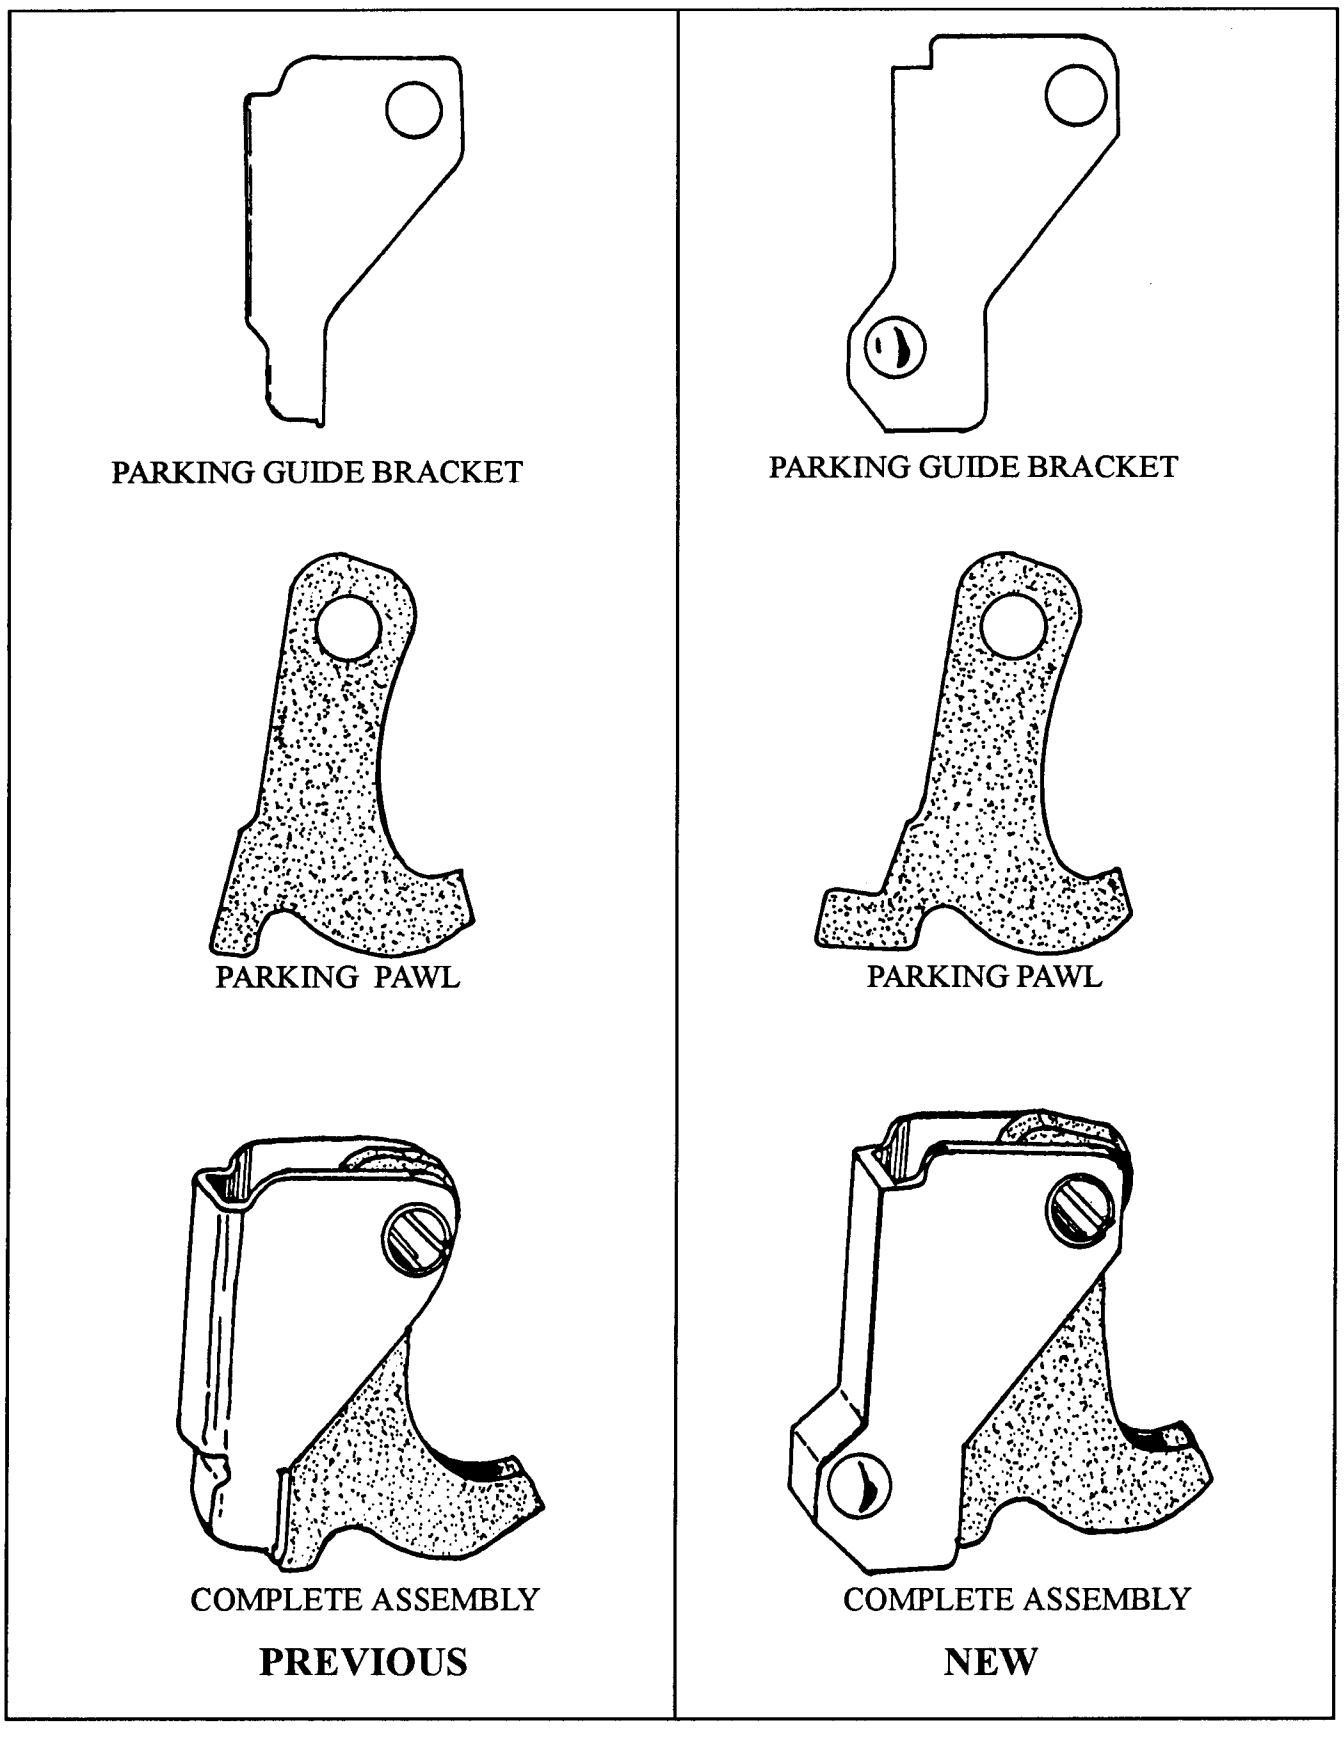
Figure 7 Automatic Transmission Service Group -11-

CHANGE: A new Parking Sprag Guide Bracket and Parking Pawl has been introduced as a 1989 running change (See Figure 7).

- (1) PARKING GUIDE BRACKET Previously the Parking Guide Bracket was a stamped steel unit, and has been replaced by a high quality casting, along with dimensional changes. See Figure 7 for identification.
- (2) PARKING PAWL The new Parking Pawl, or "Boot", also required some dimensional changes. The heel of the new "Boot" is wider than the previous models, as shown in Figure 7.

The new parts will retrofit back to all previous models, but both pieces must be replaced as an assembly. (See Figure 7).

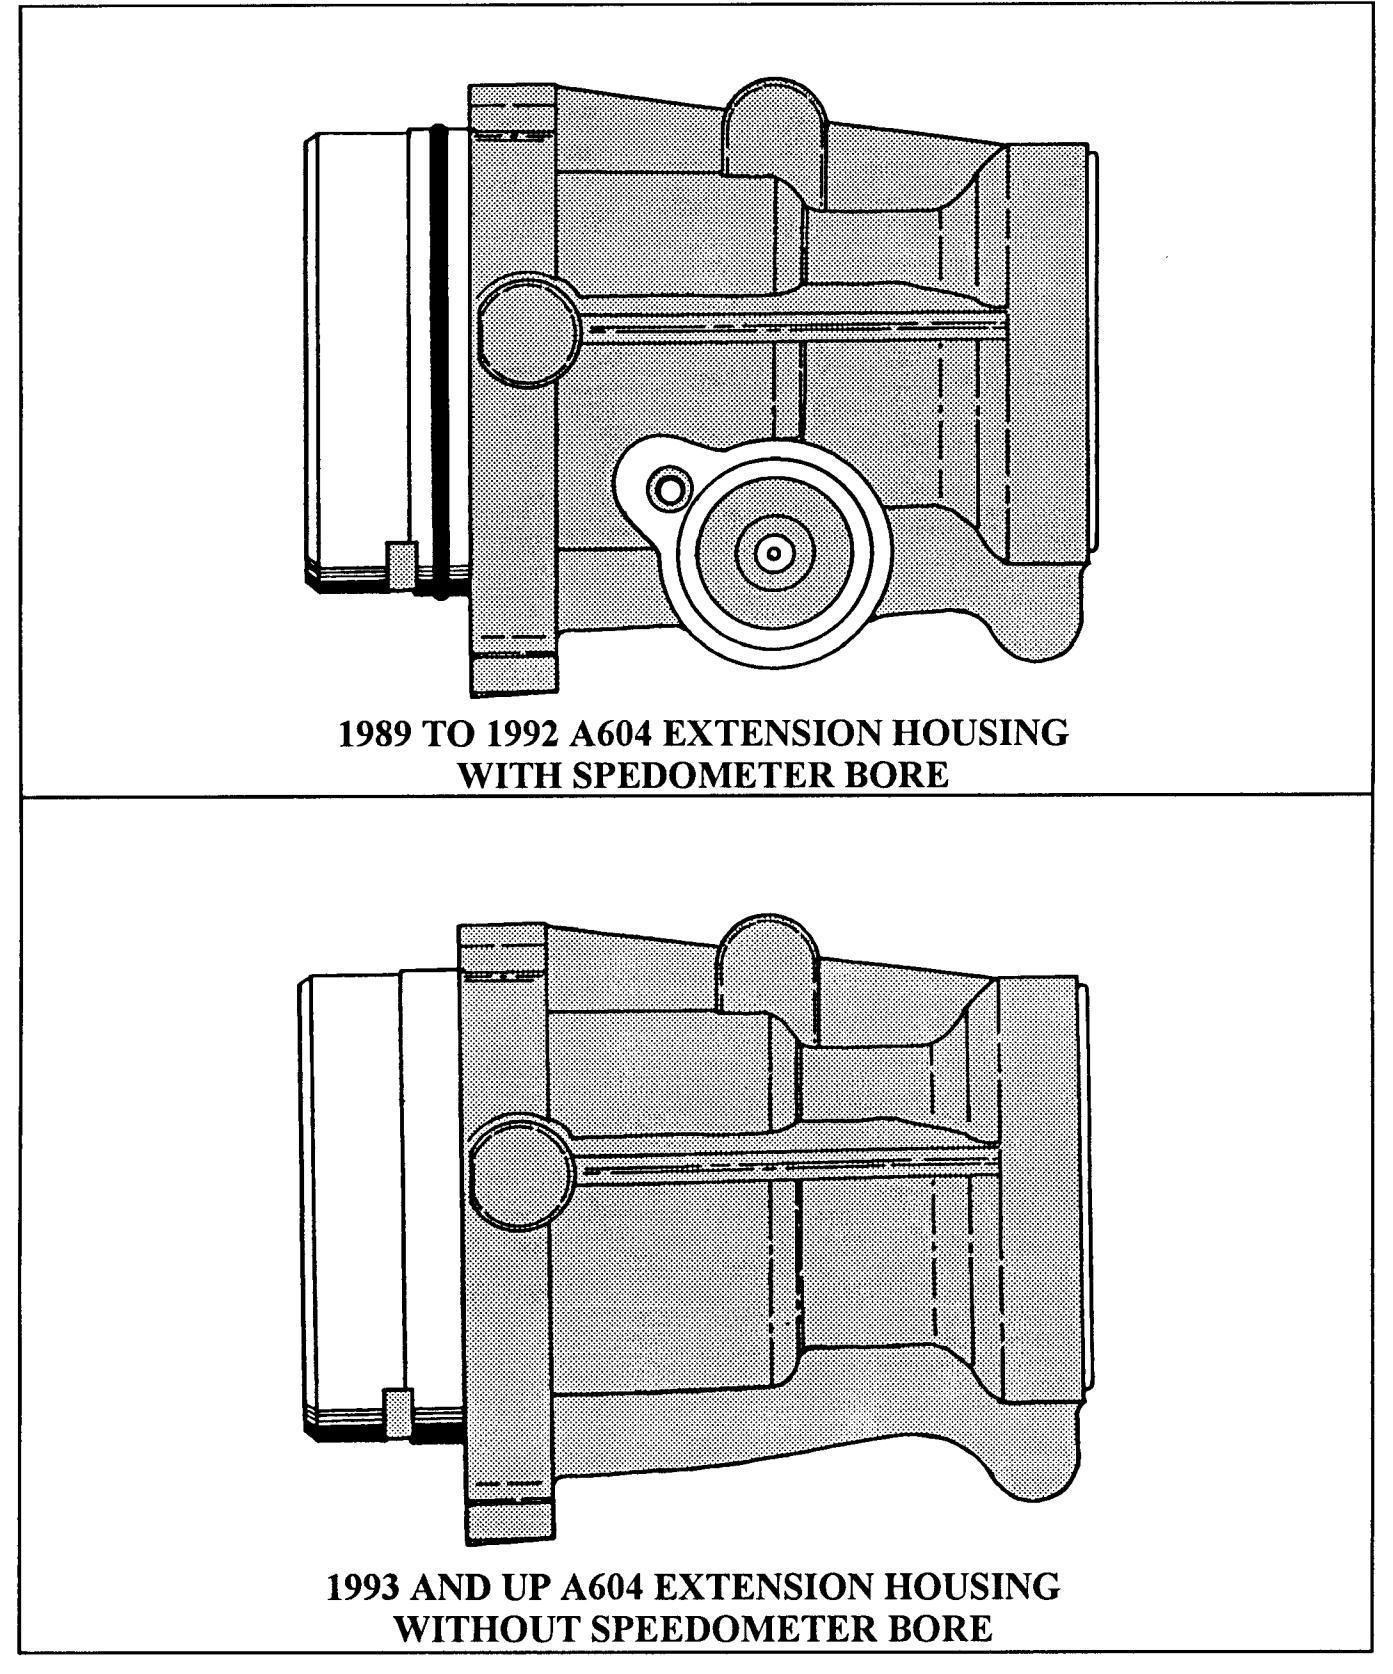
Figure 10

1993 to present controllers received a logic change to use the output shaft speed sensor as the source for vehicle speed. Refer to figure 10 which shows the elimination of the speedometer from the extension housing in 1993.

- (2) TRANSAXLE EXTENSION HOUSING 1993 extension housings no longer have a speedometer bore. The speedometer assembly is no longer needed since the transaxle controller will now look at the output shaft speed sensor for this information (See Figure 10).

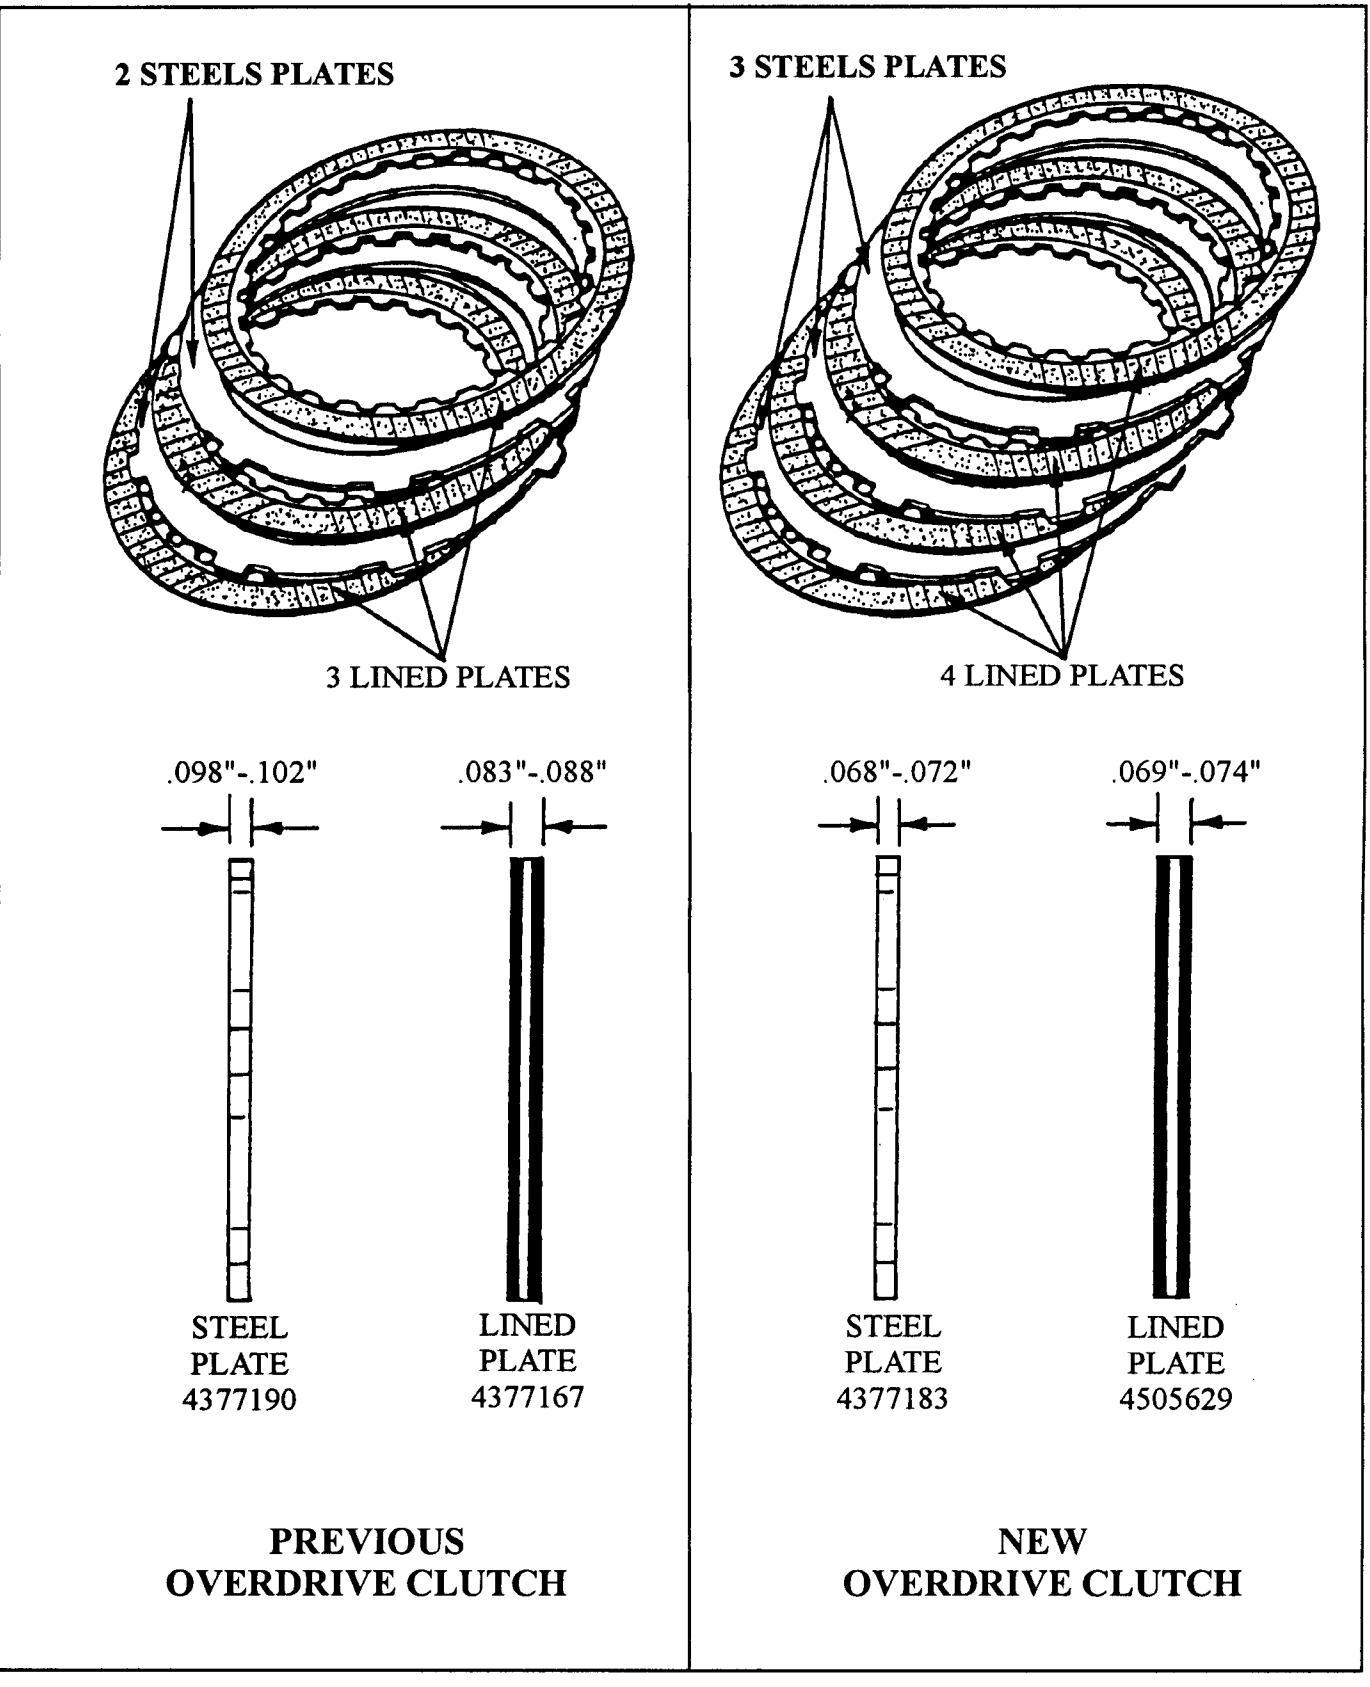
Figure 15

- CHANGE: A running change for 1990 model A604 transaxles was the introduction of a four (4) disc Overdrive Clutch Assembly, to replace the previous three (3) disc clutch assembly (See Figure 15).
- REASON: Higher horsepower (3.3L V-6) engines introduced in New Yorker, Dynasty, Imperial, Caravan, and Voyager models.

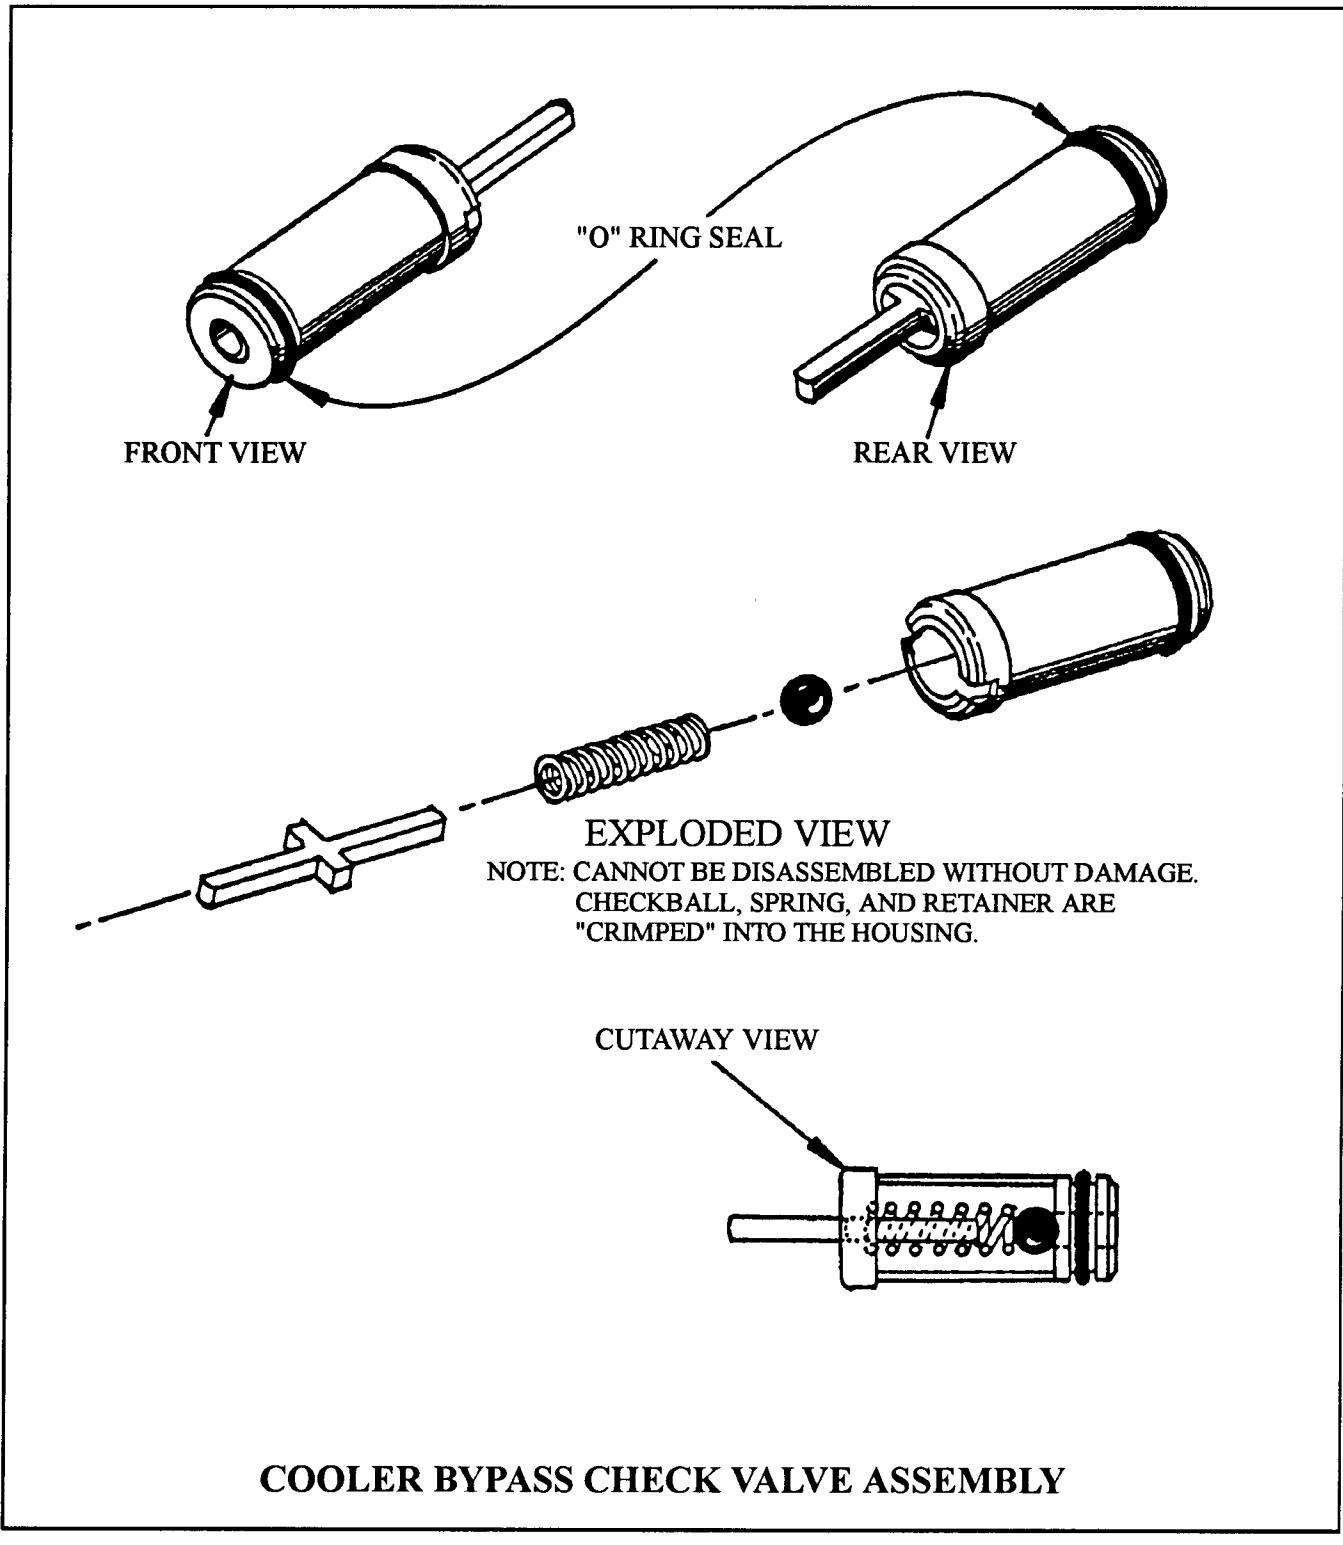
Figure 42

(1) COOLER BYPASS CHECK VALVE - added into the case cooler passage behind the oil pump (See Figure 43). If cooler oil flow is restricted, or blocked, the new check valve will open, and allow cooler feed oil direct into the lube circuit to prevent transaxle damage. Normal operation is resumed after oil temperature is warm enough to again flow through the cooler. (See Figure 42).

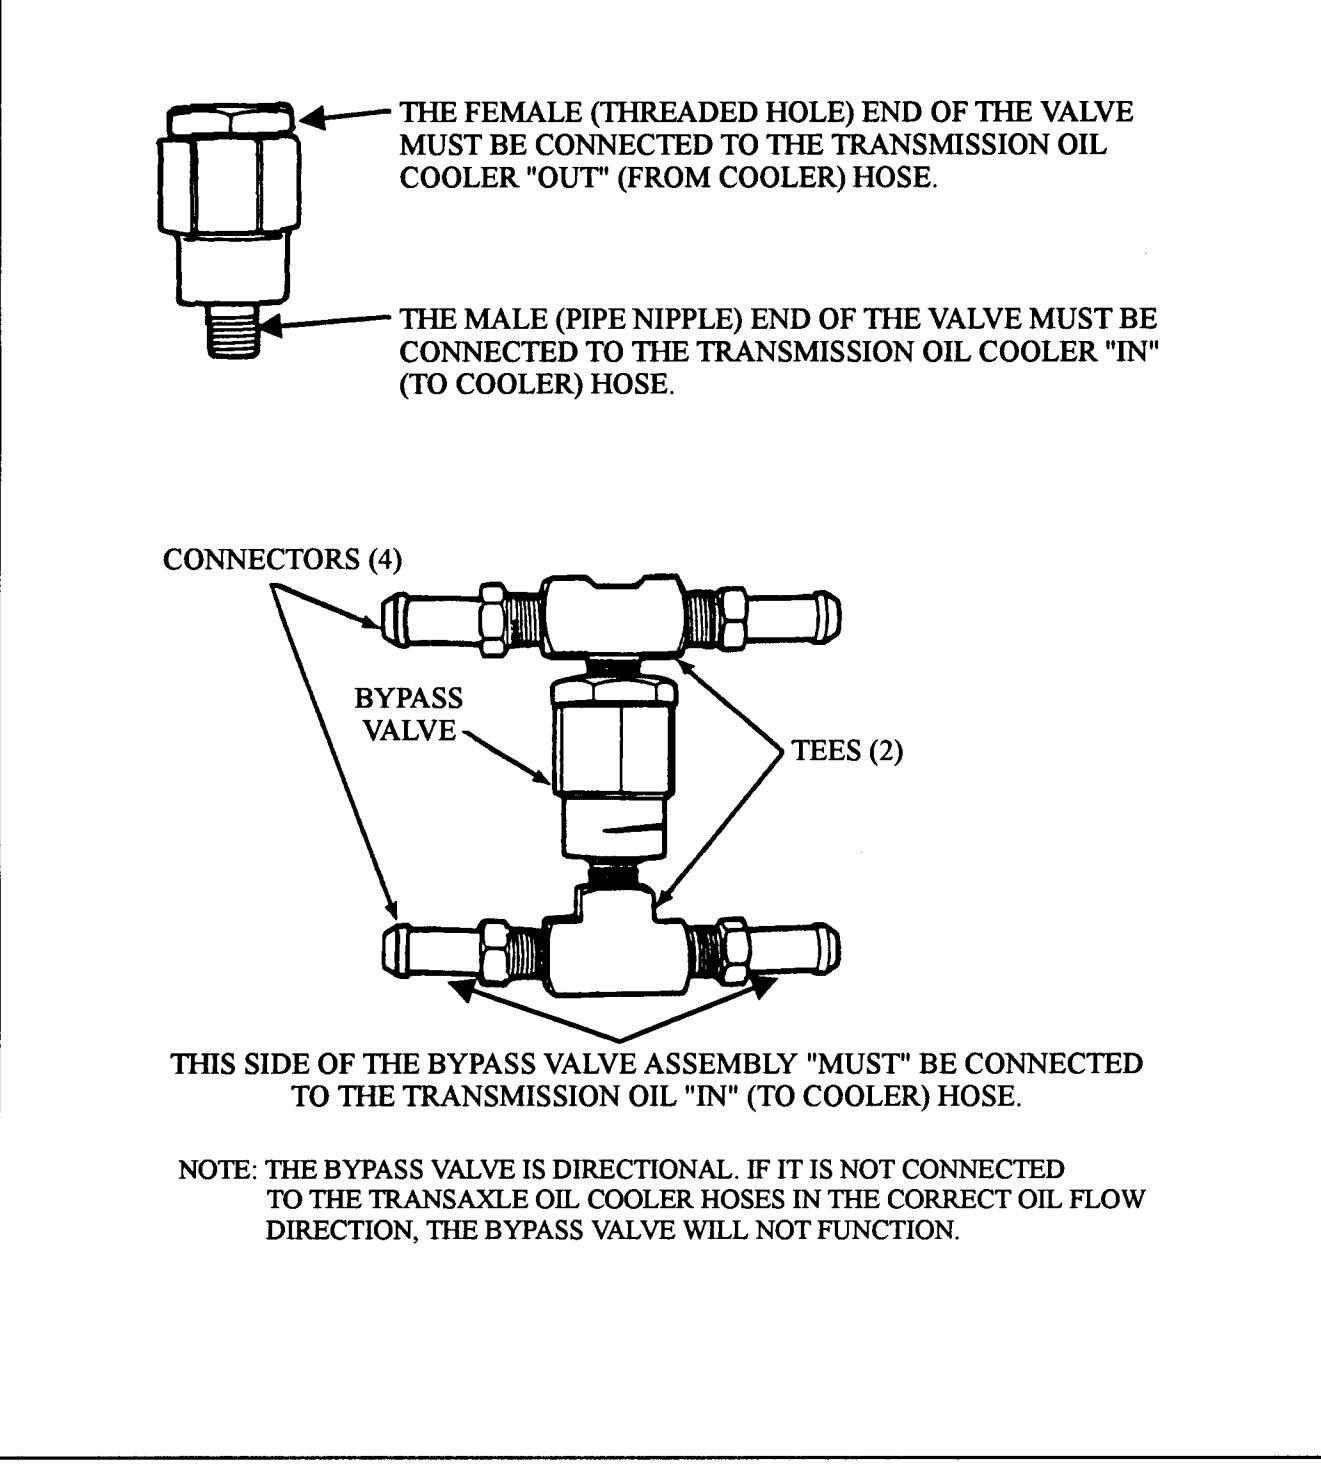
Figure 45

- COMPLAINT: On 1989 and 1990 Chrysler models, equipped with the A604 transaxle, under extremely cold ambient operating temperatures (0°F or Below), transmission fluid may get cold enough to resist flow through the transmission oil cooler. The transaxle may fail prematurely due to lack of lubrication.
- CAUSE: Not enough lube flow to the transaxle because of the restriction.

- 1. Using thread sealer on all connections, assemble the supplied bypass valve, tees, and hose connectors as shown in Figure 45.
- 2. Raise the vehicle on a hoist for working access to the transmission oil cooler hoses, that are routed along the inboard side of the left front frame rail.
- 3. Place an oil drain pan under the vehicle to catch oil leakage. Oil loss will be very minimal.
- 4. Referring to Figure 46, follow the cooler hoses routed from the transaxle to CLEARLY IDENTIFY THE COOLER "IN" (TO COOLER) HOSE.
- 5. Install the bypass valve assembly as per the following instruction sheets, as installation procedures vary depending on vehicle model.

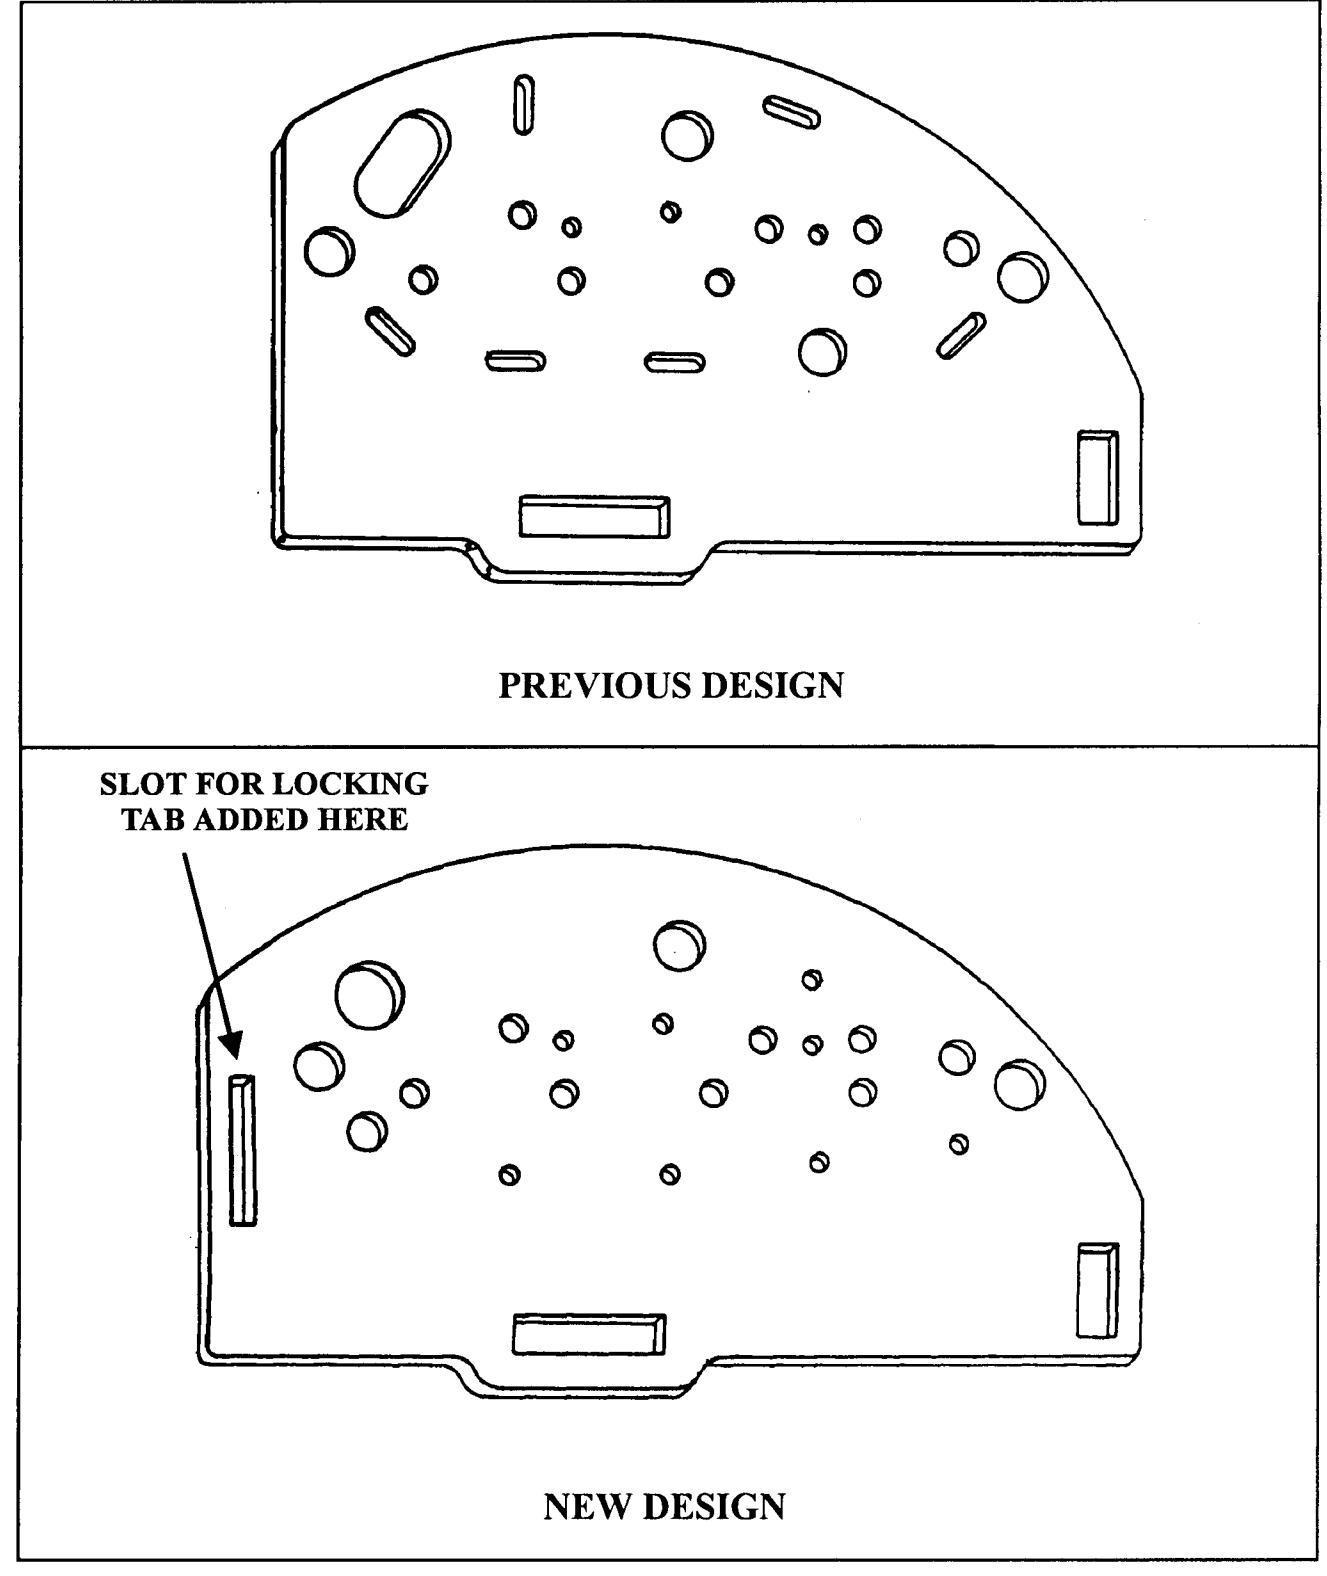
Figure 64

- (1): SOLENOID SOUND COVER An additional locking tab was added to the sound cover for a more secure fit to the solenoid spacer plate.
- (2): SOLENOID SPACER PLATE The solenoid spacer plate received an added slot to accommodate the additional locking tab made to the solenoid sound cover. There were also subtle changes made to the venting holes and slots found in the spacer plate (See Figure 64).

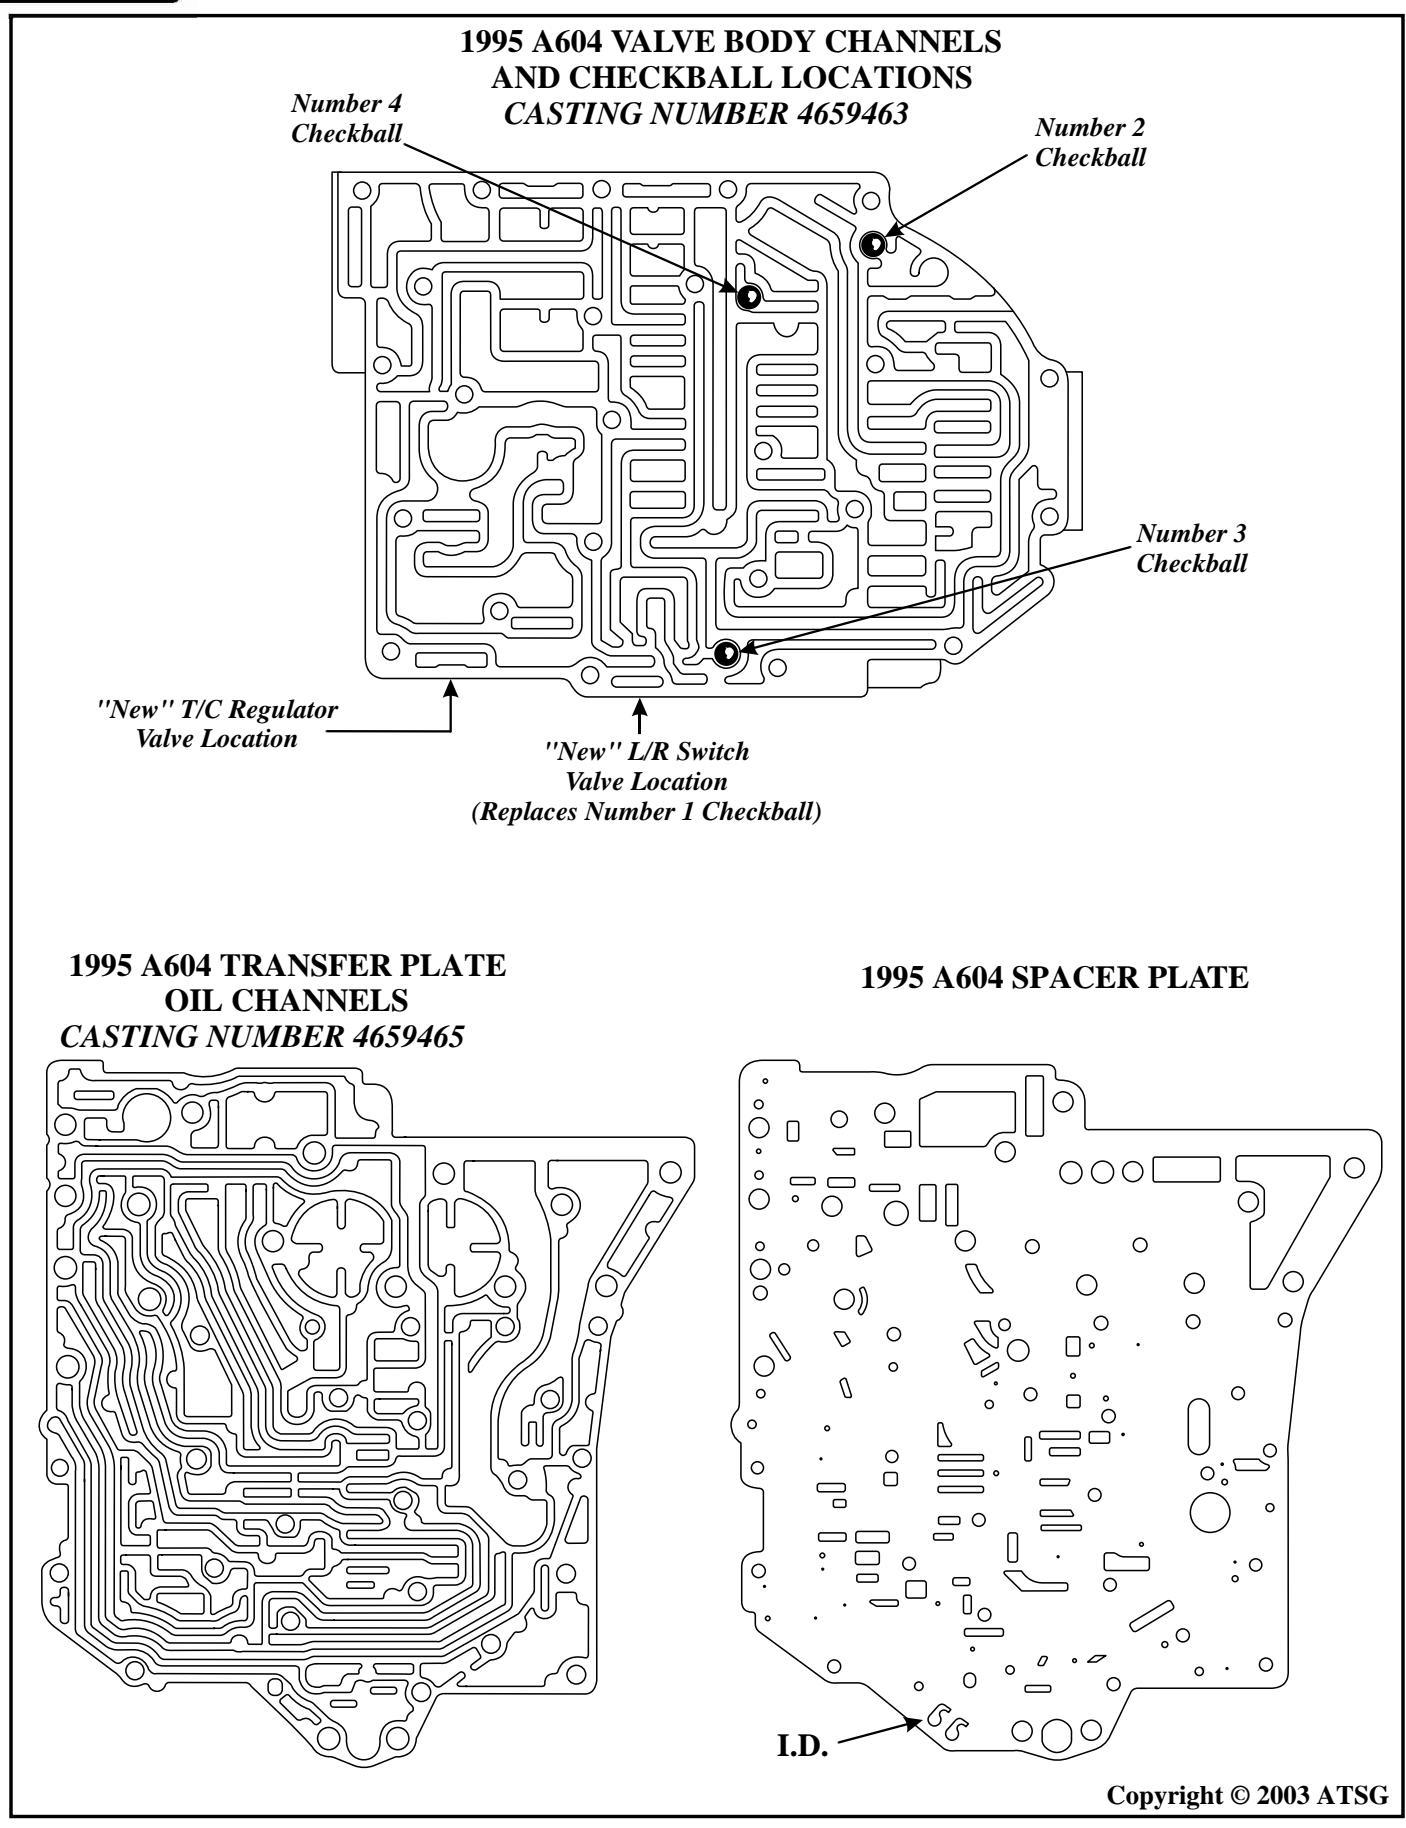
Figure 72 Automatic Transmission Service Group -95-

Casting number for identification on new valve body is 4659463. Casting number for identification on new transfer plate is 4659465. Number stamped for identification into new spacer plate is "66" (See Figure 72).

Currently not recommended to retro-fit back to previous models, but new design service valve bodies will soon be available.
