# **Agilent Technologies**

# GC Troubleshooting Series Part Eight: Loss of Resolution Over Time

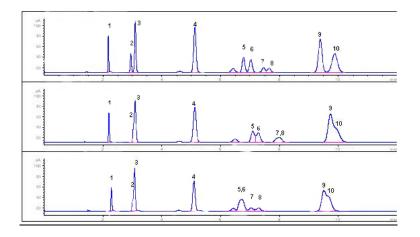
# ISSUE: Increases in Peak Width

### Possible Cause: Change in Carrier Gas Velocity

For increases in peak width, start by checking your gas velocity, to ensure it has not changed since your original method. You'll also see a change in retention time if this is your issue.
