Agilent Technologies

GC Troubleshooting Series Part Five: Split Peaks

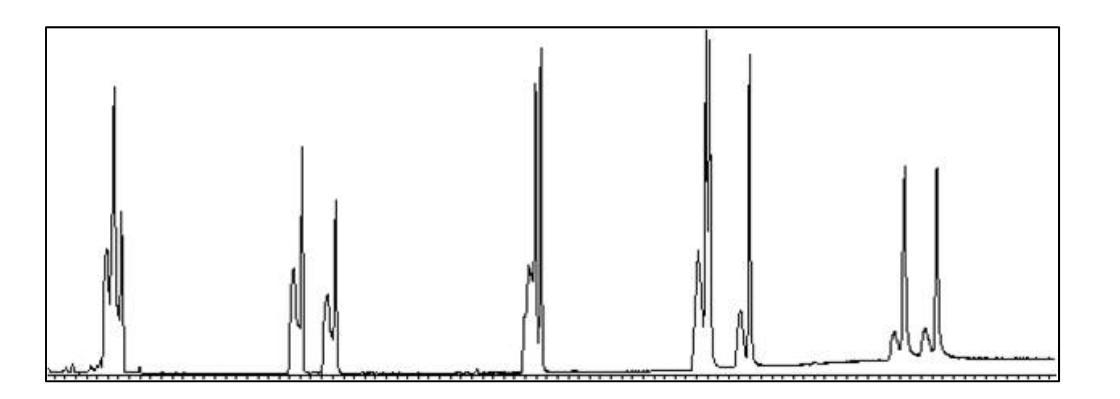
Split peaks are almost always related to the injector / inlet.

Possible Cause: Injection Technique

Erratic injections can cause split peaks. Using an autosampler can help you avoid injection inconsistencies and issues.

Possible Cause: Poor Column Installation

If split peaks occur right after installing a column, check to see if you have the right position in the injector.

Possible Cause: Mixed Sample and Solvent

Possible Cause: Poor Sample Focusing

Possible Cause: Sample degradation in the injector

Cause: Volatility Issue

Splitting in later eluting peaks indicate volatility issues. Check temperatures at transfer line, detector base, etc.

Using a single solvent for sample extraction and final dilution will help avoid peak splitting, especially for splitless injections.

Adjust the temperature, or use a retention gap, to focus your sample more.

Inlet conditions may have changed; check to be sure that temperature, flow, etc., are consistent.
