# Release Notes

Agilent Microarray Scanner Software Versions A.8.3

Agilent G2565CA Microarray Scanner

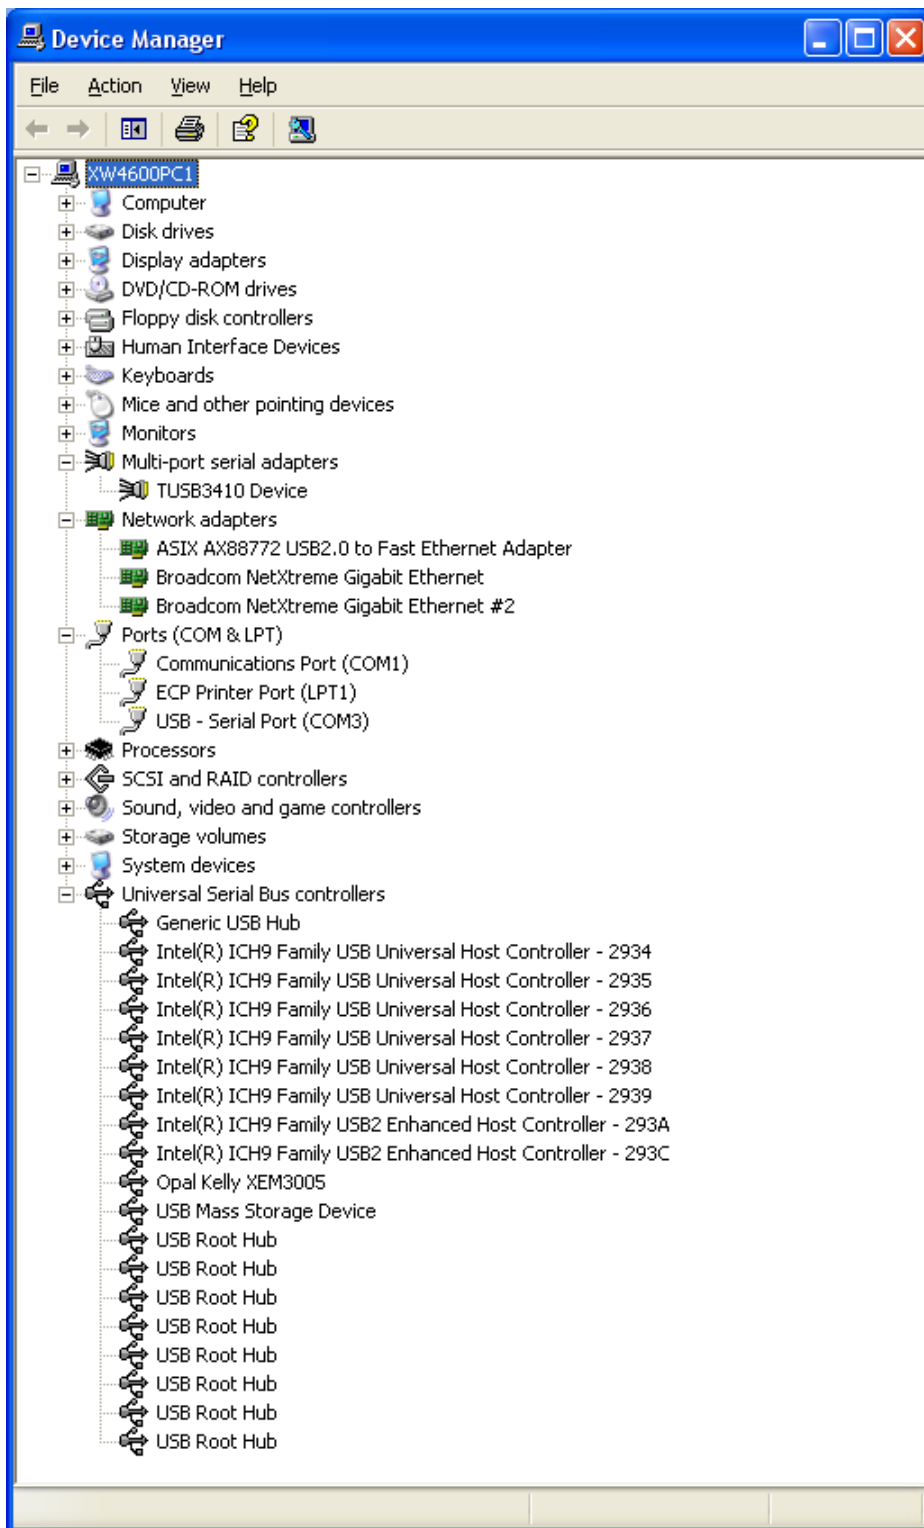
When operating correctly, these connections can all be seen in the Device Manager, as shown below. The hub is visible as "Generic USB Hub"; the data collection system can be seen as "Opal Kelly XEM3005"; the Ethernet as "ASIX AX88772" Ethernet adapter; and the serial as "USB - Serial Port (COM3)".

Use of a high-quality USB2 cable is required for correct operation of the scanner. Using a USB1 cable, or a cable with a ferrite, may result in failure to connect, or loss of data.
