Automatic Transmission Rebuilders Association

Honda

Table Of Contents

Honda/Acura

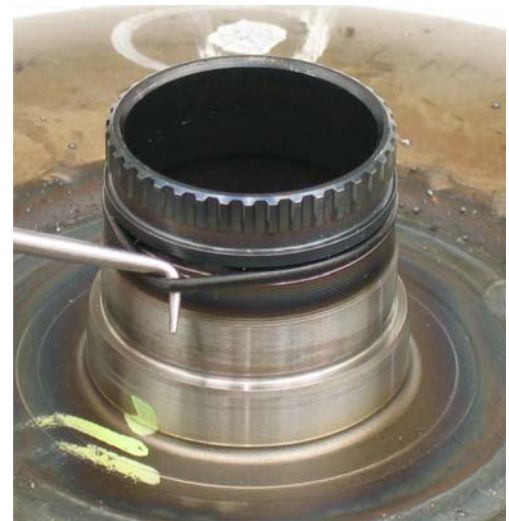
Converter Hub O-Ring (32mm x 1.9mm)

Honda Part Number:
91302-P7A-003

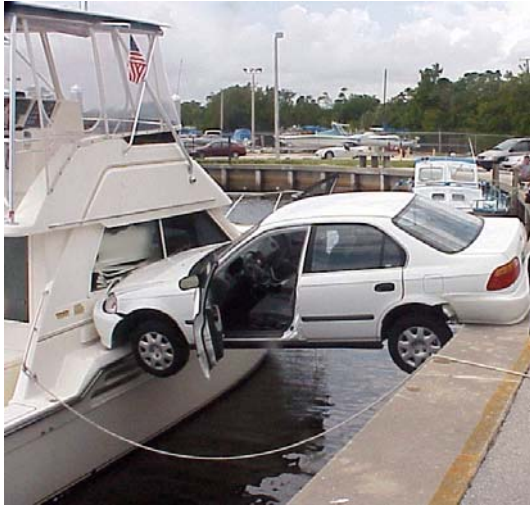
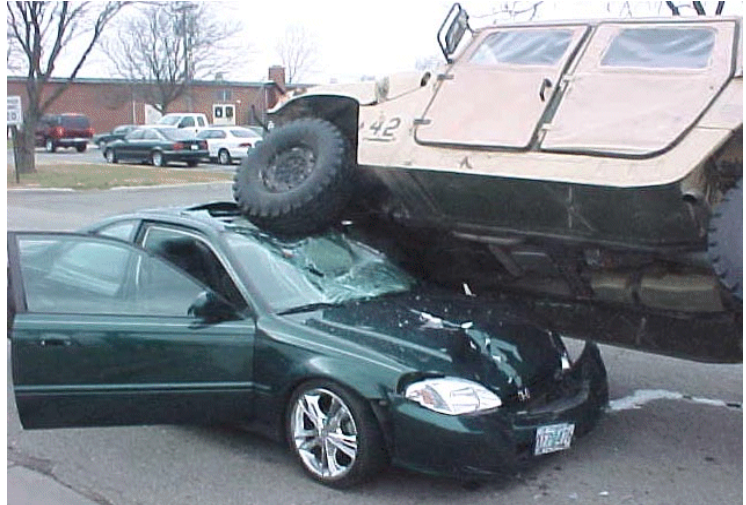
Common Transmission Problems Caused by Collision Damage

Honda/Acura automatic transmissions have all of their solenoids located externally. This makes them vulnerable to being damaged when the vehicle is involved in a collision and surrounding body parts are crushed in on the transaxle.

1. Poor shift quality, flares, bindups, neutralizing, delayed and or harsh engagements, P0715, P0730, P0740, P0780, P1750, P1751: check for bent/damaged solenoids
2. Damaged wire harnesses, improperly repaired wiring.
3. Grounds left loose, dirty, damaged, painted over, or left off.
3. Kinked cooler lines

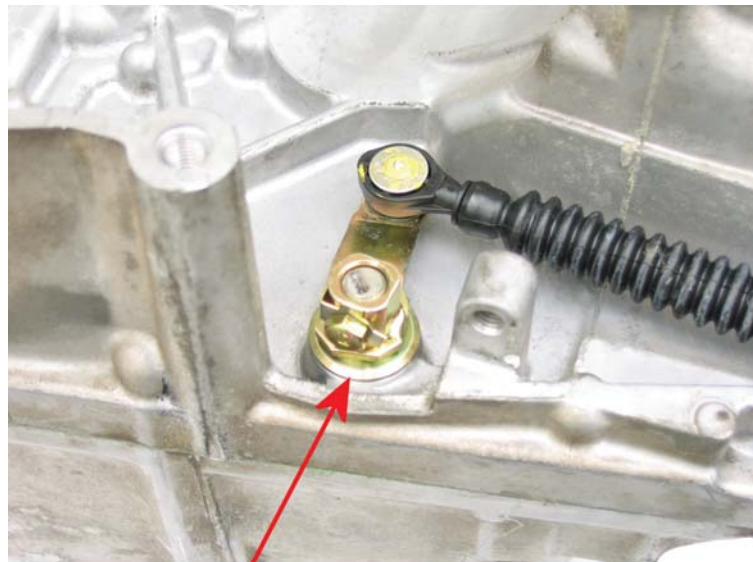
Some 1998 year model 4 cylinder Accords and 2.3CLs had a problem with the transaxle side cover casting. A selective collar was fitted behind the control lever on the control shaft to repair the affected vehicles.

**Selective Collar
fitted under Control Lever**

It is important to note the installation of this collar whenever the transaxle is removed or transaxle service work is performed and make sure the collar is reinstalled correctly.

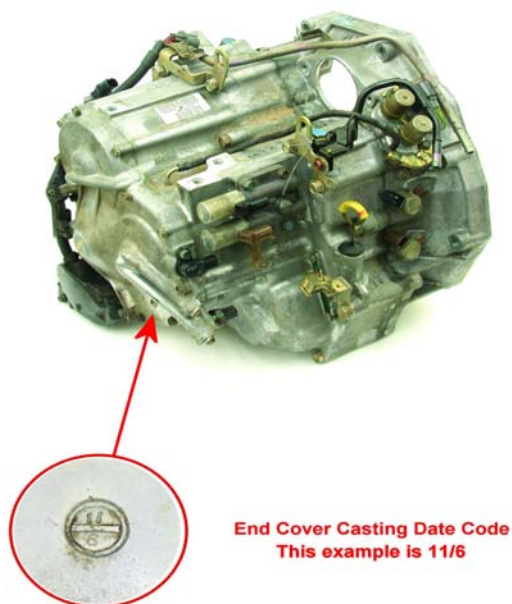
Affected 1998 side covers can be identified by the casting date code on the side cover. The date code can be cast in any position (upside down, sideways, etc.) so look carefully at the numbers to determine which way is up. The affected casting date codes are 10/19 thru 11/18. These will require the installation of the selective control shaft collar.

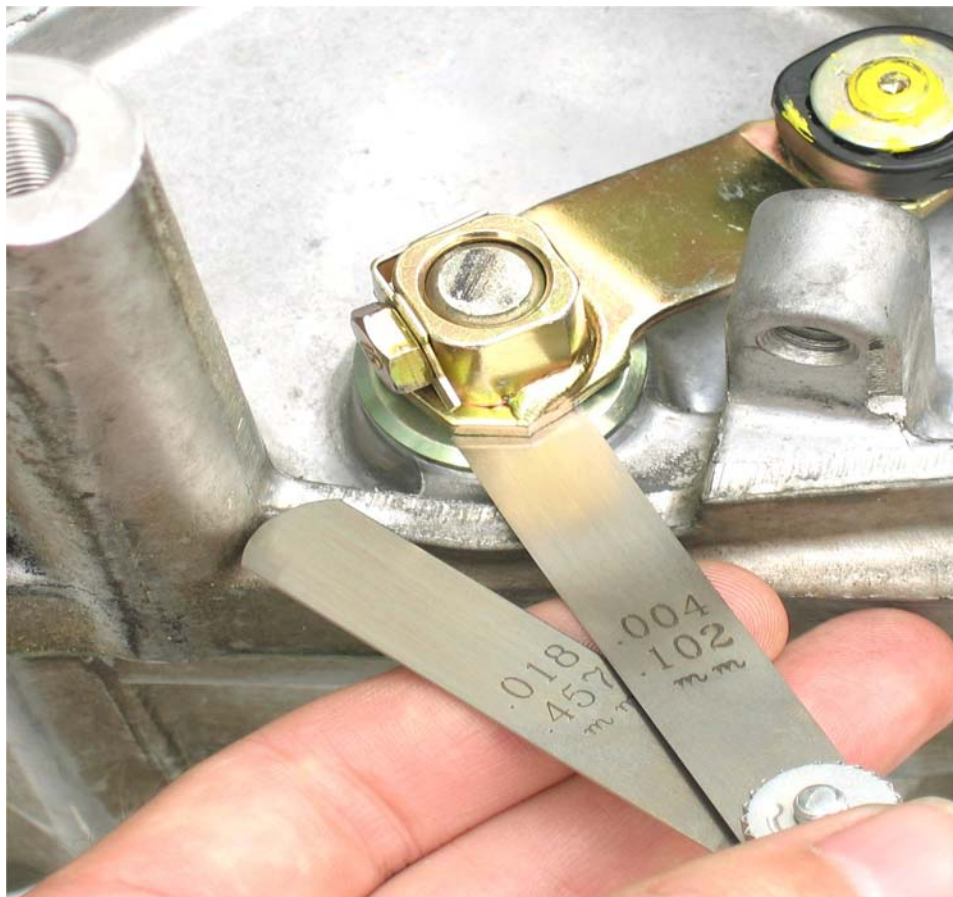
Install collar "B" behind the control lever, then check the clearance between the collar lip and control lever using a feeler gauge. The desired clearance is 0.004" to 0.018". If the clearance is not correct, select a thicker or thinner collar from the chart on the following page.

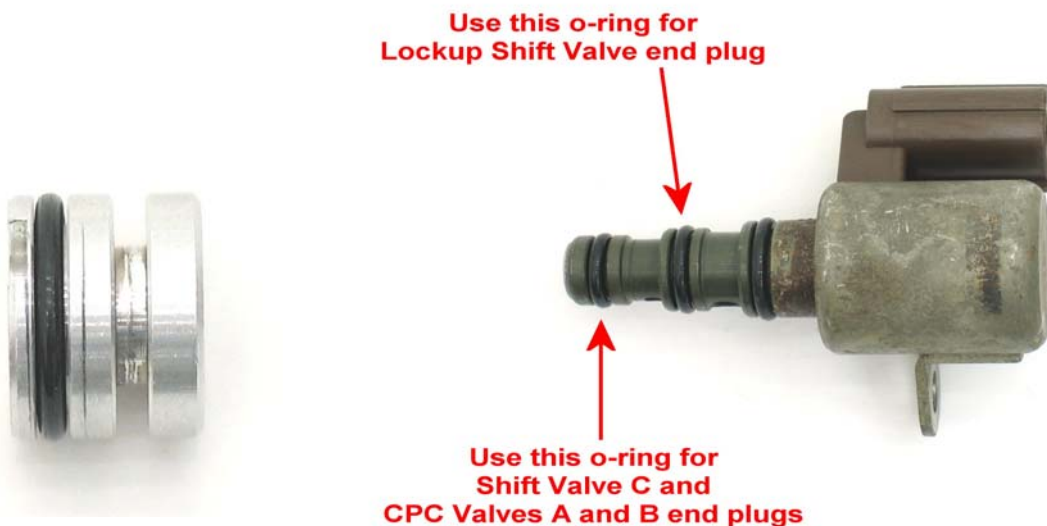
Use these lines as a guide for cutting the o-ring groove. The groove should be offset toward the valve/spring to help compensate for flexing of the retainer clip and movement under pressure.

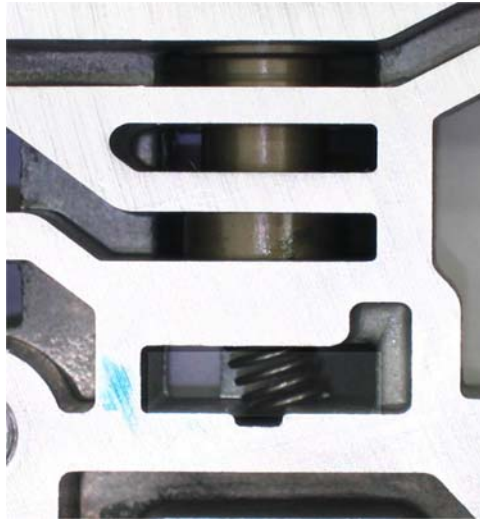
Center Springs

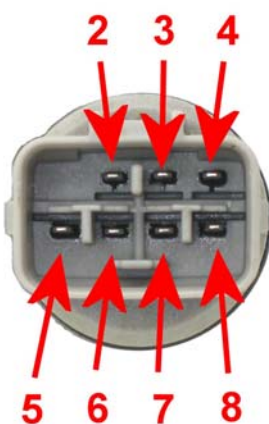
Solenoid	Measure Between	Resistance Specification
Drive Pulley Control Solenoid	Terminals 3 and 7	3.8 - 6.8 ohms
Driven Pulley Control Solenoid	Termnals 2 and 6	3.8 - 6.8 ohms
Start Clutch Control Solenoid	Terminals 4 and 8	3.8 - 6.8 ohms
Reverse Inhibitor Solenoid	Terminal 5 and the valve body	11.7 - 21.0 ohms

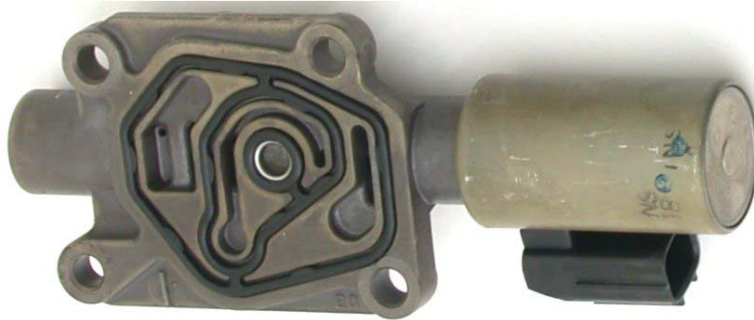
Honda Part Number: 28250-P4R-315

Linear Solenoid

Note: Civic (thru 2000), CRV (thru 2001)

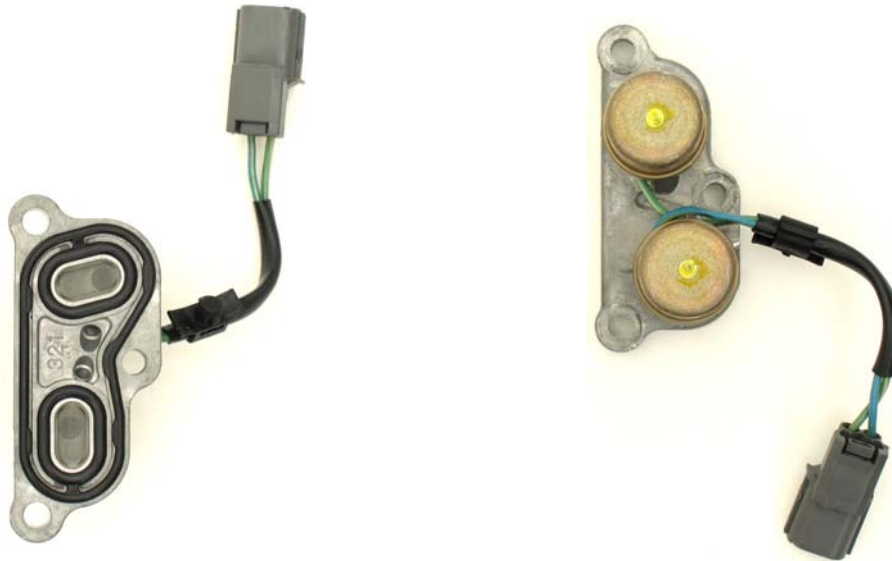
Honda Part Number 28200-P4R-003

Shift Solenoids

Notes: Civic (thru 2000), CRV (thru 2001)

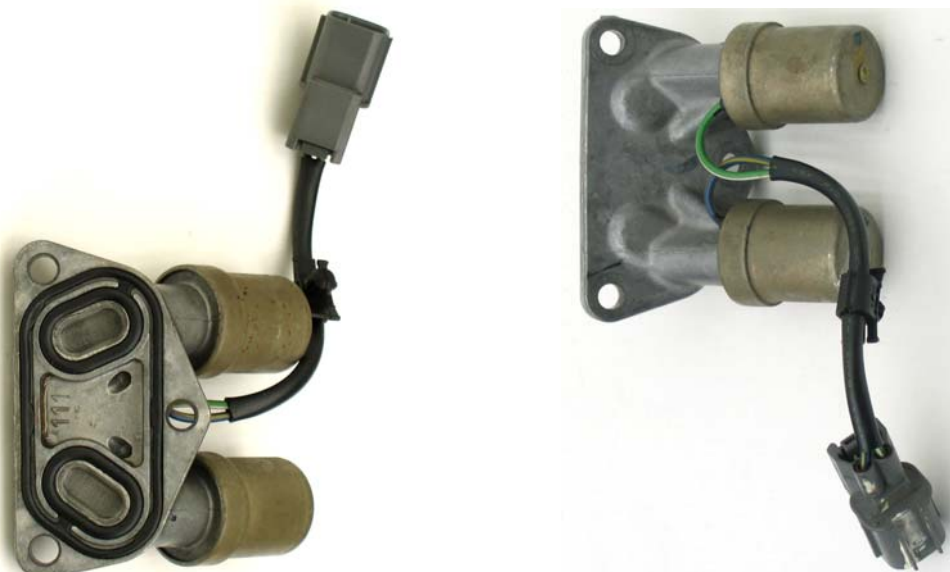
**Honda Part Number: 28200-PLX-003**

Shift Solenoids

Note: BMXA Shift Solenoid A and B assembly

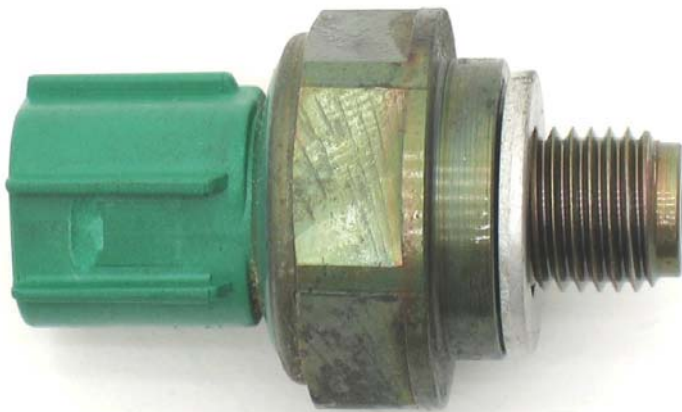
Honda Part Number: 28600-P6H-003

2nd clutch pressure switch: (Green Connector)

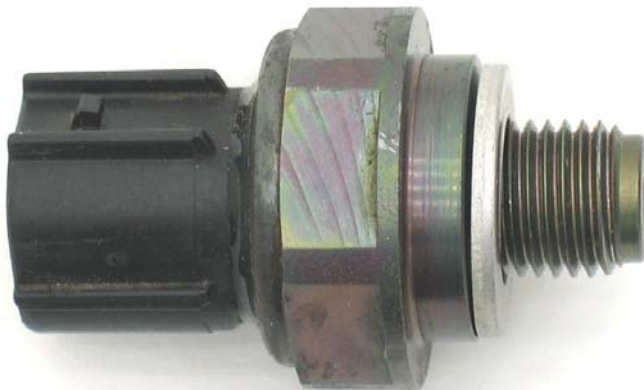
Honda Part Number: 28600-P7Z-003

3rd clutch pressure switch (black connector)
