CHRYSLER A604 (41TE) UPDATE HANDBOOK

AUTOMATIC TRANSMISSION SERVICE GROUP 9200 S. DADELAND BLVD. SUITE 720 MIAMI, FLORIDA 33156 (305) 670-4161

CHRYSLER A604 (41TE) "UPDATE HANDBOOK"

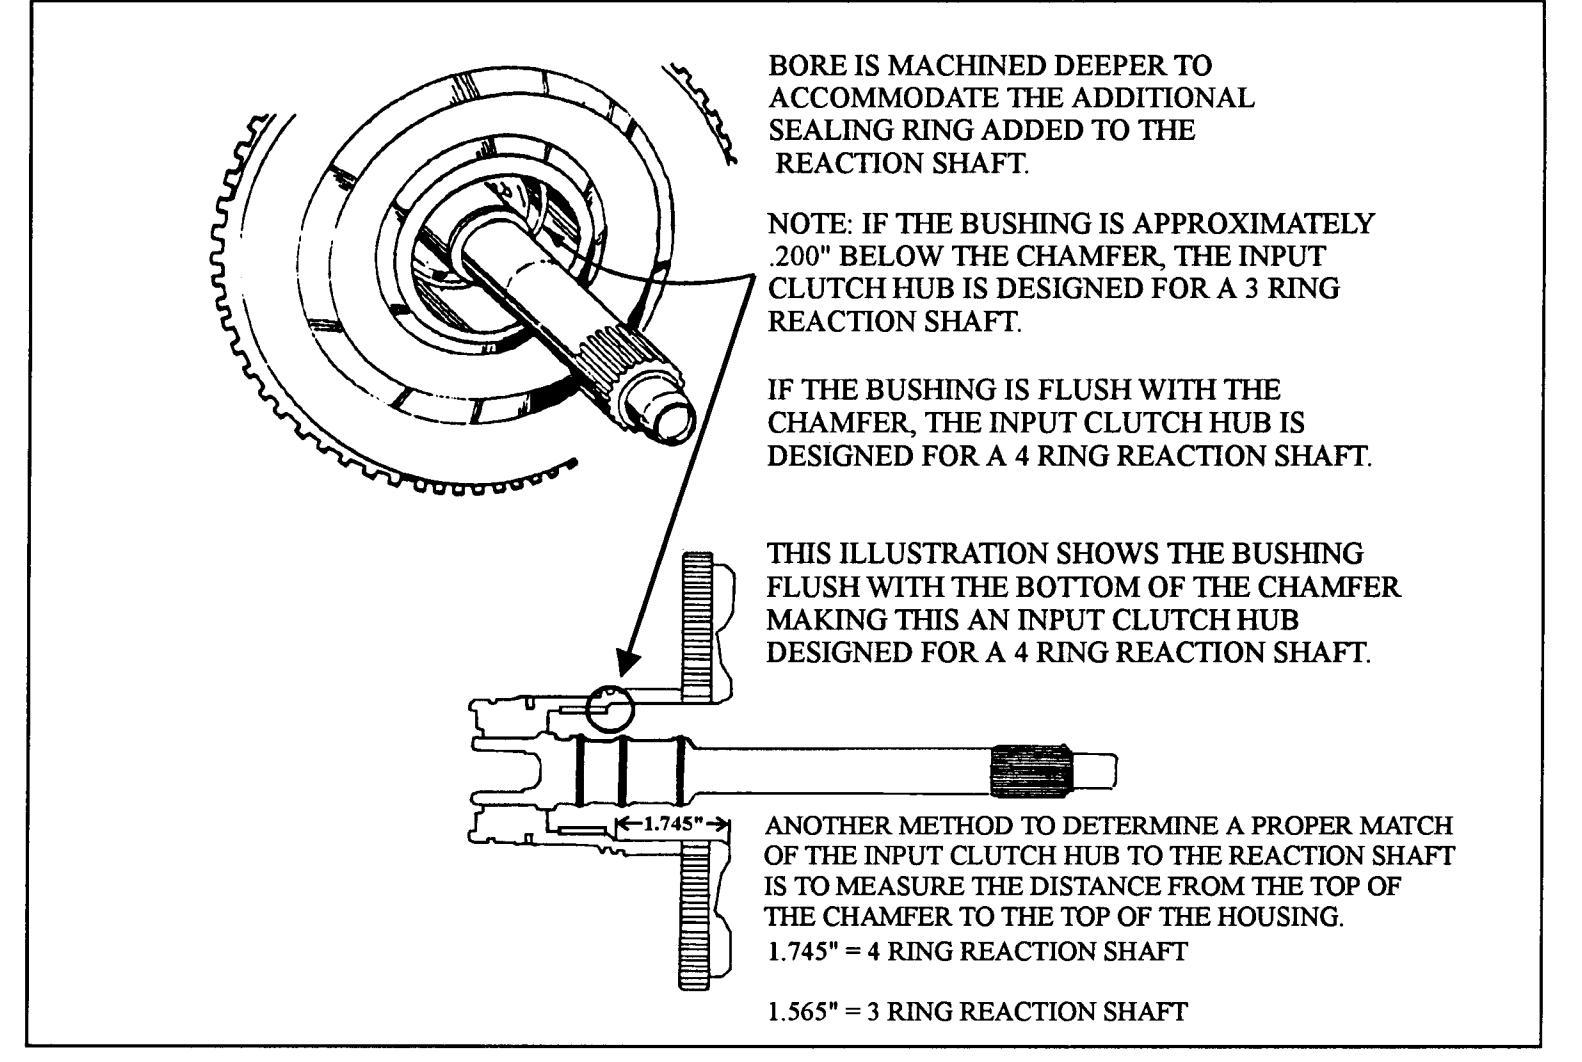
Figure 2

- (1) REACTION SHAFT SUPPORT The new support is longer, and has 4 sealing rings, where the old support only has three (See Figure 1).
- (2) INPUT SHAFT/CLUTCH HUB The new Input Clutch Hub bore is machined deeper to accommodate the additional length of the reaction shaft, created by the added sealing ring (See Figure 2). The "O" Ring grooves are also cut shallower than the old input clutch hub, which increases the groove diameter, and provides improved compression or "Crush", between the "O" rings and the input clutch retainer. (See Figure 3).

ALWAYS UPDATE to the four ring reaction shaft support. There is now available a repair package, OEM part number 4549248, that includes the following:

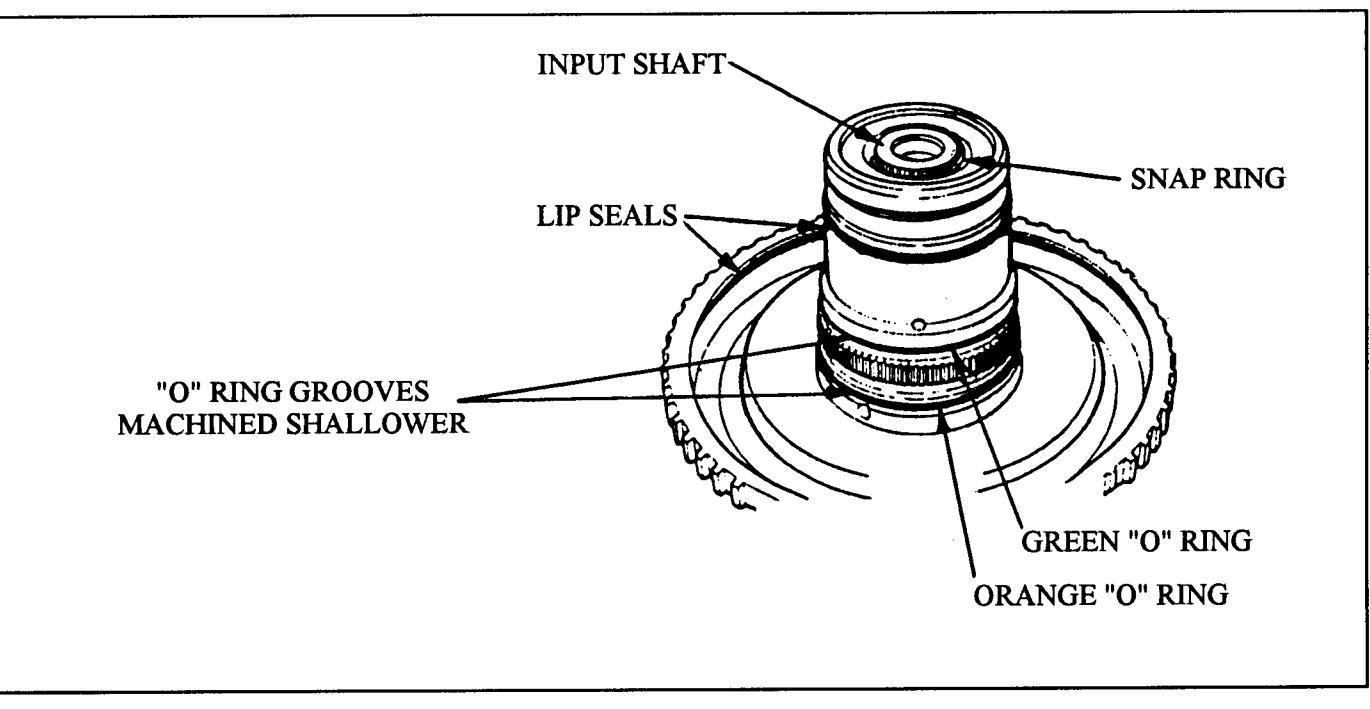
Figure 3

- (3) INPUT SHAFT/CLUTCH HUB "O" RINGS The new "O" Rings are "Teflon Coated" for greater tear resistance during the assembly process. The coatings also identify the locations for the "O" Rings. The orange ring goes to the front, and the green one goes to the rear (See Figure 3). The early "O" rings were black.

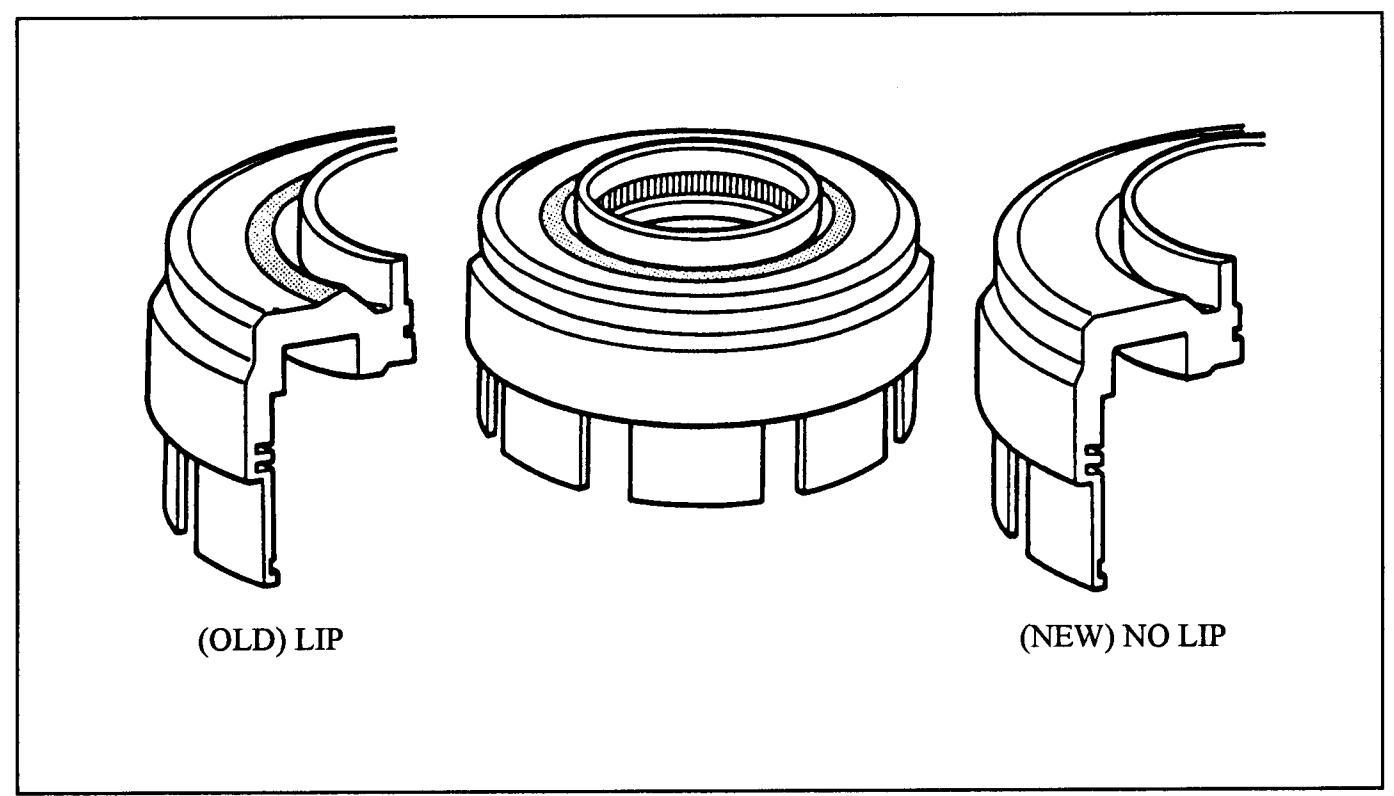
Figure 4

- (4) INPUT CLUTCH RETAINER The Input Clutch Retainer was modified, by machining off the "Lip" (See Figure 4), to allow more travel of the overdrive/reverse piston. The old Input Clutch Retainer can be machined at the local machine shop if necessary.

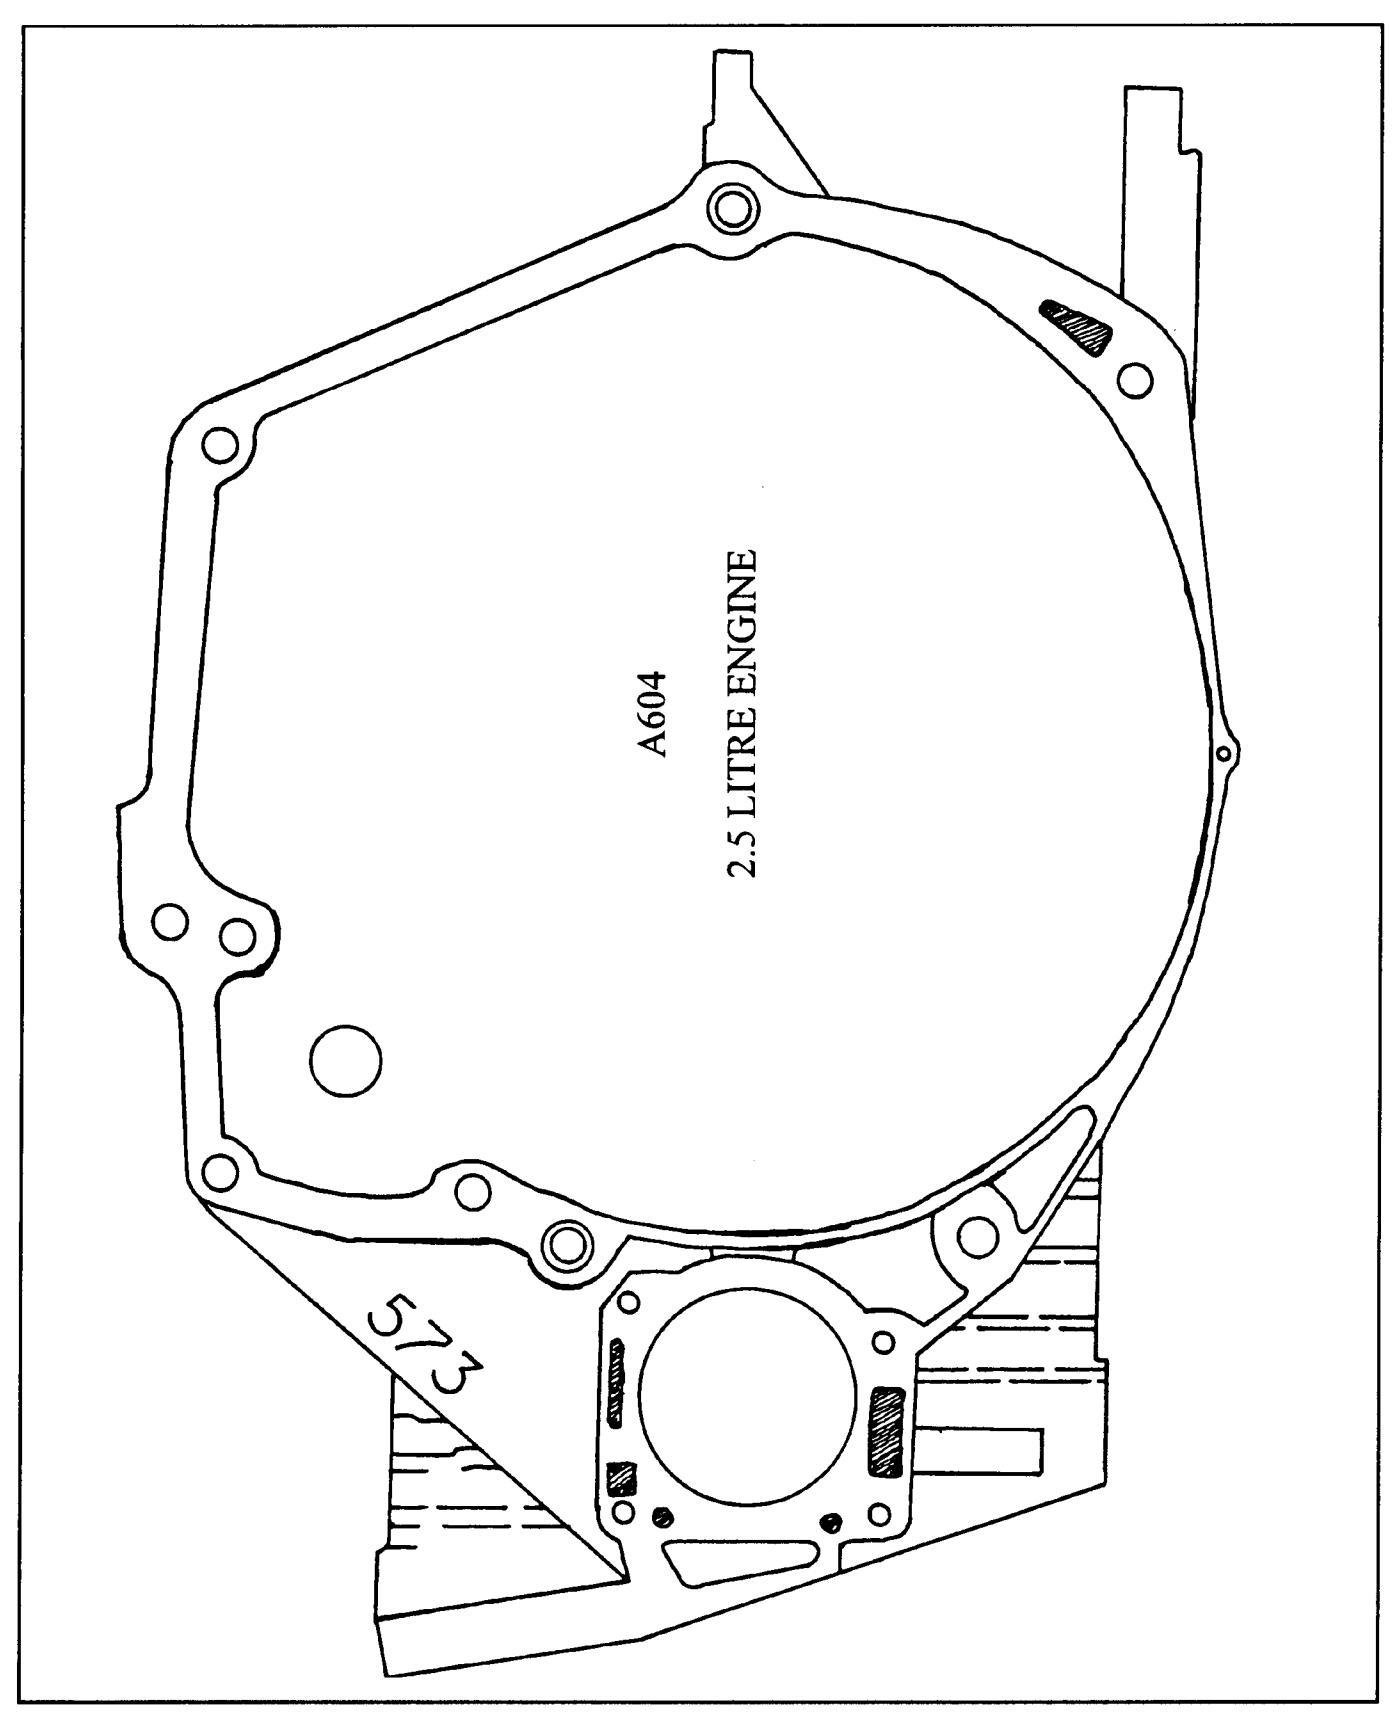
Figure 11

For the 2.5 Litre Bell Housing pattern, refer to Figure 11. For the 3.0 Litre Bell Housing pattern, refer to Figure 12.

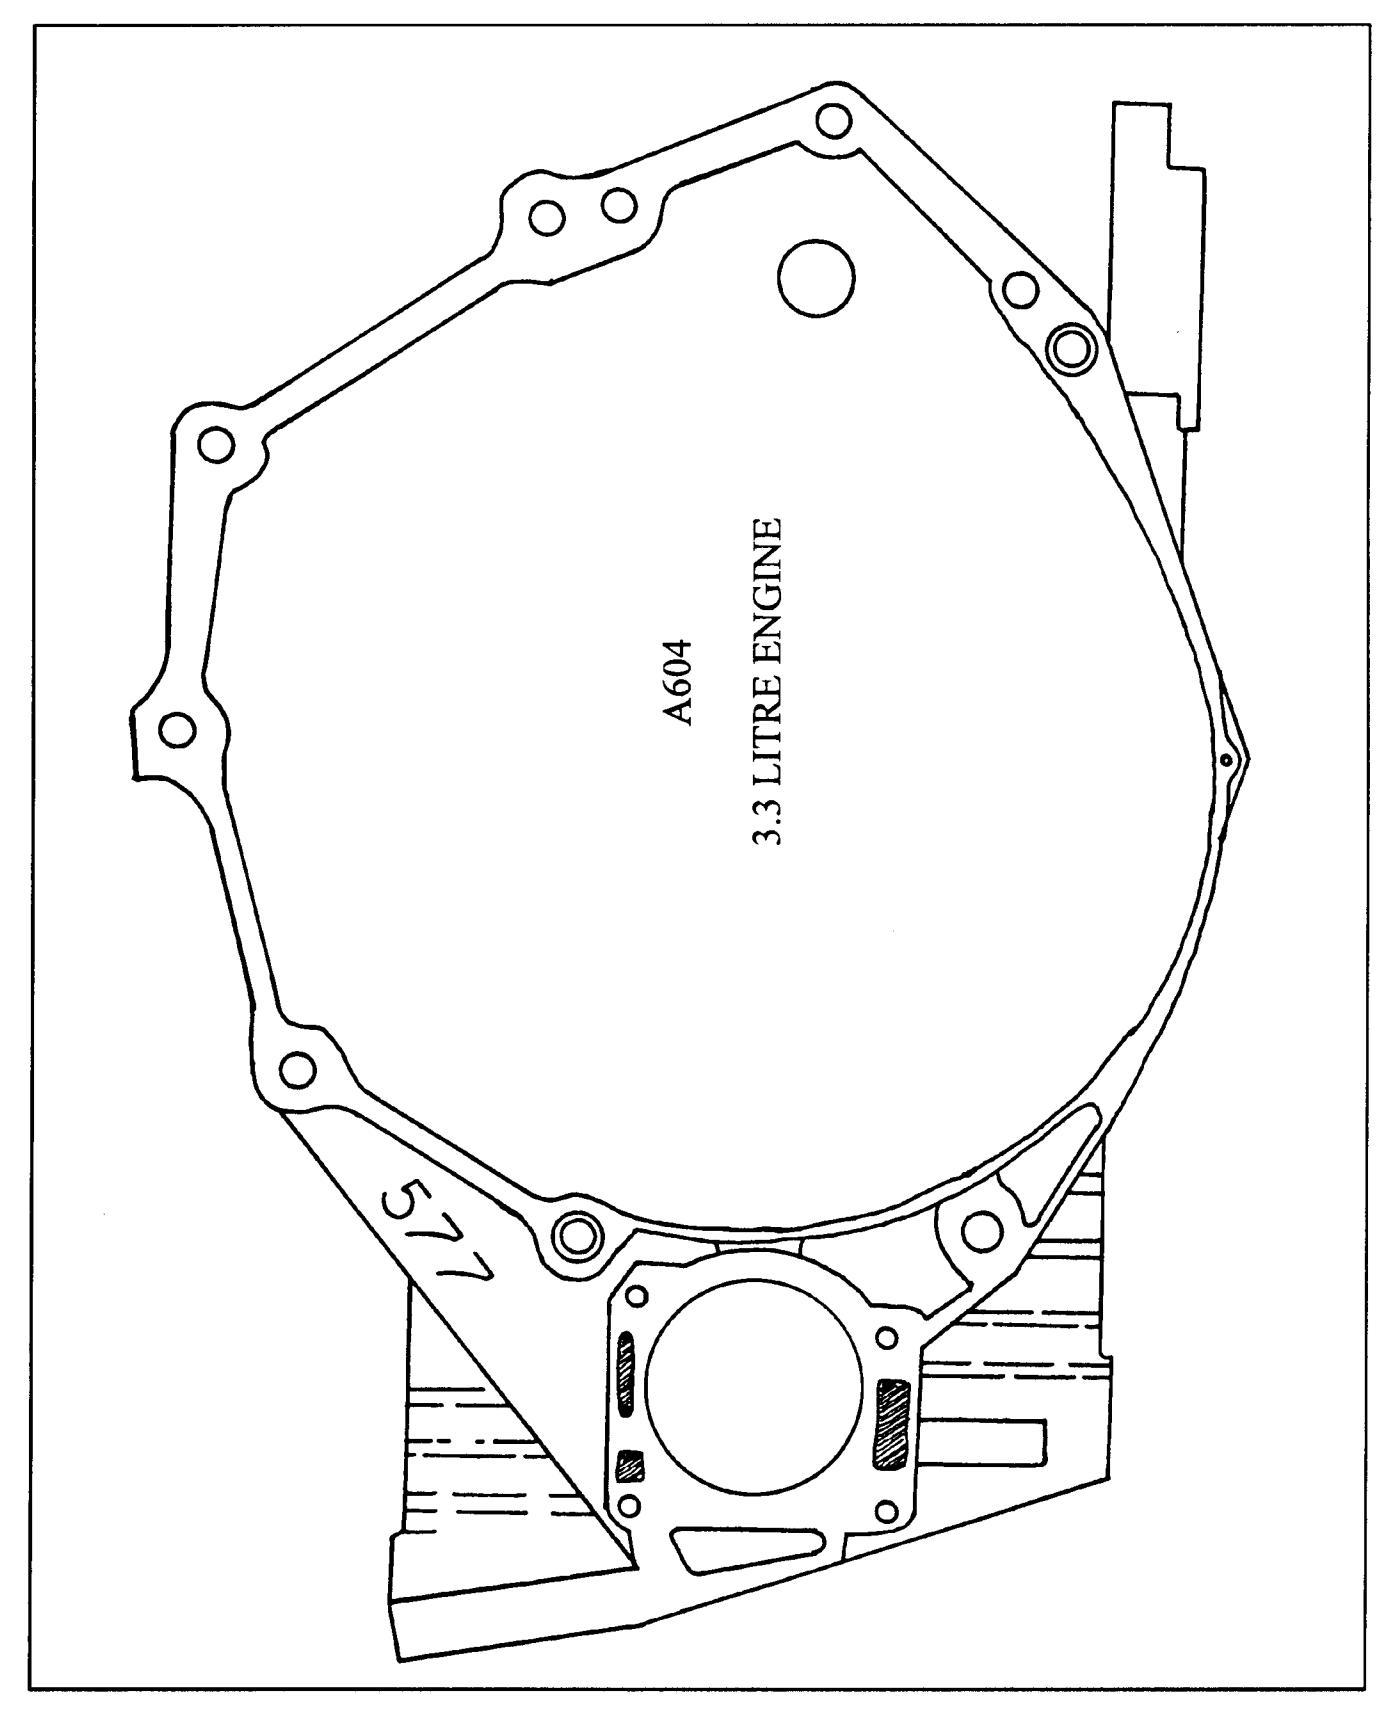
Figure 13

For the 3.3 Litre Bell Housing pattern, refer to Figure 13.

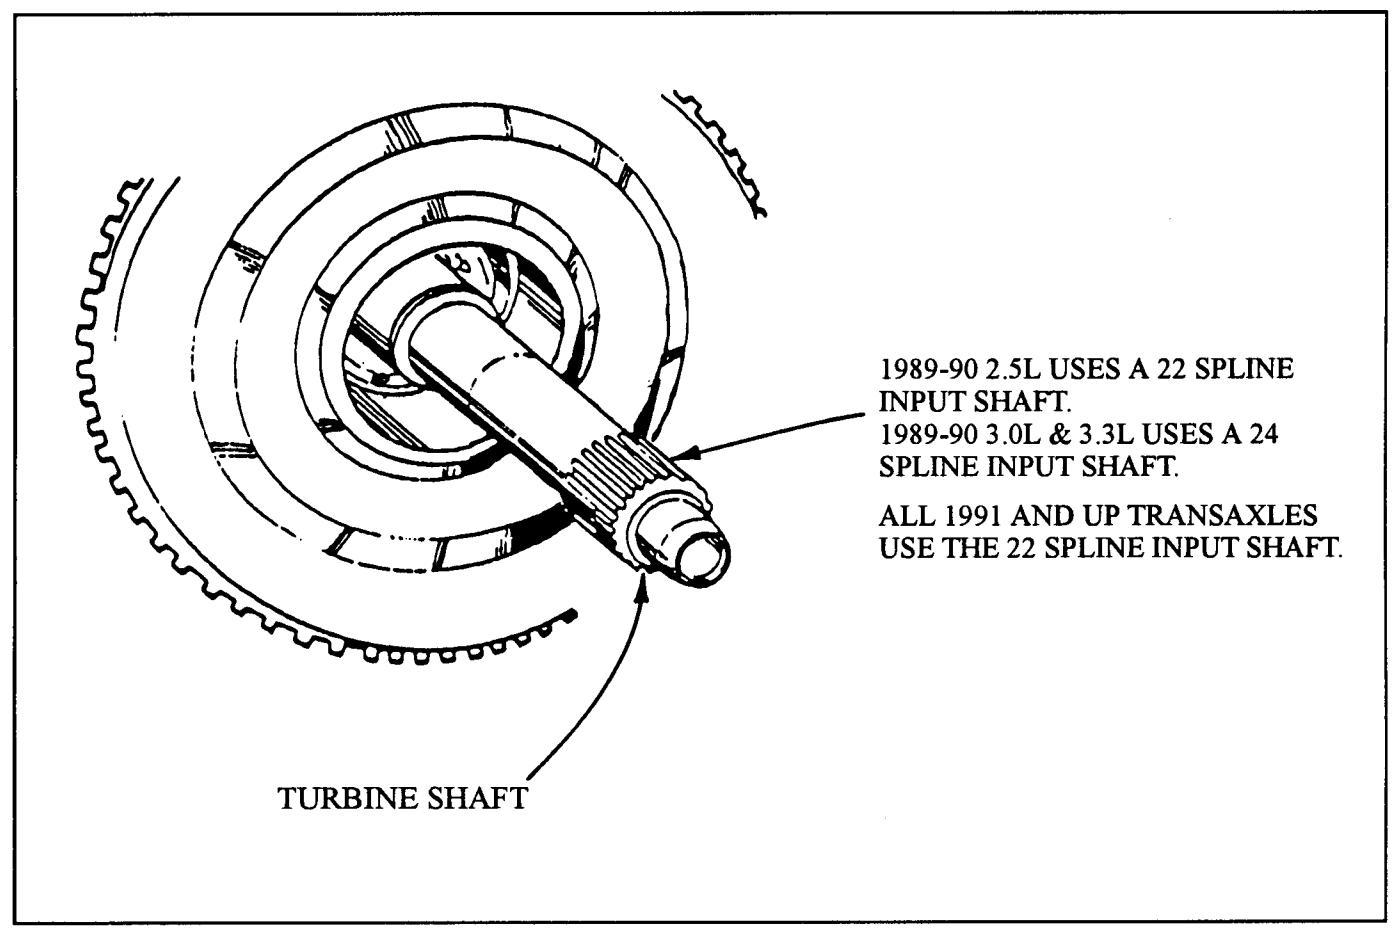
Figure 14

(2) TURBINE SHAFT SPLINES - 1989-1990 2.5 Litre engine uses a turbine shaft with 22 splines for the torque converter, and the 1989-1990 3.0 and 3.3 Litre engines will use the a 24 spline turbine shaft (See Figure 14).

NOTE: All 1991 and up A604 transaxles will use a 22 spline input shaft to fit a new torque converter with a torsional vibration damper (See Figure 14).

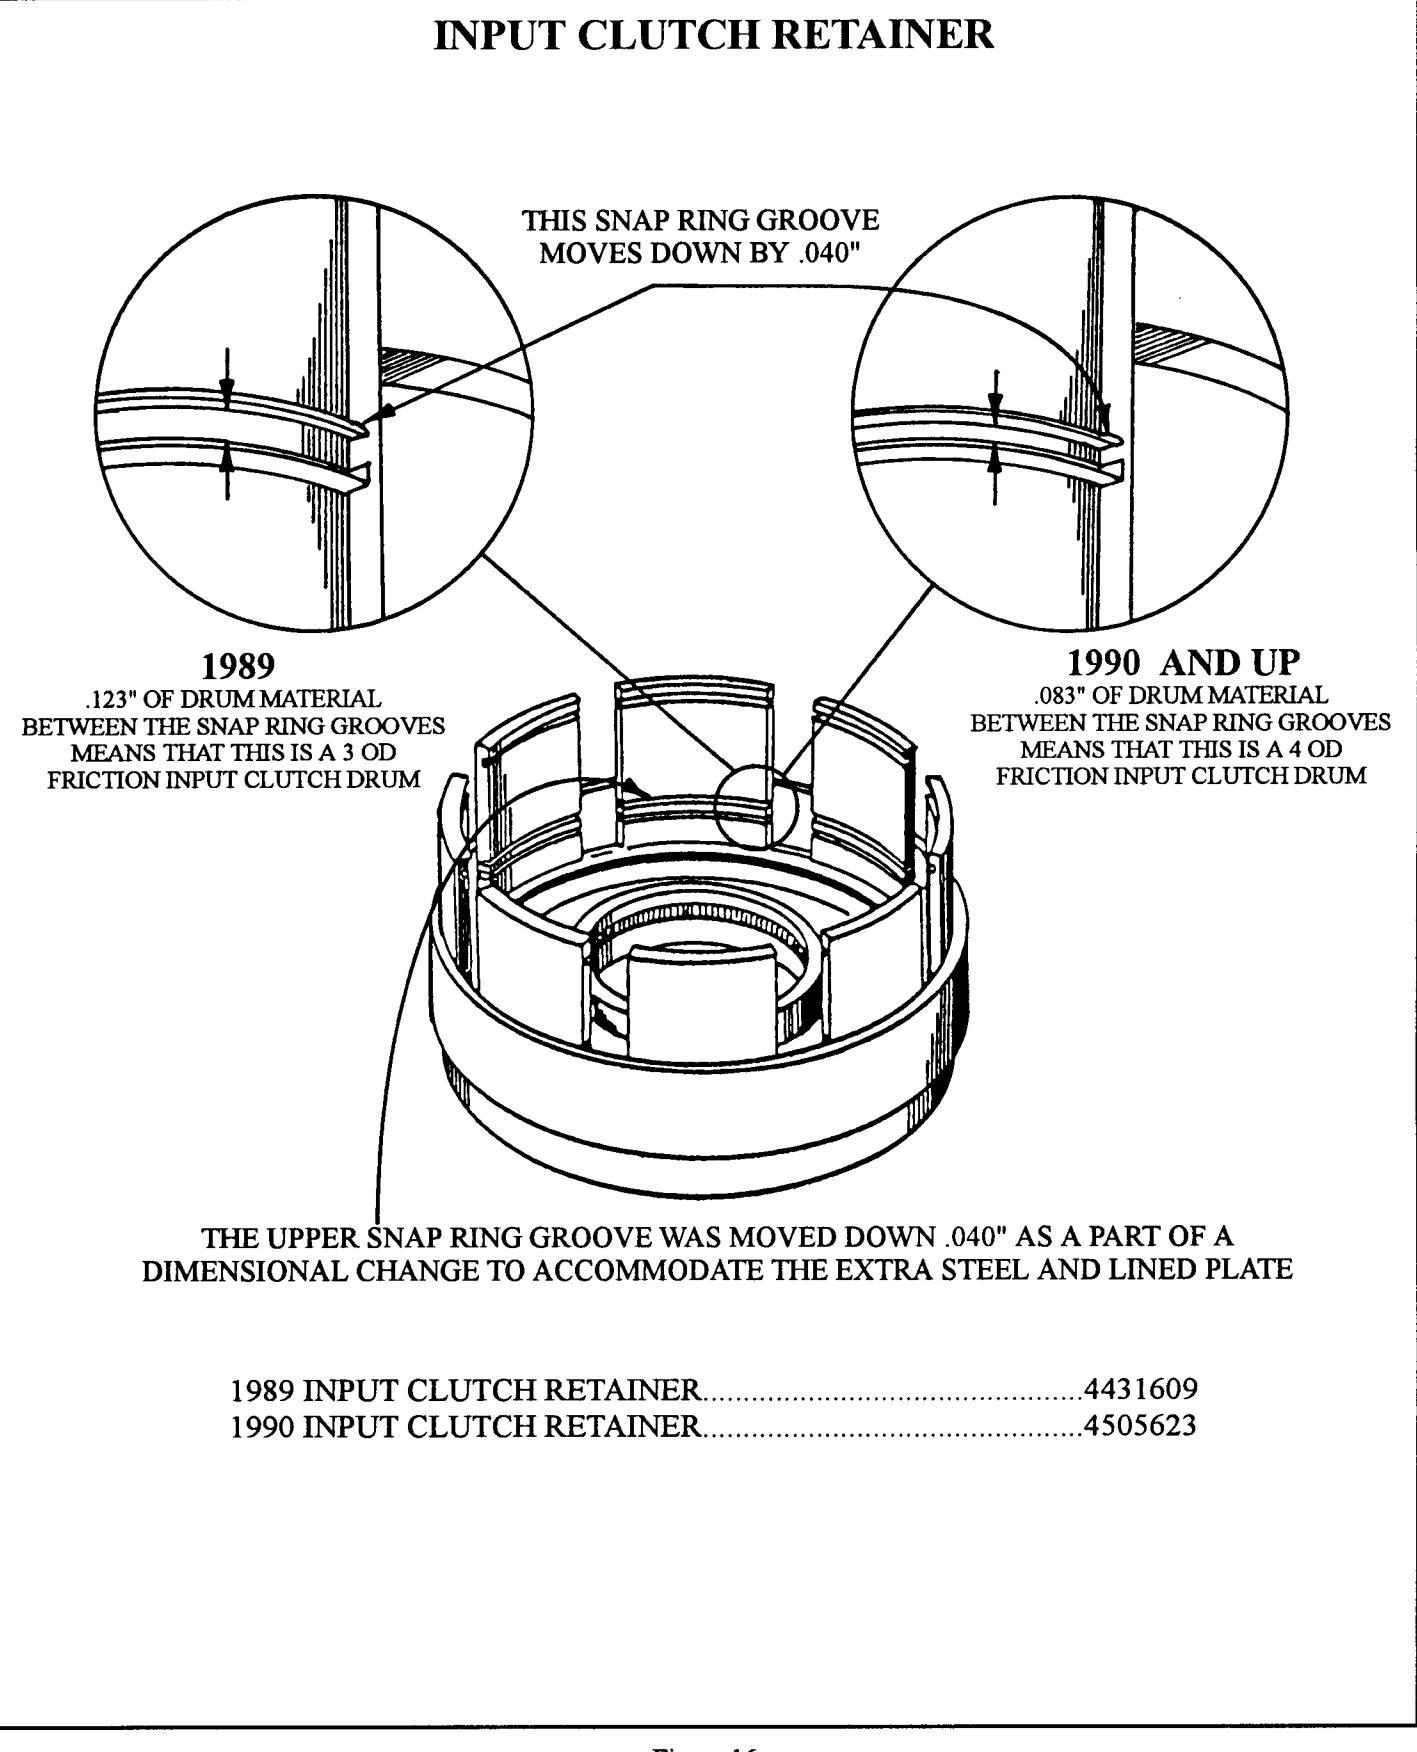
Figure 16 Automatic Transmission Service Group -25-

- (3) INPUT CLUTCH RETAINER The underdrive/overdrive reaction plate tapered snap ring groove was moved "Down" by .040" (Can be detected visually) to make room for the added lined and steel plates (See Figure 16). This also necessitated a change to be made to the underdrive/overdrive reaction plate as explained below. Another change that occurred at the same time is the underdrive clutch outer lip seal groove depth is .040" "Shallower" to accommodate a new underdrive clutch outer lip seal (See Figure 17).

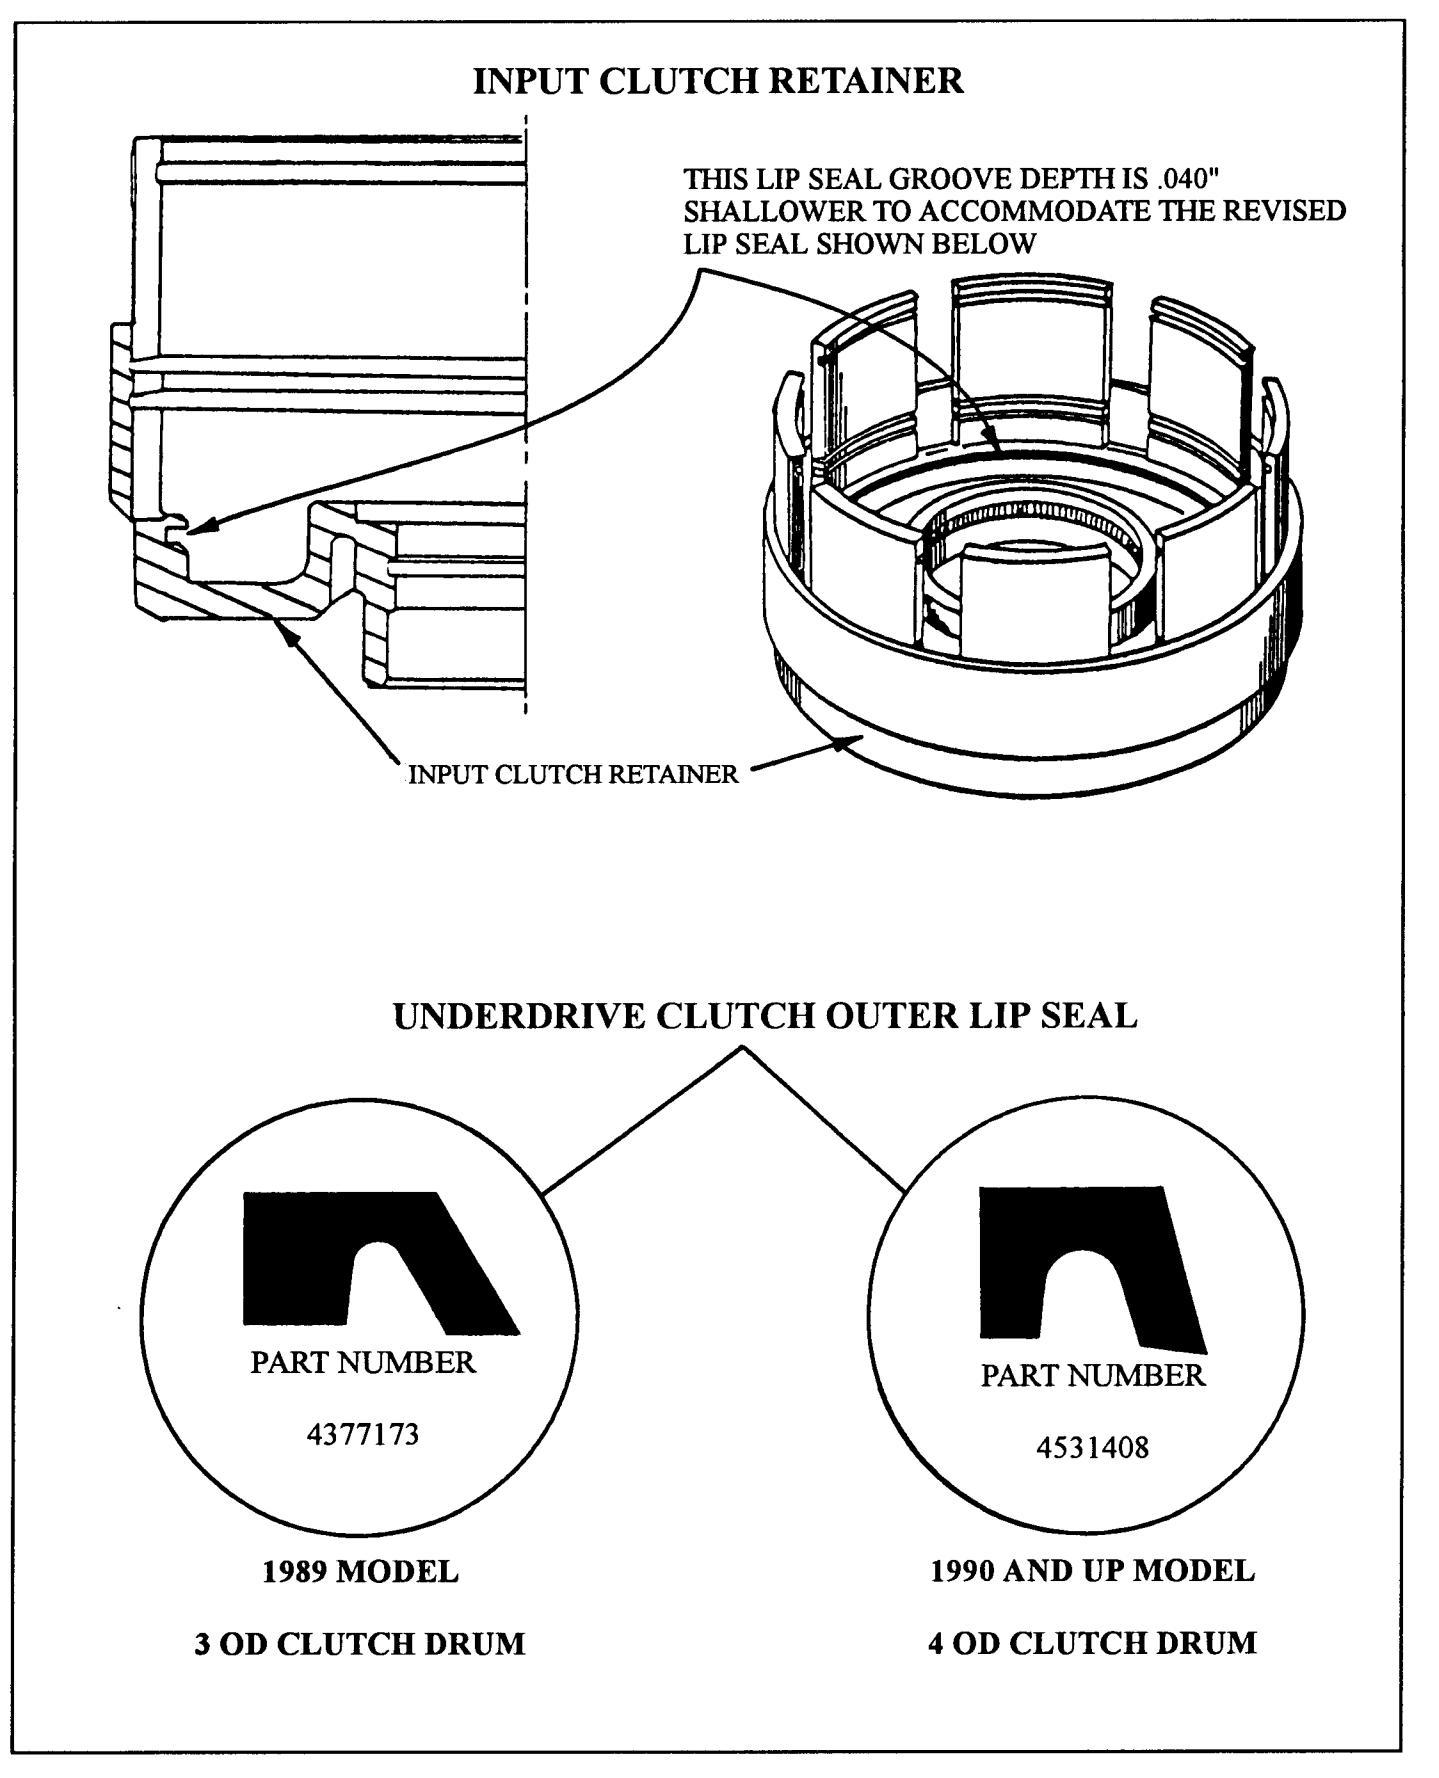
Figure 17

- (4) UNDERDRIVE CLUTCH OUTER LIP SEAL The lip seal cross section has been reduced by .040" (Smaller in Overall Diameter) to accommodate the change in the depth of the groove in the input clutch retainer (See Figure 17). The OEM part number is printed on the seals for identification. The 1989 (Large) is 4377173, and the 1990 (Small) is 4531408. This will confirm that you have the proper seal for this location (See Figure 17).

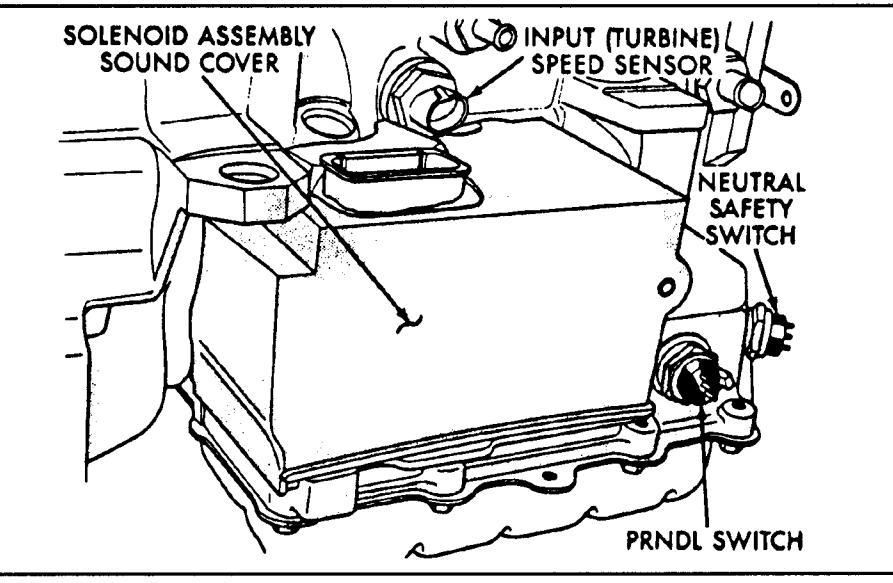
CHANGE: PRNODL Switch and Neutral Safety Switch have been changed for the 1990 model year, as well as the vehicle wiring harness connectors. Refer to Figure 20 for location of switches on the transaxle.

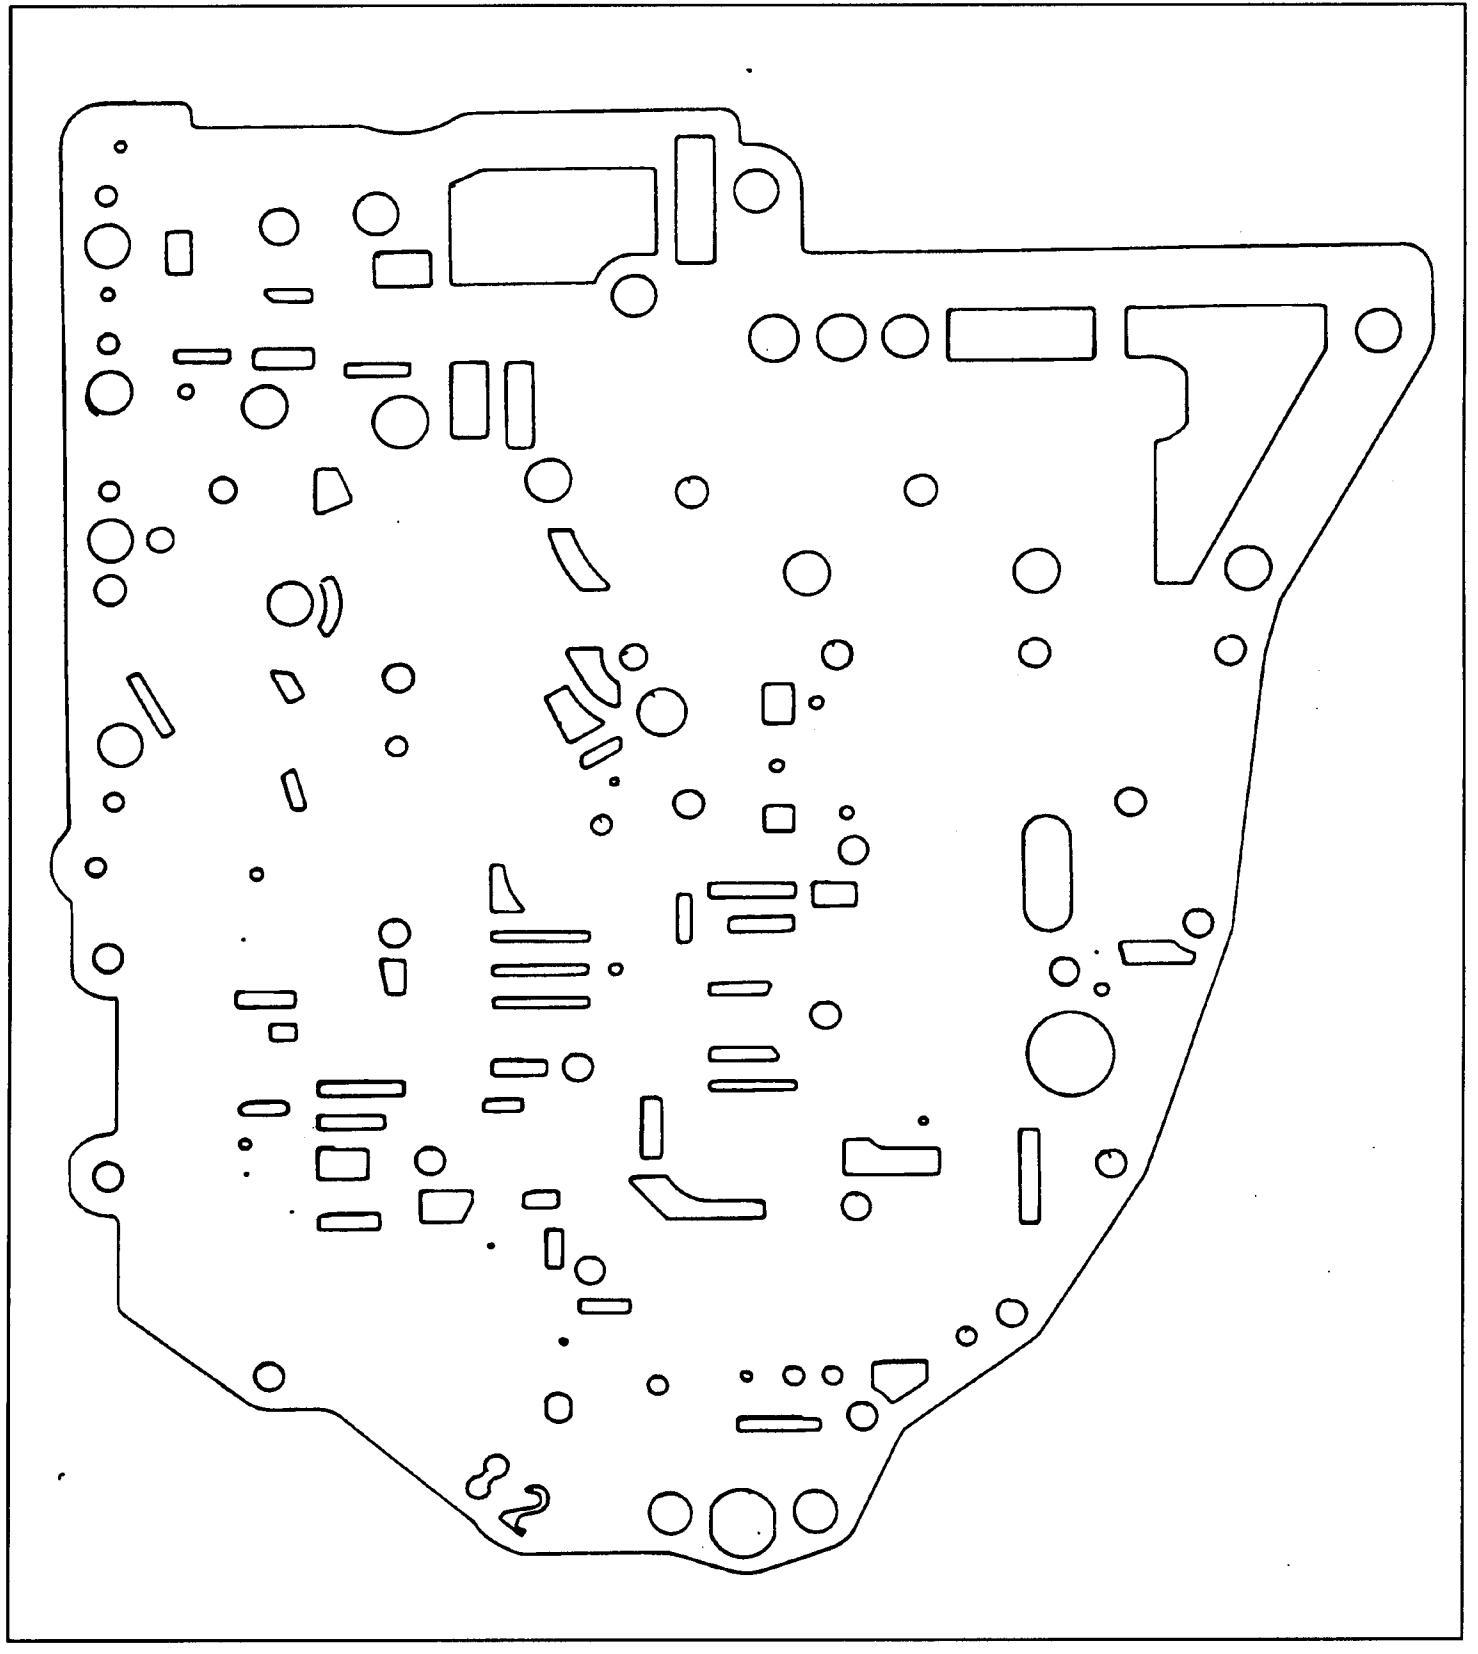
Figure 60

- CHANGE : A running change in 1994 was made to the spacer plate (See Figure 60) and to the Pressure Regulator Valve (See Figure 61).
- REASON : To eliminate a field complaint of a "Valve Body Whistle".

- (1): SPACER PLATE: The "X1 Orifice" in the spacer plate has been eliminated as shown in figure 62. The plate can be easily identified by the number "82" that is punched through the plate (See Figure 62).
- (2) : PRESSURE REGULATOR VALVE: A ground step has been machined to the inner land on the Pressure Regulator Valve causing two different diameters to exist on one land (See Figure 63). There are no obvious or visible signs or identification marks to indicate the updated Pressure Regulator Valve. Careful measurement of the valve land is needed to properly identify the valve (See Figure 63). The spring side of the land measures approximately .6255". The opposite end of the same land will measure approximately .6245" (See Figure 63).

The new "82" spacer plate replaces the previous "96" spacer plate and can retrofit back to all valve bodies and Transfer Plates that use the # 96 spacer plate provided that the new pressure regulator valve is used together with the # 82 spacer plate. Valve bodies that use a 96 spacer plate has a casting number of 4511644 (See Figure 52 on Page 68). Transfer Plates that use the # 96 spacer plate has a casting number of 4511645 (See Figure 54 on Page 70).

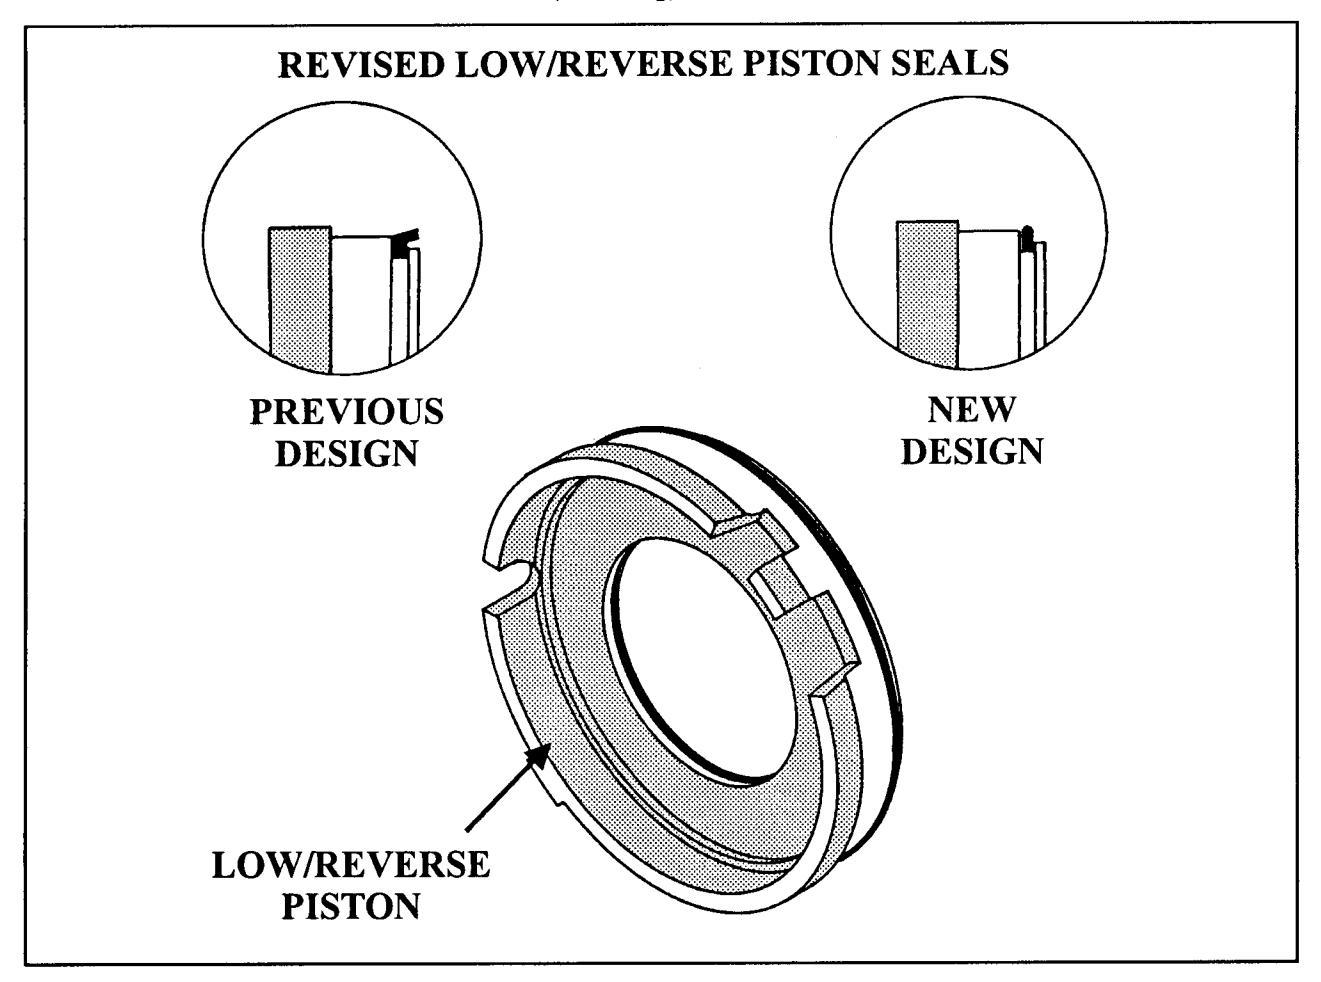
Figure 65 Automatic Transmission Service Group

CHANGE: Beginning at the start of production for 1995 model year, all Chrysler A604 (41TE) and A 606 (42LE) transaxles were produced using revised seals for the Low/Reverse piston. The previous "Lip" type seals have been replaced by a "D" Ring type seal for both inner and outer seals, as shown in Figure 65.

(1) LOW/REVERSE PISTON SEALS - Both the inner and outer lip seals have been replaced by a "D" Ring type seal, as shown in Figure 65. There were no dimensional changes necessary to the Low/Reverse piston to accommodate the new "D" Ring seals. The seals are available under OEM part number 4659185 for the outer seal, and 4659184 for the inner seal.

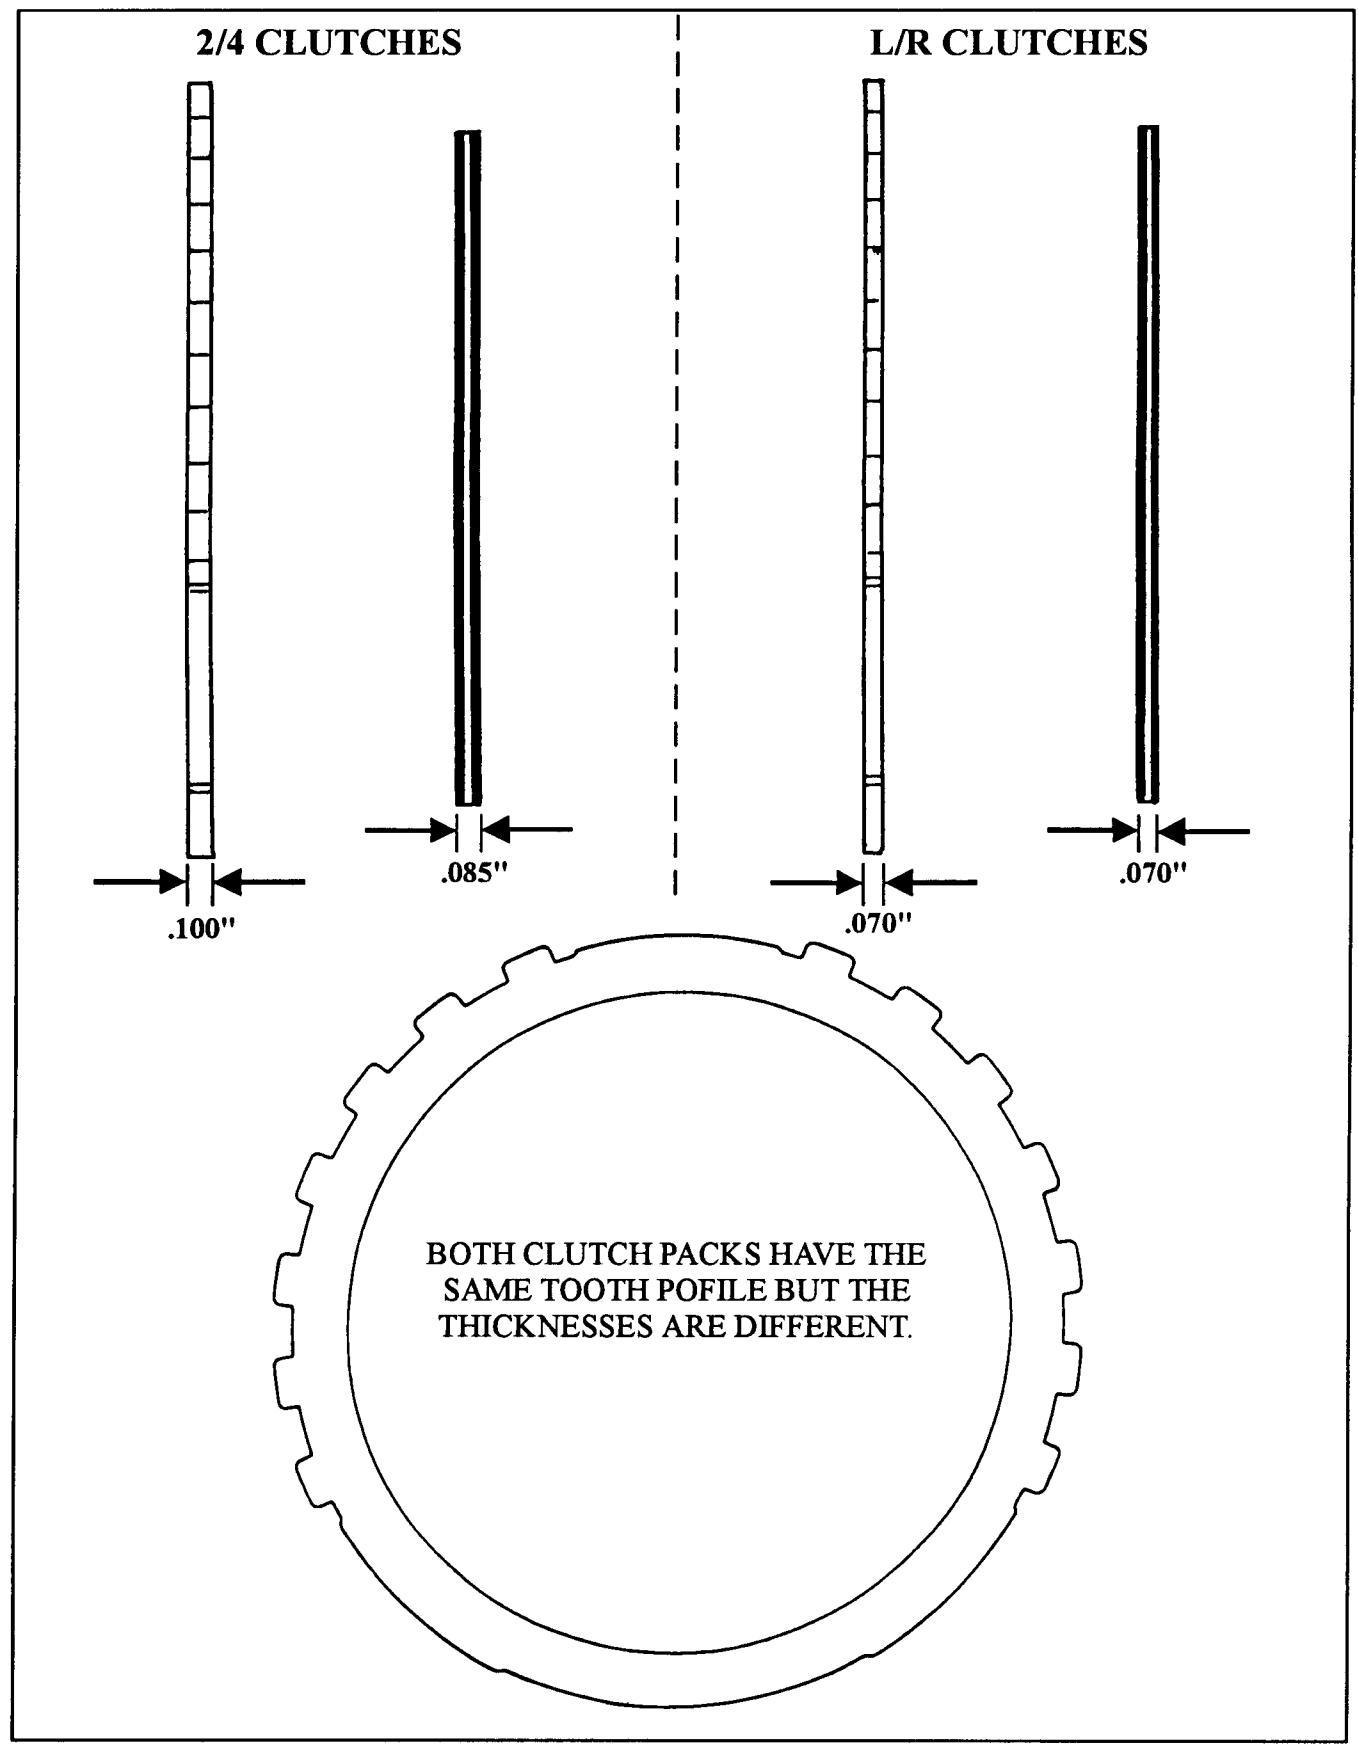
Figure 67

- (1) Both clutch packs, on the steel plates, have the same tooth profile, but the thicknesses are different (See Figure 67).
 - A. 2/4 STEEL PLATE THICKNESS IS .100" (4 Required).
 - B. L/R STEEL PLATE THICKNESS IS .070" (5 Required).
- (2) Both clutch packs, on the lined plates, have the same tooth count and the same lining, but the thicknesses are different (See Figure 67).
