CHRYSLER A604 (41TE) UPDATE HANDBOOK

AUTOMATIC TRANSMISSION SERVICE GROUP 9200 S. DADELAND BLVD. SUITE 720 MIAMI, FLORIDA 33156 (305) 670-4161

CHRYSLER A604 (41TE) "UPDATE HANDBOOK"

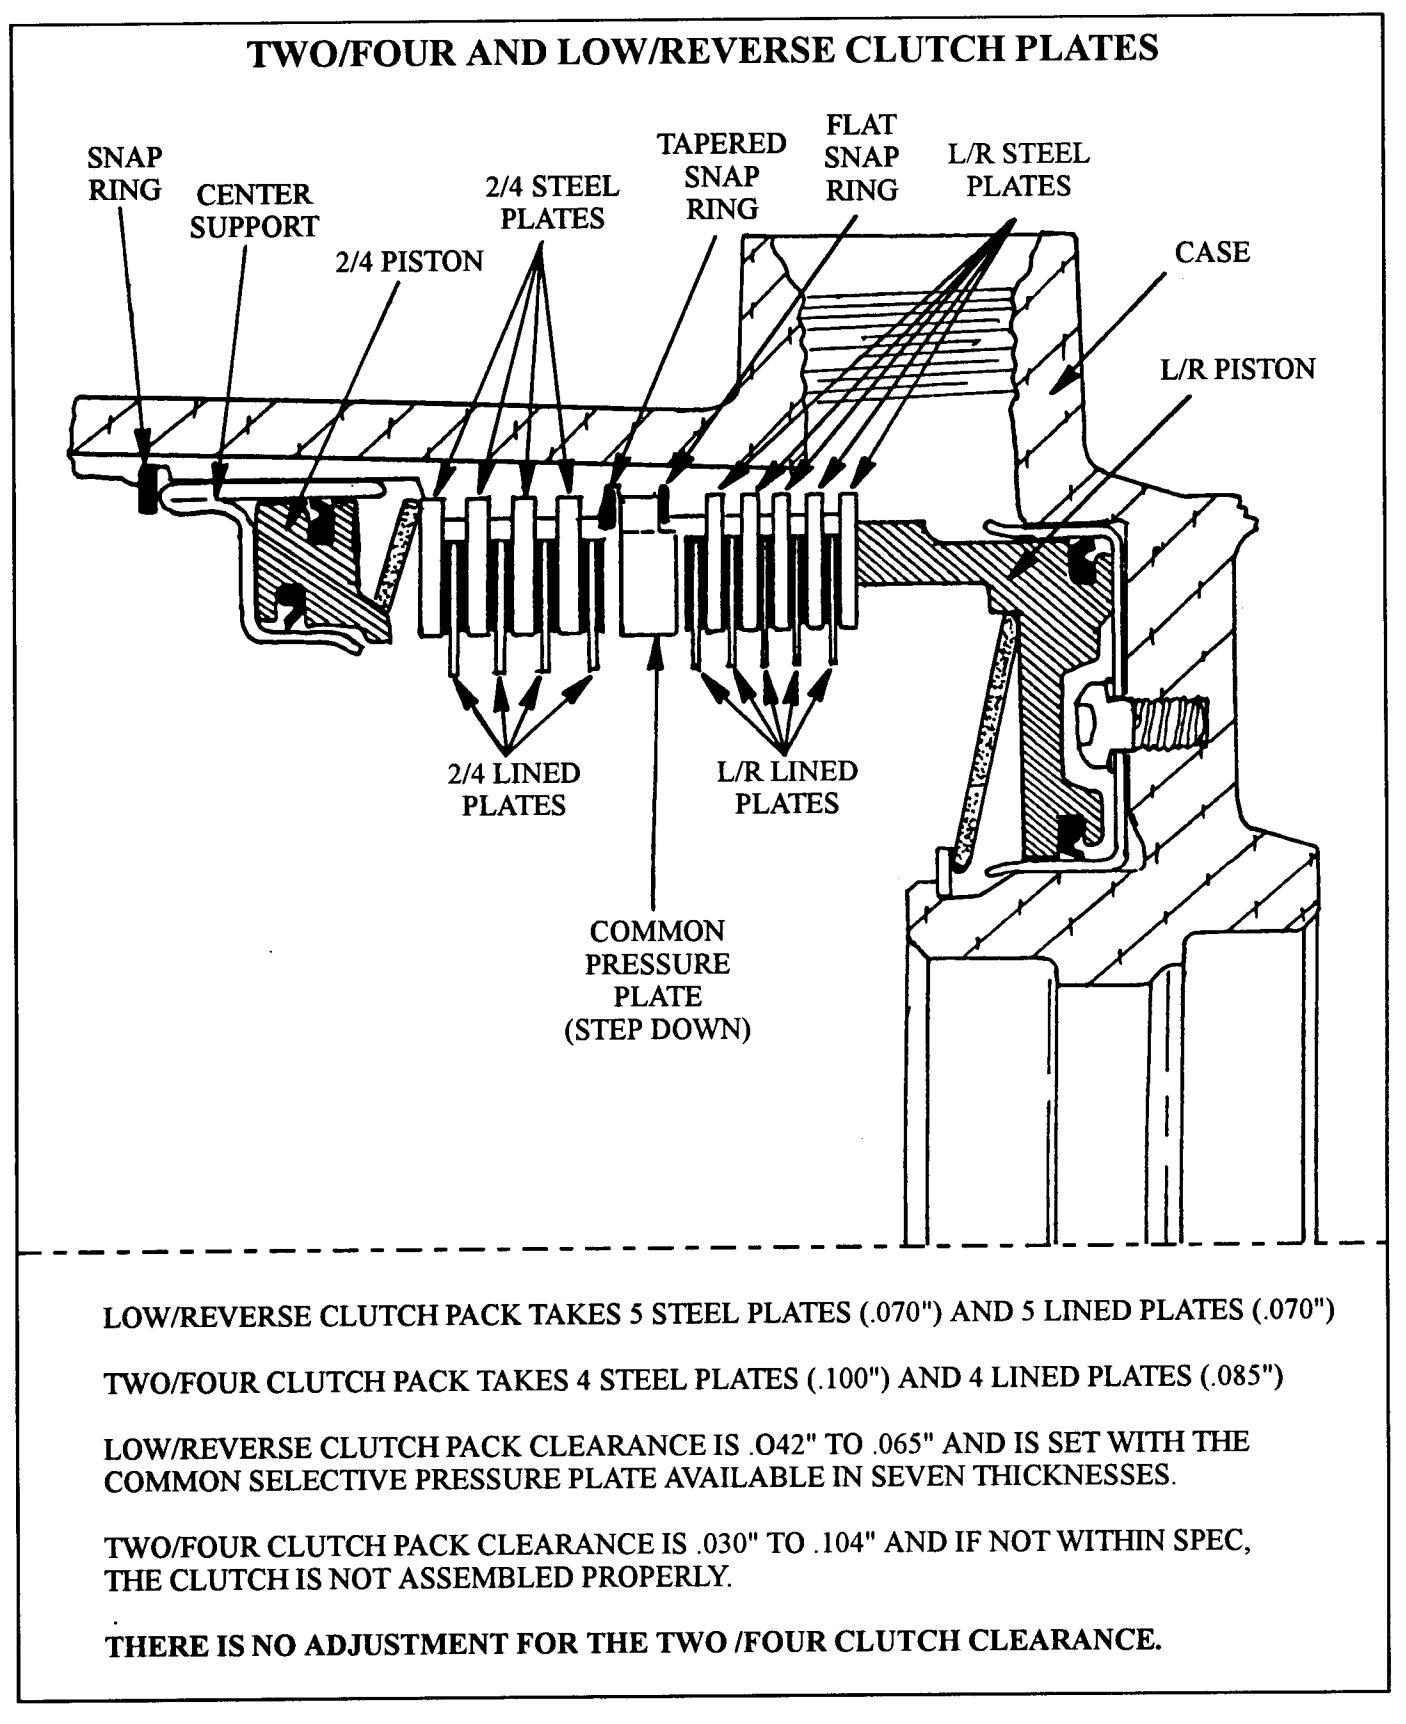
Figure 68 Automatic Transmission Service Group -87-

We have provided you with the correct clutch plate arrangement to assist you with proper assembly of the 2/4 and L/R clutch packs. Refer to Figure 68 for proper assembly procedures.

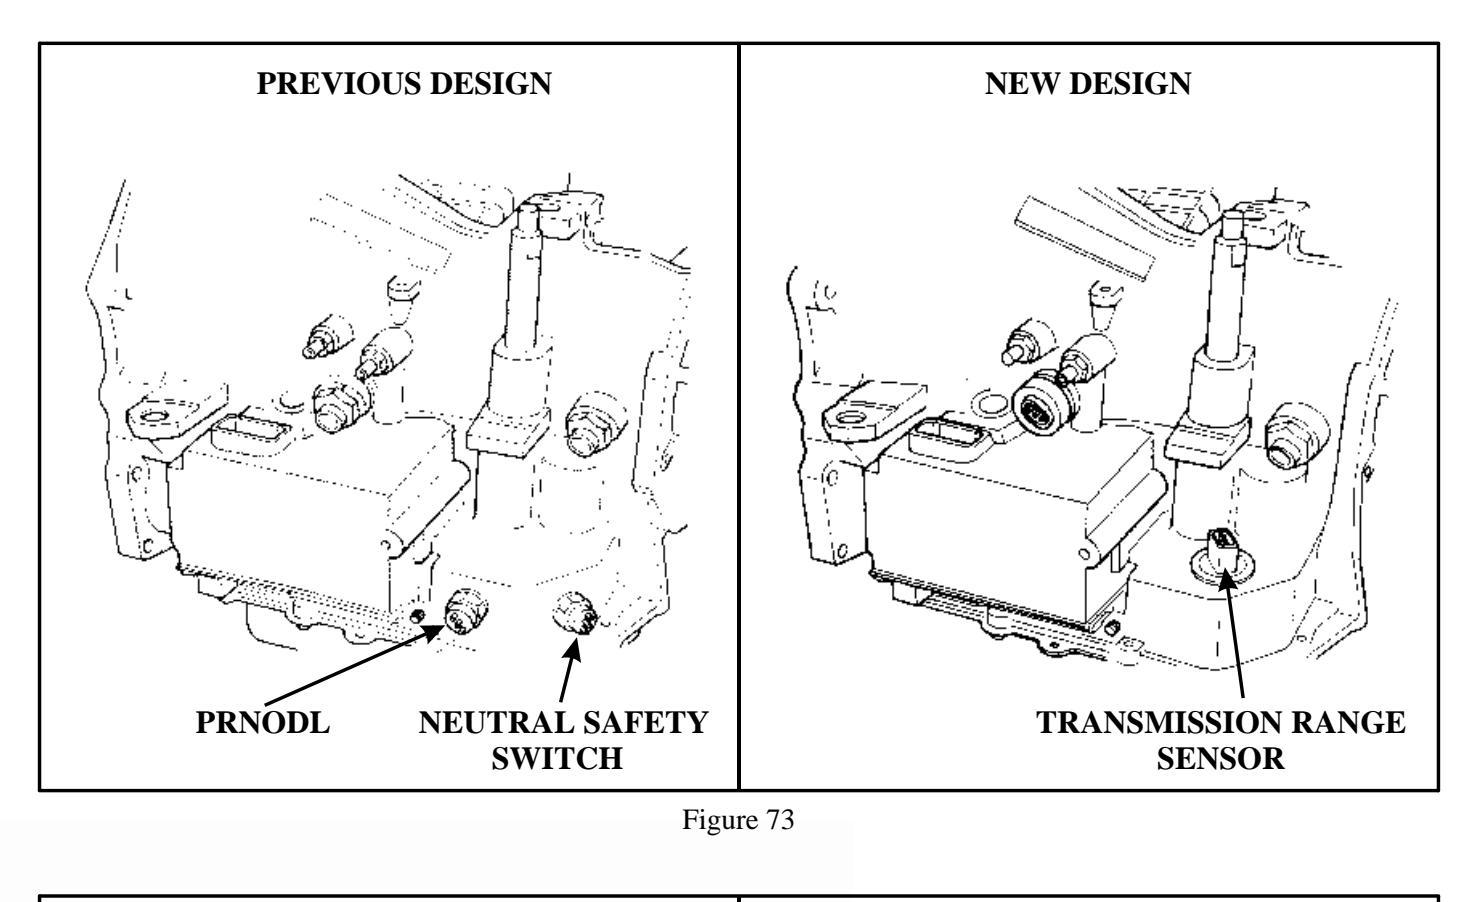
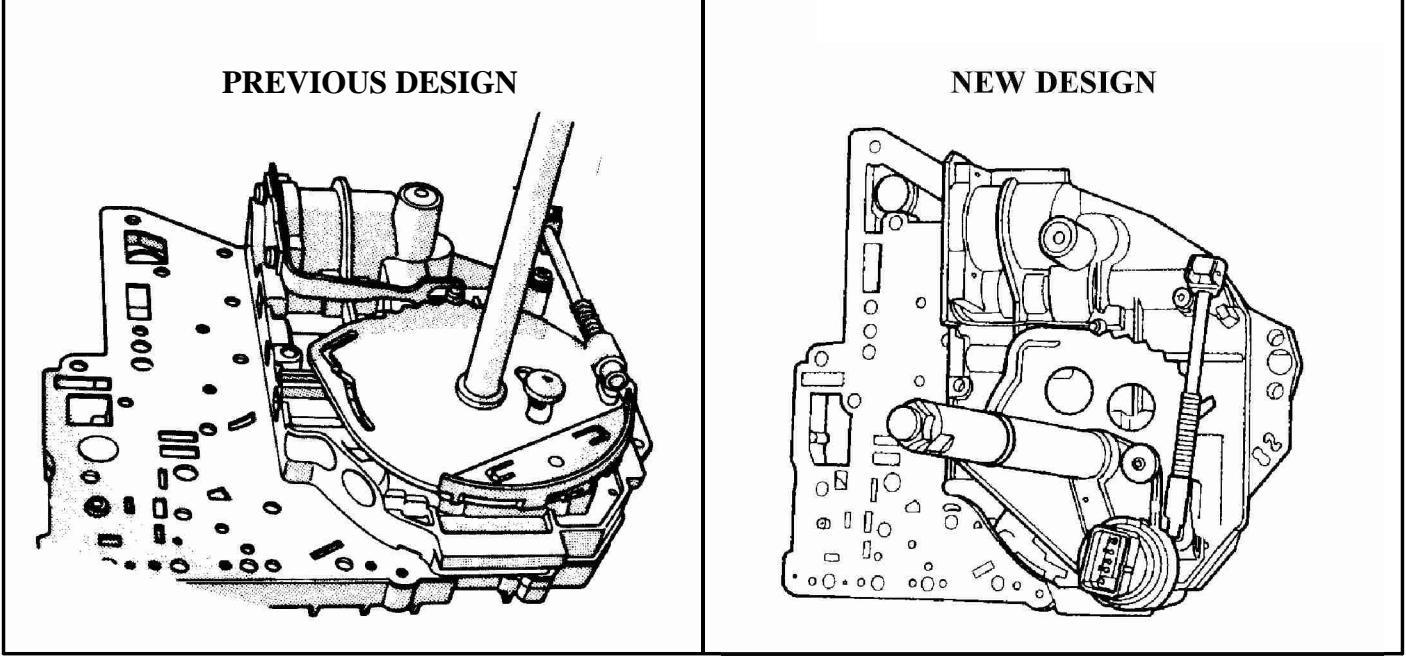
Figure 74

- (4) VALVE BODY The manual arm shaft and rooster comb assembly and the valve body changed in design to accommodate the mounting of the new TRS sensor (See Figure 74).

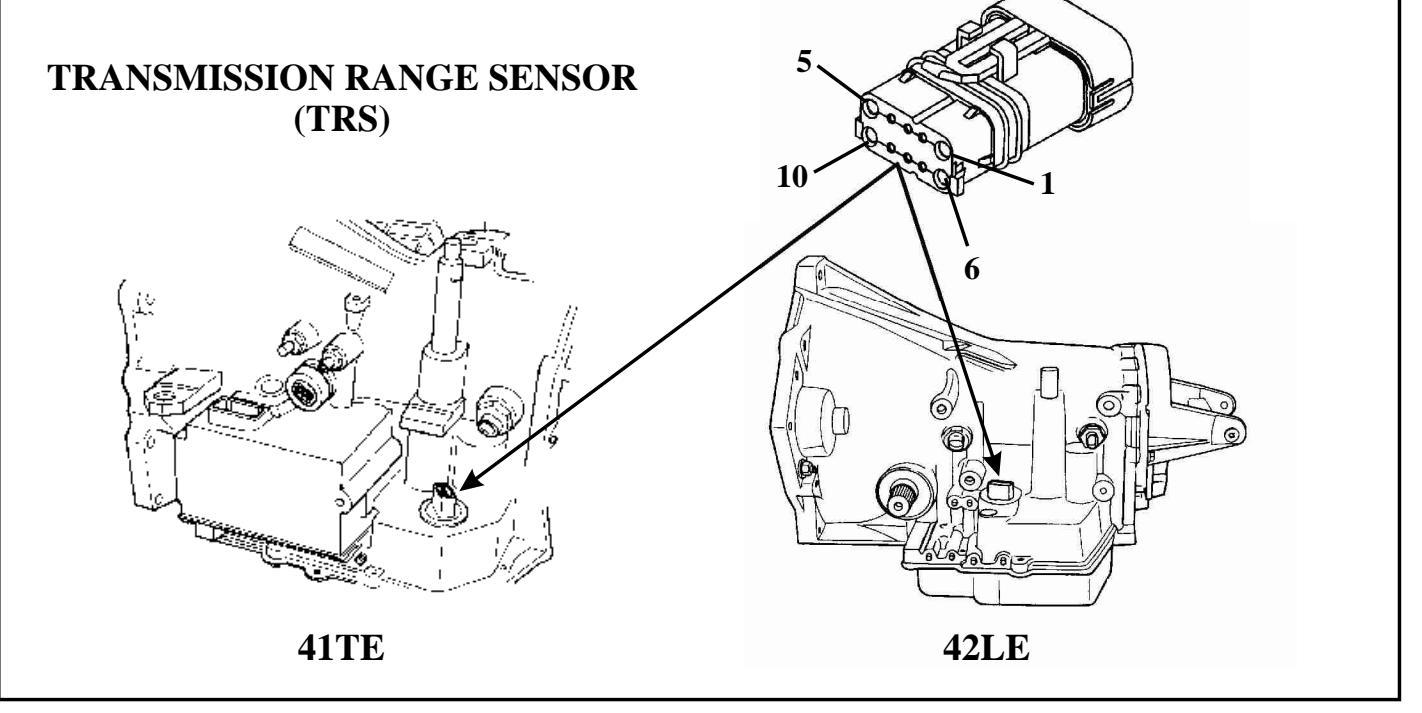
A scanner can be used to observe the OPEN/CLOSED state of the C1/T41, C2/T42, C3/T3 and the C4/T1 circuits. This can be especially helpful in determining which exact circuit is malfunctioning. Refer to Figure 75 for the Open/Closed status chart and circuit identification. Refer to Pages 99 and 100 for diagnostic routines for the new TRS.

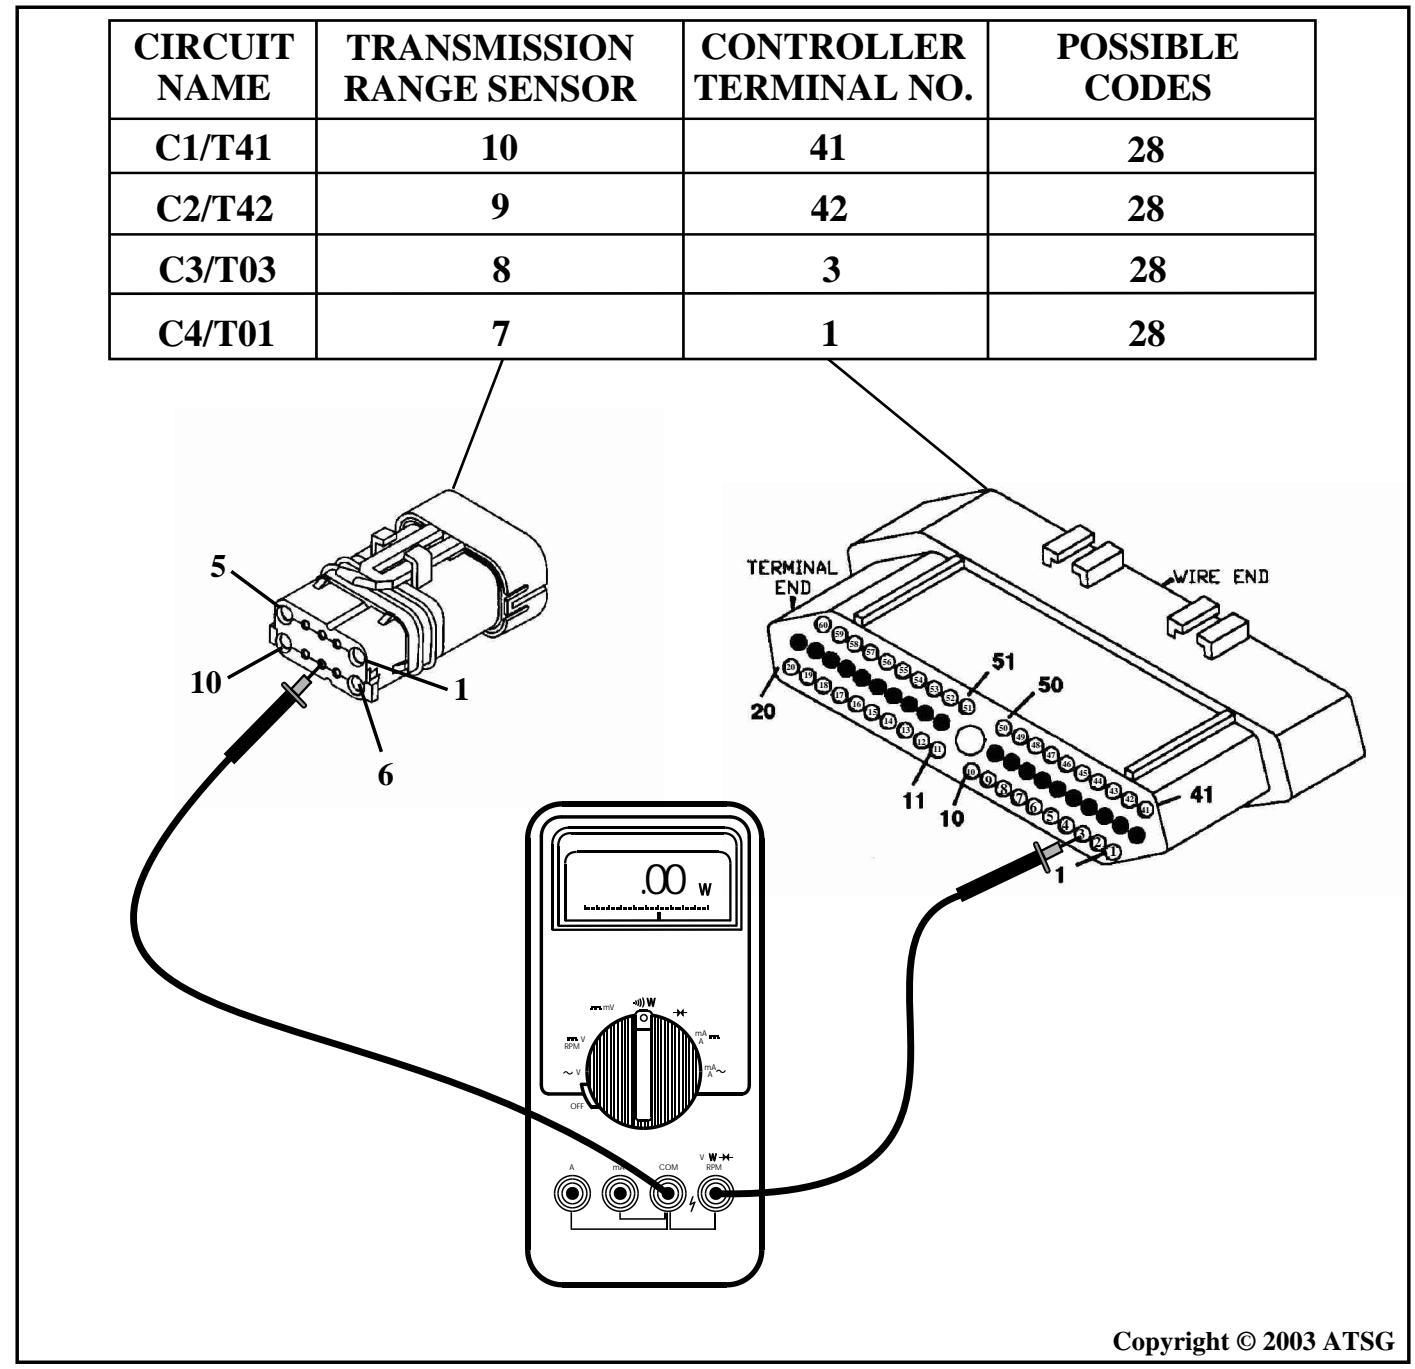
Figure 75 Automatic Transmission Service Group

Once the circuit which malfunctioned has been identified, a continuity check should be made on that circuit. Use the chart found in Figure 75 to assist in identifying the specific circuit or circuits in question. For example, if the scanner reveals that the T3 (C3) circuit does not close when the selector lever is placed in Park, 3 or 1, that specific circuit will need to be checked. In the chart below circuit T3 is the wire which runs from the number eight cavity in the TRS connector to the number three cavity in the TCM connector.

If an open circuit is seen when checking for continuity across any one of the Transmission Range Sensor wires, repair or replace the wire or wires. If continuity is seen, inspect both the TCM and TRS connector cavities for drag and that they have not been pushed back into the connector. The shank end of a drill bit may be employed to check for pin drag in the TRS connector. For cavities 7, 8 and 9, use a .035" wire gauge or a # 65 drill bit. For cavity 10, use an .089" wire gauge or a # 43 drill bit. If pin cavities are not pushed back and they have a good drag on the wire gauge test remove the valve body from the transmission. With the TRS still mounted to the valve body, place the manual valve in the park position. Fasten the negative meter lead to the metal portion of the rooster comb (See Figure 5). While pushing the switch down onto the rooster comb with one hand, use the positive meter lead to make contact with pins 7, 8, 9 and 10 individually. Approximately .05 to 1.5 ohms should be seen on each pin except # 7, it should read open. Use the chart in Figure 76 to check the TRS in each manual valve selection. Replace the TRS sensor if necessary. If all ranges test good, replace the TCM.

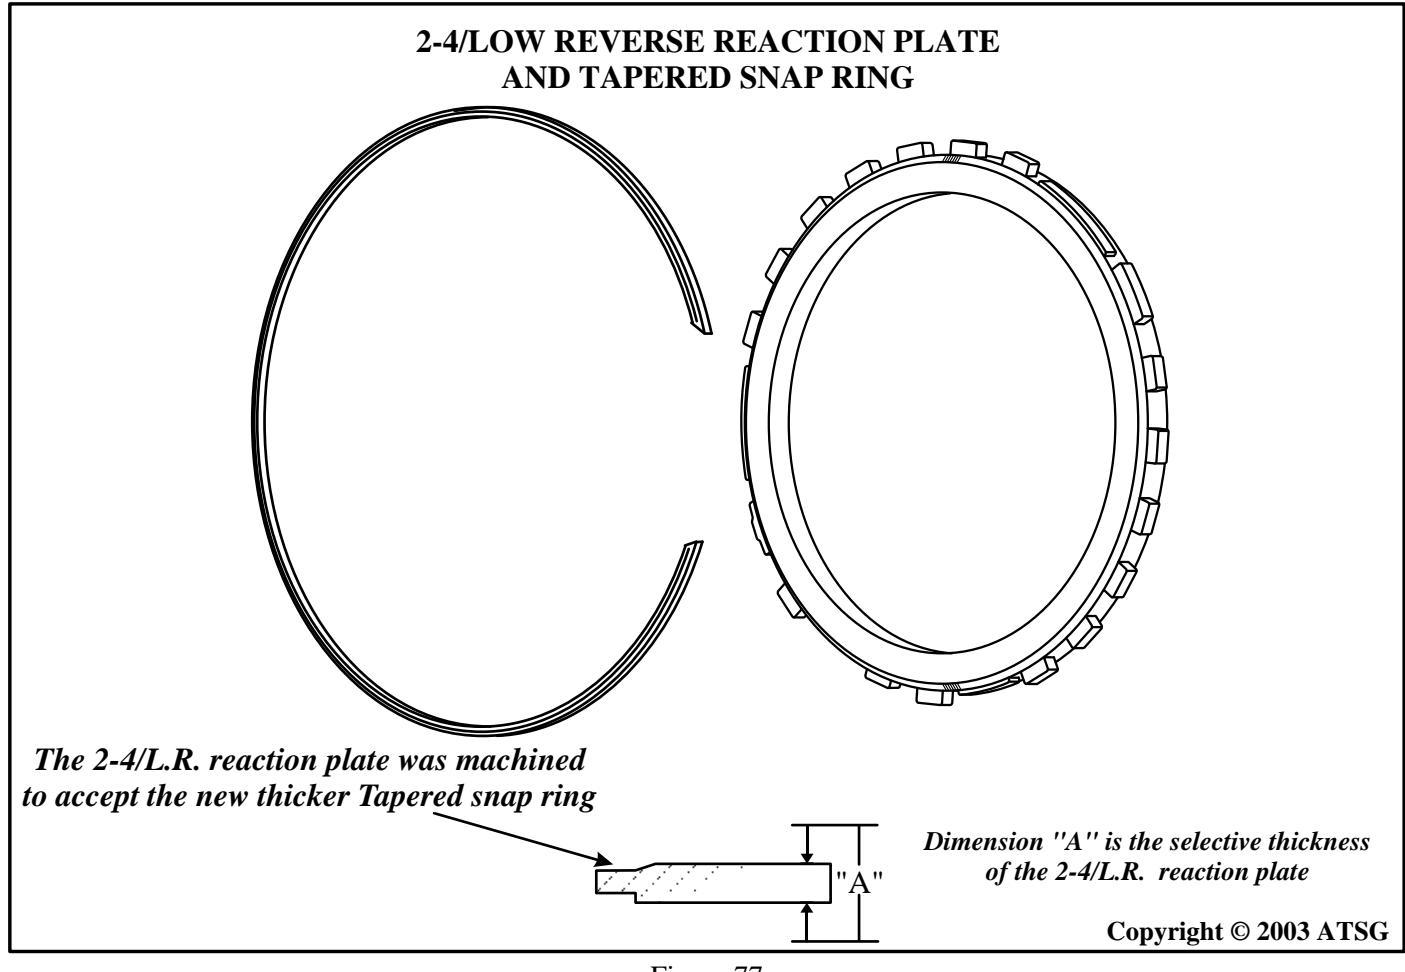
Figure 77 Automatic Transmission Service Group

- **CHANGE:** Some time in 1999, four of the previous 2-4/Low Reverse Reaction Plate selectives were changed to acommodate a new Tapered Snap Ring as shown in Figure 77.
- **REASON:** For increased durability of the Tapered Snap Ring.

Part No. 4377149 (.262"	thickness)	Now Part No. 4897455AA
Part No. 4377148 (.252"	thickness)	Now Part No. 4897454AA
Part No. 4412268 (.242"	thickness)	Now Part No. 4897453AA
Part No. 4412267 (.232"	thickness)	Now Part No. 4897452AA

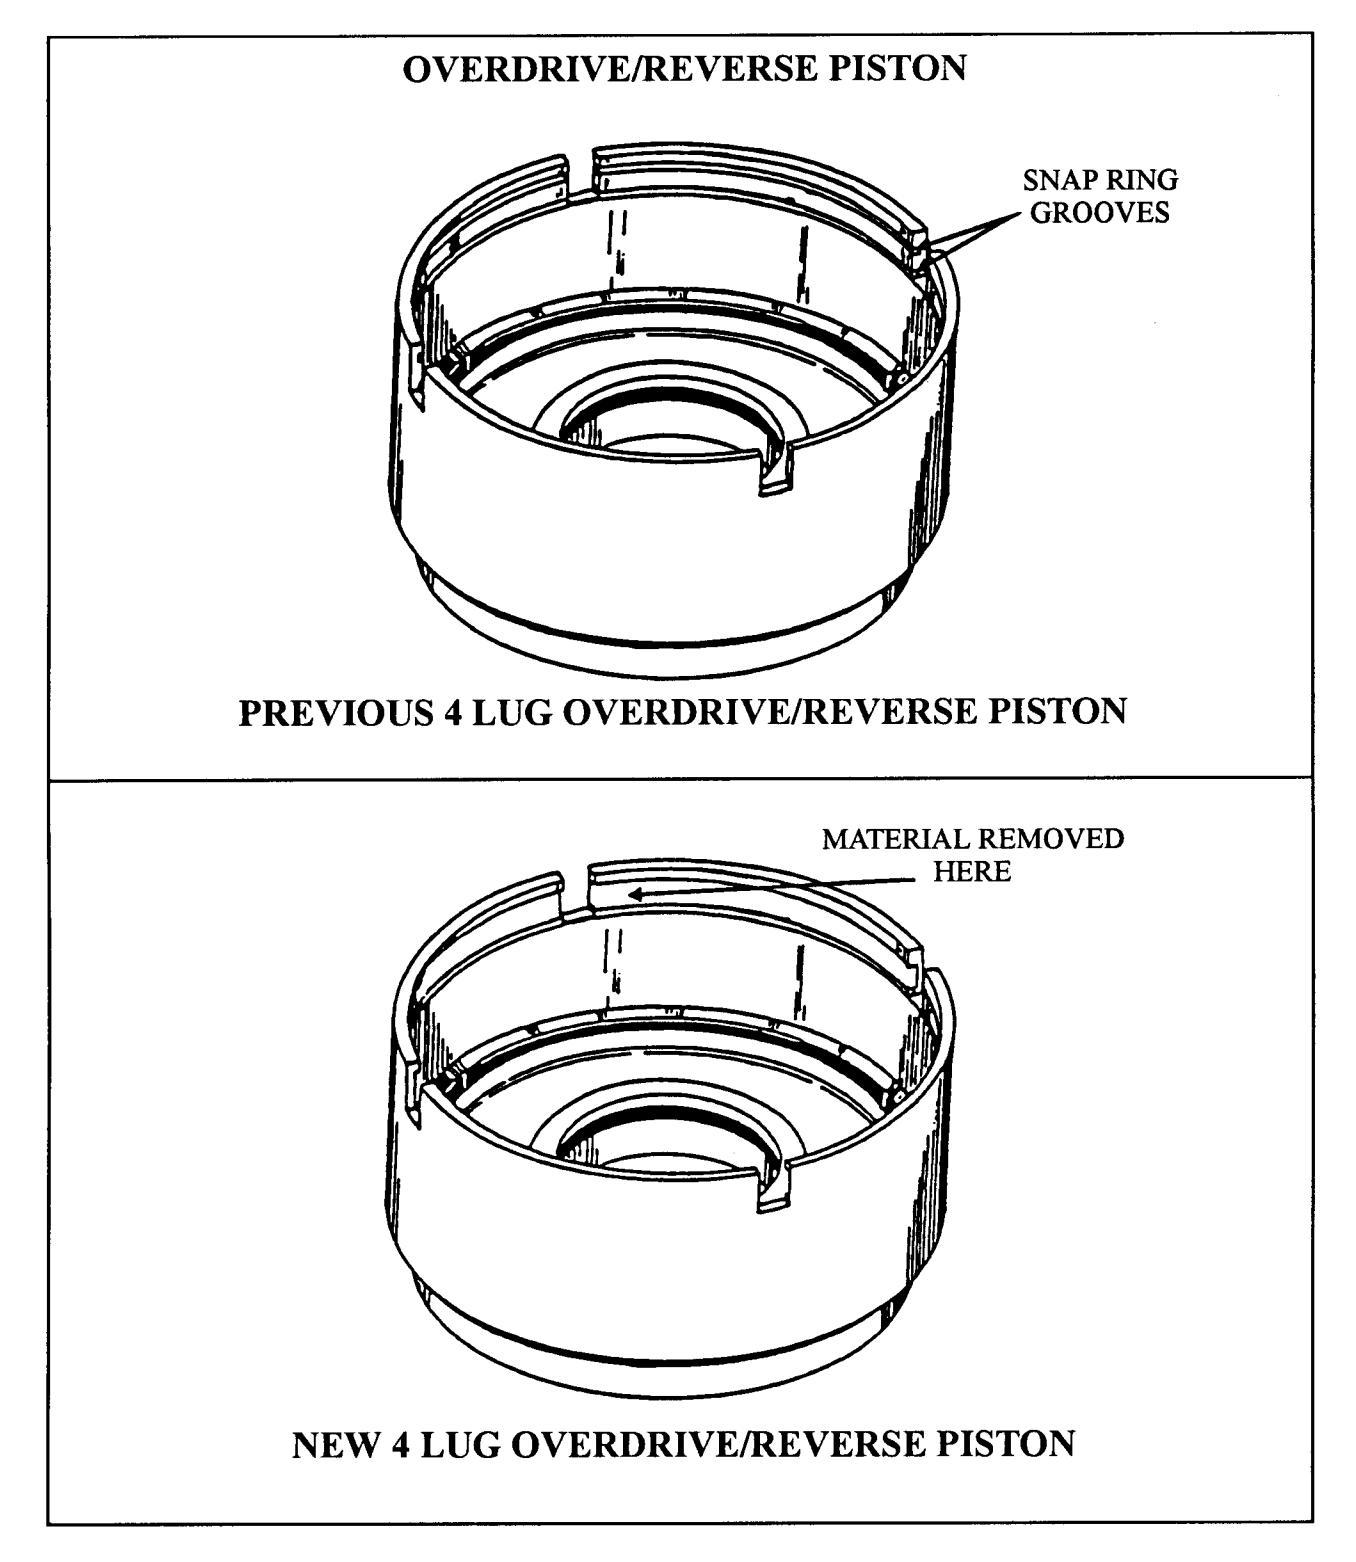
Figure 71

This is a "Waved" snap ring used on the bottom side of the Overdrive/Reverse Selective Pressure Plate and IS USED even when you have one "Wide" groove in the Overdrive/Reverse Housing, instead of the previous two grooves (See Figure 71).

This is a "Flat" snap ring used on the top of the Overdrive/Reverse Selective Pressure Plate and IS USED even when you have one "Wide" groove in the Overdrive/Reverse Housing, instead of the previous two grooves (See Figure 71).

BOTH SNAP RINGS (RING NO. 3 & RING NO. 4) ARE USED IN THIS HOUSING. REGARDLESS OF DESIGN LEVEL, IN THE LOCATIONS THAT ARE SHOWN IN FIGURE 1.
