KINGSTON & ARTHUR'S VALE HISTORIC AREA  
NORFOLK ISLAND  
HERITAGE MAINTENANCE MANUAL  
21 NOVEMBER 2019

# I INTRODUCTION

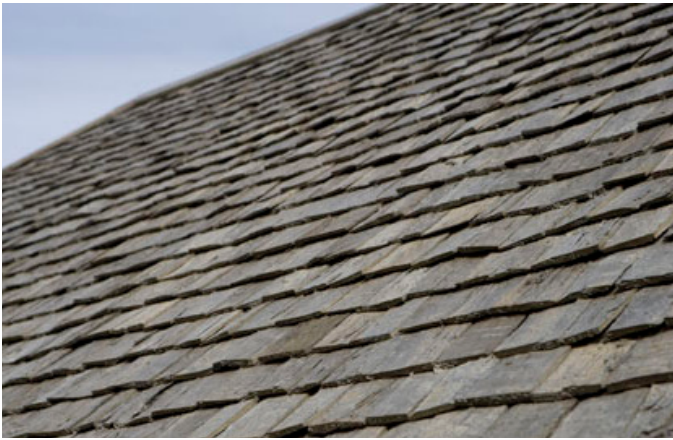
Norfolk Island Pine sourced for timber roofing shingles. Source: Department of Environment, 2007.

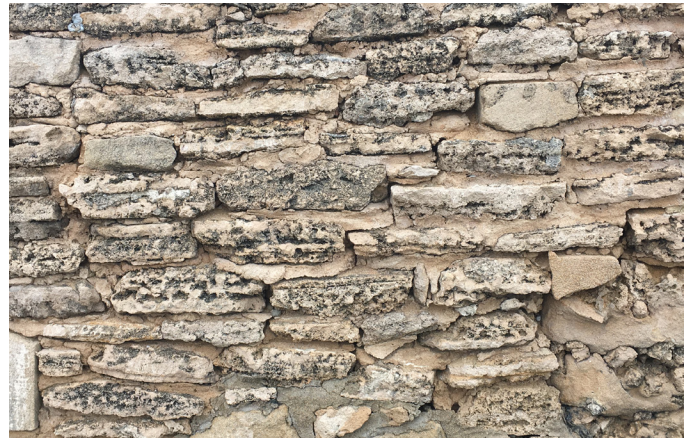
An example of the Calcarenite as found in Slaughter Bay. Note sound condition given the exposed location. Source: Purcell.

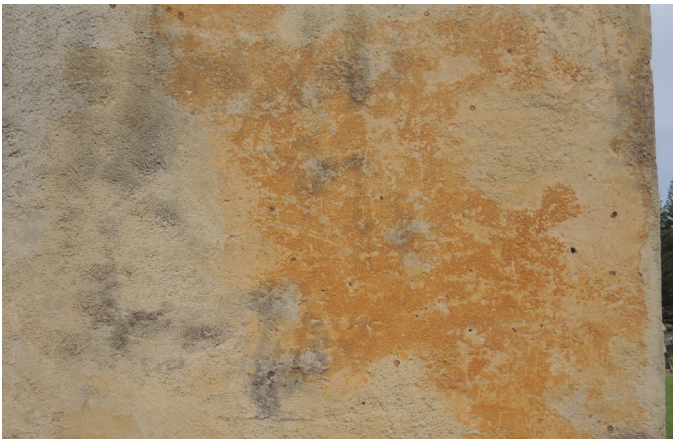
Extant renders and harling to the outbuildings of No. 10 Quality Row. Source: Purcell.

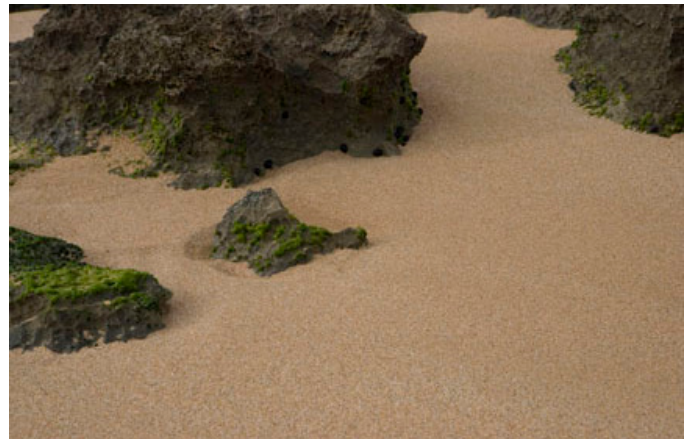
Sand was traditionally sourced from the adjacent Emily and Slaughter Bays. Source: Purcell.
