# Agilent 2100 Bioanalyzer Maintenance and Troubleshooting Guide

Edition November 2003

**Manual Part number:** G2946-90001

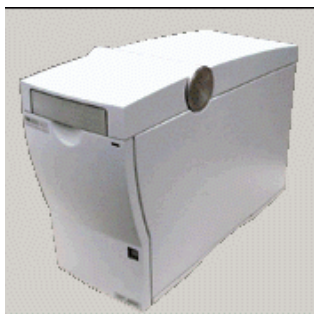
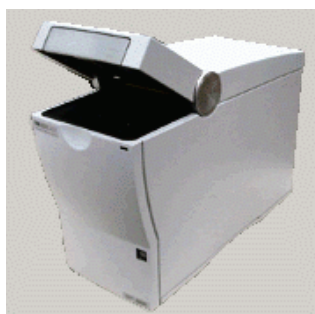
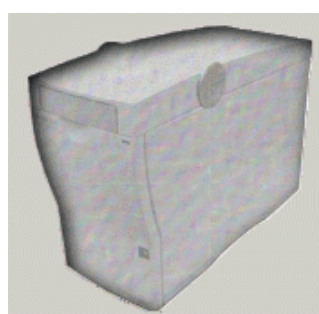
**Figure 1 2100 bioanalyzer icons showing the instrument status**

bioanalyzer online  
and lid closed.

bioanalyzer online  
and lid open.

Dimmed icon: instrument  
switched off or not connected  
to PC.

- 3 Open and close the lid—the icon in the instrument context should change from closed to open, see Figure 1, “2100 bioanalyzer icons showing the instrument status”

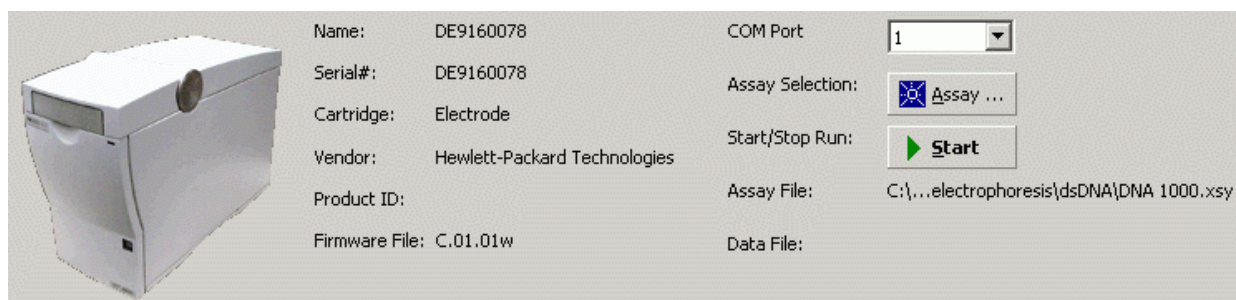
**Figure 2 Bioanalyzer hardware information**

If the instrument is connected successfully, additional hardware information (serial number, cartridge type,...) is displayed on top of the screen, see Figure 2, “Bioanalyzer hardware information”.

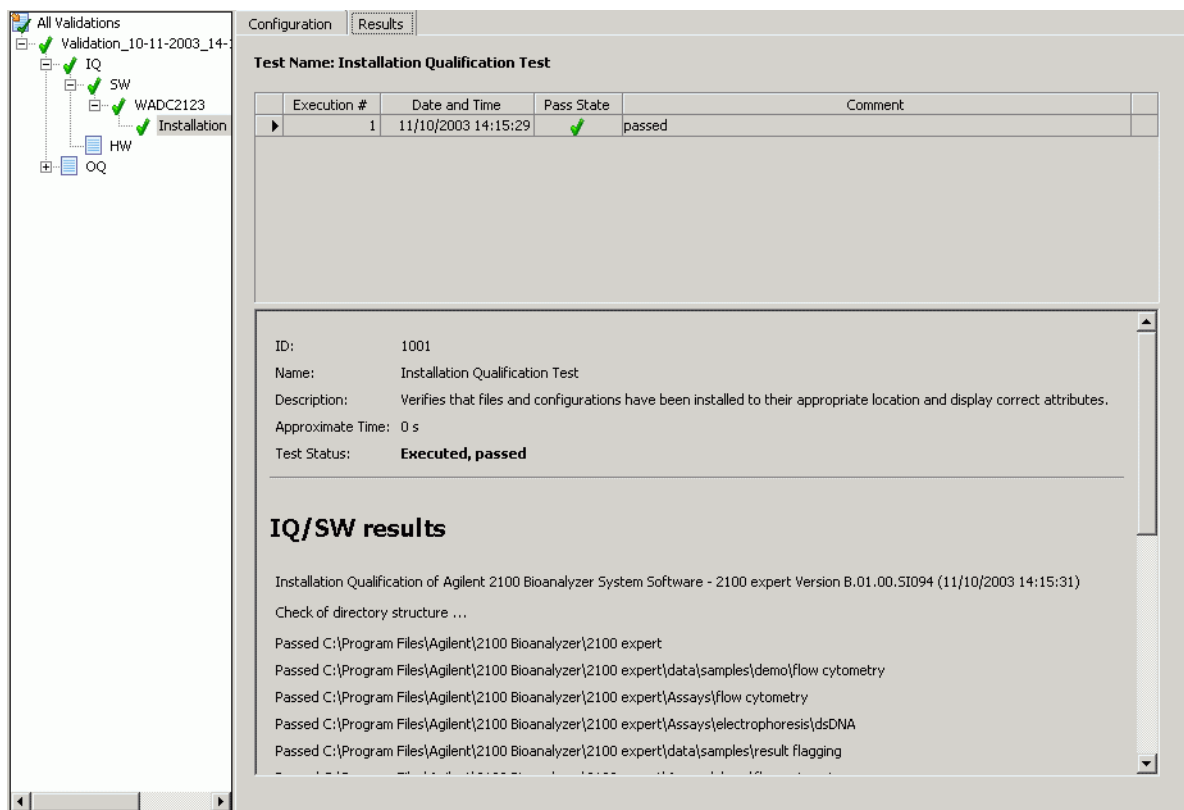
The screenshot displays the 'Results' tab of a software interface. On the left, a tree view shows a hierarchy of validation items: 'All Validations' (expanded), 'Validation\_10-11-2003\_14-' (expanded), 'IQ' (expanded), 'SW' (expanded), 'WADC2123' (expanded), 'Installation' (expanded), 'HW', and 'OQ'. The main area shows the 'Test Name: Installation Qualification Test'. Below this is a table with the following data:

Execution #	Date and Time	Pass State	Comment
1	11/10/2003 14:15:29	✓	passed

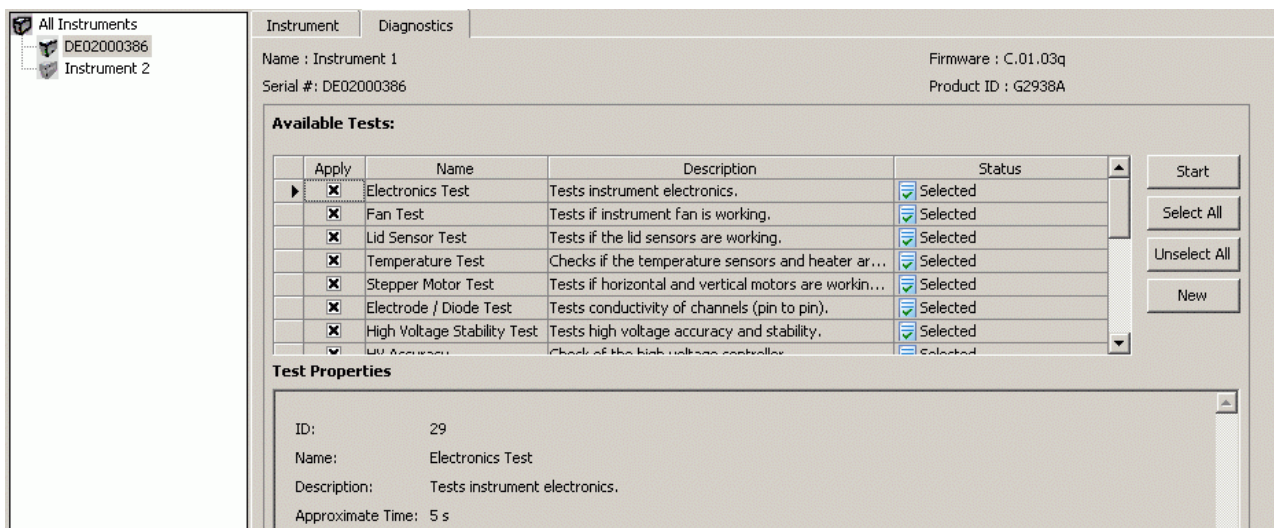
The screenshot shows the 'Diagnostics' tab in the software. The instrument details are: Name: Instrument 1, Serial #: DE02000386, Firmware: C.01.03q, and Product ID: G2938A. The 'Available Tests' table is as follows:

Apply	Name	Description	Status
<input checked="" type="checkbox"/>	Electronics Test	Tests instrument electronics.	<input checked="" type="checkbox"/> Selected
<input checked="" type="checkbox"/>	Fan Test	Tests if instrument fan is working.	<input checked="" type="checkbox"/> Selected
<input checked="" type="checkbox"/>	Lid Sensor Test	Tests if the lid sensors are working.	<input checked="" type="checkbox"/> Selected
<input checked="" type="checkbox"/>	Temperature Test	Checks if the temperature sensors and heater ar...	<input checked="" type="checkbox"/> Selected
<input checked="" type="checkbox"/>	Stepper Motor Test	Tests if horizontal and vertical motors are workin...	<input checked="" type="checkbox"/> Selected
<input checked="" type="checkbox"/>	Electrode / Diode Test	Tests conductivity of channels (pin to pin).	<input checked="" type="checkbox"/> Selected
<input checked="" type="checkbox"/>	High Voltage Stability Test	Tests high voltage accuracy and stability.	<input checked="" type="checkbox"/> Selected

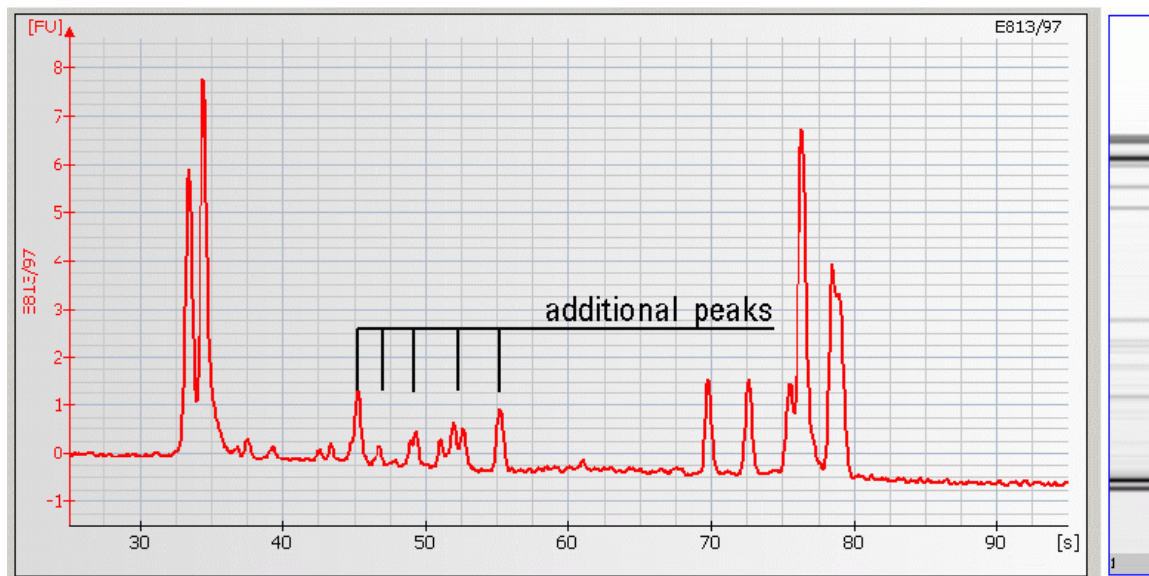
## Additional Sample or Ladder Peaks

<b>Most Probable Causes</b>	<b>Solution</b>
Chip contaminated.	Wear powder-free gloves only.
Dust particles in separation channels.	Clean the electrodes.  Load the chip immediately after taking it out of its sealed bag.
<b>Probable Causes</b>	<b>Solution</b>
Sample degraded or contaminated.	Always wear gloves when handling chips and samples to prevent them from getting contaminated.
Chip preparation with cold reagents.	Prepare a new chip. Allow all reagents and reagent mixes to warm up to room temperature for 30 minutes before use.
Chip not properly primed. Clogged chip priming station or wrong settings of priming station.	Use a new chip. Check chip priming station as described in " <a href="#">Checking the Chip Priming Station for Proper Performance - Seal Test</a> " on page 209). Check if clip and base plate of priming station are in the correct position (see DNA Reagent Kit Guide).
Vibration of Agilent 2100 bioanalyzer.	Don't touch Agilent 2100 bioanalyzer during a run. Remove vibration devices, such as vortexers and vacuum pumps, from bench.

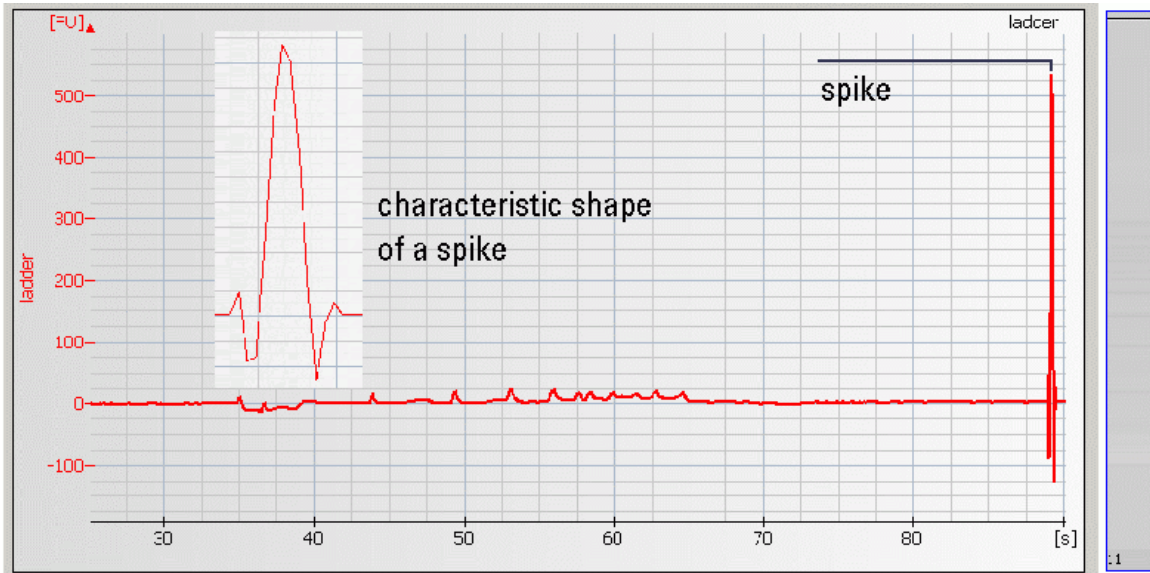
# Spikes

Most Probable Causes	Solution
Vibration of Agilent 2100 bioanalyzer.	Don't touch Agilent 2100 bioanalyzer during a run. Remove vibration devices, such as vortexers and vacuum pumps, from bench.
Chip/gel-dye mix contaminated with particles.	Prepare new chip with new gel-dye mix: Wear powder-free gloves only. Don't touch the underside of the chip. Don't touch the wells of the chip. Clean the electrodes. Load the chip immediately after taking it out of its sealed bag.
Dye agglomerates present in the gel-dye mix.	Use dye concentration according to the Reagent Kit Guide. Let the dye warm up to room temperature for 30 minutes before preparing the gel-dye mix. Protect the dye from light during this time.

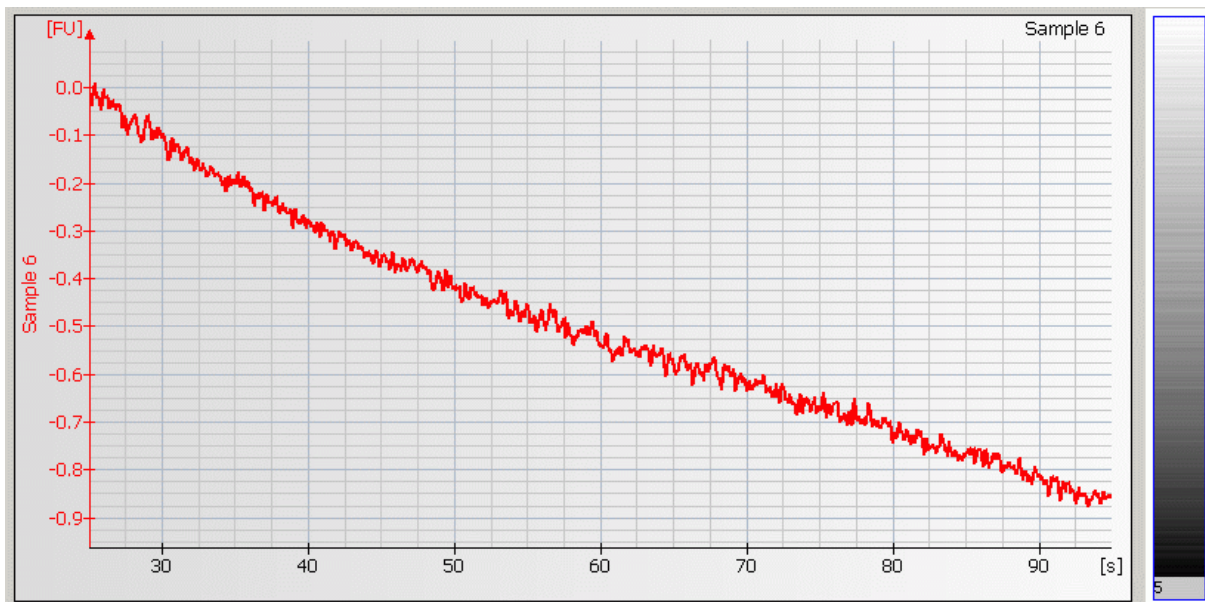
# Missing Peaks

Most Probable Causes	Solution
Too high salt concentration in sample	Refer to the maximum sample buffer salt concentration as specified in the reagent kit guide. Dilute samples with deionized DNase free water if necessary.
Clogged gasket and plastic adapter of priming station	Check chip priming station as described in <a href="#">“Checking the Chip Priming Station for Proper Performance - Seal Test”</a> on page 209). Clean/replace gasket and plastic adapter if necessary.
Wrong settings of the chip priming station.	Check if clip and base plate of priming station are in the right position (see Reagent Kit Guide).
Current leaks due to contaminated electrodes.	Clean electrodes with analysis-grade water and a toothbrush, see <a href="#">“How to clean the Pin Set of the Electrode Cartridge”</a> on page 192.

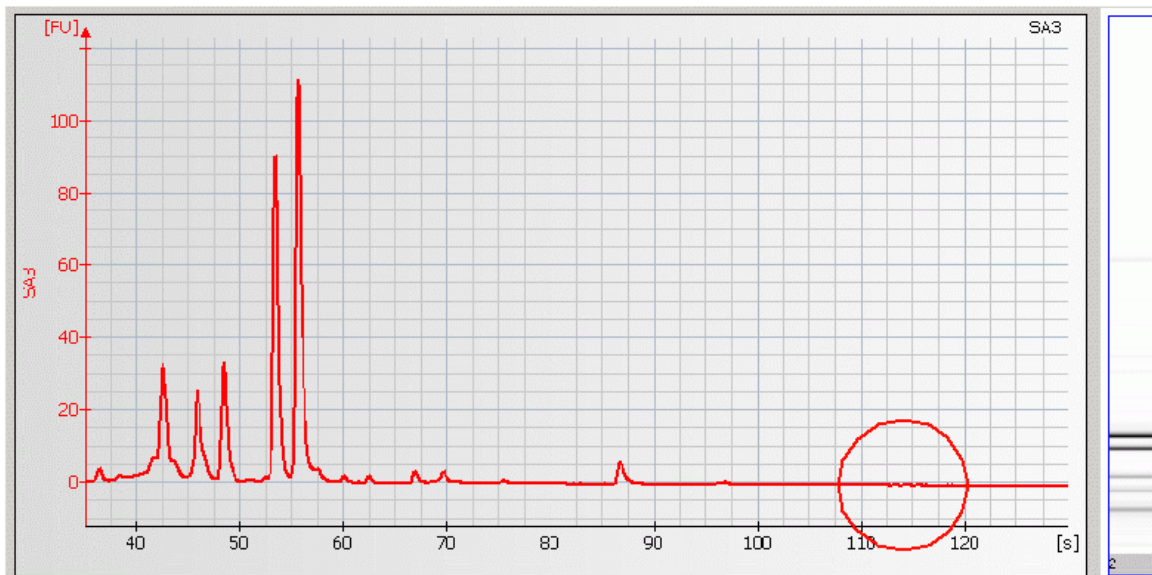
# Missing Upper Marker

Most Probable Causes	Solution
Alignment of upper marker not worked properly	Manually set the upper marker: <ol style="list-style-type: none"><li>1 In the electropherogram tab, highlight the appropriate peak in the peak table.</li><li>2 With a right-mouse click, select “Manually Set Upper Marker”.</li></ol>
Upper marker digested by restriction enzymes.	Inactivate restriction enzyme by adding EDTA or heat inactivate according to the manufacturers instruction.
Probable Causes	Solution
Too high salt concentration in sample	Refer to the maximum sample buffer salt concentration as specified in the reagent kit guide. Dilute samples with deionized DNase free water if necessary.

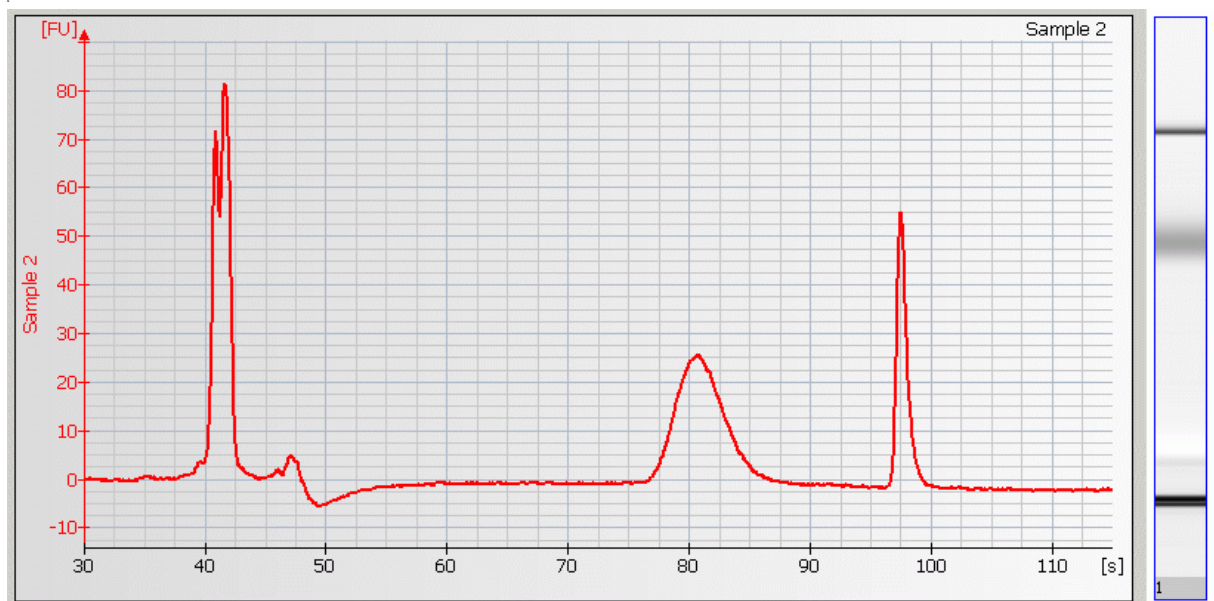
## Broad Peaks

Most Probable Causes	Solution
Current leaks due to contaminated electrodes.	Clean electrodes with analysis-grade water and a toothbrush, see <a href="#">“How to clean the Pin Set of the Electrode Cartridge”</a> on page 192.
Clogged gasket and plastic adapter of priming station	Check the priming station as described in <a href="#">“Checking the Chip Priming Station for Proper Performance - Seal Test”</a> on page 209. Clean/replace gasket and plastic adapter if necessary.
Wrong settings of the chip priming station.	Check if clip and base plate of priming station are in the right position (see Reagent Kit Guide).
Dye concentration too high.	Use dye concentration according to the Reagent Kit Guide. Let the dye warm up to room temperature for 30 minutes before preparing the gel-dye mix.
Probable Causes	Solution
Genomic DNA or cDNA contamination.	Check DNA preparation procedure.

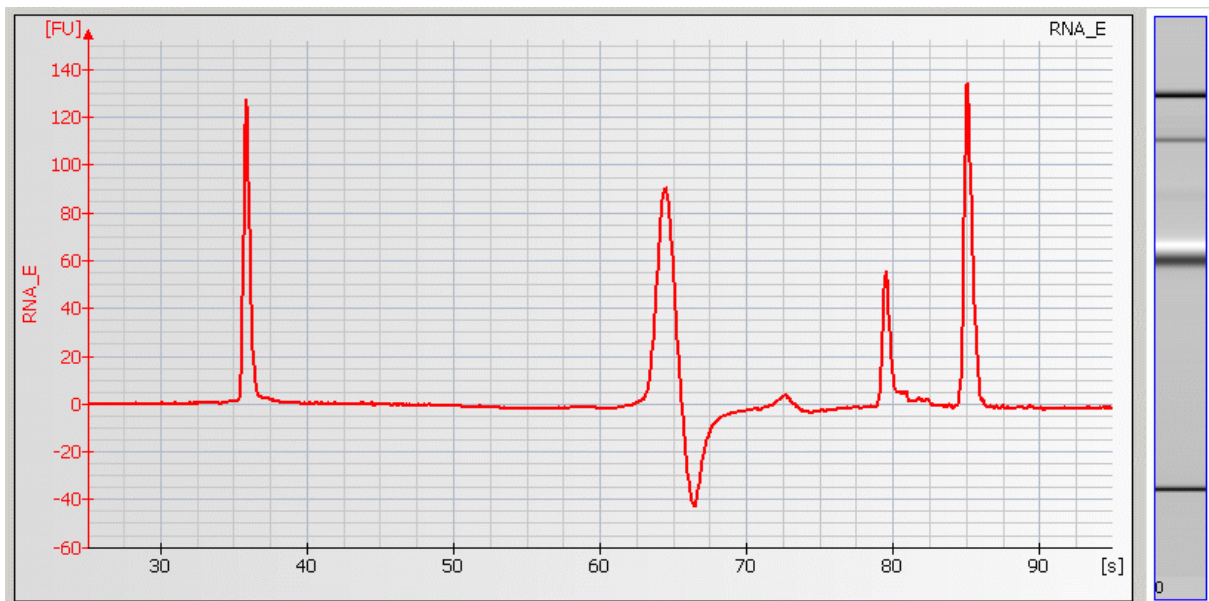
# Baseline Dips

Probable Causes	Solution
Too high sample concentration.	Use sample concentration according to the DNA Reagent Kit Guide.
Sample impurities: e.g. genomic DNA, ss DNA, etc.	Check DNA-isolation protocol. If possible, clean up samples.
Probable Causes	Solution
Dye concentration too low.	Use dye concentration according to the Reagent Kit Guide. Let the dye warm up to room temperature for 30 minutes before preparing the gel-dye mix. Protect the dye from light during this time.
Least Probable Causes	Solution
Autofocus failure.	Check autofocus by means of the “ <a href="#">Hardware Diagnostics</a> ” on page 33. If autofocus fails, contact Agilent Technologies.

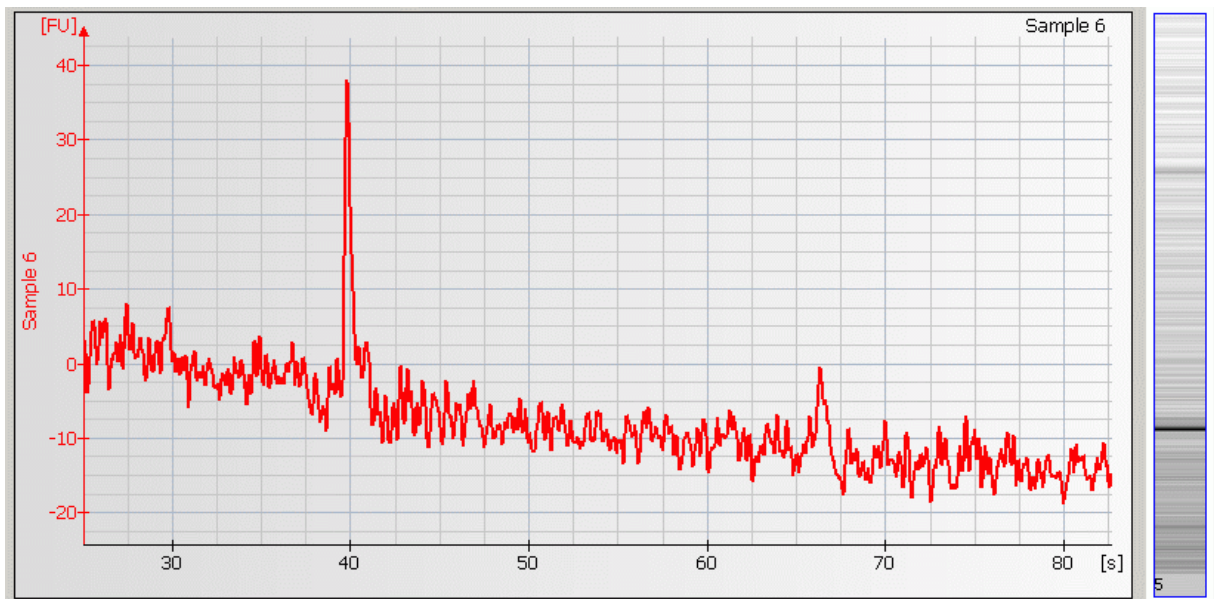
# Baseline Noise

Most Probable Causes	Solution
Fingerprint on focusing lens or on the backside of the chip.	Clean lens as described in “ <a href="#">Cleaning the Lens</a> ” on page 222.  Do not touch the underside of the chip.
Probable Causes	Solution
Autofocus failure or High voltage power supply defective	Check autofocus and high voltage power supply by means of the “ <a href="#">Hardware Diagnostics</a> ” on page 33. If tests fail, contact Agilent Technologies.
Least Probable Causes	Solution
Chip contaminated.	Wear powder-free gloves only.  Don't touch the underside of the chip.  Don't touch the wells of the chip.  Clean the electrodes.  Load the chip immediately after taking it out of its sealed bag.

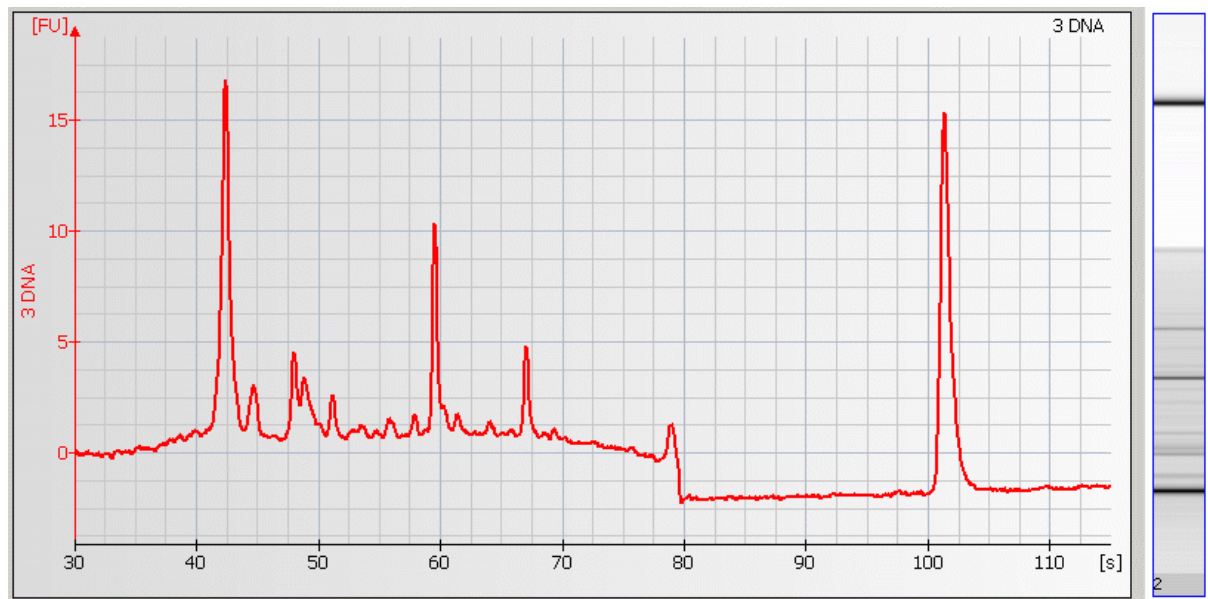
# Baseline Jumps

<b>Most Probable Causes</b>	<b>Solution</b>
Vibration of Agilent 2100 bioanalyzer.	Remove vibration devices, such as vortexers and vacuum pumps, from bench.
Instrument lid was touched during the run.	Don't touch Agilent 2100 bioanalyzer during a run.
<b>Least Probable Causes</b>	<b>Solution</b>
Laser defective.	Check Laser by using the “ <a href="#">Hardware Diagnostics</a> ” on page 33.If the laser test fails, contact Agilent Technologies.

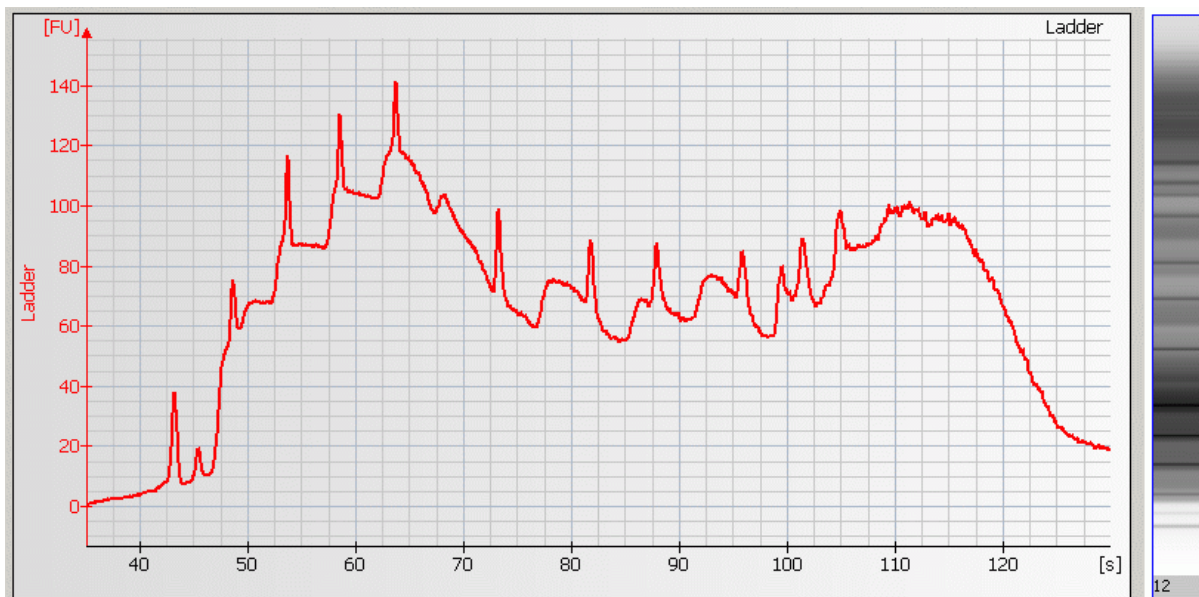
# Wavy Baseline

Most Probable Causes	Solution
Leak current due to dirty electrodes.	Clean electrodes as described in <a href="#">“How to clean the Pin Set of the Electrode Cartridge”</a> on page 192.
Detergents in PCR-buffer lowers surface tension in wells of chip. This leads to liquid spill on top of the chip during vortexing. As a result leak currents during the run will occur.	Prepare a new chip. Lower vortexing speed or mix samples manually.
Dye concentration too low.	Use dye concentration according to the Reagent Kit Guide. Let the dye warm up to room temperature for 30 minutes before preparing the gel-dye mix.

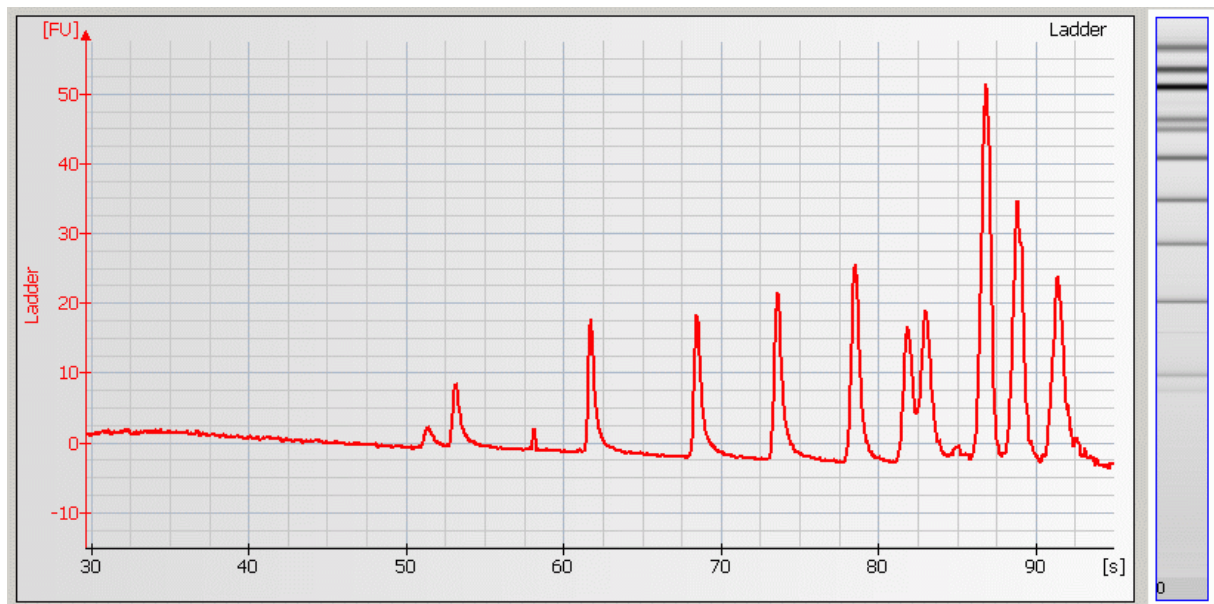
# Late Migration

Most Probable Causes	Solution
Vortex speed too high.	Vortex at lower (medium) speed. For chips use only the IKA vortexer.
Leak current due to dirty electrodes.	Clean electrodes as described in <a href="#">“How to clean the Pin Set of the Electrode Cartridge”</a> on page 192.
Detergents in PCR-buffer lowers surface tension in wells of chip. This leads to liquid spill on top of the chip during vortexing. As a result leak currents during the run will occur.	Prepare a new chip. Lower vortexing speed or mix samples manually.
Dye concentration too low.	Use dye concentration according to the Reagent Kit Guide. Let the dye warm up to room temperature for 30 minutes before preparing the gel-dye mix.
Probable Causes	Solution
Vortex adapter not connected tightly.	Press vortex adapter tightly on mount (vortex adapter must not rock).  Replace vortex adapter (p/n 5022-2190) as described in <a href="#">“Maintenance of the Vortexer: Changing the Adapter”</a> on page 228.

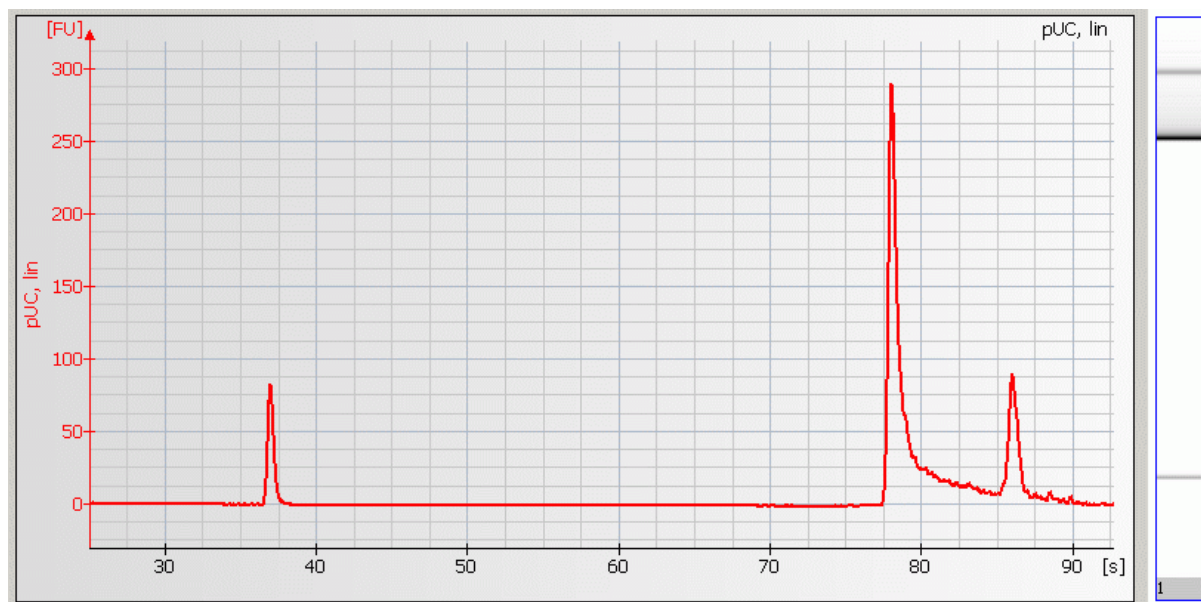
# Peak Tailing

Restriction enzymes may cause peak tailing.

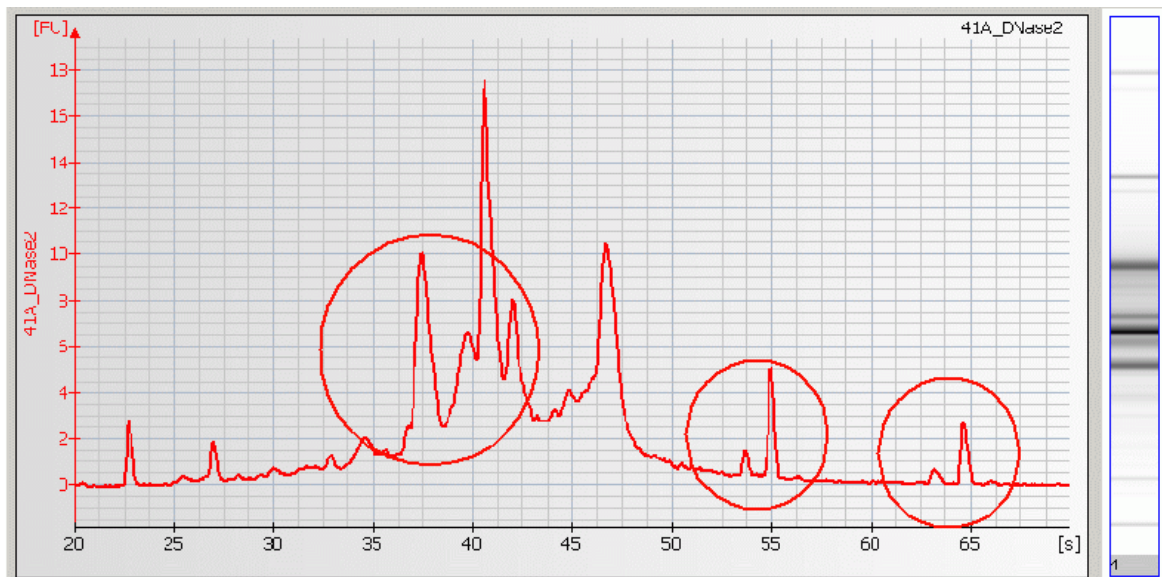
## Additional Sample or Ladder Peak

<b>Most Probable Causes</b>	<b>Solution</b>
Gel-dye mix expired.	Use prepared gel-dye mix within one day.
RNA ladder/sample not denaturated properly.	Heat ladder/samples at 70 °C for 2 minutes.
Particles in tubes.	For reagent preparation, use tubes that are supplied with the kit. Do not use autoclaved tubes.
Chip contaminated.	Wear powder-free gloves only.
Dust particles in separation channels.	Don't touch the wells of the chip. Clean the electrodes. Load the chip immediately after taking it out of its sealed bag.
<b>Probable Causes</b>	<b>Solution</b>
Dye agglomerates present in the gel-dye mix.	Use dye concentration according to the Reagent Kit Guide. Let the dye warm up to room temperature for 30 minutes and vortex for 10 seconds before preparing the gel-dye mix. Protect the dye from light during this time. After centrifugation, the freshly prepared gel-dye should be taken up from the top of the tube.

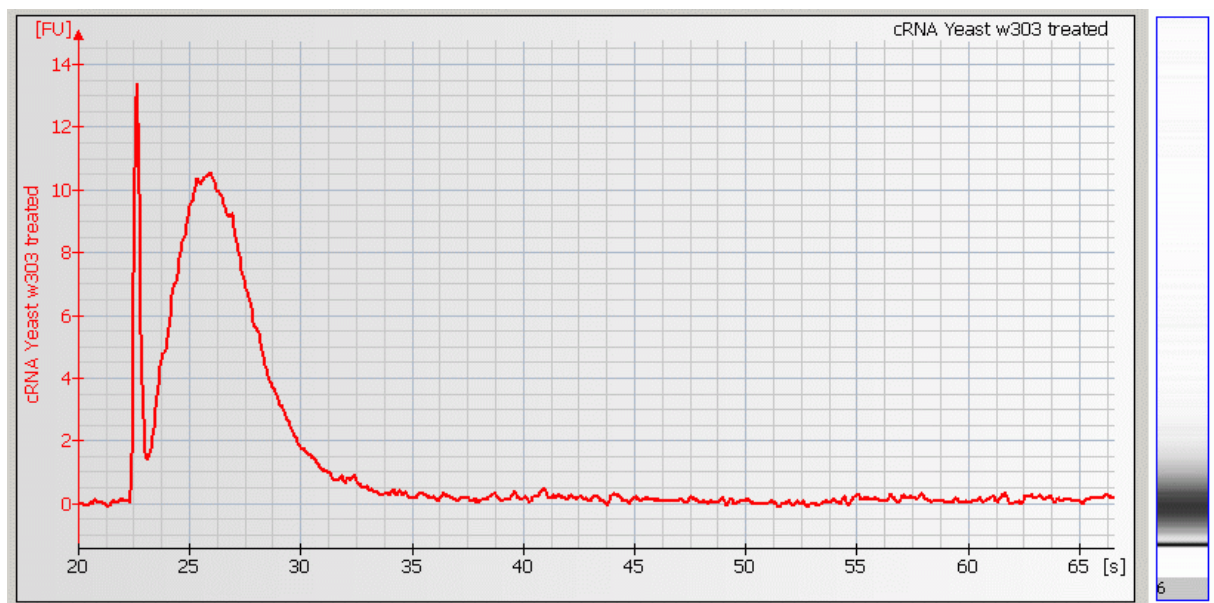
## Degraded RNA Ladder and/or Samples

Most Probable Causes	Solution
RNase contamination of the pin-set.	Decontaminate the pin-set. Follow decontamination procedure, see “ <a href="#">How to clean the Pin Set of the Electrode Cartridge</a> ” on page 192.
RNase contamination of chips and/or reagents.	Use a new chip and/or fresh reagents. Wear powder-free gloves when preparing the chip.

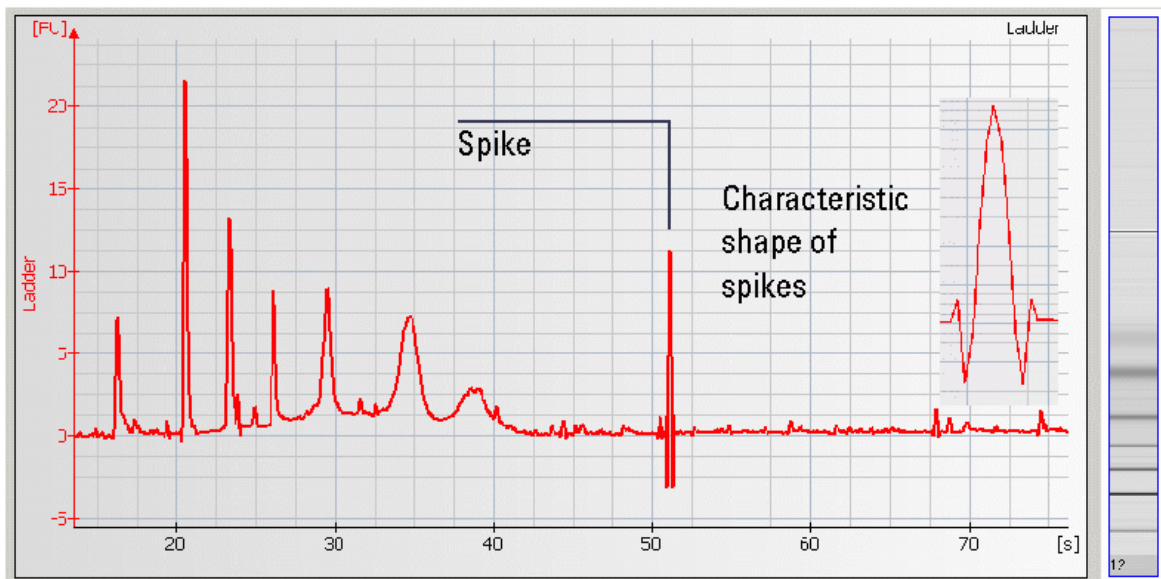
# Spikes

Most Probable Causes	Solution
Vibration of Agilent 2100 bioanalyzer.	Don't touch Agilent 2100 bioanalyzer during a run. Remove vibration devices, such as vortexers and vacuum pumps, from bench.
Particles in tubes.	For reagent preparation, use tubes that are supplied with the kit. Do not use autoclaved tubes.
Chip/gel-dye mix contaminated.	Prepare new chip with new gel-dye mix: Wear powder-free gloves only. Don't touch the underside of the chip. Don't touch the wells of the chip. Clean the electrodes. Load the chip immediately after taking it out of its sealed bag.

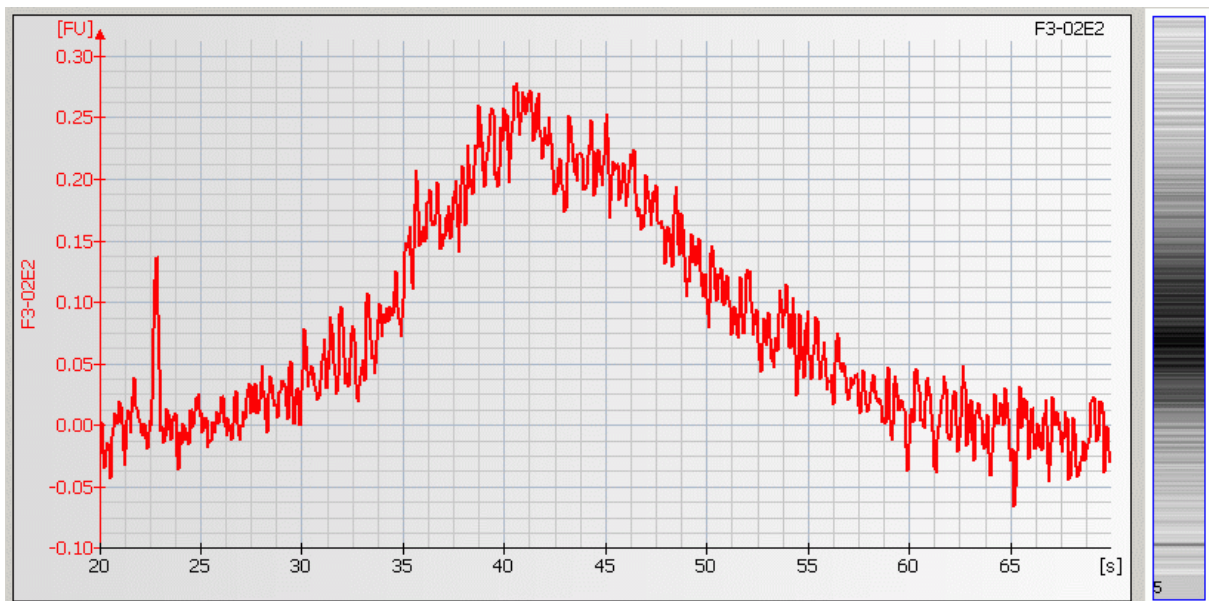
# Low Sensitivity

<b>Most Probable Causes</b>	<b>Solution</b>
Gel-dye mix expired.	Use prepared gel-dye mix within one day.
Dye concentration too low.	Use dye concentration according to the Reagent Kit Guide. Let the dye warm up to room temperature for 30 minutes before preparing the gel-dye mix. Protect the dye from light during this time.
Pipetting error during preparation of mixtures.	Check dilution procedure and calibration of pipette.
Chip pipetting error.	Pipette new chip. Always insert the pipette tip to the bottom of the well when dispensing the liquid. Use appropriate pipette and tips.
<b>Probable Causes</b>	<b>Solution</b>
Fingerprint on focusing lens or on the backside of the chip.	Clean lens as described in <a href="#">“Cleaning the Lens”</a> on page 222.  Do not touch the underside of the chip
Insufficient vortexing of chip.	Vortex chip for 1 minute. Only use IKA shaker for chip vortexing. Adjust speed to set-point (2400 rpm).

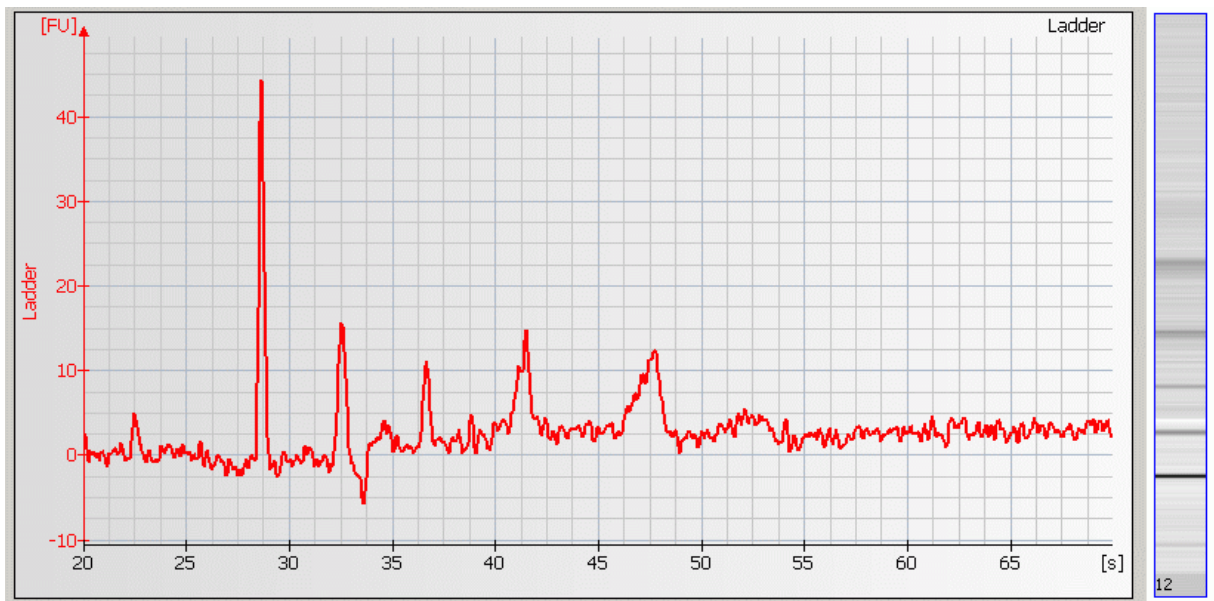
# Baseline Noise

Most Probable Causes	Solution
Fingerprint on focusing lens or on the backside of the chip.	Clean lens as described in <a href="#">“Cleaning the Lens”</a> on page 222.  Do not touch the underside of the chip
Chip contaminated.	Wear powder-free gloves only.  Don't touch the underside of the chip.  Don't touch the wells of the chip.  Clean the electrodes.  Load the chip immediately after taking it out of its sealed bag.
Vibration of Agilent 2100 bioanalyzer.	Don't touch Agilent 2100 bioanalyzer during a run. Remove vibration devices, such as vortexers and vacuum pumps, from bench.
Probable Causes	Solution
Dye concentration too low.	Use dye concentration according to the RNA Reagent Kit Guide. Let the dye warm up to room temperature for 30 minutes before preparing the gel-dye mix. Protect the dye from light during this time.

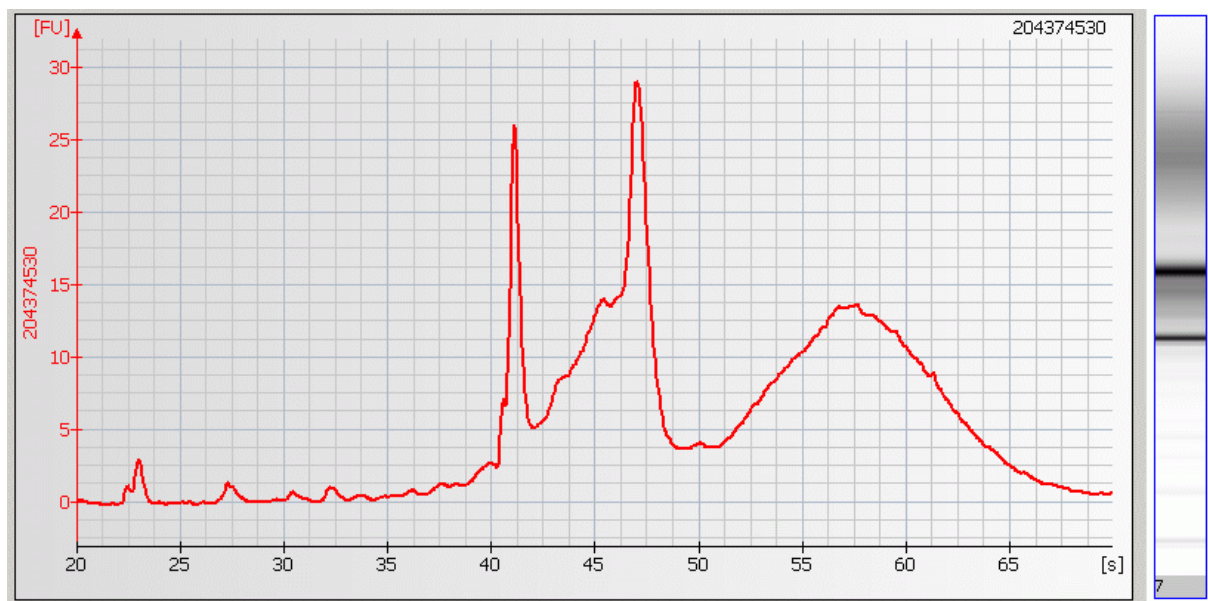
## Broad Peaks

<b>Most Probable Causes</b>	<b>Solution</b>
Sample contaminated with genomic DNA.	Check RNA-isolation protocol. To remove genomic DNA, perform DNase treatment.
Leaks currents due to contaminated pin-set.	Clean the pin-set of the electrode cartridge. Follow cleaning procedure, see <a href="#">“How to clean the Pin Set of the Electrode Cartridge”</a> on page 192
Electrodes contaminated with RNases.	Clean electrodes with RNaseZAP. Follow cleaning procedure, see <a href="#">“How to clean the Pin Set of the Electrode Cartridge”</a> on page 192
<b>Probable Causes</b>	<b>Solution</b>
Clogged gasket and plastic adapter of priming station	Check the priming station as described in <a href="#">“Checking the Chip Priming Station for Proper Performance - Seal Test”</a> on page 209. Clean/replace gasket and plastic adapter if necessary.
Wrong settings of chip priming station.	Check if clip and base plate of priming station are in the right position (see RNA Reagent Kit Guide).

Least Probable Causes	Solution
Dye concentration too high.	Use dye concentration according to the Reagent Kit Guide. Let the dye warm up to room temperature for 30 minutes before preparing the gel-dye mix. Protect the dye from light during this time.

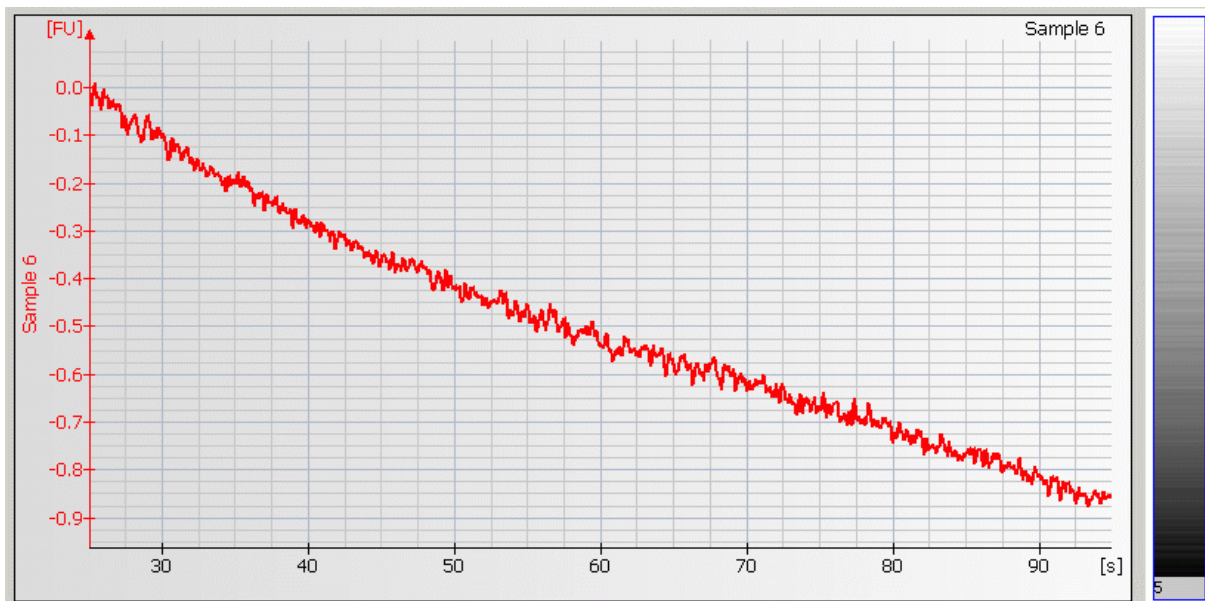
# Missing Peaks

Most Probable Causes	Solution
Too high salt concentration in sample	Refer to the maximum sample buffer salt concentration as specified in the reagent kit guide. Dilute samples with deionized RNase free water if necessary.
Clogged gasket and plastic adapter of priming station	Check chip priming station as described in <a href="#">“Checking the Chip Priming Station for Proper Performance - Seal Test”</a> on page 209). Clean/replace gasket and plastic adapter if necessary.
Wrong settings of the chip priming station.	Check if clip and base plate of priming station are in the right position (see Reagent Kit Guide).
Leak current due to contaminated electrodes or wet chip surface (detergents in RNA elution buffer)	Clean electrodes with analysis-grade water and a toothbrush, see <a href="#">“How to clean the Pin Set of the Electrode Cartridge”</a> on page 192.  Prepare a new chip. Lower vortexing speed or mix samples manually

<b>Probable Causes</b>	<b>Solution</b>
Laser broken.	Perform Laser/LED/Optics test and Autofocus test as described in “ <a href="#">Hardware Diagnostics</a> ” on page 33. If tests fail contact Agilent Technologies.
<b>Least Probable Causes</b>	<b>Solution</b>
Autofocus failure or high voltage power supply defective	Check autofocus and high voltage power supply by means of the “ <a href="#">Hardware Diagnostics</a> ” on page 33. If diagnostic fails, contact Agilent Technologies.
Sample wells filled with water.	Refer to the Reagent Kit Guide for proper preparation of the chip.

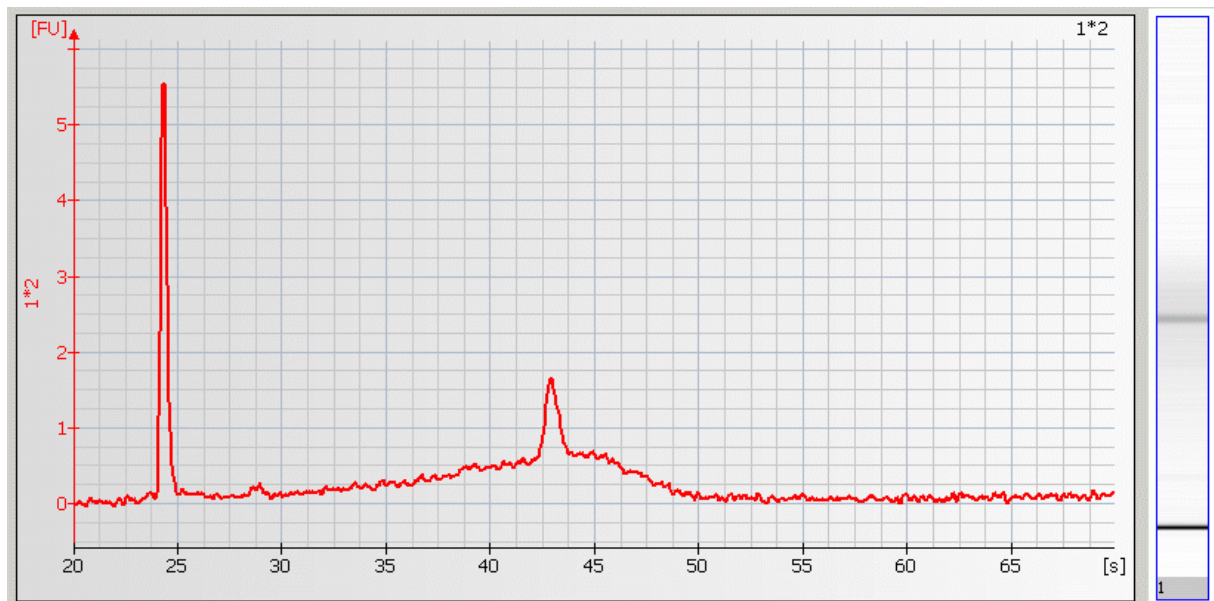
# Missing RNA Fragment

Most Probable Causes	Solution
Too high salt concentration in sample.	Refer to the maximum sample buffer salt concentration as specified in the reagent kit guide, Dilute samples with deionized RNase free water if necessary,
Probable Causes	Solution
Sample degradation because of RNase-contamination of electrodes or reagents.	Clean electrodes with RNaseZAP. Follow cleaning procedure, see <a href="#">“How to clean the Pin Set of the Electrode Cartridge”</a> on page 192.  Use a new chip and/or fresh reagents. Wear powder-free gloves when preparing the chip.
Incompatible column material of RNA extraction kit.	Use RNA extraction kit of different vendor.

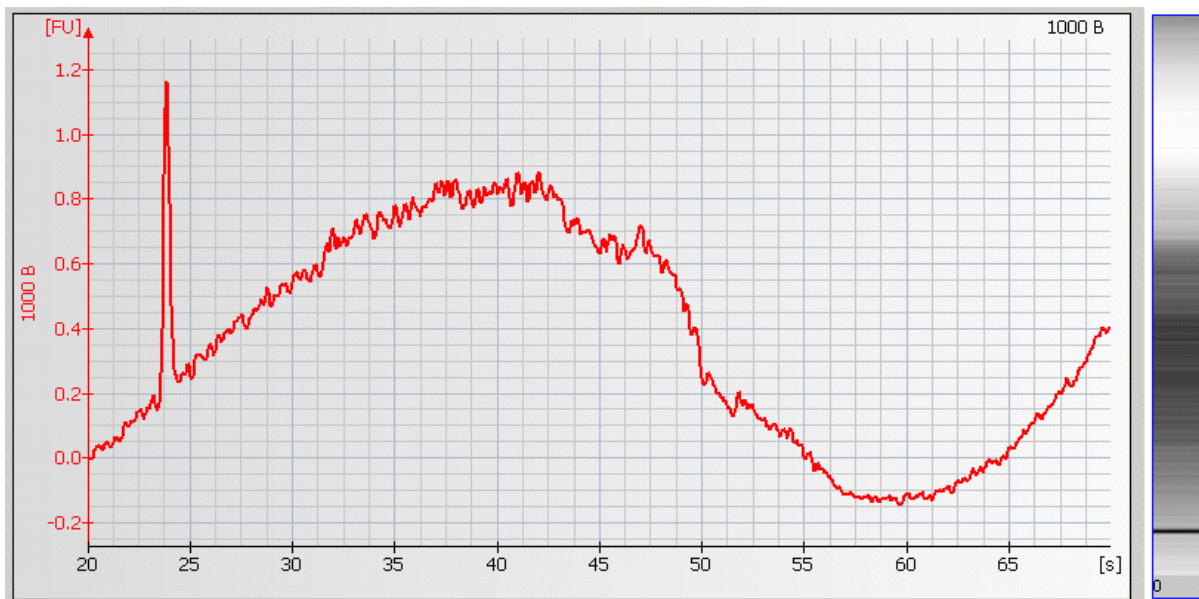
# Wavy Baseline

Most Probable Causes	Solution
Following sample contaminated with genomic DNA causes baseline fluctuations.	Check RNA-isolation protocol. To remove genomic DNA, perform DNase treatment.
Leak current due to contaminated electrodes or wet chip surface (detergents in RNA elution buffer).	Clean electrodes with analysis-grade water and a toothbrush, see <a href="#">“How to clean the Pin Set of the Electrode Cartridge”</a> on page 192.  Prepare a new chip. Lower vortexing speed or mix samples manually
Clogged gasket and plastic adapter of priming station	Check chip priming station as described in <a href="#">“Checking the Chip Priming Station for Proper Performance - Seal Test”</a> on page 209). Clean/replace gasket and plastic adapter if necessary.
Contaminated electrode cartridge.	Clean the electrode cartridge as described in <a href="#">“RNA Nano Assay”</a> on page 184 or <a href="#">“RNA Pico Assay”</a> on page 188.

<b>Probable Causes</b>	<b>Solution</b>
Wrong settings of the chip priming station.	Check if clip and base plate of priming station are in the right position (see Reagent Kit Guide).
<b>Least Probable Causes</b>	<b>Solution</b>
Autofocus failure or high voltage power supply defective	Check autofocus and high voltage power supply by means of the “ <a href="#">Hardware Diagnostics</a> ” on page 33. If diagnostic fails, contact Agilent Technologies.

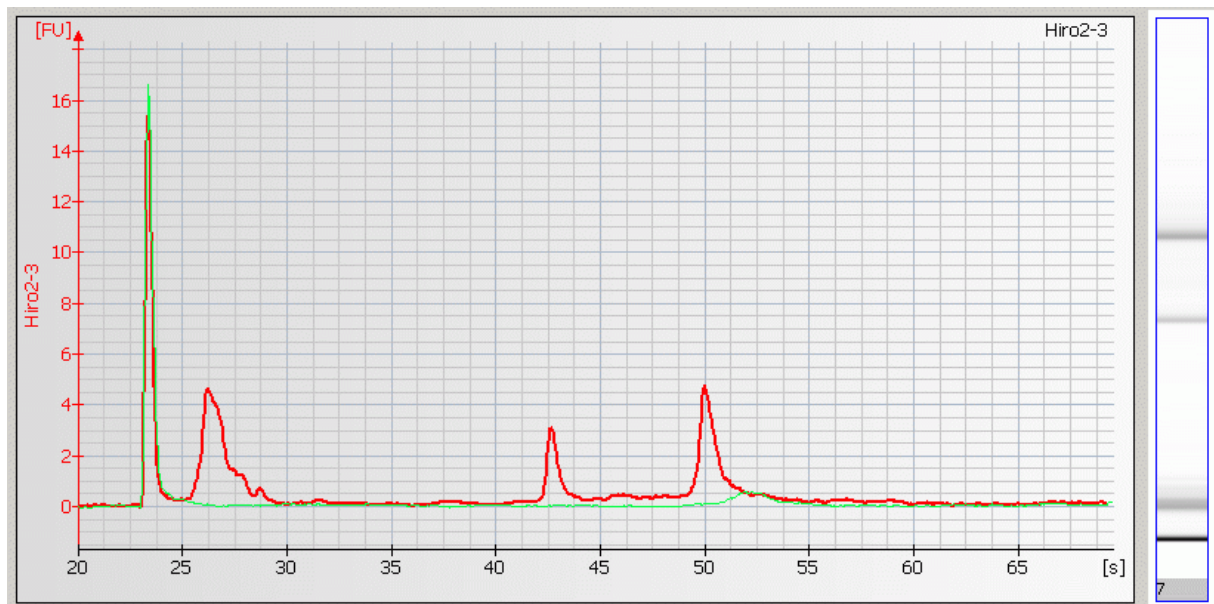
# Cross Contamination

Most Probable Causes	Solution
Contamination of pipette tips.	Use fresh tips for each pipetting step.
Contamination of electrodes.	Clean electrodes between runs like described in " <a href="#">Maintenance of the Electrode Cartridge</a> " on page 180.
Least Probable Causes	Solution
Leaks currents due to contaminated pin-set.	Clean the pin-set of the electrode cartridge. Follow cleaning procedure, see " <a href="#">How to clean the Pin Set of the Electrode Cartridge</a> " on page 192.
