# Agilent 2100 Bioanalyzer Maintenance and Troubleshooting Guide

Edition November 2003

**Manual Part number:** G2946-90001

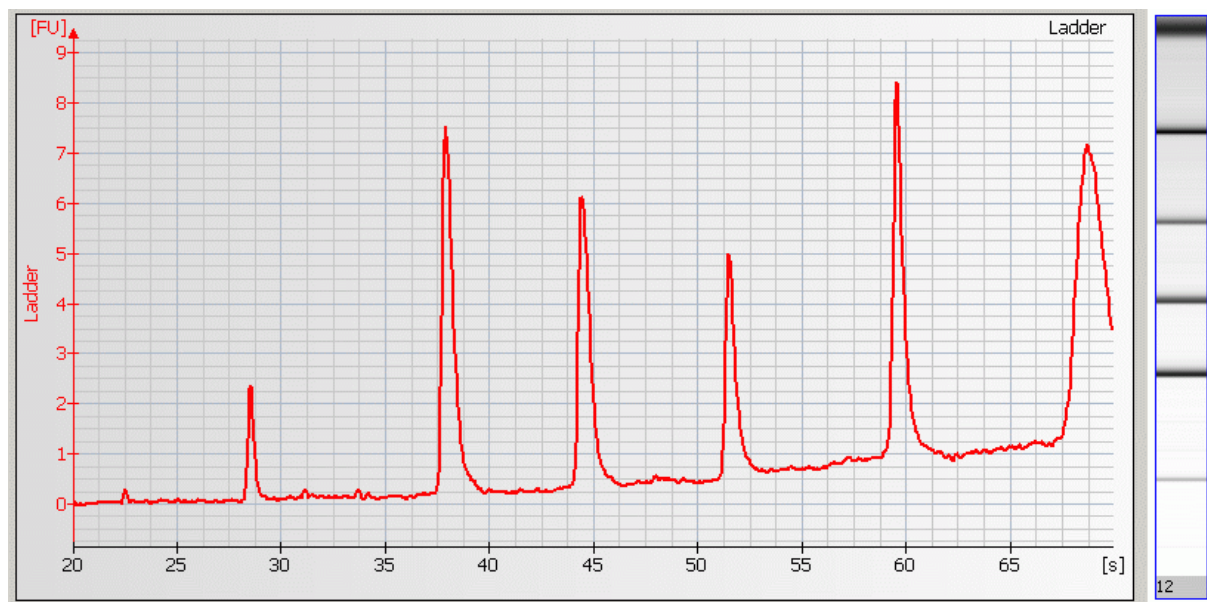
## Late Migration of RNA Ladder or Samples

Most Probable Causes	Solution
Vortex speed too high.	Vortex at lower (medium) speed. For chips use only the IKA vortexer.
Leak current due to dirty electrodes.	Clean electrodes as described in <a href="#">“How to clean the Pin Set of the Electrode Cartridge”</a> on page 192.
Detergents in RNA elution buffer lowers surface tension in wells of chip. This leads to liquid spill on top of the chip during vortexing. As a result leak currents during the run will occur.	Prepare a new chip. Lower vortexing speed or mix samples manually.
Probable Causes	Solution
Vortex adapter not connected tightly.	Press vortex adapter tightly on mount (vortex adapter must not rock).  Replace vortex adapter (p/n 5022-2190) as described in <a href="#">“Maintenance of the Vortexer: Changing the Adapter”</a> on page 228.

Probable Causes	Solution
Clogged gasket and plastic adapter of priming station	Check chip priming station as described in “ <a href="#">Checking the Chip Priming Station for Proper Performance - Seal Test</a> ” on page 209). Clean/replace gasket and plastic adapter if necessary.

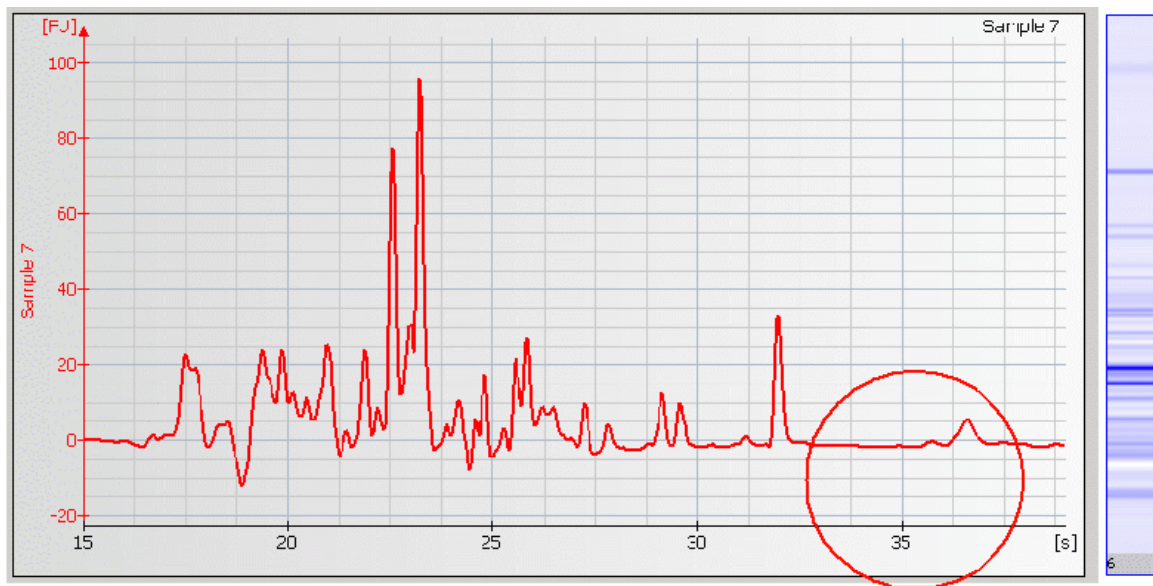
## Short Run Time

Most Probable Causes	Solution
<p>Upper marker in ladder was not correctly assigned due to low intensity of upper marker in the ladder.</p>	<p>To correct for wrong selected upper marker in ladder, set upper marker manually. If necessary, adjust peak find settings. If peaks are detected that are not part of the ladder, exclude them. For better upper marker identification:</p> <p>Turn off the analysis. For correct alignment overlay electropherograms of multiple wells to clearly identify the upper marker. For details please refer to the Online Help or Users Guide.</p> <p>See also “<a href="#">Low or Missing Upper Marker in Ladder</a>” on page 139 for probable causes.</p>

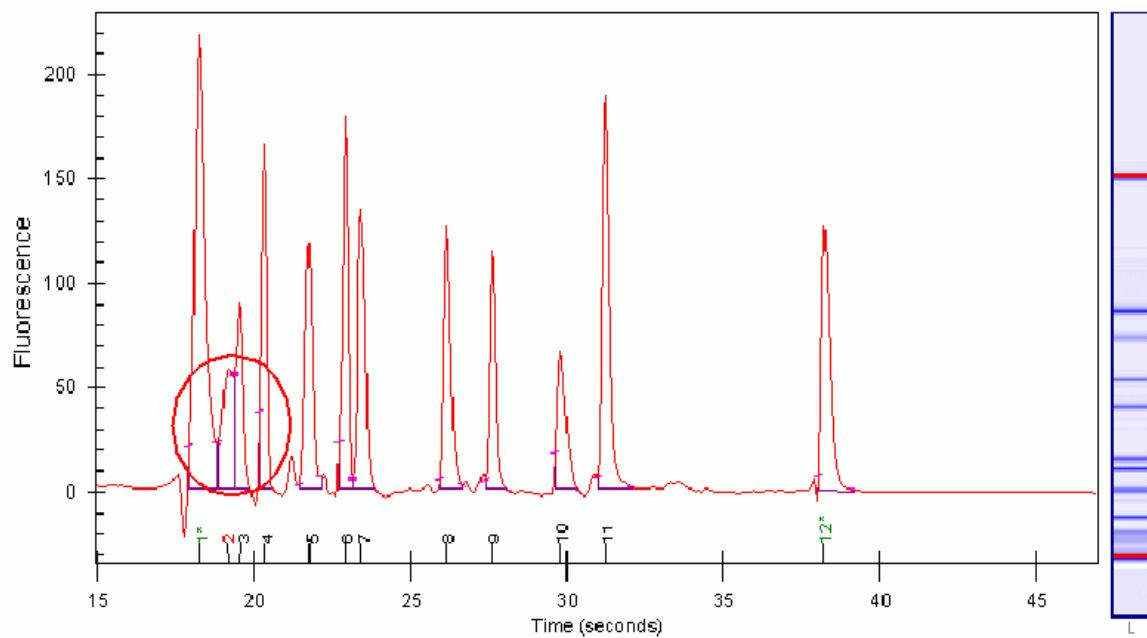
## Additional Sample or Ladder Peaks

Most Probable Causes	Solution
Sample or ladder not denaturated properly.	Use fresh sample aliquot. Heat sample/ denaturating solution and ladder for 5 min at 100 °C
Sample/denaturating solution and/or ladder are dried out during denaturation.	Sample/denaturating solution and/or ladder were denaturated in 1.5 ml tubes. Use 0.5 ml tubes for denaturating
Chip contaminated. Dust particles in separation channels.	Wear powder-free gloves only. Don't touch the wells of the chip.  Clean the electrodes: see <a href="#">“How to clean the Pin Set of the Electrode Cartridge”</a> on page 192 for additional information.  Load the chip immediately after taking it out of its sealed bag.
Probable Causes	Solution
Ladder degraded.	Refer to the protein reagent kit guide for proper ladder storage. Optional: Prepare ladder aliquots and use a new aliquot.
Vibration of Agilent 2100 bioanalyzer.	Don't touch Agilent 2100 bioanalyzer during a run. Remove vibration devices, such as vortexers and vacuum pumps, from bench.

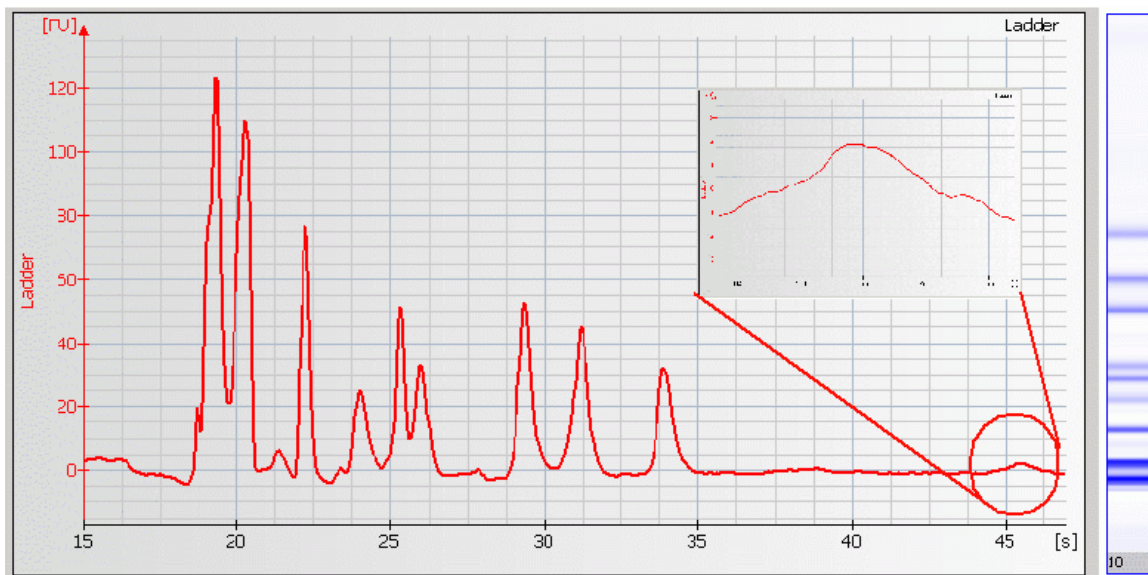
## Low or Missing Upper Marker in Ladder

<b>Most Probable Causes</b>	<b>Solution</b>
Ladder degraded.	<p>For correct ladder storage and denaturation, refer to the protein reagent kit guide. To correct for wrong selected upper marker, set upper marker manually. If necessary, adjust peak find settings. If peaks are detected that are not part of the ladder, exclude them.</p> <p>For better upper marker identification: Turn off the analysis. For correct alignment overlay electropherograms of multiple wells to clearly identify the upper marker. For details please refer to the Online Help or Users Guide.</p>
Diluted ladder is too old.	Use diluted ladder within one day.
<b>Probable Causes</b>	<b>Solution</b>
Ladder not denaturated properly.	Use fresh ladder aliquot. Heat ladder for 5 min at 100 °C
Ladder dried out during denaturation.	Ladder was denaturated in 1.5 ml tubes. Use 0.5 ml tubes for denaturing.

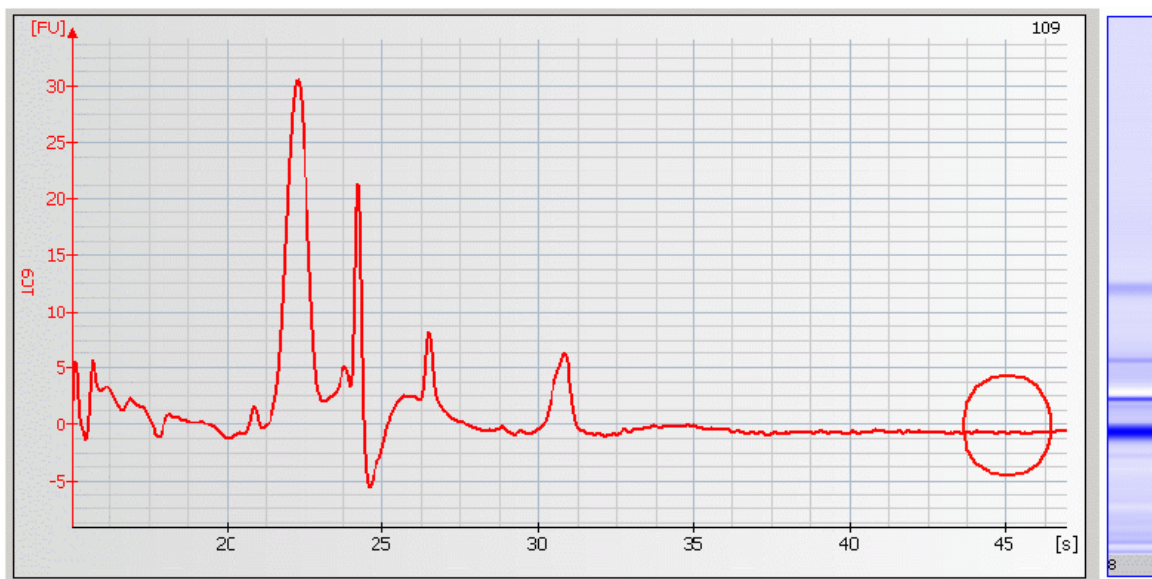
## Low or Missing Upper Marker in Sample

Most Probable Causes	Solution
Sample buffer/denaturing solution not handled according to the instructions.	<p>Refer to the instructions provided with the reagent kit guide for storage and preparation of the sample buffer/denaturing solution. To correct for wrong selected upper marker, set upper marker manually. If necessary, adjust peak find settings.</p> <p>For better upper marker identification: Turn off the analysis. For correct alignment overlay electropherograms of multiple wells to clearly identify the upper marker. For details please refer to the Online Help or Users Guide.</p>
Incompatible sample component. Some components of the buffer, e.g. CHAPS, TFA, etc. interfere with the upper marker and decrease sensitivity.	<p>See protein reagent kit guides for a list of compatible buffers and buffer compounds. For an updated list please refer to the web-site <a href="http://www.agilent.com/chem/labonachip">www.agilent.com/chem/labonachip</a>.</p> <p>If necessary dilute, dialyze or desalt the sample. It is recommended to dilute the samples 1:2, 1:4, ... with water to find the optimal dilution.</p>

<b>Probable Causes</b>	<b>Solution</b>
Upper marker was digested by proteases.	Add protease inhibitor cocktails to cell lysate samples.
Samples not denatured properly.	Use fresh sample aliquot. Heat samples with denaturing solution for 5 min at 100 °C
Samples dried out during denaturation.	Samples were denatured in 1.5 ml tubes. Use 0.5 ml tubes for denaturing.

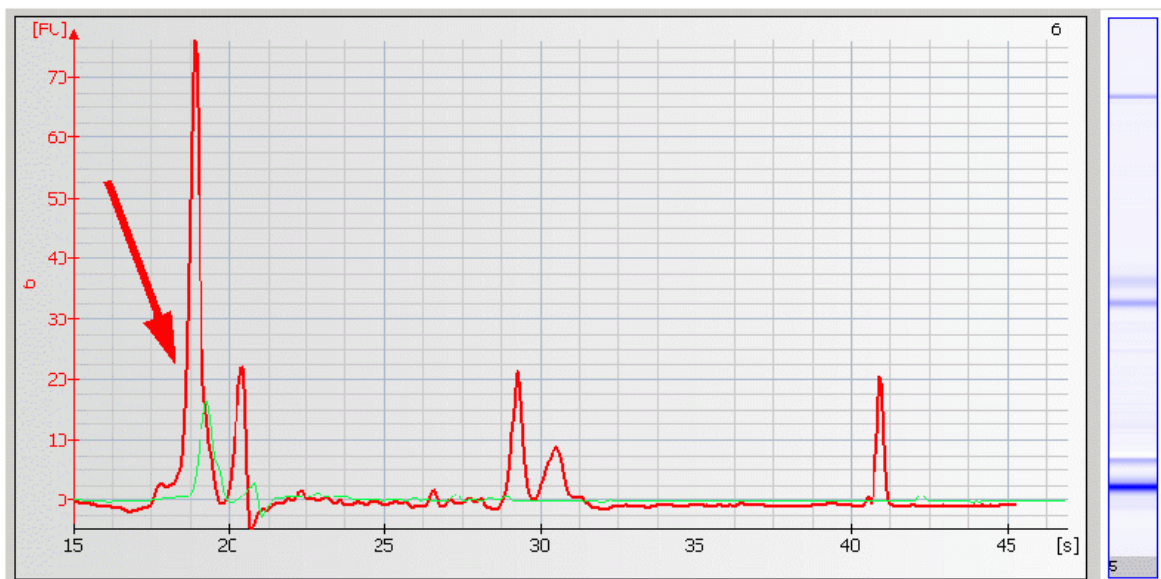
## High Lower Marker Variability

As long as the lower marker is detected, the assay performance is not affected by lower marker or system peak variability.

Most Probable Causes	Solution
<p>Buffer components of the sample , e.g. salts, detergents, other additives etc. interfere with the lower marker.</p> <p>Variability of ionic strength of the sample influence the lower marker intensity.</p>	<p>See protein reagent kit guide for a list of compatible buffers and buffer compounds. For an updated list please refer to the web-site <a href="http://www.agilent.com/chem/labonachip">www.agilent.com/chem/labonachip</a>.</p> <p>If necessary dilute, dialyze or desalt the sample. It is recommended to dilute the samples 1:2, 1:4, ... with water to find the optimal dilution.</p>

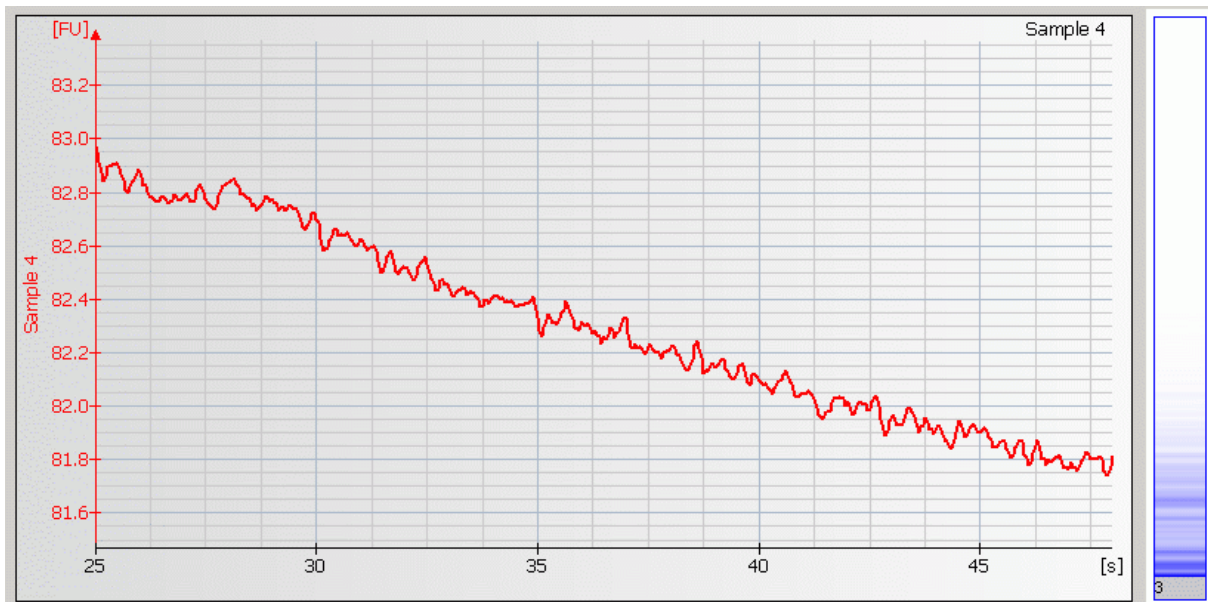
# Missing Peaks

<b>Most Probable Causes</b>	<b>Solution</b>
Laser defective.	Check laser using the “ <a href="#">Hardware Diagnostics</a> ” on page 33. If the laser test fails, contact Agilent Technologies.
Gel dye mix was loaded in the destain well instead of destaining solution.	Discard chip and prepare new chip according to protocol.
<b>Probable Causes</b>	<b>Solution</b>
Autofocus failure.	Check autofocus using the “ <a href="#">Hardware Diagnostics</a> ” on page 33. If autofocus test fails, contact Agilent Technologies.
<b>Least Probable Causes</b>	<b>Solution</b>
High voltage power supply defective.	Check high voltage power supply using the “ <a href="#">Hardware Diagnostics</a> ” on page 33. If the power supply is defective, contact Agilent Technologies.
Fingerprint on focusing lens or on the backside of the chip.	Clean lens as described in “ <a href="#">Cleaning the Lens</a> ” on page 222.  Do not touch the underside of the chip

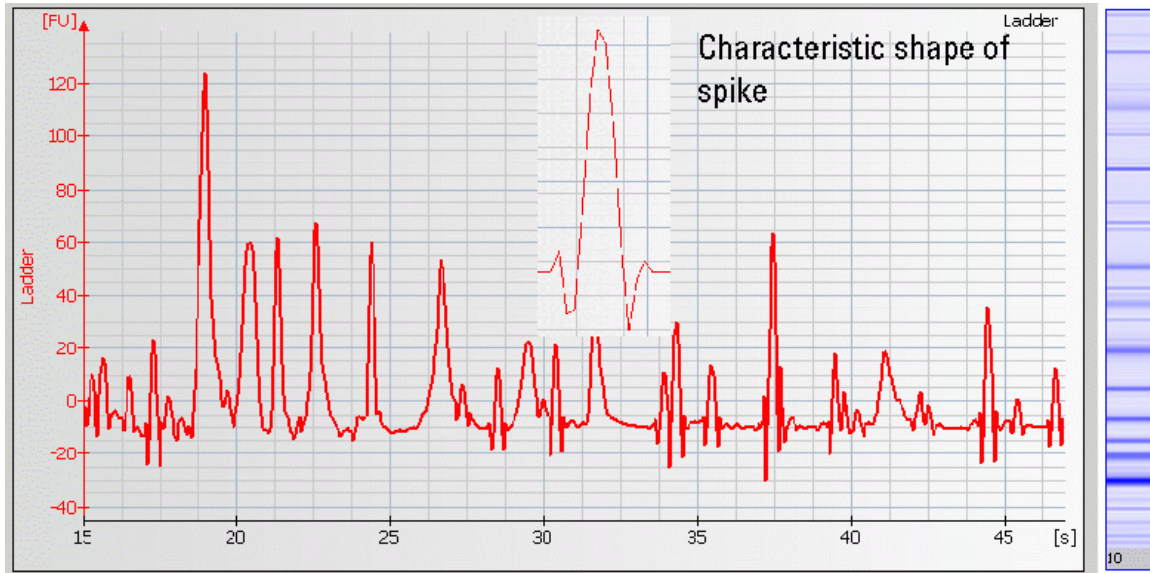
# Spikes

Most Probable Causes	Solution
<p>Chip/gel-dye mix/destaining solution/electrodes contaminated.</p>	<p>Prepare new chip with new gel-dye mix and new destaining solution:</p> <p>Wear powder-free gloves only. Don't touch the underside of the chip. Don't touch the wells of the chip.</p> <p>Clean the electrodes as described in <a href="#">"Maintenance of the Electrode Cartridge"</a> on page 180.</p> <p>Load the chip immediately after taking it out of its sealed bag.</p>
<p>Gel-dye mix/destaining solution not properly prepared.</p>	<p>Refer to the reagent kit guide for proper preparation of the gel-dye mix and destaining solution. Let the dye warm up to room temperature for 30 min before preparing the gel-dye mix. Protect the dye from light during this time</p>

Probable Causes	Solution
Vibration of Agilent 2100 bioanalyzer.	Don't touch Agilent 2100 bioanalyzer during a run. Remove vibration devices, such as vortexers and vacuum pumps, from bench.

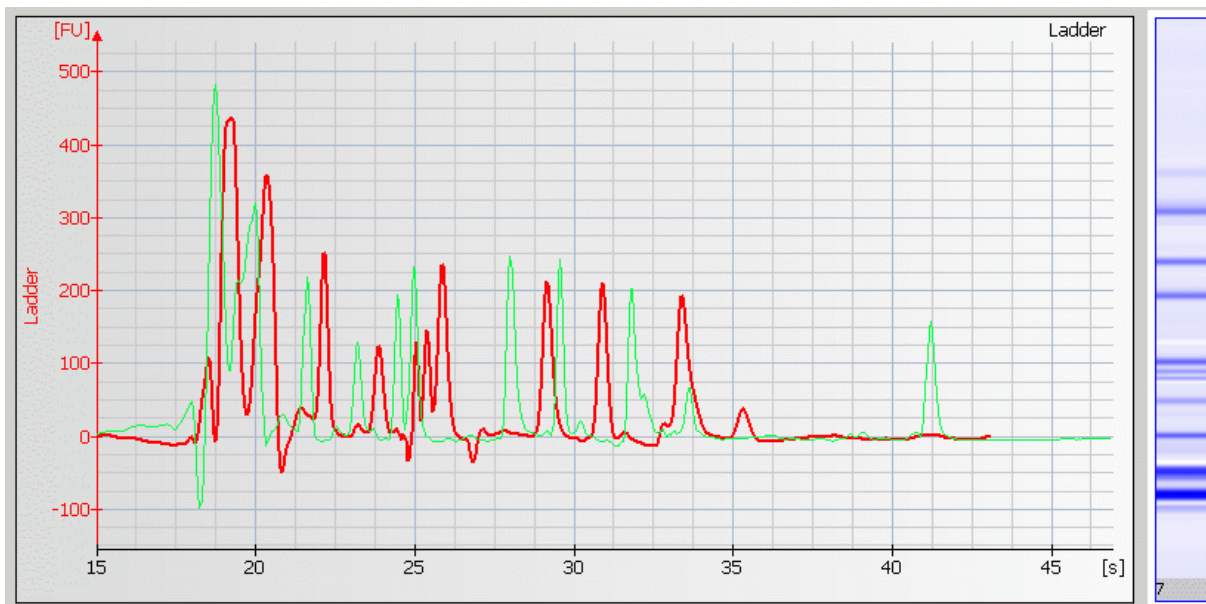
## Poor Reproducibility

Most Probable Causes	Solution
Wrong peak alignment.	Check if alignment is correct.  For better identification of the lower and upper marker: Turn off the analysis. For correct alignment overlay electropherograms of multiple wells to clearly identify the lower and upper marker. For further information, please refer to the Online Help or Users Guide.
One or more samples not denaturated properly.	Use fresh sample aliquot. Heat samples with denaturing solution for 5 min at 100 °C
One or more sample dried out during denaturation.	Samples were denaturated in 1.5 ml tubes. Use 0.5 ml tubes for denaturing.
Reducing agent (BME or DTT) was added in one sample and not in the other.	Refer to the reagent kit guide for proper sample reduction.
Dirty electrodes.	Thoroughly clean the electrodes as described " <a href="#">Maintenance of the Electrode Cartridge</a> " on page 180.

Probable Causes	Solution
Diluted samples are too old.	Use diluted samples within one day.
Incompatible buffer component.	<p>See protein reagent kit guide for a list of compatible buffers and buffer compounds. For an updated list please refer to the web-site <a href="http://www.agilent.com/chem/labonachip">www.agilent.com/chem/labonachip</a>.</p> <p>If necessary dilute, dialyze or desalt the sample.</p>
Samples were not mixed properly after sample buffer and water and water was added.	Stick to the protocol as described in the reagent kit guide.
Samples were not centrifuged after denaturation	After denaturation step, spin down samples.

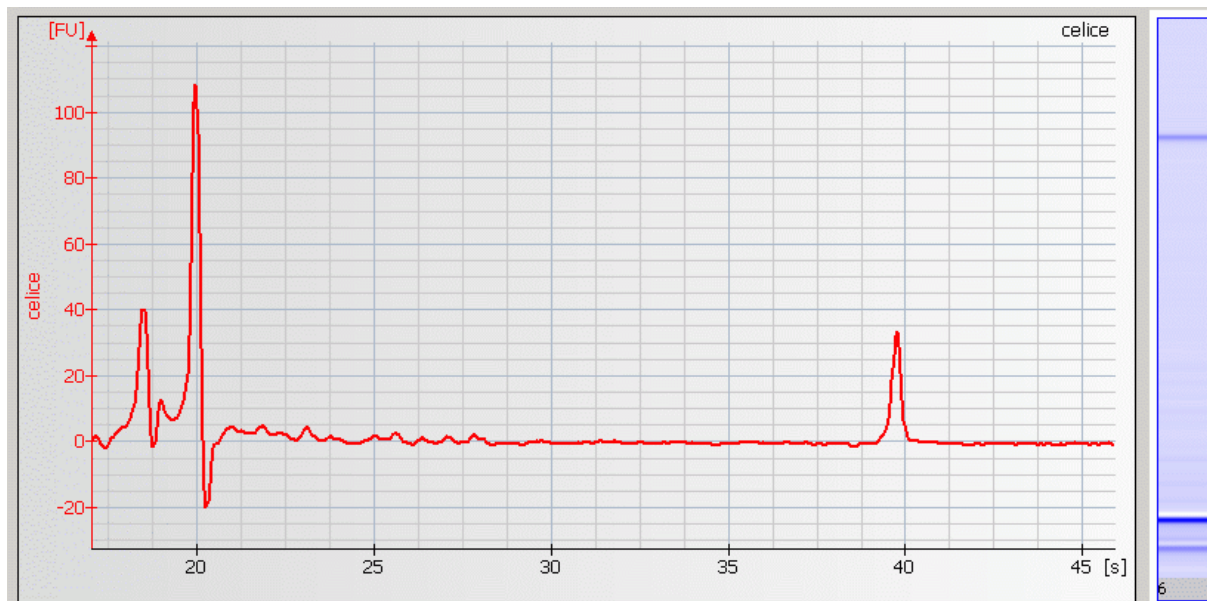
## Low Sensitivity

Most Probable Causes	Solution
Protein concentration in samples too low.	Use protein concentration according to specifications given in the reagent kit guide.
Too high salt concentration in samples.	Sensitivity is strongly affected by salt concentration. Dilute samples in deionized H <sub>2</sub> O, dialyze samples against low salt buffer or desalt samples using spin filters.
SDS not completely dissolved in dye concentrate.	Let dye concentrate equilibrate to room temperature for 30 min before use. Protect dye concentrate from light during this time. Check for undissolved SDS crystals in the tube. Vortex dye concentrate well before use. If necessary heat the sample buffer to 37 °C for 2 min.
Samples were not diluted prior to chip loading	Dilute samples according to protocol given in the reagent kit guide.

<b>Probable Causes</b>	<b>Solution</b>
Samples not completely denatured.	Use fresh sample aliquot. Heat sample/ denaturing solution for 5 min at 100 °C.
Sample/denaturing solution are dried out.	Sample/denaturing solution were denatured in 1.5 ml tubes. Use 0.5 ml tubes for denaturing.
Pipetting error during preparation of mixtures.	Check dilution procedure and check calibration of pipette.
<b>Least Probable Causes</b>	<b>Solution</b>
Samples dissolved in acidic buffer.	Neutralize samples with appropriate buffer or dilute samples in deionized H <sub>2</sub> O. Alternatively dialyze samples against buffer with medium pH.

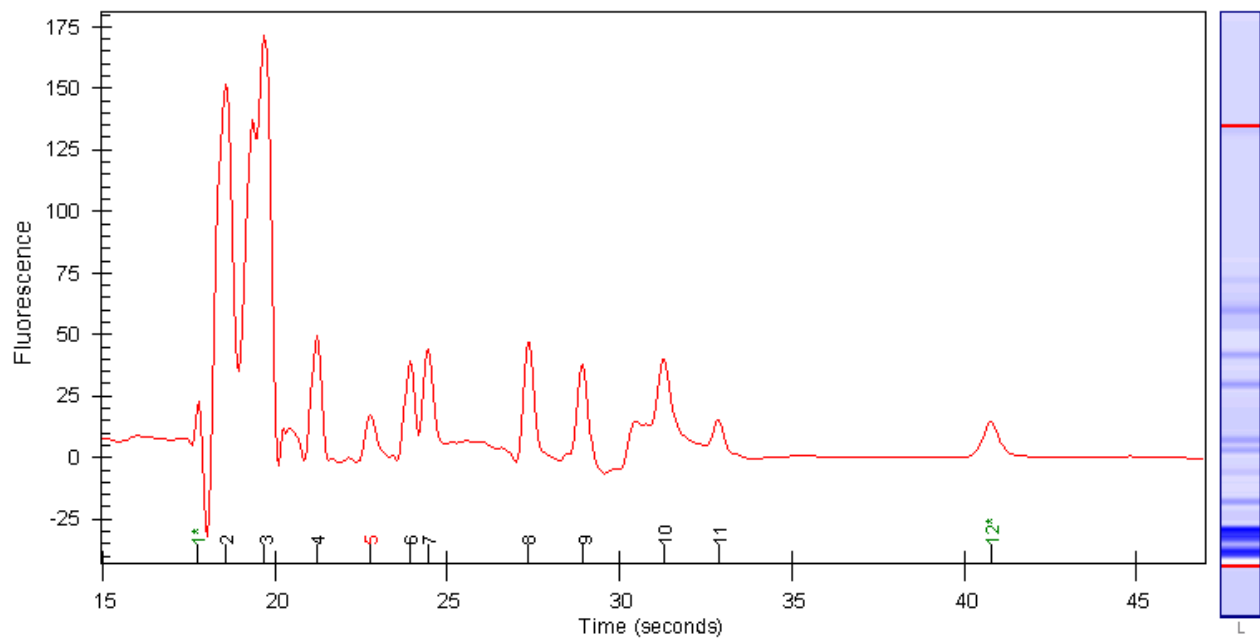
## Low Ladder Peaks

<b>Most Probable Causes</b>	<b>Solution</b>
Ladder degraded.	Refer to the protein reagent kit guide for proper ladder storage. Optional: Prepare ladder aliquots and use a new aliquot.
Ladder not diluted after denaturation.	Refer to the Reagent Kit Guide for proper chip preparation.
<b>Probable Causes</b>	<b>Solution</b>
Ladder not completely denaturated.	Use fresh ladder aliquot. Heat ladder for 5 min at 100 °C.
Ladder dried out.	Ladder was denaturated in 1.5 ml tubes. Use 0.5 ml tubes for denaturing.
Diluted ladder is too old.	Use diluted ladder within one day.
Pipetting error during preparation of mixtures.	Check dilution procedure and calibration of pipette.

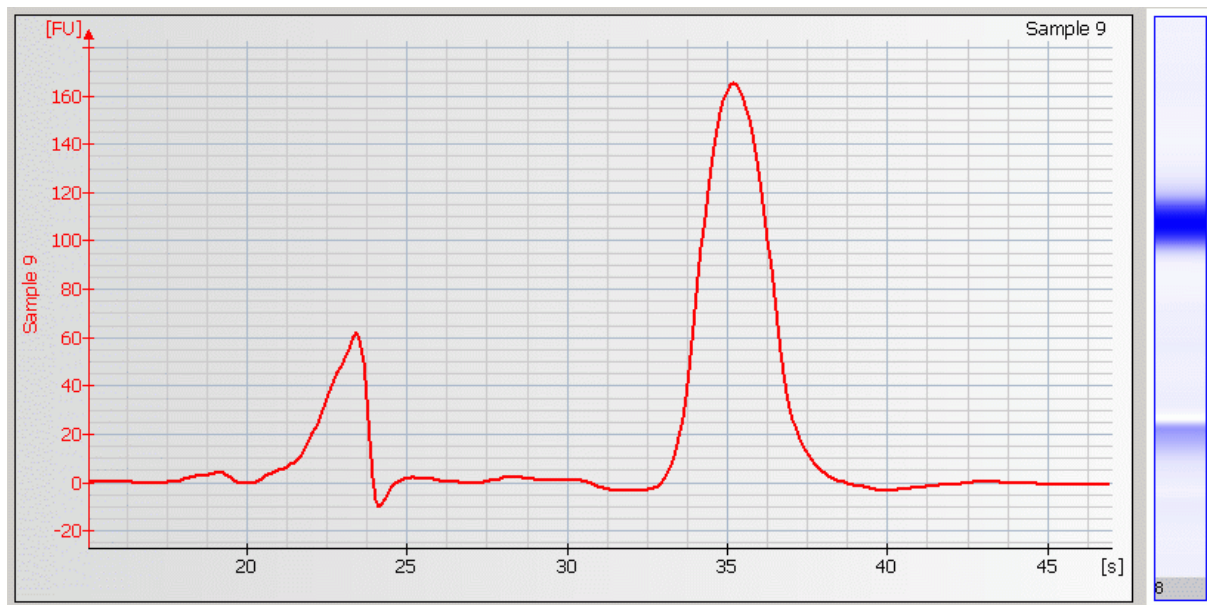
## Broad Peaks

Most Probable Causes	Solution
Wrong peak alignment.	<p>Check if alignment is correct (wrong alignment might cause broad peaks compared to the rest of the chip).</p> <p>For better identification of the lower and upper marker: Turn off the analysis. For correct alignment overlay electropherograms of multiple wells to clearly identify the lower and upper marker. For further information, please refer to the Online Help or Users Guide.</p>
Air bubbles in the bottom of the well.	<p>Always insert the pipette tip to the bottom of the well when dispensing the liquid. Remove large air bubbles with a pipette tip (small bubbles on top of well do not affect the assay).</p>

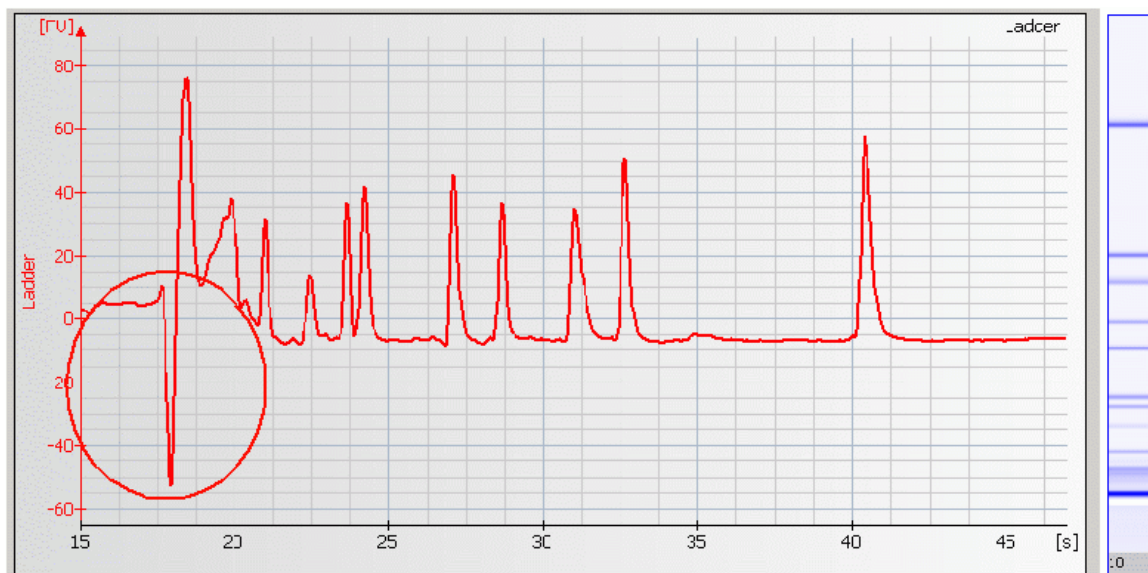
## Baseline Dips

As long as the lower marker is detected, the assay performance is not affected by dips.

Most Probable Causes	Solution
Sample contains additional detergents and/or dyes.	See protein reagent kit guide for a list of compatible buffers and buffer compounds. For an updated list please refer to the web-site <a href="http://www.agilent.com/chem/labonachip">www.agilent.com/chem/labonachip</a> .  If necessary dilute, dialyze or desalt the sample.

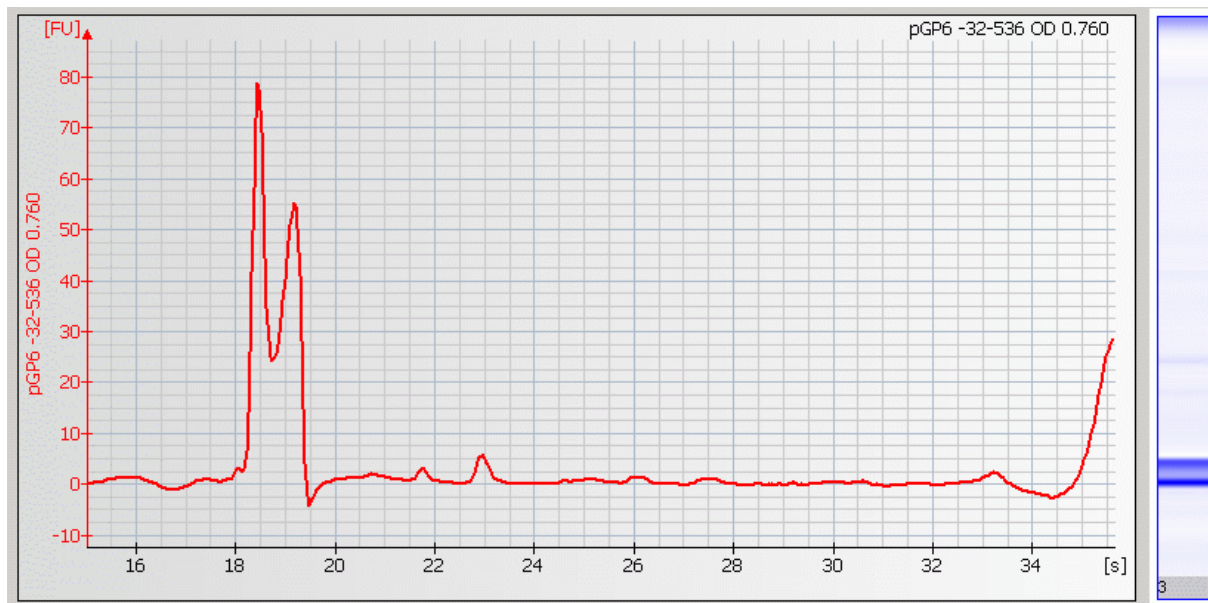
# Late Migration

Most Probable Causes	Solution
Protein chips expired	Check expiration date on chip box.
Protein concentration in samples too high.	Use protein concentration according to specifications given in the reagent kit guide.
Chip not properly primed. Clogged chip priming station or wrong settings of priming station.	Prepare a new chip. Check chip priming station as described in <a href="#">“Checking the Chip Priming Station for Proper Performance - Seal Test”</a> on page 209. Clean/replace gasket and plastic adapter if necessary. Check if clip and base plate of priming station are in the correct position (see protein reagent kit guide)
Least Probable Causes	Solution
Defect Heater Plate	Run the temperature test by using the <a href="#">“Hardware Diagnostics”</a> on page 33. If the heater plate is defective, contact Agilent Technologies.

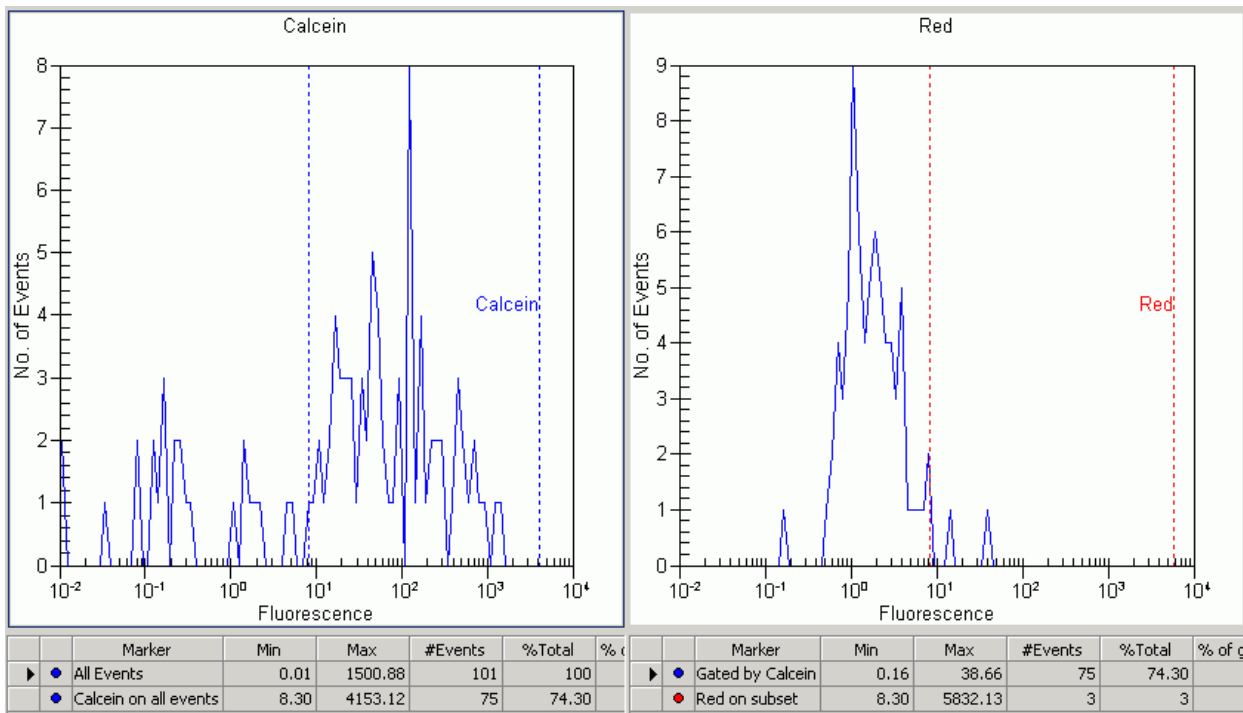
At the recommended cell concentration of 2 million/ml, an average of 750 cells are measured per sample. Event numbers below 400 are considered as low.

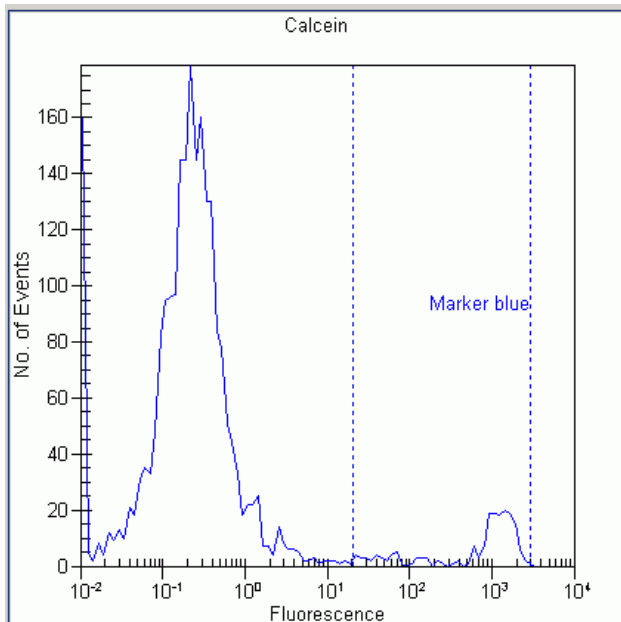
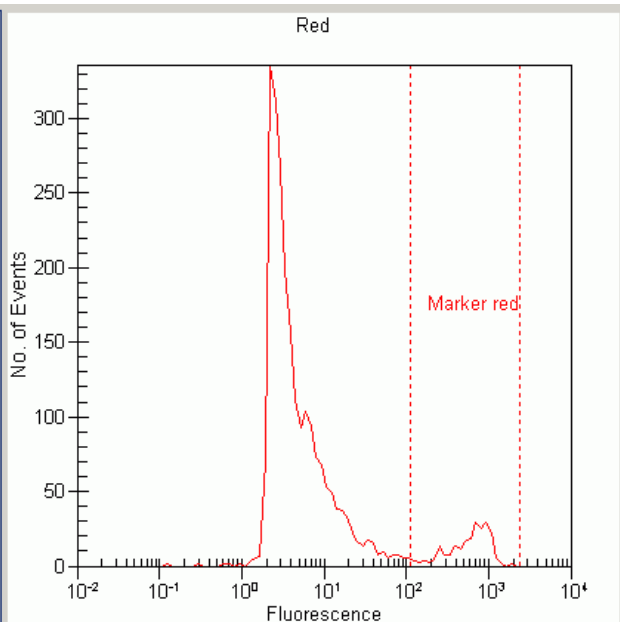
# Low Sensitivity

Marker	Min	Max	#Events	%Total
▶	● All Events	0.01	2829.89	2450	100
	● Marker blue on all events	20.20	2891.20	185	7.60

Marker	Min	Max	#Events	%Total
▶	● All Events	0.13	1915.89	2450	100
	● Marker red on all events	110.13	2351.03	212	8.70

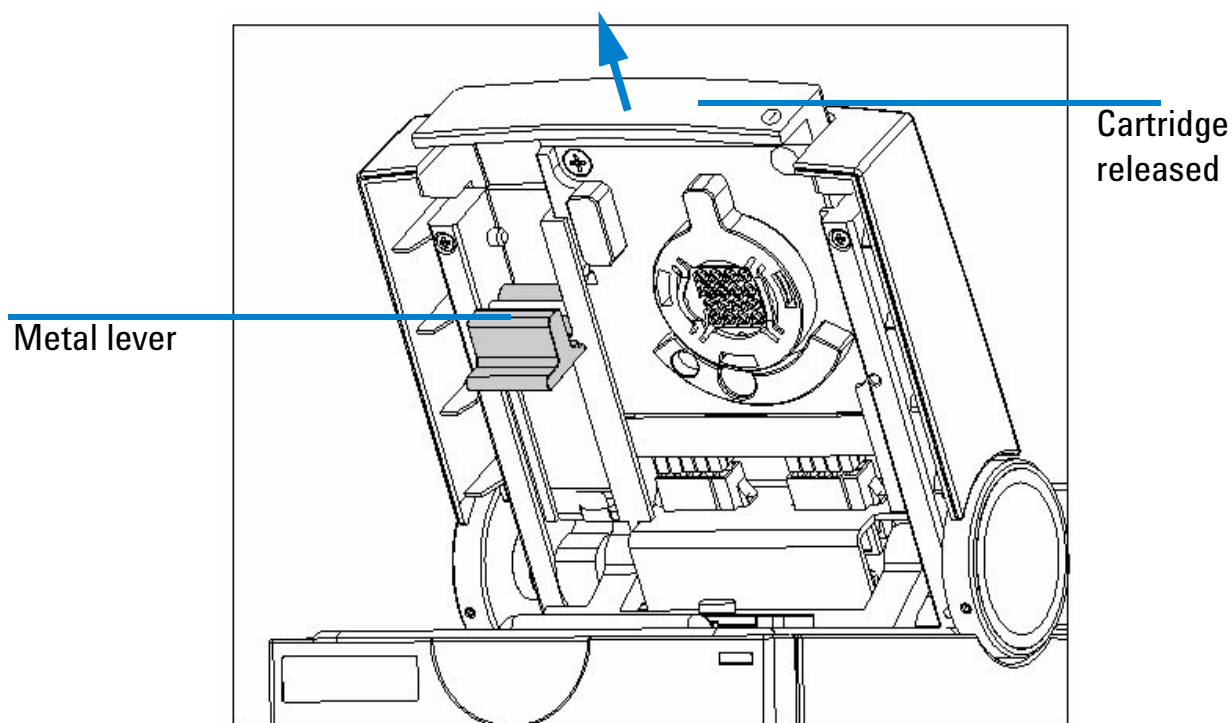
**Figure 3 Removing the Electrode Cartridge**

- 1 Turn off line power to the 2100 bioanalyzer. The line switch is located at the rear of the 2100 bioanalyzer.
- 2 Open the lid and pull the metal lever on the inside left of the lid to the vertical position as shown in Figure 2. When the lever is in the vertical position, the cartridge is released from the lid by about 10 mm.
- 3 Gently pull the cartridge out of the lid as shown in Figure 3, “[Removing the Electrode Cartridge](#)”.

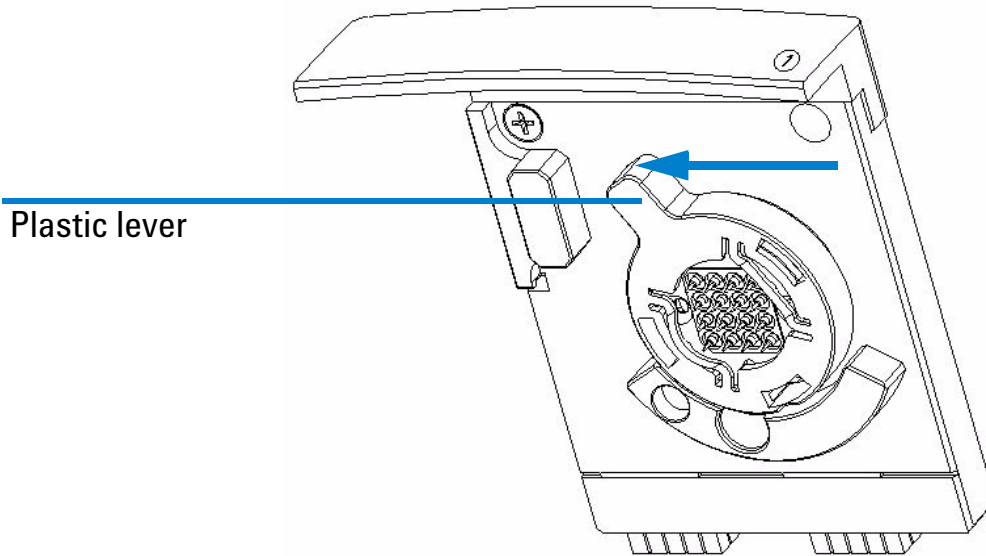
**Figure 4** Opening the bayonet socket of the Pin Set

- 4 Open the bayonet socket of the pin set by turning the plastic lever to the left as described in Figure 4, “Opening the bayonet socket of the Pin Set”.

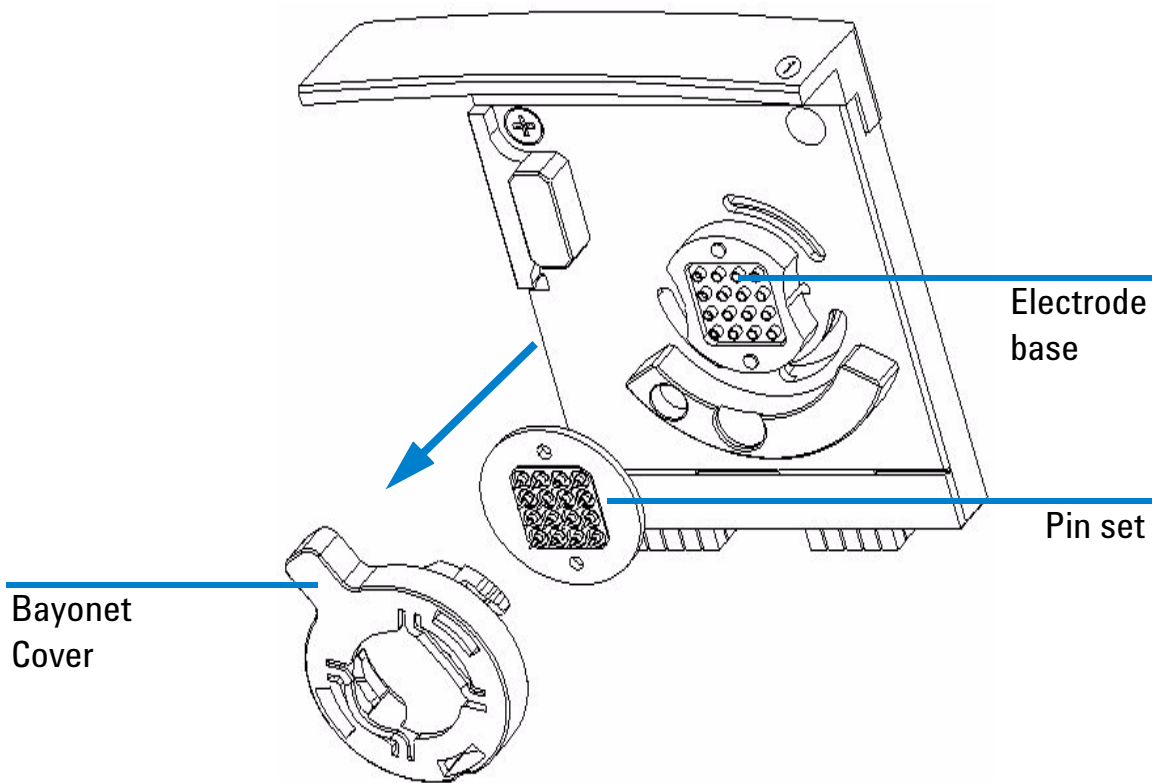
**Figure 5 Releasing the Pin Set**

- 5 Remove the cover of the bayonet socket by gently pulling the plastic lever. The pin set may stick to the electrode base. Remove it by carefully pulling it off. See Figure 5, “Releasing the Pin Set”.

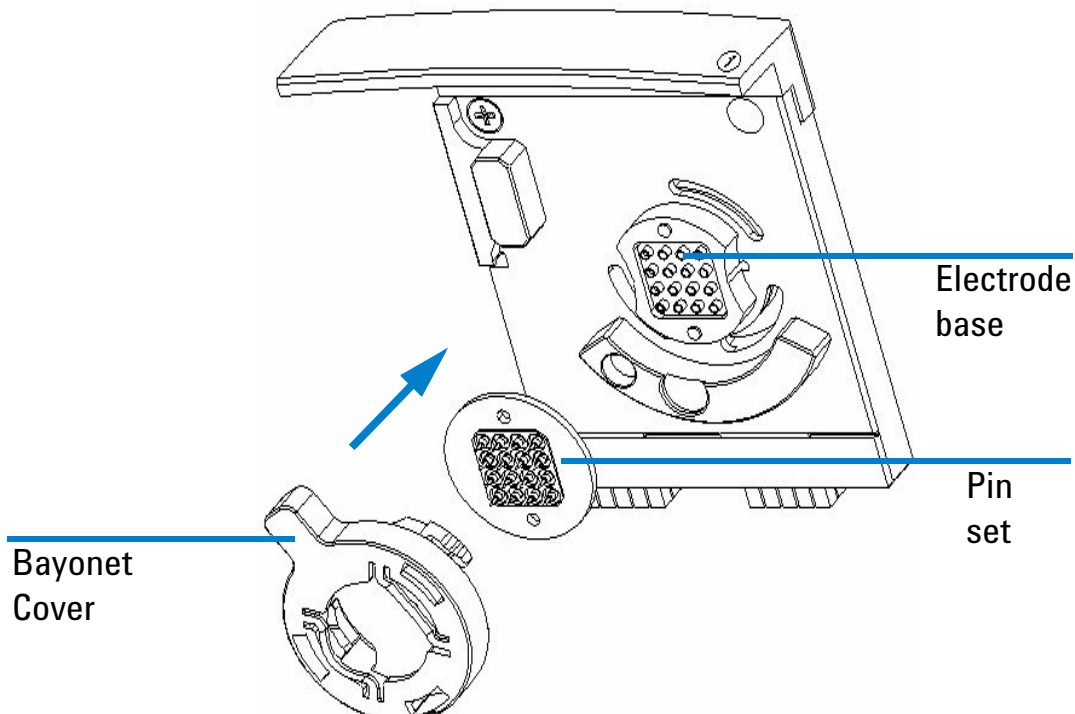
**Figure 6** Inserting the Pin Set

**10** Put the pin set on the cartridge base and the bayonet cover on the pin set. See Figure 6, “Inserting the Pin Set”.

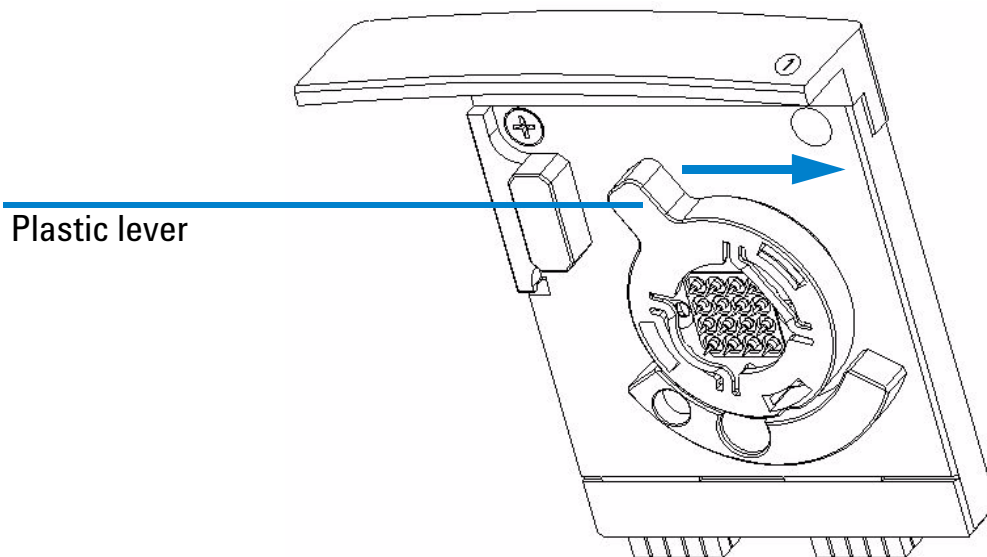
**Figure 7 Closing the Socket of the Pin Set**

**11** Lock the pin set to the electrode base by pushing the plastic lever of the bayonet cover to the right as shown in Figure 7, “Closing the Socket of the Pin Set”.

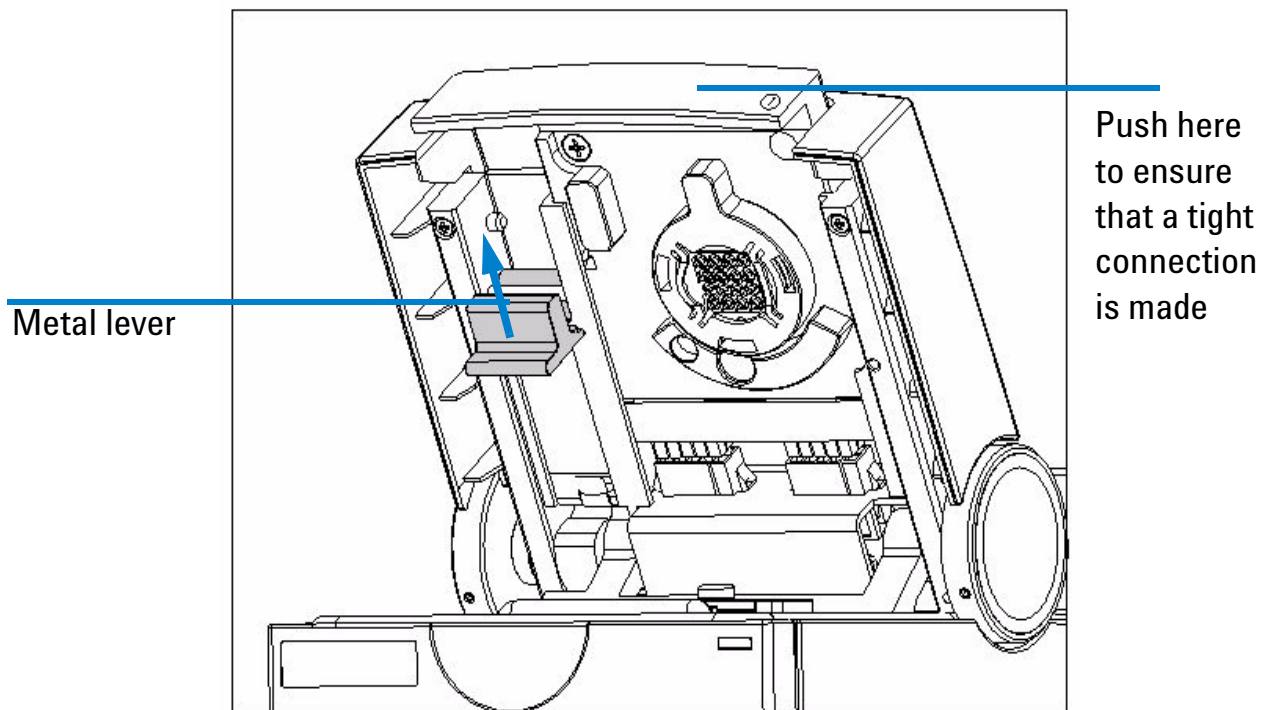
**Figure 8 Inserting the Electrode Cartridge**

- 12** Slide the electrode cartridge with the pin-set into the bioanalyzer lid as shown in Figure 8, “Inserting the Electrode Cartridge” and move the metal lever in the flat (closed) position.
- 13** Push the metal front of the electrode cartridge to ensure a tight connection to the 2100 bioanalyzer.

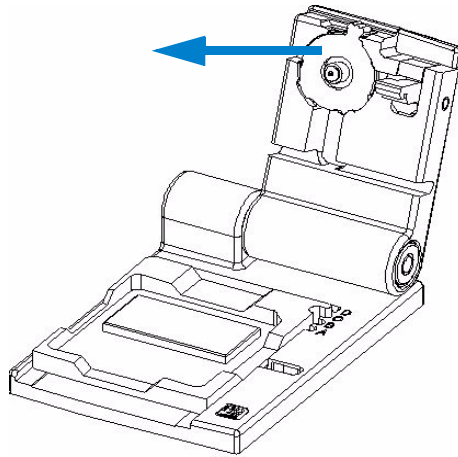
- 1 Remove the syringe by gently pulling it out of the adapter.
- 2 Open the Chip Priming Station.
- 3 Move the ring holding the adapter in place to the left as shown in Figure 9, “Releasing the Mounting Ring of the Syringe Adapter”. The ring will come off.

**Figure 9** Releasing the Mounting Ring of the Syringe Adapter

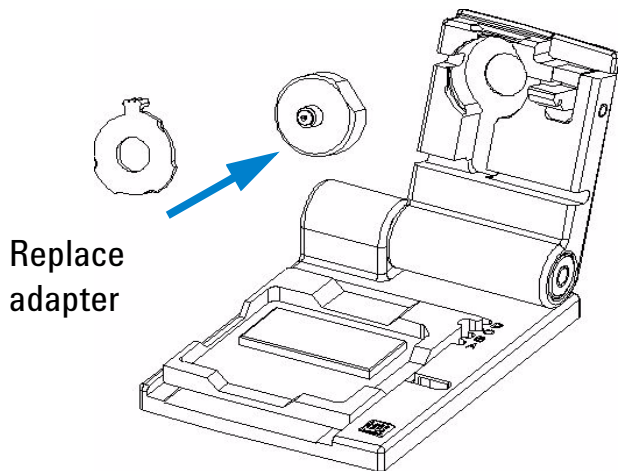
- 4 Press the syringe adapter out of its mount and dispose it according to good laboratory practices, as shown in Figure 10, “Replacing the Syringe Adapter”.
- 5 Insert the new syringe adapter.

**Figure 10 Replacing the Syringe Adapter**

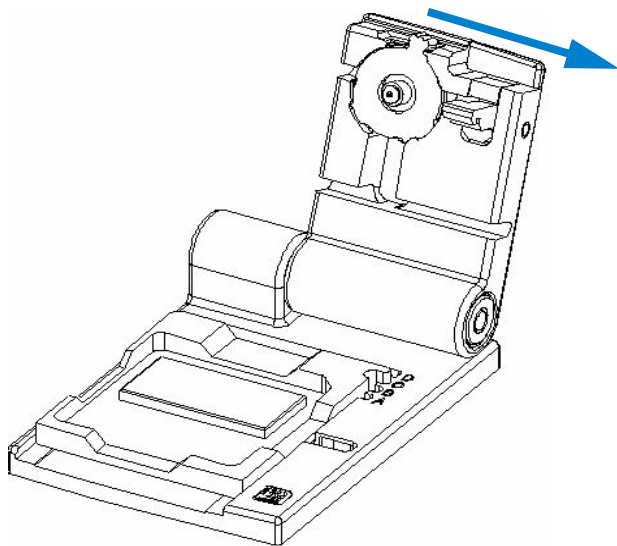
- 6 Insert the mounting ring and move it to the right in order to fix the syringe adapter as shown in Figure 11, “Fixing the Syringe Adapter”.

**Figure 11 Fixing the Syringe Adapter**

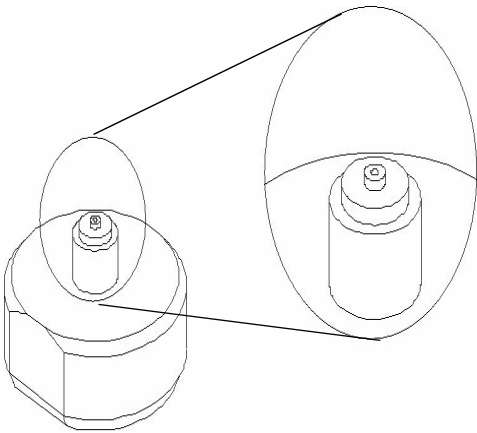
The silicone gasket, see Figure 12, “[Syringe Adapter with Gasket](#)”, ensures a tight connection between chip and syringe adapter.

**Figure 12 Syringe Adapter with Gasket**

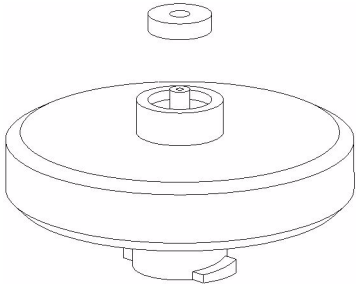
- 2 Pull out the old gasket with your fingers or with the help of a needle. See Figure 13, “[Syringe Adapter with disassembled Silicone Gasket](#)” for a disassembled adapter.

**Figure 13 Syringe Adapter with disassembled Silicone Gasket**

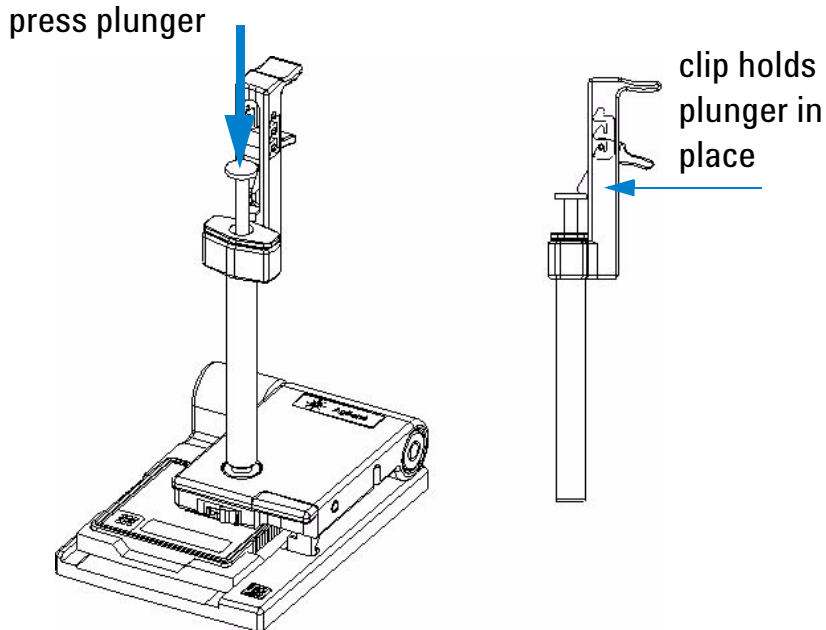
- 5 Press the plunger down until it is locked by the clip. This is shown in Figure 14, “Locking the Plunger of the Syringe with the Clip”.

**Figure 14 Locking the Plunger of the Syringe with the Clip**
