# Agilent 2100 Bioanalyzer Maintenance and Troubleshooting Guide

Edition November 2003

**Manual Part number:** G2946-90001

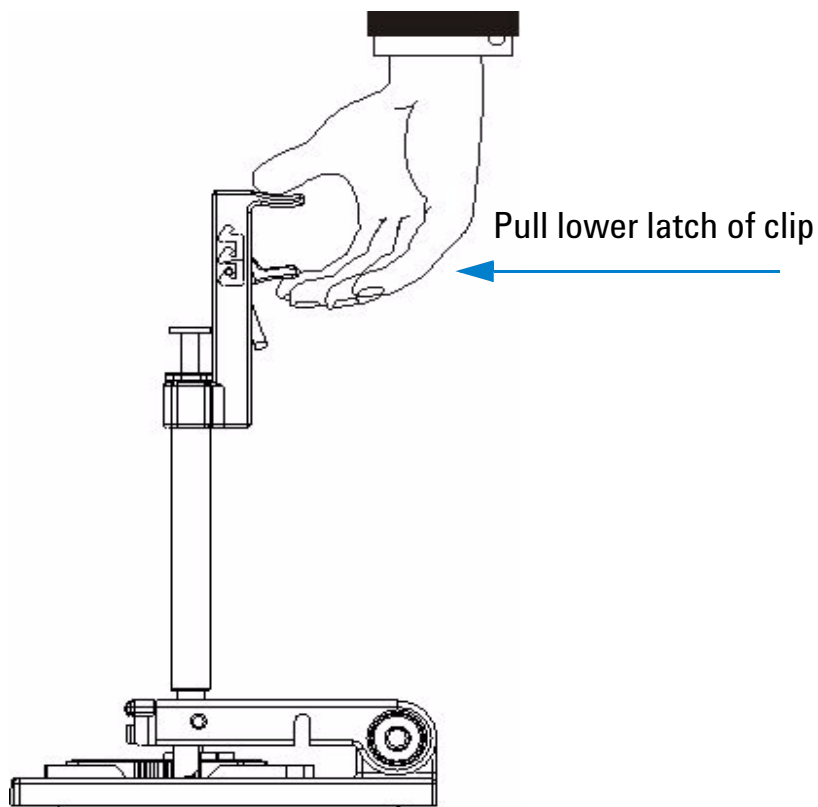
- 6 Wait for 5 seconds and press the side of the clip to release the plunger as shown in Figure 15, “Releasing the Plunger of the Syringe”.

**Figure 15 Releasing the Plunger of the Syringe**

- 7** Appropriate sealing is verified, if the plunger moves back up to the 0.3 ml mark within less than 1 second.

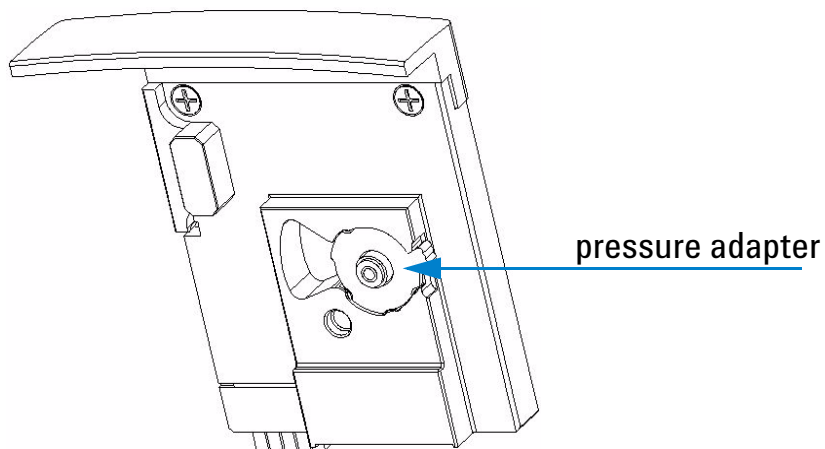
- 1 Open the instrument and remove the chip.
- 2 Should there be liquid at the adapter of the pressure cartridge, use a tissue to dry off the gasket. Make sure not to touch the lens.

**Figure 16 Pressure cartridge with pressure adapter.**

When the chip run is finished, immediately remove the chip out of the Agilent 2100 bioanalyzer. Then perform the following procedure to ensure that the pressure adapter, see Figure 16, "[Pressure cartridge with pressure adapter.](#)" on page 215, is clean and no residues are left over from the previous assay.

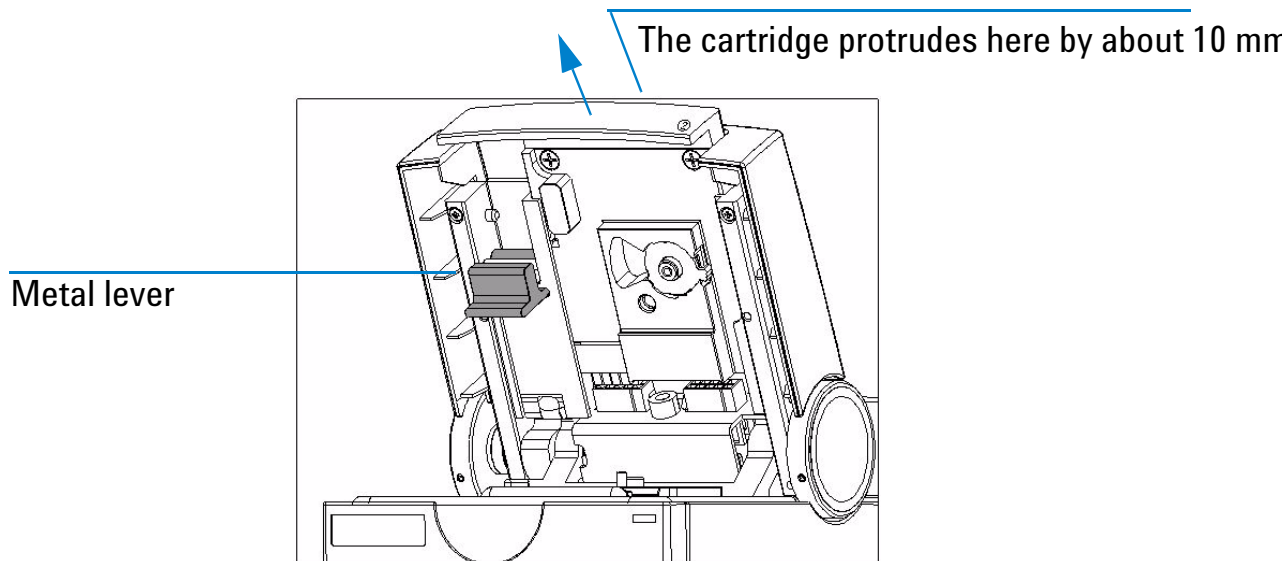
- 1 Switch off the instrument. The line switch is located at the rear of the 2100 bioanalyzer.
- 2 Open the lid and pull down the locking lever on the left inside the lid to the open position as shown in Figure 17, “[Removing the pressure cartridge](#)”. The cartridge is pushed out about 10 mm.

**Figure 17 Removing the pressure cartridge**

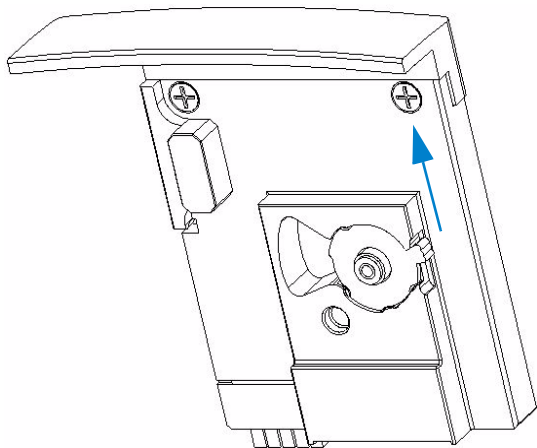
- 4 Move the ring holding the adapter in place to the left as shown in Figure 18, “Opening the ring of the pressure cartridge”. The ring will come off.

**Figure 18** Opening the ring of the pressure cartridge

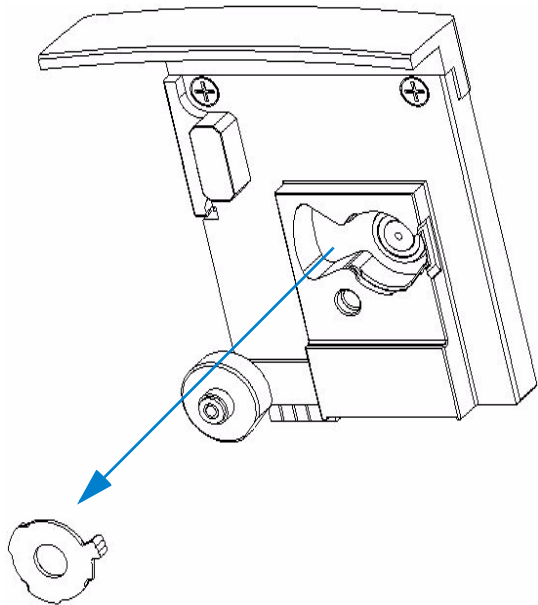
- 5 Pull the pressure adapter out of its mount, and replace it, as shown in Figure 19, “Releasing the pressure adapter”.

**Figure 19 Releasing the pressure adapter**

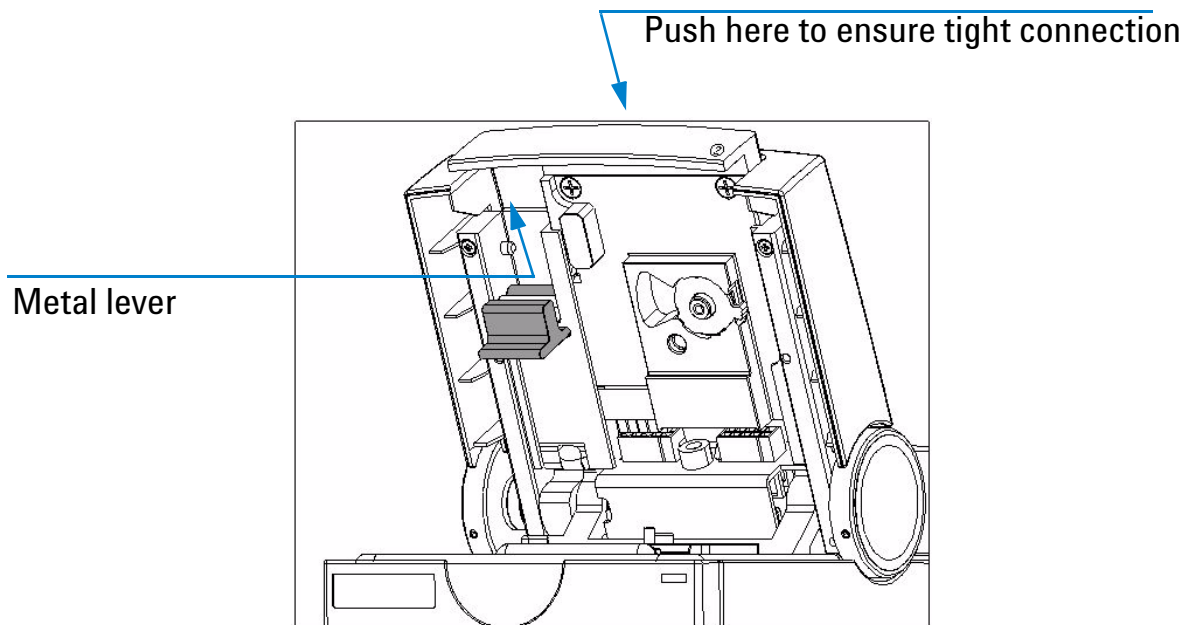
- 7 Slide the Pressure Cartridge in the lid as shown in Figure 20, “Inserting the pressure cartridge”.
- 8 Move the metal lever in the flat (closed) position.
- 9 Push the metal front of the pressure cartridge to ensure a tight connection to the 2100 bioanalyzer.

**Figure 20 Inserting the pressure cartridge**

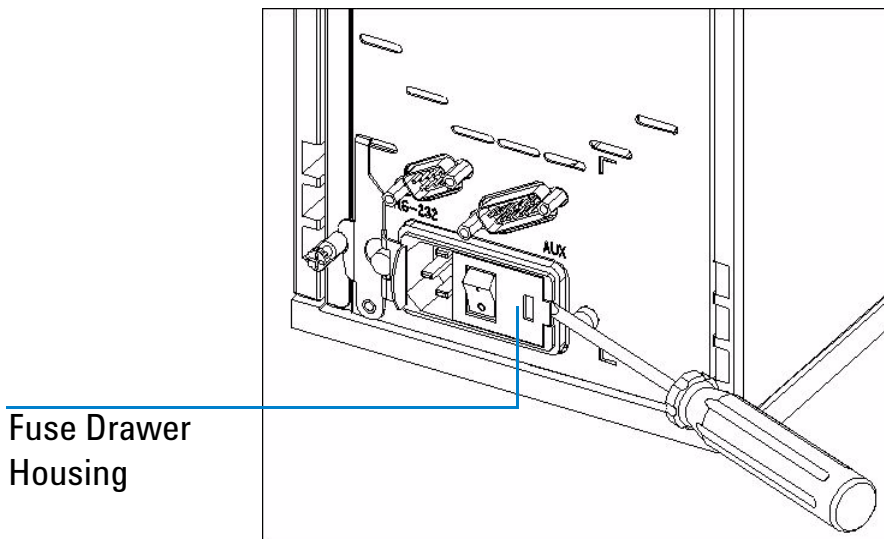
- 3 To access the fuse drawer, gently lift the outer plastic housing of the power inlet socket using a screwdriver, see Figure 21, “Lifting the Housing of the Power Inlet”.

**Figure 21 Lifting the Housing of the Power Inlet**

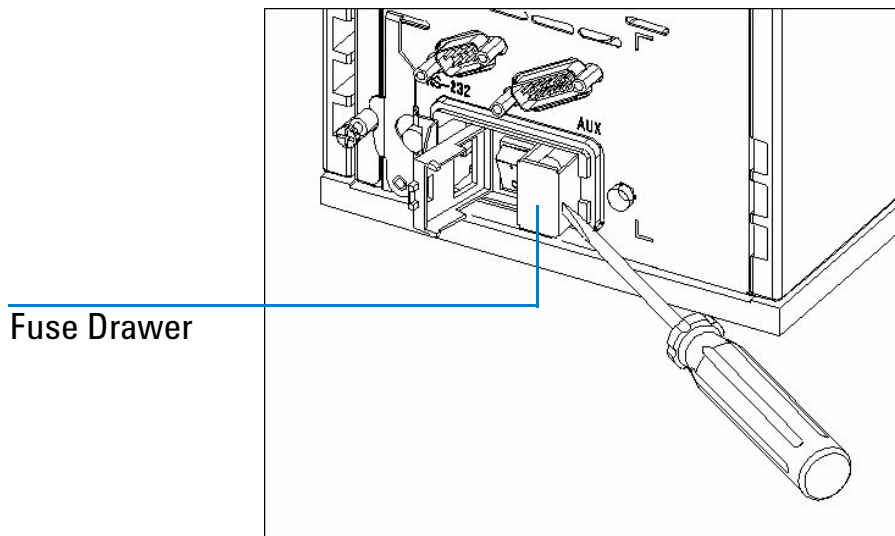
4 Pull out the fuse drawer as shown in Figure 22, “Pulling out the Fuse Drawer”.

**Figure 22 Pulling out the Fuse Drawer**

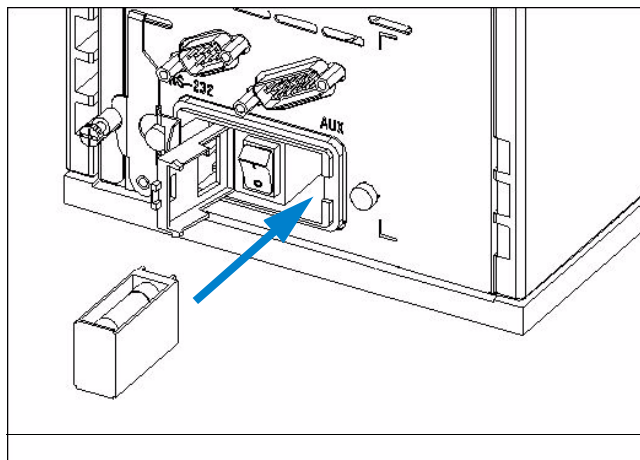
- 6 Slide in the fuse drawer and push till it fits tightly as shown in the Figure 23, “Slide in the Fuse Drawer”.

**Figure 23 Slide in the Fuse Drawer**

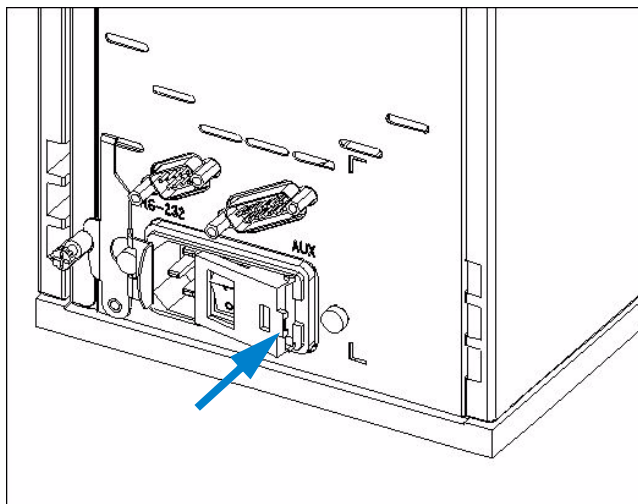
- 7 Finally, close the fuse drawer housing, reconnect the instrument to the power line and switch it on.

**Figure 24 Close Fuse Drawer Housing**
