Dell™ PowerVault™ ML6000 Maintenance Guide

Document Number: 6-01367-10 Rev A

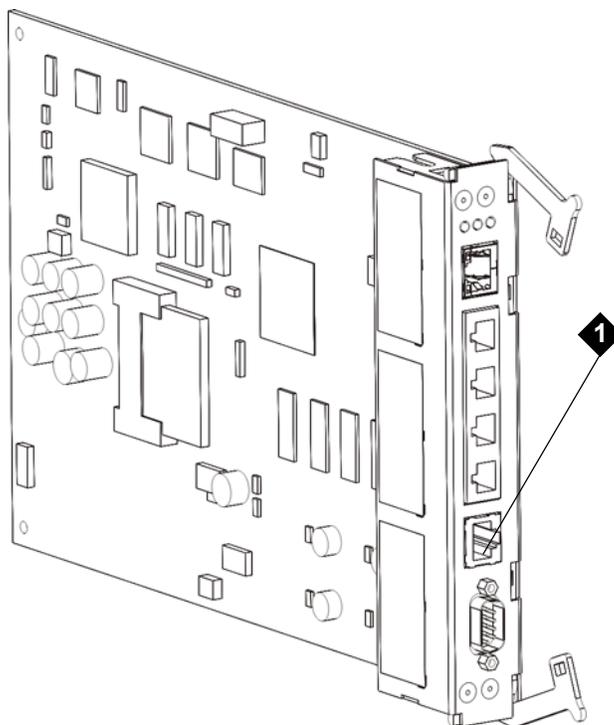
The library control blade (LCB) provides an Ethernet port that is reserved for use by service personnel. When servicing a library, connect your laptop to this port to access the remote Web client.

1 Service Port

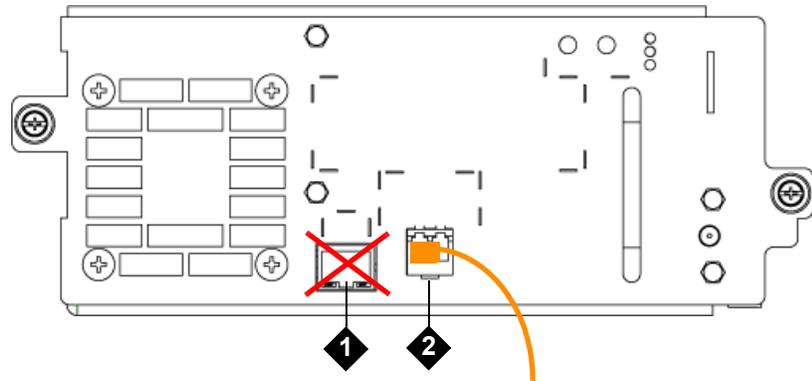
Figure 1 IBM LTO-5 Single Port Fibre Channel Tape Drive

-
- 1 Ethernet port - do not use
 - 2 Fibre Channel port - use this port
-

The library handles the Ethernet and data ports on LTO-5 and LTO-6 tape drives differently, depending on the tape drive. See [Figure 1](#) and [Figure 2](#) for details.

LTO-5 and LTO-6 Fibre Channel tape drives can be configured for speeds of up to 8 Gb/s. If they are configured for 8 Gb/s, you should connect them directly to a host or switch and not to an FC I/O blade, because the FC I/O blade only allows speeds up to 4 Gb/s. If you connect an LTO-5 or LTO-6 Fibre Channel tape drive to an FC I/O blade, the speed will autonegotiate to 4 Gb/s.

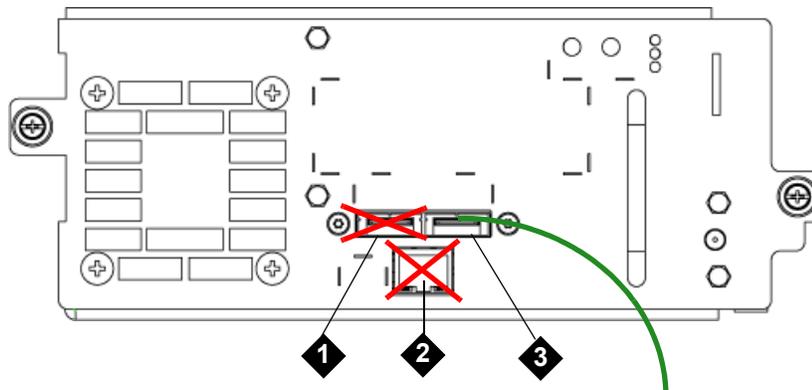
Figure 2 IBM LTO-5 Dual Port SAS Tape Drive

-
- 1 SAS port 1 - use this port
 - 2 SAS port 2 - do not use
 - 3 Ethernet port - do not use
-

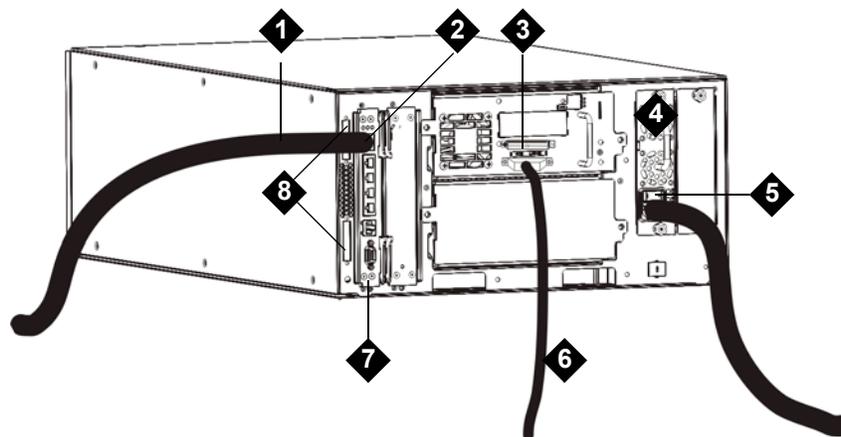
Figure 3 Stand-Alone 5U Library Control Module SCSI Cabling

1	Ethernet cable to customer network	5	Rear power switch
2	GB Ethernet port	6	SCSI cable to host
3	SCSI terminator	7	Library control blade
4	Power supply	8	Module terminators

Use this procedure, along with [Figure 3](#) and [Figure 4](#) on page 25, if you are installing a library that includes SCSI tape drives:

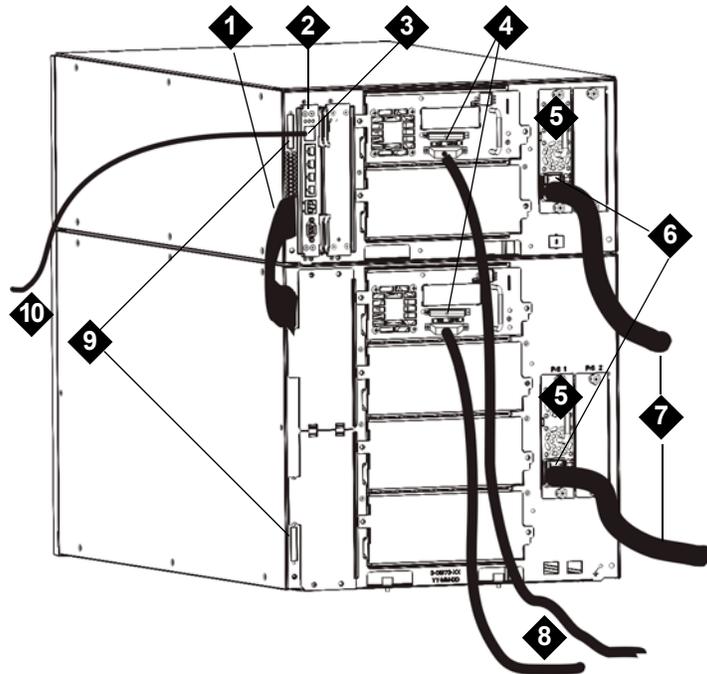
Figure 4 Multi-Module SCSI Cabling

1	Module-to-module cable	6	Rear power switch
2	Library control blade	7	Power cords
3	GB Ethernet port	8	SCSI drive to host cable
4	SCSI terminator	9	Module terminator
5	Power supply	10	Ethernet cable to customer network

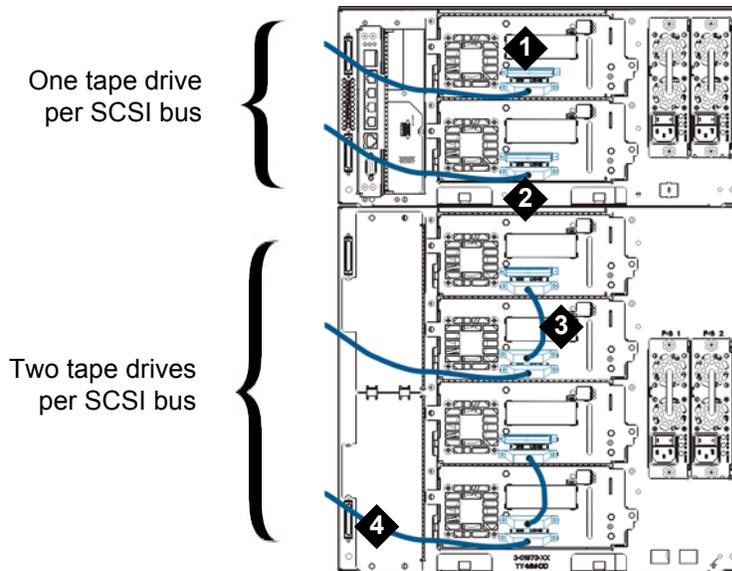
Figure 5 Cabling One or Two Tape Drives Per SCSI Bus

| 1 SCSI terminator | 3 SCSI cable connecting two SCSI tape drives |

- 1 If your library is taller than 14U, install it in a rack. See [Using the Rack-mount Kit to Install a Library in a Rack](#) on page 108 for instructions. The instructions include procedures for removing and replacing tape drives.
- 2 Connect the SCSI cables to the tape drives. There are two recommended ways to cable SCSI tape drives: one tape drive per SCSI bus or two tape drives per SCSI bus (see [Figure 5](#)).

- a. Connect one end of the SCSI cable to the top SCSI port of the bottom tape drive. Then connect the other end of the cable to the bottom SCSI port of the tape drive above. The SCSI cable connecting the two tape drives should be at least 30 cm in length.
- b. Use another SCSI cable to connect the bottom tape drive of the SCSI bus to your host.
- c. Use a SCSI terminator to terminate the top tape drive of the SCSI bus.

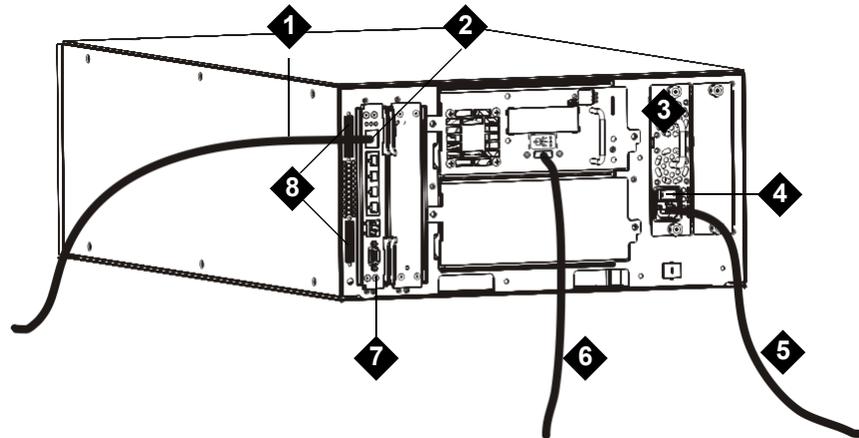
Figure 6 Stand-Alone 5U Library Control Module SAS Cabling

| 1 | Ethernet cable to customer network | 5 | Power cord |

Use this procedure, along with [Figure 6](#) and [Figure 7](#) on page 29, to connect SAS cables directly to the host.

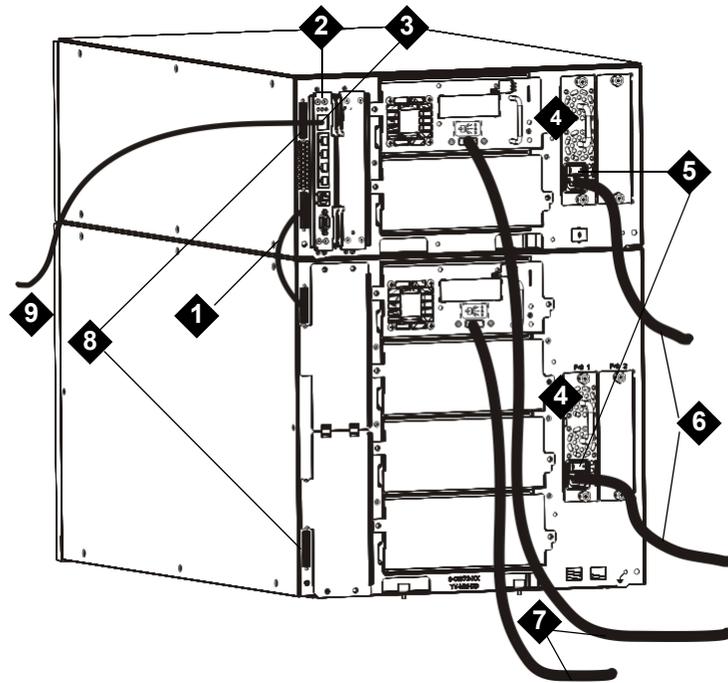
Figure 7 Multi-Module SAS Cabling

1	Module-to-module cable	6	Power cords
2	Library control blade	7	SAS cables to host
3	GB Ethernet port	8	Module terminators
4	Power supply	9	Ethernet cable to customer network
5	Rear power switch

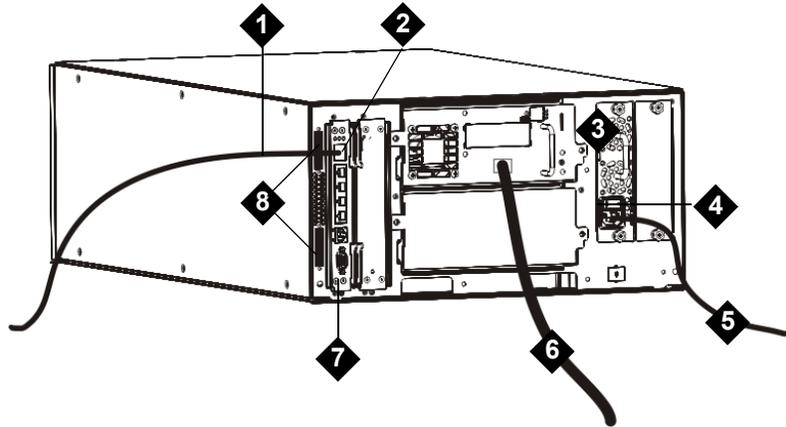
Figure 8 Stand-Alone 5U Library Control Module Fibre Channel Cabling

| 1 | Ethernet cable to customer network | 5 | Power cord |

Use this procedure, along with [Figure 8](#) and [Figure 9](#) on page 32, if you are installing a library that includes FC tape drives that are connected directly to a host.

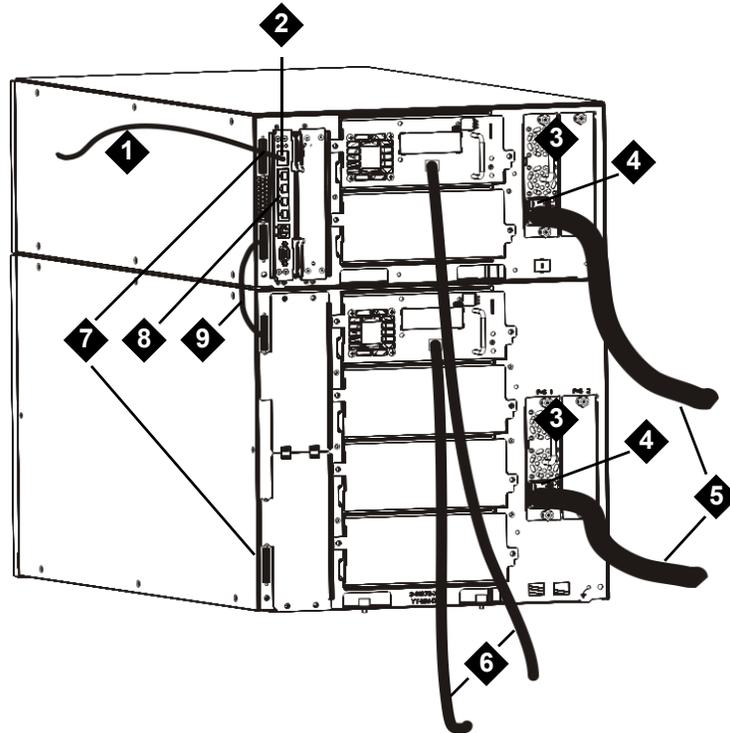
Figure 9 Multi-Module Fibre Channel Cabling

| 1 | Ethernet cable to customer network | 5 | Power cords |

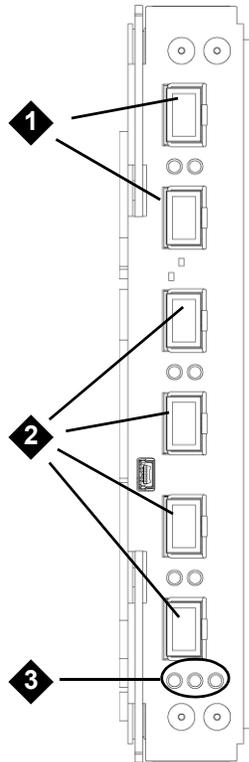
Figure 10 FC I/O Blade

-
- 1** Target ports 1 and 2 to host(s)
 - 2** Initiator ports 3 – 6 to drives
 - 3** LEDs (blue, amber, green)
-

- Each expansion module can support up to two FC I/O blades. A maximum of four FC I/O blades can be present in any library configuration. A maximum of four FC drives can be connected to one FC I/O blade.
- Ports 1 and 2 on each FC I/O blade are reserved for connection to hosts. Ports 1 and 2 are always in target mode. The other four ports (3, 4, 5 and 6) are always in initiator mode. See [Figure 14](#) on page 45.
- SAN-ready tape drives that are shipped with FC I/O blades include 24-inch, orange fibre optic cables to connect tape drives to initiator ports on an FC I/O blade.
- Ideally, an installed tape drive should be cabled to a port on the nearest FC I/O blade to eliminate the need to manage excessively long cables. The nearest FC I/O blade is usually located in the same 9U library expansion module as the tape drive.

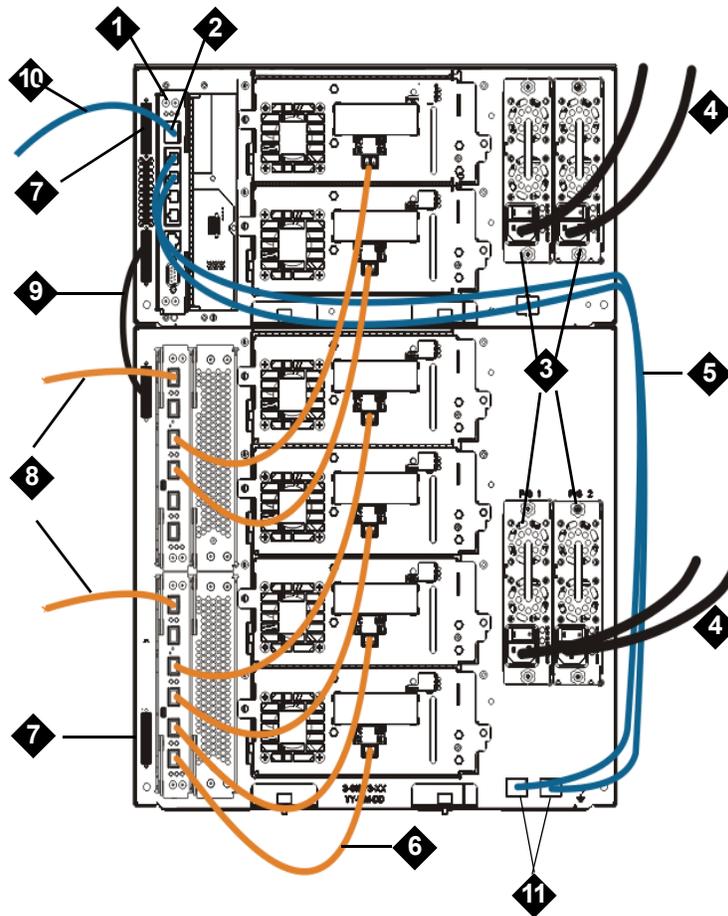
Figure 11 FC With I/O Blade Cabling

| 1 Library control blade (LCB) | 6 FC cable to tape drive |

Use the following procedure, along with [Figure 11](#), if you are installing a library that includes FC tape drives that are connected to FC I/O blades.

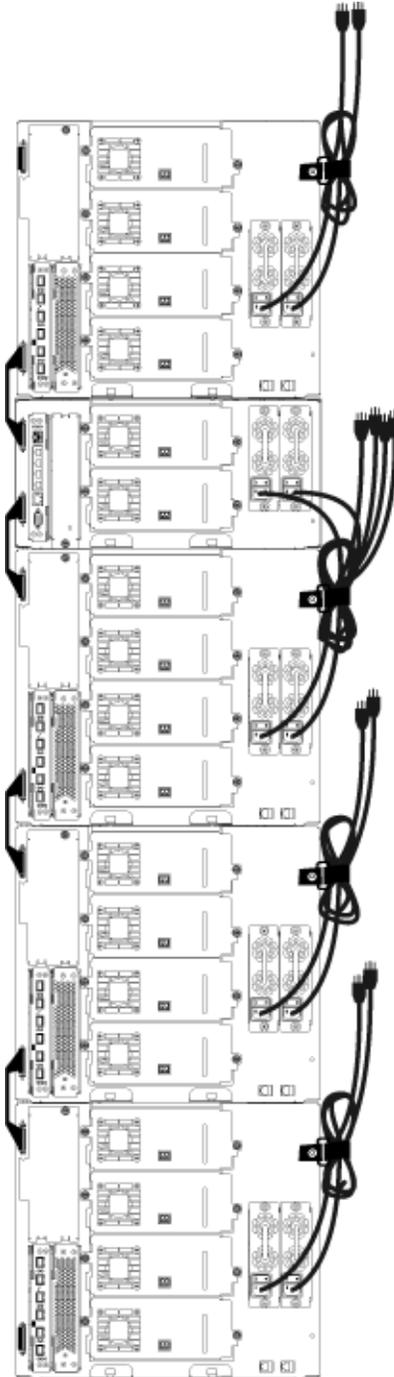
Figure 12 Power Cord Management

Once complete, power cord management for an ML6030 CM plus two PowerVault ML6000 9U Expansion Modules should look similar to [Figure 12](#) below.

- 1 Facing the rear of the library, locate a specific hole that is drilled into the back of the 9U Expansion Module for the hook-and-loop fastener. This hole is located on the rear of the library, about three inches from the top of the 9U Expansion Module near the right side of the library chassis. See [Figure 12](#) on page 42 for the location of this hole.

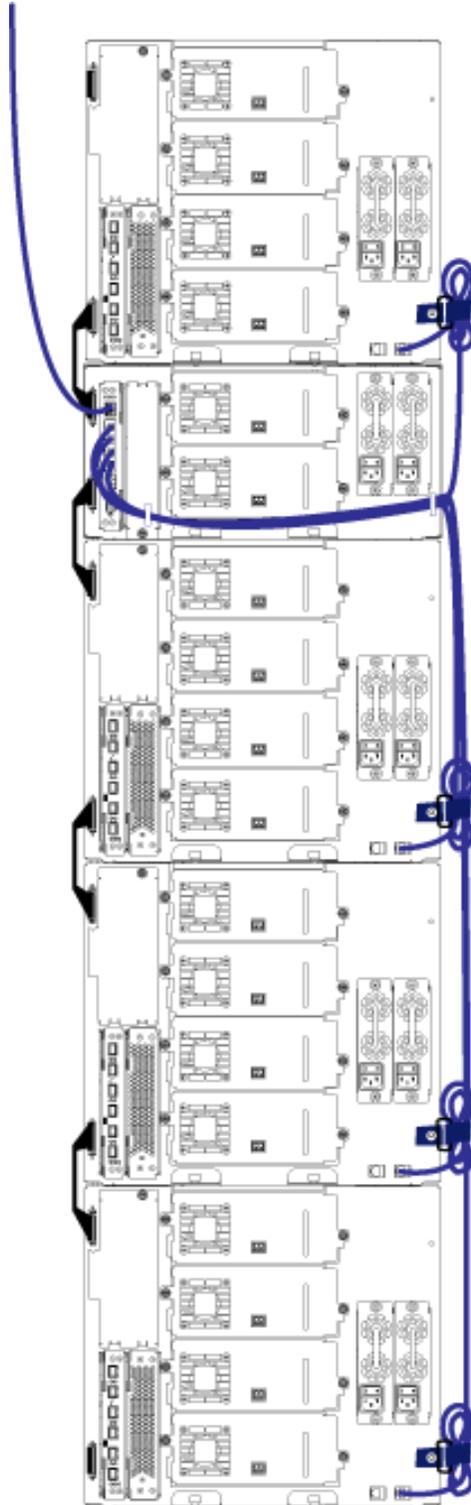
Figure 13 Ethernet Cable Management

Once complete, the Ethernet cabling for a an ML6030 Control Module plus two PowerVault ML6000 9U Expansion Modules containing four I/O blades should appear similar to the illustration below.

- 1 Facing the rear of the library, install the two push-in wire saddle cable clamps onto the 5U Control Module chassis. Push the rivet of one clip into the hole drilled into the cover plate located to the right of the LCB. Push the rivet of the other clip into the hole located near the extreme right side of the library, below the 5U Control Module's power supplies. See [Figure 13](#) on page 44 for the locations of these holes.

If your 5U Control Module chassis does not have the drilled holes, use the adhesive -backed wire saddle cable clamps in the location shown in [Figure 13](#).

- 2 Locate a specific hole that is drilled into the back of the 9U Expansion Module for the hook-and-loop strap. This hole is located on the rear of the library, about three inches from the bottom of the 9U Expansion Module on the right side of the frame back plane. See [Figure 13](#) on page 44 for the location of this hole.

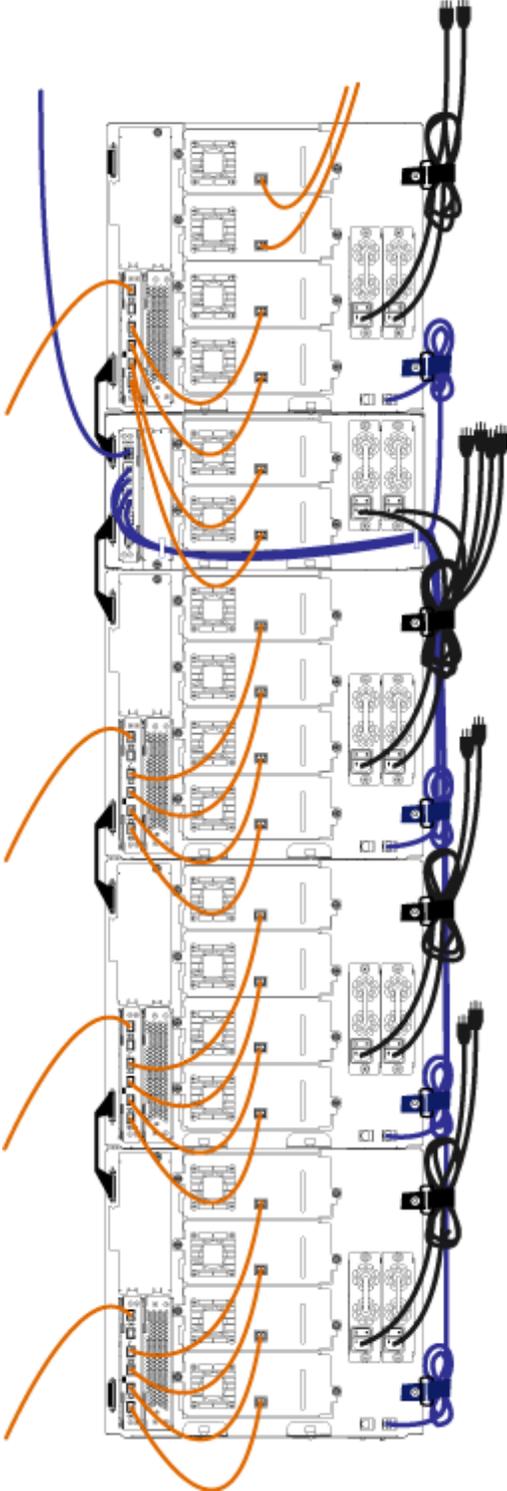
Figure 14 Cable Management, All Cables, FC I/O Blades Installed

Figure 14 shows how a 41U library with FC I/O blades would appear with power, Ethernet, and fibre cables installed and managed according to these guidelines.

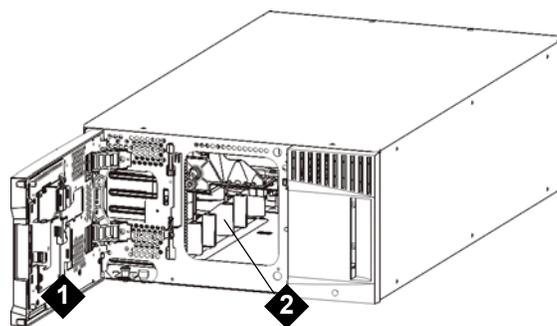
1 access door

2 tape blockers (installed)

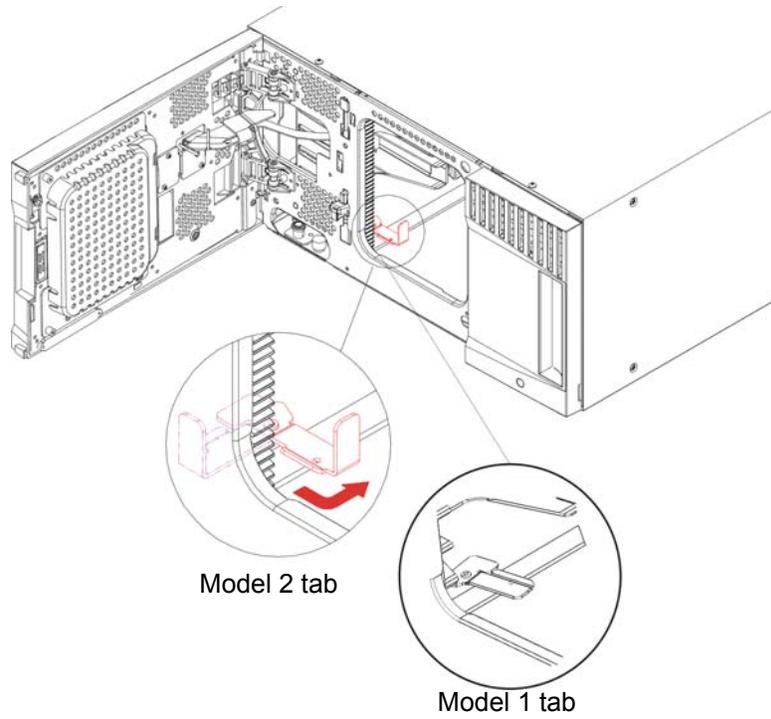
- c. After raising the robot assembly to the approximate middle of the 5U Library Control Module, hold it in place with one hand, and using your other hand, move the parking tab to the "parked" position (**Model 1 parking tab**: swivel toward you; **Model 2 parking tab**: move the parking tab in a counter-clockwise direction). The metal parking tab is located at the bottom of column 1.
- d. Gently release the robot assembly to rest on the parking tab.

Model 2 tab

Model 1 tab

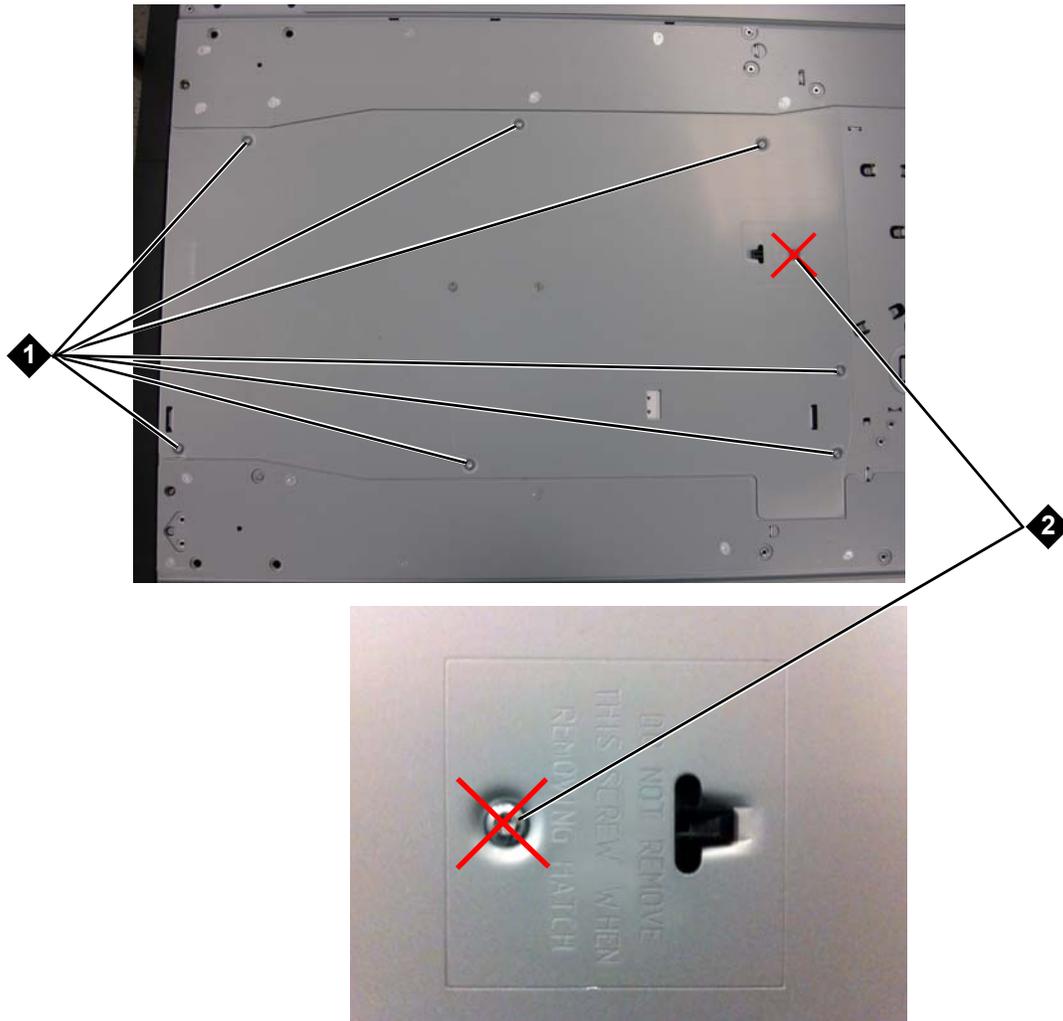
Figure 15 Cover plate with y-home flag

-
- 1 Screws to remove
 - 2 Y-home flag screw - do not remove
-

- 5 Remove and replace the cover plates, if appropriate. When removing the cover plate, ensure that you do not remove the y-home flag screw, as shown in [Figure 15](#),

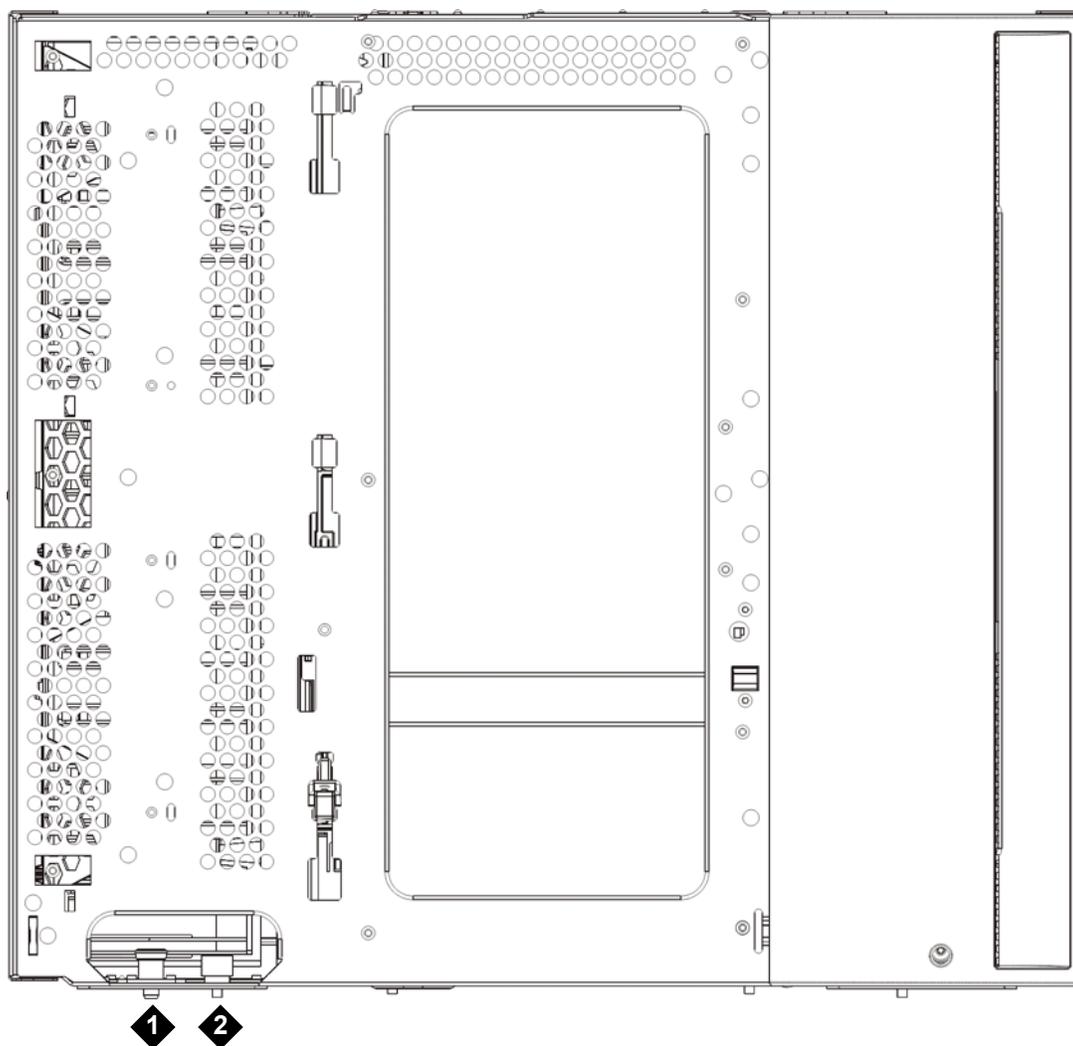
- 1 Open the 9U Expansion Module's access door and raise the guide pin by pulling it up and turning it slightly, as if it were a screw. Otherwise, the guide pin may scratch the front doors of the module on which you are stacking.

-
- 1 Guide pin
 - 2 Thumbscrew
-

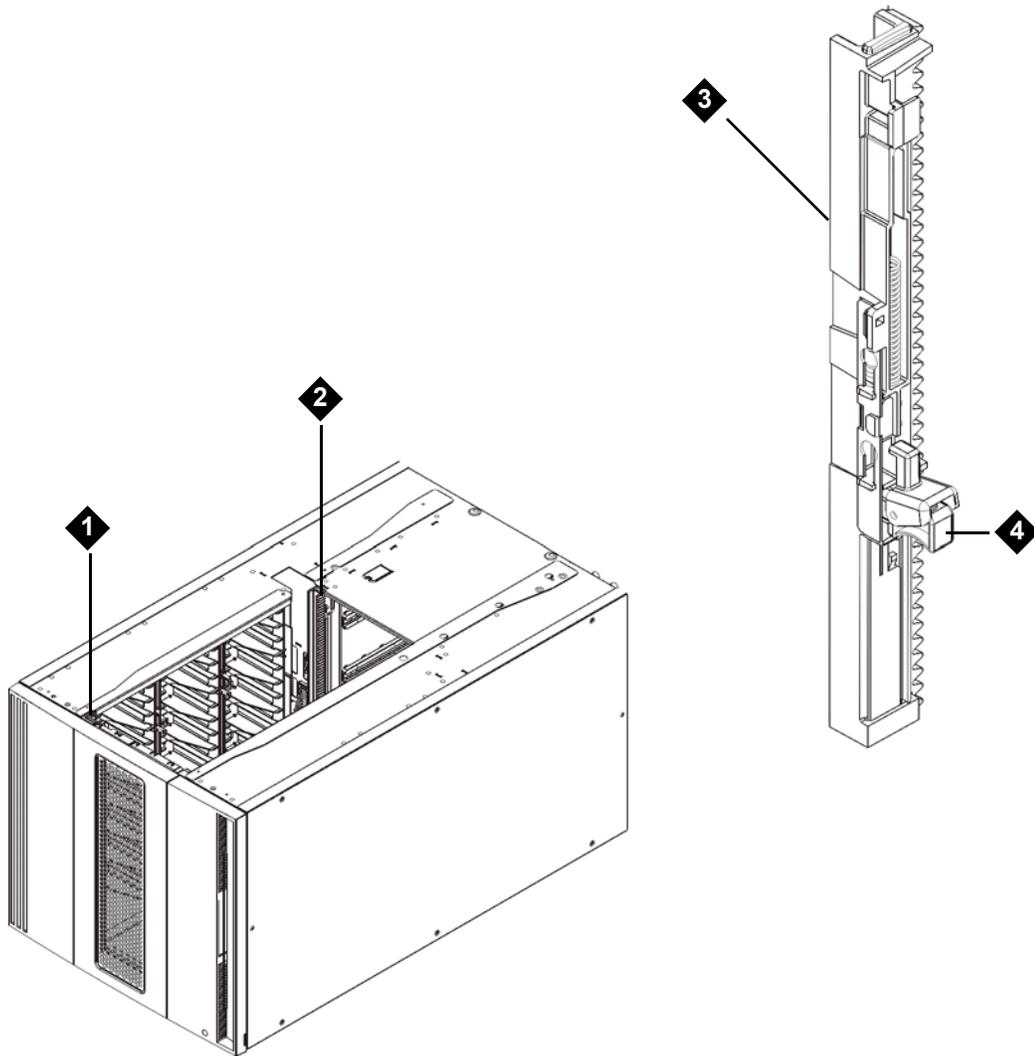
- 6 If stacking the 9U Expansion Module on top of another module, engage the Y-rails of the new module in your library configuration. Ensure that the Y-rails are properly aligned and the thumbscrews are tightened.

| 1 | Front Y-rail | 3 | Y-rail (this end up) |

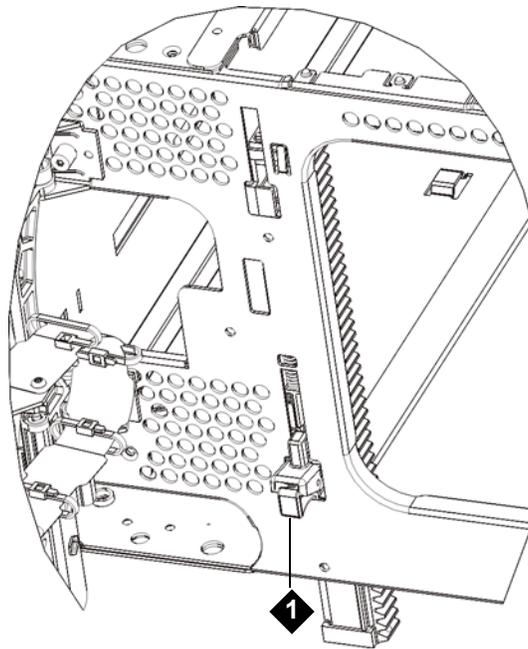
Doing this aligns the Y-rails with the Y-rails of the module beneath it.

1 Y-rail in unlocked, functional position

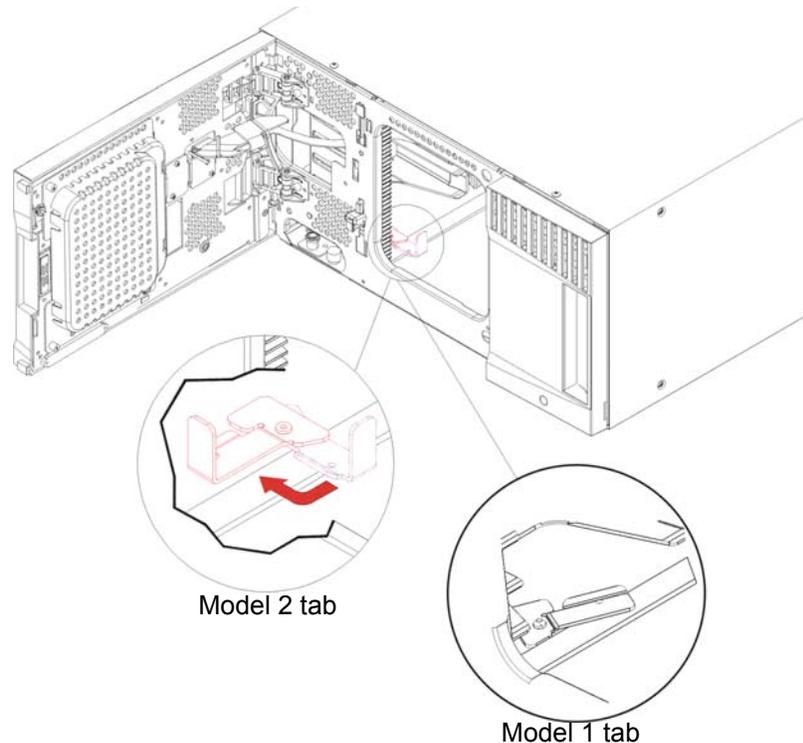
- b. With your free hand, move the parking tab to the "unparked" position so that it is removed completely from the interior of the module (**Model 1 parking tab**: swivel the parking tab away from you; **Model 2 parking tab**: move in a clockwise direction). When replaced correctly, the parking tab will not accidentally swivel into the path of the robot.

- c. Gently release the robot assembly. It will lower to the bottom module of the library.

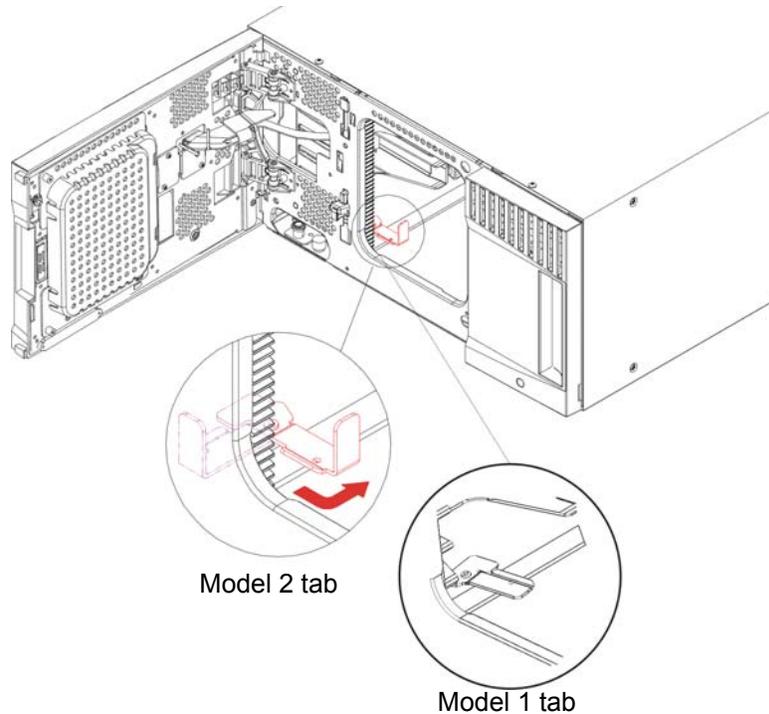
- c. After raising the robot assembly to the approximate middle of the 5U Library Control Module, hold it in place with one hand, and using your other hand, move the parking tab to the "parked" position (Model 1 parking tab: swivel toward you; Model 2 parking tab: move in a counter-clockwise direction). The metal parking tab is located at the bottom of column 1.
- d. Gently release the robot assembly to rest on the parking tab.

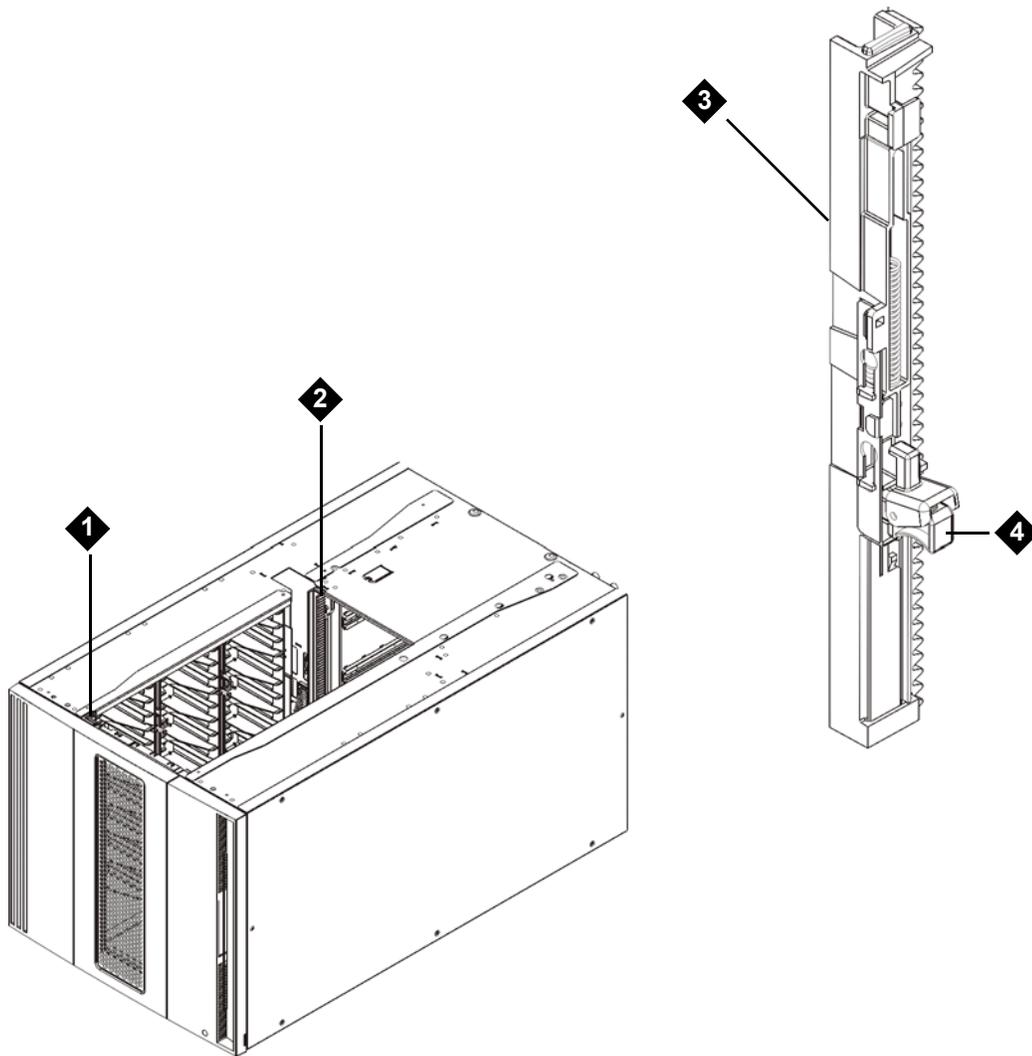
**Note** The rear Y-rail is impossible to lift up with the tape drives installed.

| 1 Front Y-rail | 3 Y-rail (this end up) |

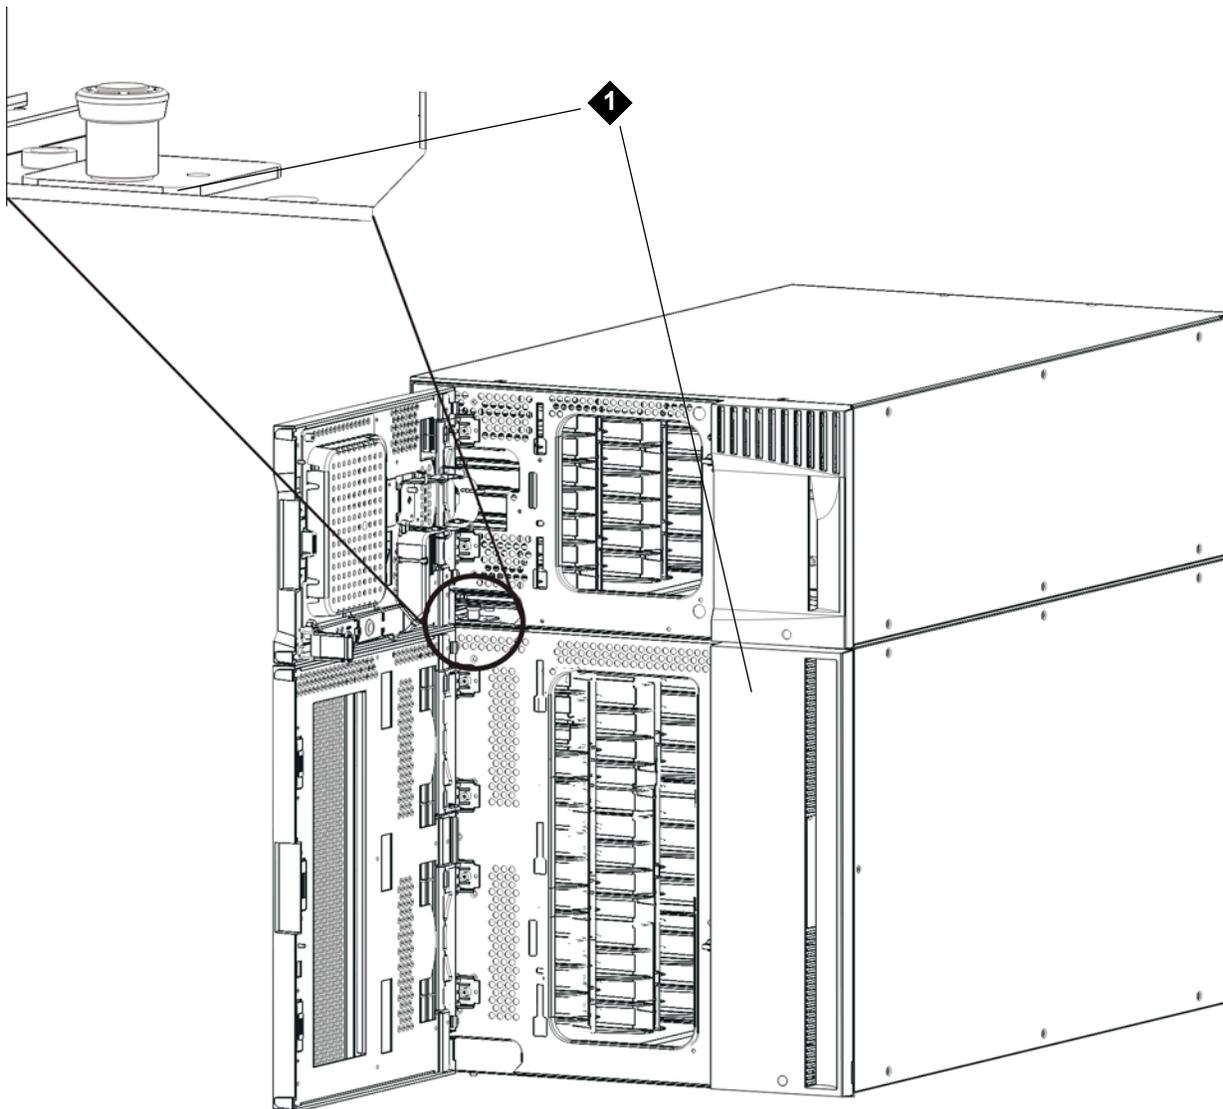
- 3 Remove the rack ears that fasten the module to the rack.
- 4 Loosen the thumbscrews located at the base of the front and rear of the module.

1 Thumbscrews (behind doors)

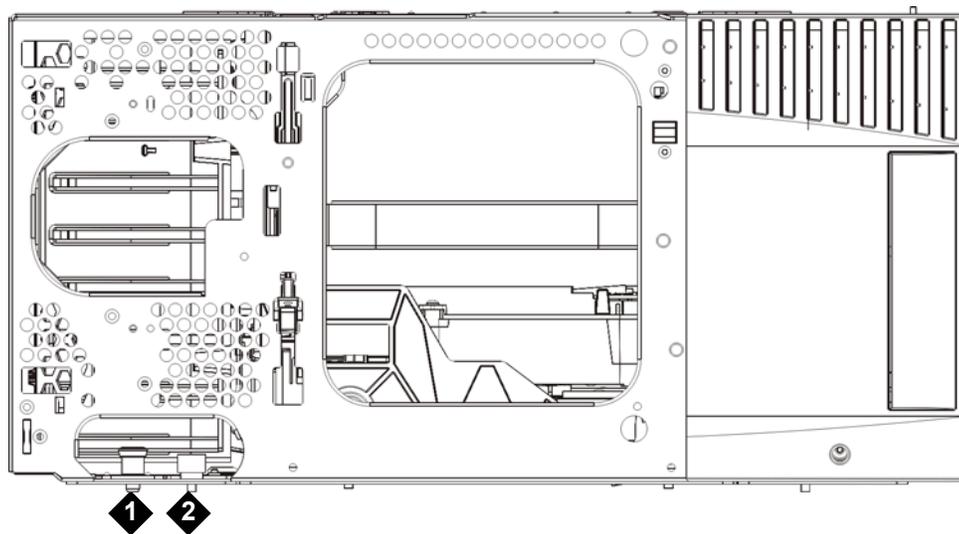
- 5 Open the module's access door and raise the guide pin by pulling it up and turning it slightly, as if it were a screw. Otherwise, the guide pin may scratch the front doors of the module beneath it.

-
- 1 Guide pin
 - 2 Thumbscrew
-

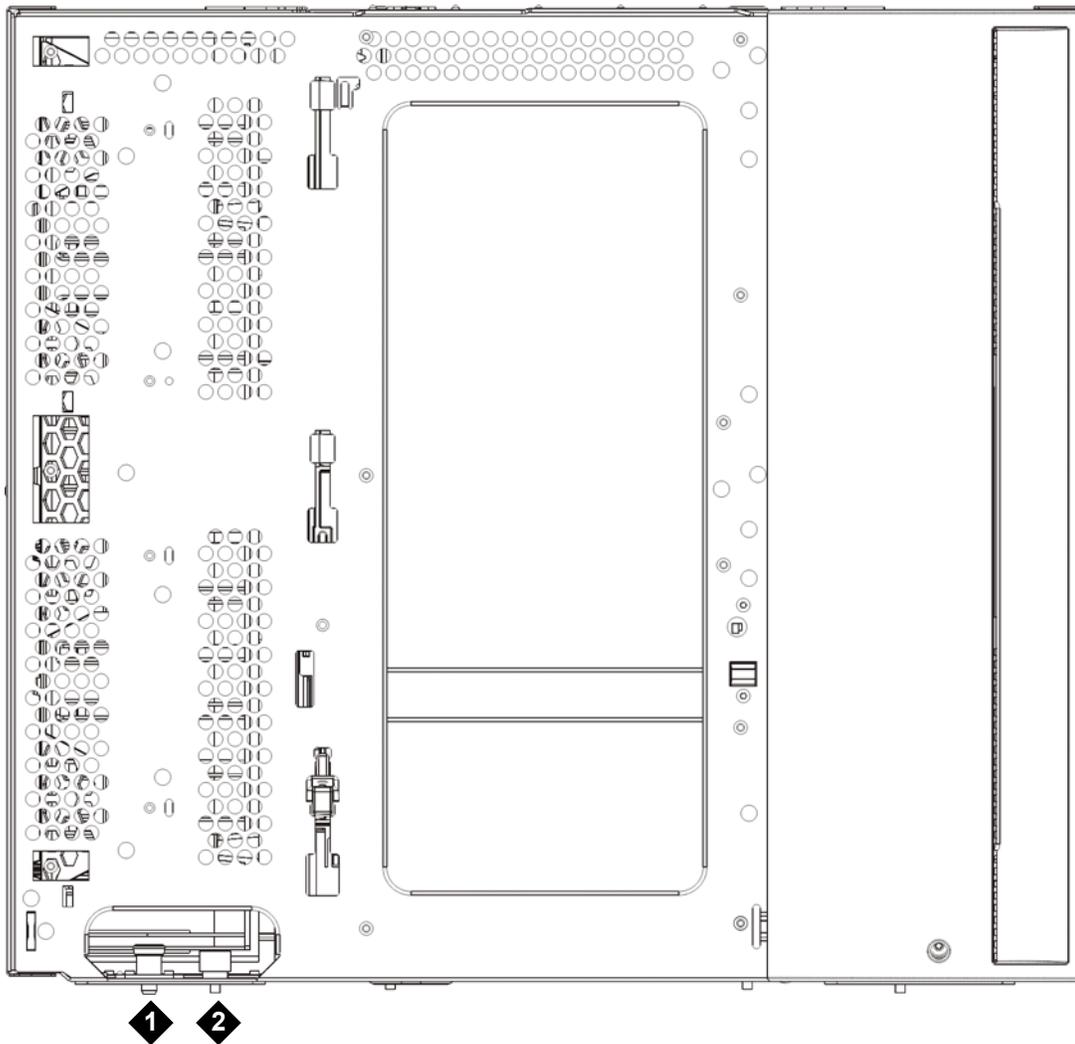
- 3 Open the 9U Expansion Module's access door and raise the guide pin by pulling it up and turning it slightly, as if it were a screw. Otherwise, the guide pin may scratch the front doors of the module on which you are stacking it.

-
- 1 Guide pin
 - 2 Thumbscrew
-

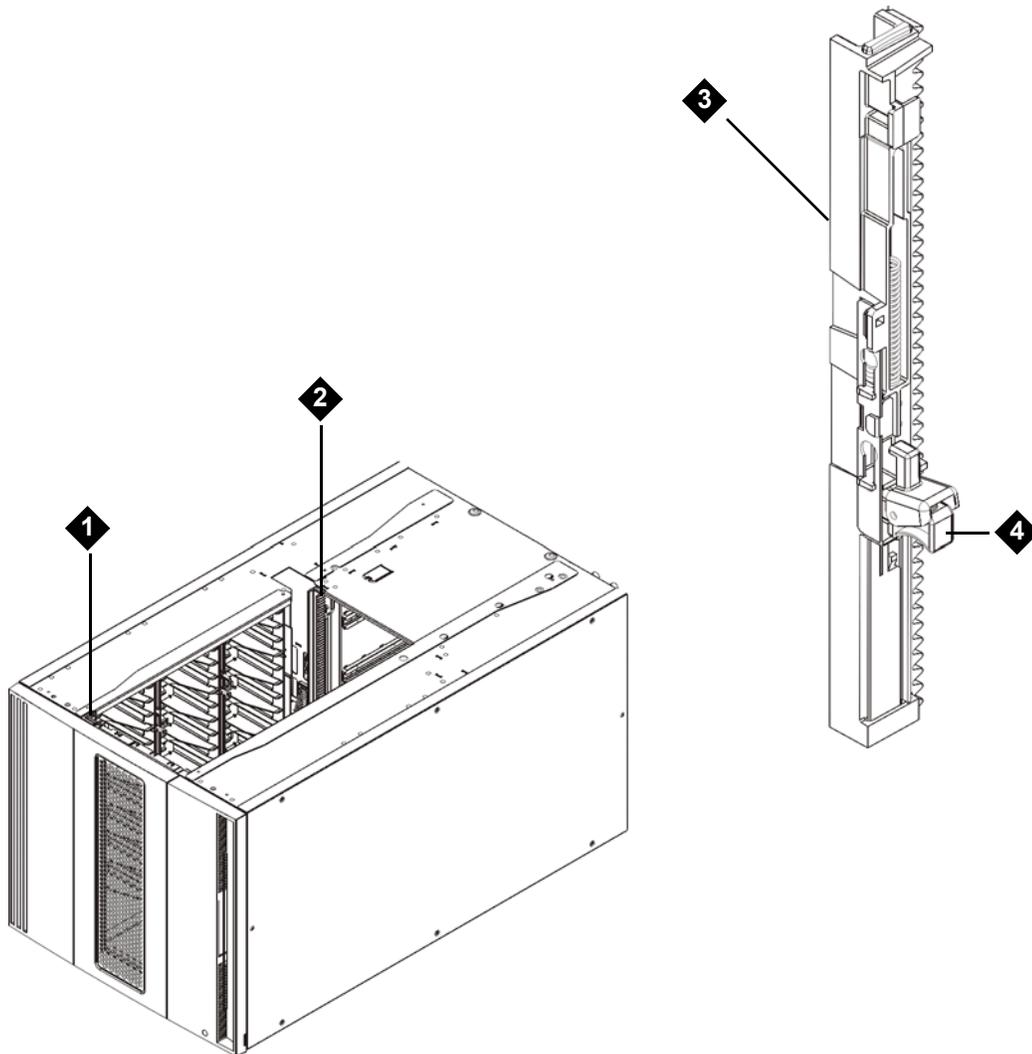
- 8 Engage the Y-rails of the new module in your library configuration. Ensure that the Y-rails are properly aligned and the thumbscrews are tightened.

| 1 | Front Y-rail | 3 | Y-rail (this end up) |

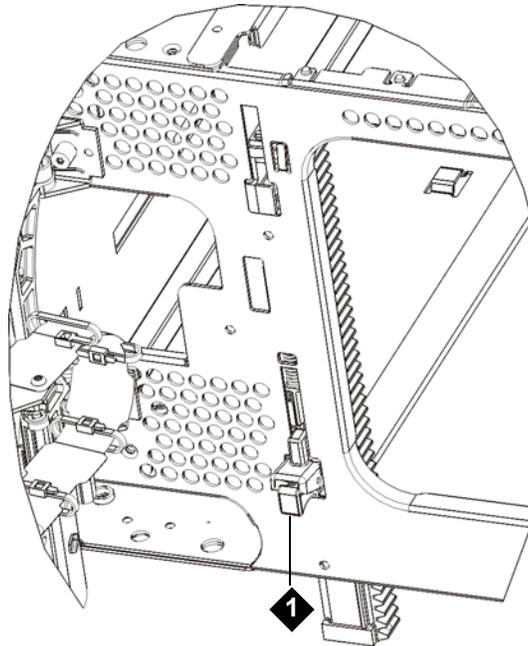
Check to make sure that there is no gap between the top and bottom Y-rails on both the front and back of the library. If a gap exists, the library cannot mechanically initialize.

1 Y-rail in unlocked, functional position

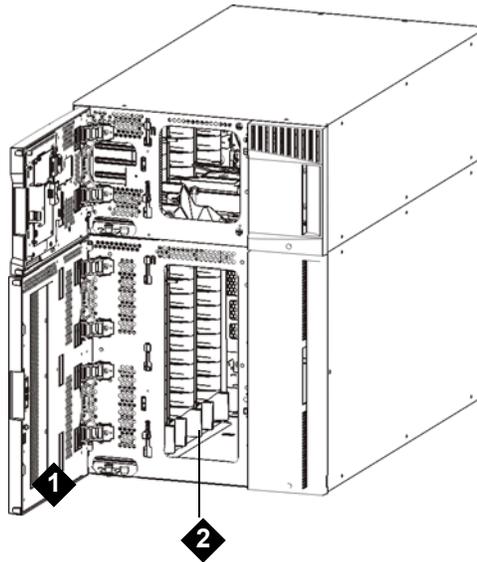
- 1 Replace the tape blockers (if required) in the bottom row of the lowest module of the library. The tape blockers block slots in the bottom two rows of the library. You can insert the tape blockers through the open access door.

1 access door

2 tape blockers (installed)

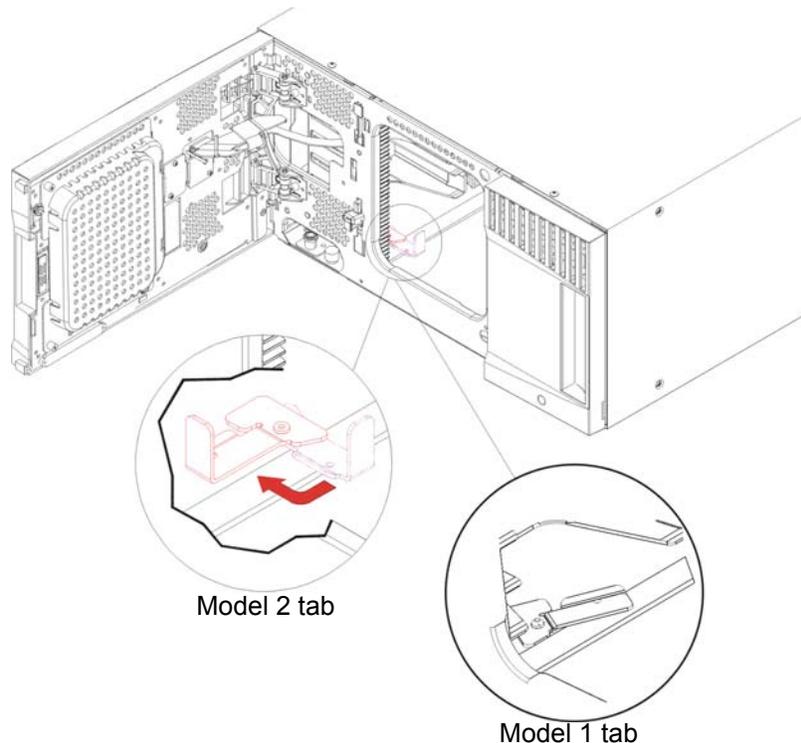
- b. With your free hand, move the parking tab to the "unparked" position so that it is removed completely from the interior of the module (**Model 1 parking tab**: swivel the parking tab away from you; **Model 2 parking tab**: move in a clockwise direction). When replaced correctly, the parking tab will not accidentally swivel into the path of the robot.
- c. Gently release the robot assembly. It will lower to the bottom module of the library.
