Dell™ PowerVault™ ML6000 Maintenance Guide

Document Number: 6-01367-10 Rev A

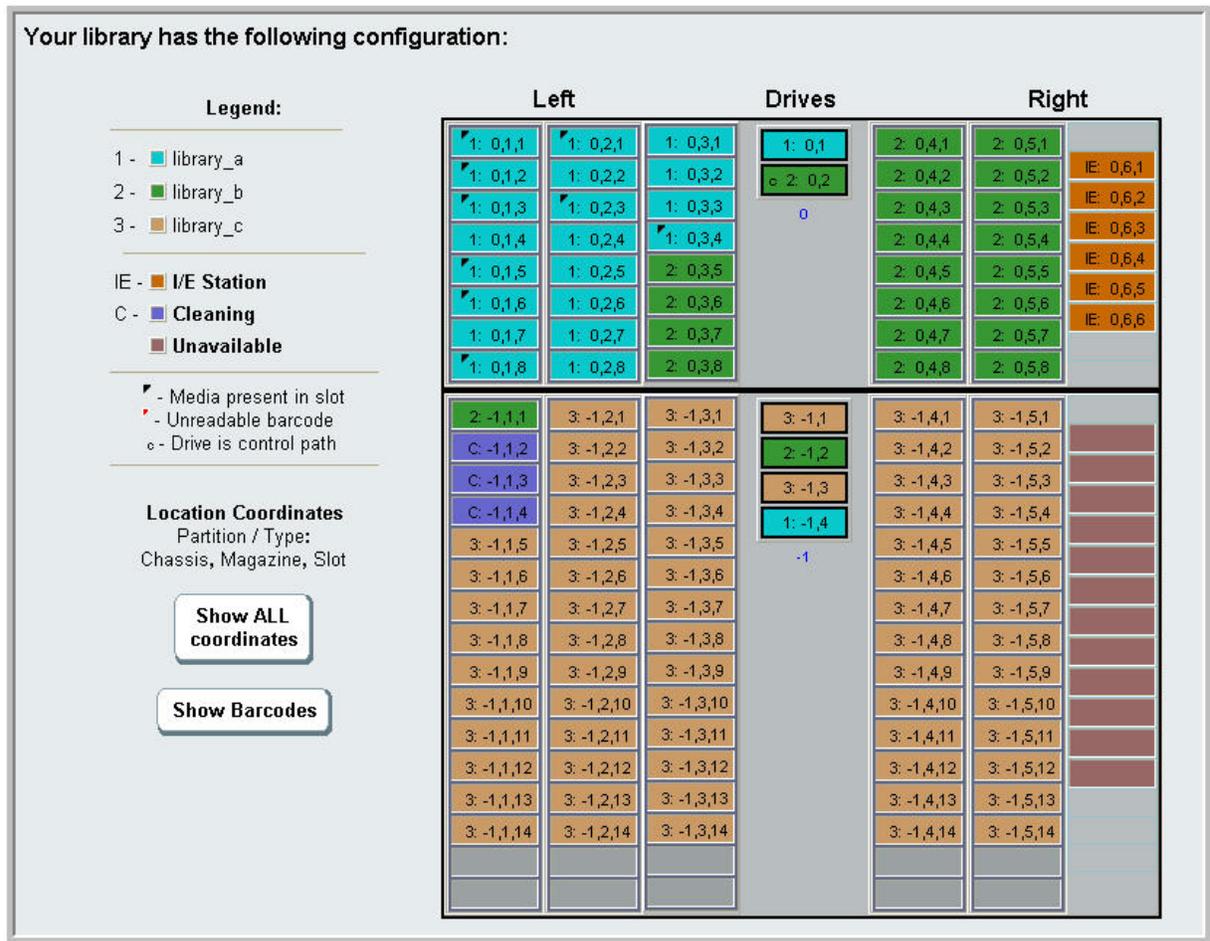
Figure 16 Library Configuration Example 1

For example, in [Figure 16](#), there are three partitions configured. All three partitions share six I/E elements in the 5U Library Control Module. The library is configured for automatic cleaning and has three cleaning slots configured in the 9U Library Expansion Module.

- **Library_a** includes all storage elements in the 5U Library Control Module, and has one drive configured in the 5U Library Control Module, and one drive configured in the 9U Library Expansion Module.
- **Library_b** includes most storage elements in the 5U Library Control Module, but references its last storage element in the 9U Library Expansion Module. This partition has one drive configured in the 5U Library Control Module and one drive configured in the 9U Library Expansion Module.
- **Library_c** includes all storage elements in the 9U Library Expansion Module, and also two drives in this 9U Library Expansion Module.

- 8 If a partition references tape drives within the module you are removing or replacing, modify any affected partition by removing the referenced drive elements from the partition.
For example, in [Figure 16](#) on page 71, all partitions reference drives in the 9U Library Expansion Modules. In [Figure 17](#) on page 73, Library_c was deleted, as well as its drive references in the 9U Library Expansion Module. Library_a and Library_b still require partition modifications to remove the drive reference and free the 9U Library Expansion Module of all partition resource references.

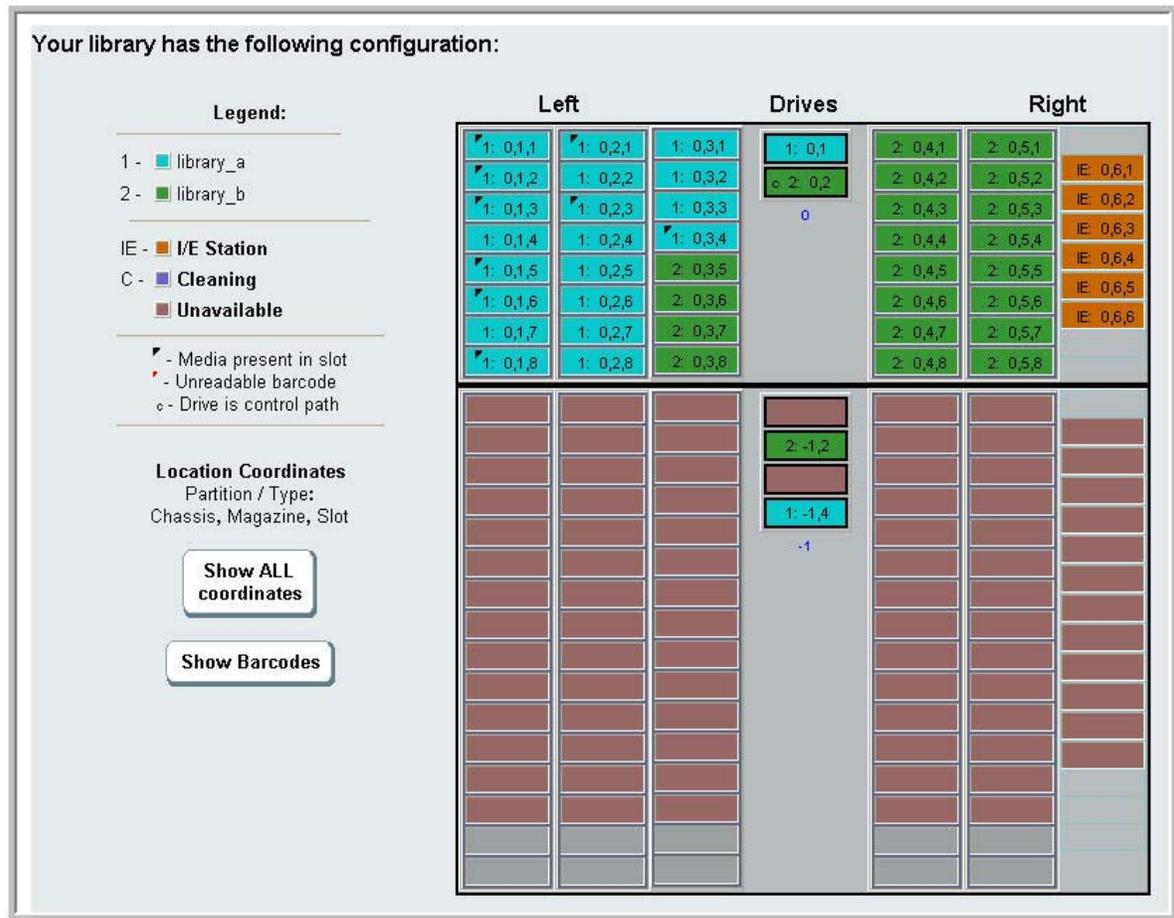
Figure 17 Library Configuration Example 2

For example, in [Figure 17](#), after exporting all affected tape cartridges from the module you are removing, the cleaning slots are deleted, then Library_c is completely deleted, and Library_b is modified to reduce its storage slot count by one, since this deletes the storage slot reference in the 9U Library Expansion Module. No storage element modifications are required for Library_a.

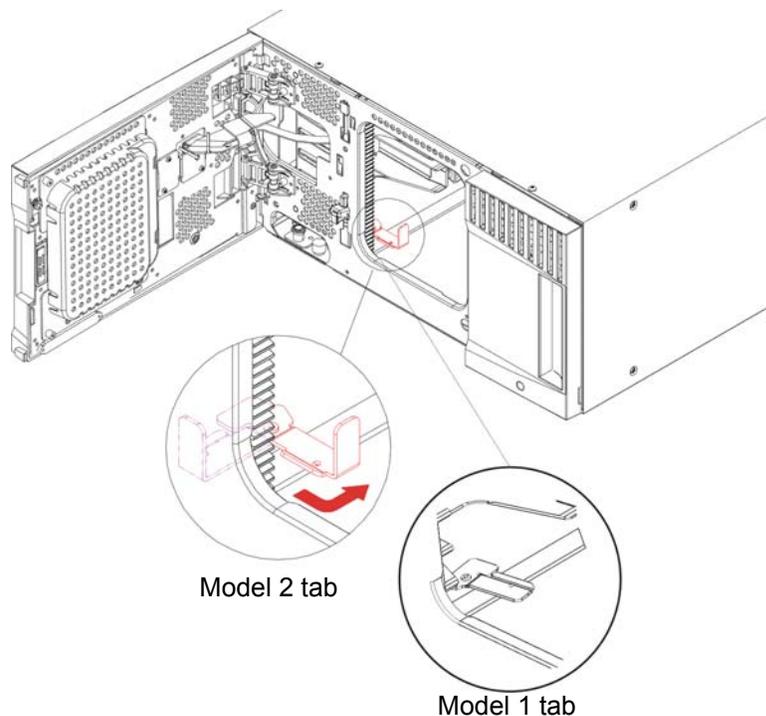
- c. After raising the robot assembly to the approximate middle of the 5U Library Control Module, hold it in place with one hand and, using your other hand, move the parking tab to the "parked" position (Model 1 parking tab: swivel toward you; Model 2 parking tab: move in a counter-clockwise direction). The metal parking tab is located at the bottom of column 1.
- d. Gently release the robot assembly to rest on the parking tab.

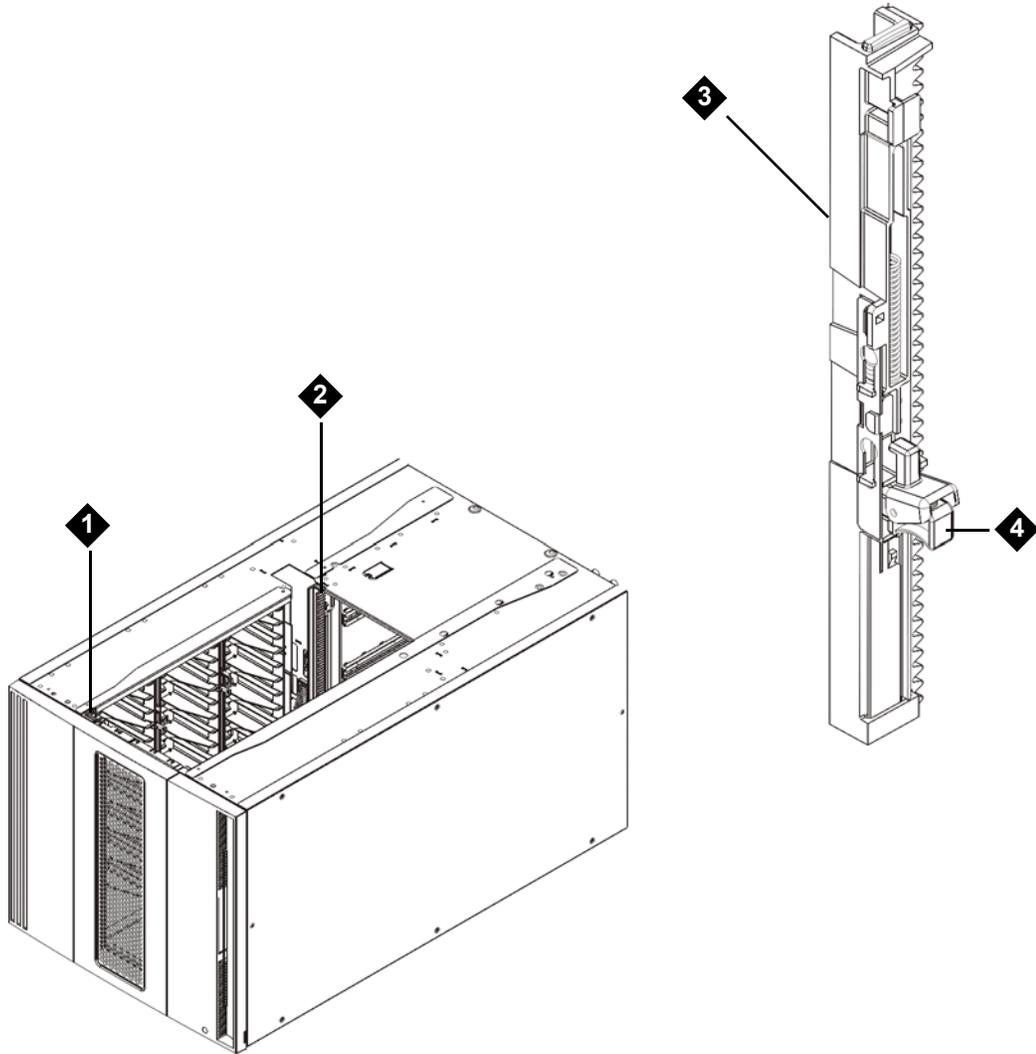
3 Disengage the Y-rails so the modules can be unstacked safely.

1 Front Y-rail

2 Rear Y-rail

4 Squeeze here to release

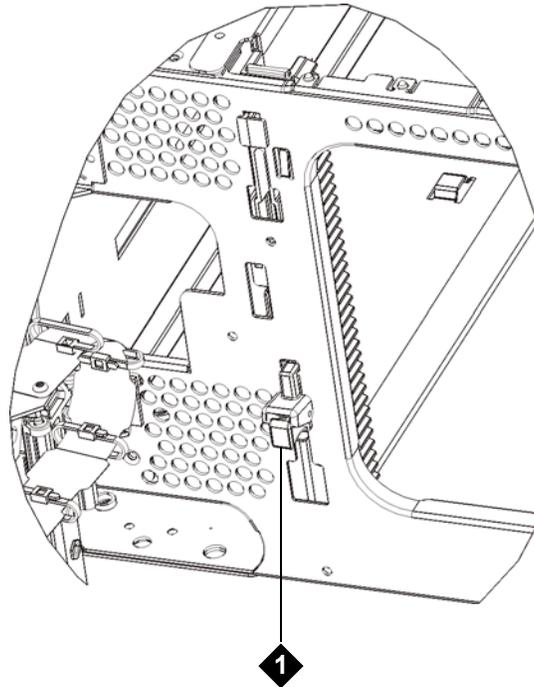
- a. From the front of the library, find the Y-rail release mechanism, which is located on the left side of the 5U Library Control Module. Squeeze the handle of the Y-rail release mechanism, lift it, and release it so that it locks into place.
- b. From the rear of the library, find the rear Y-rail release mechanism located in the interior of the right side of the module. Squeeze the handle of the Y-rail release mechanism, lift it, and release it so that it locks into place.

1 Y-rail in locked, non-functional position

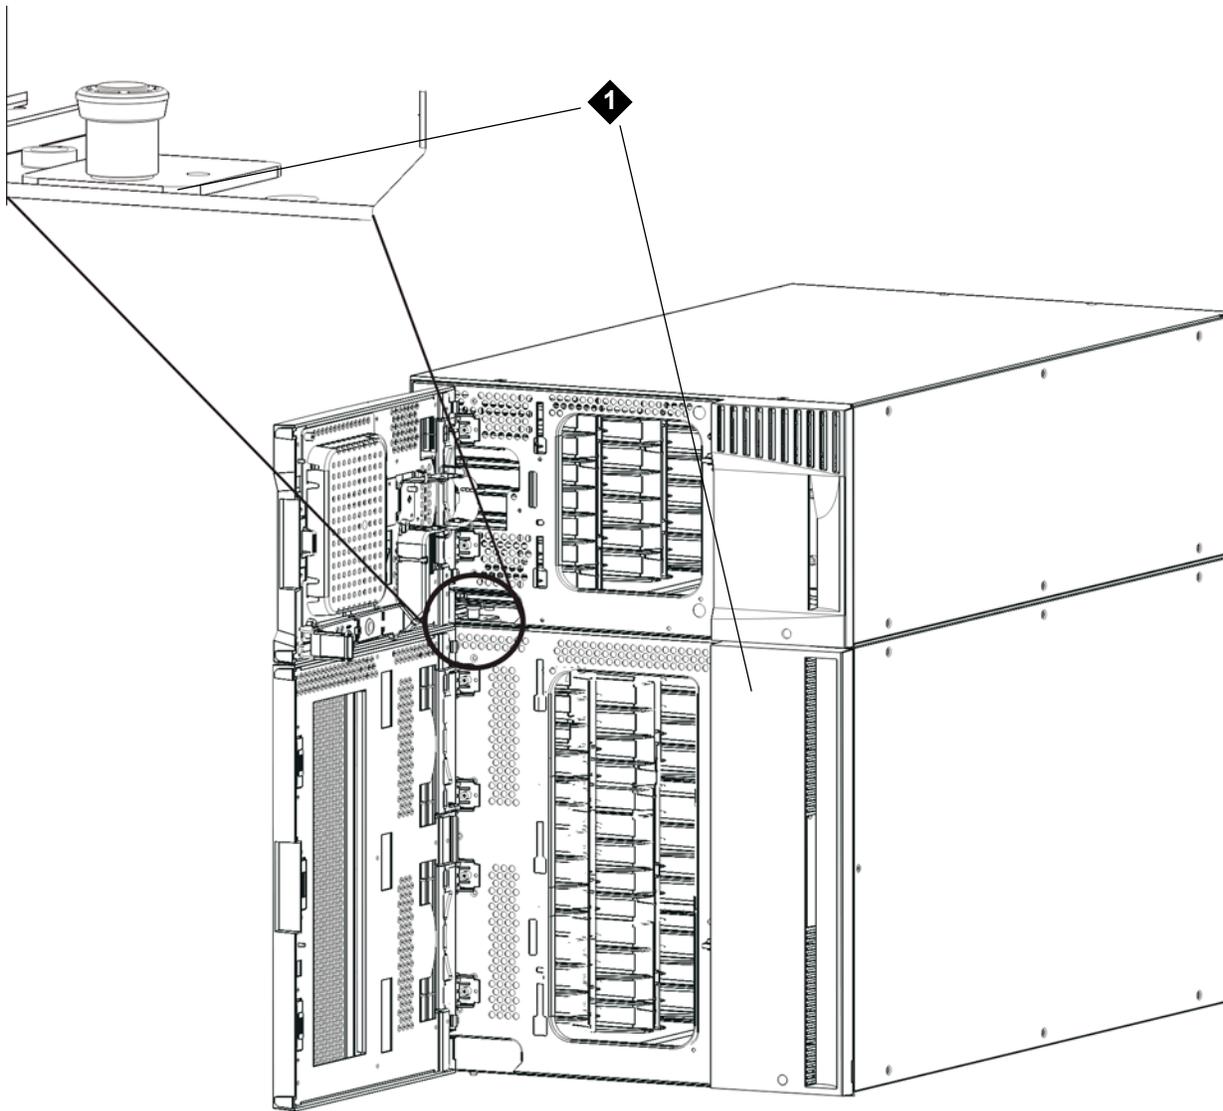
- 5 Loosen the thumbscrews located at the base of the front of the module.

1 Thumbscrews (behind doors)

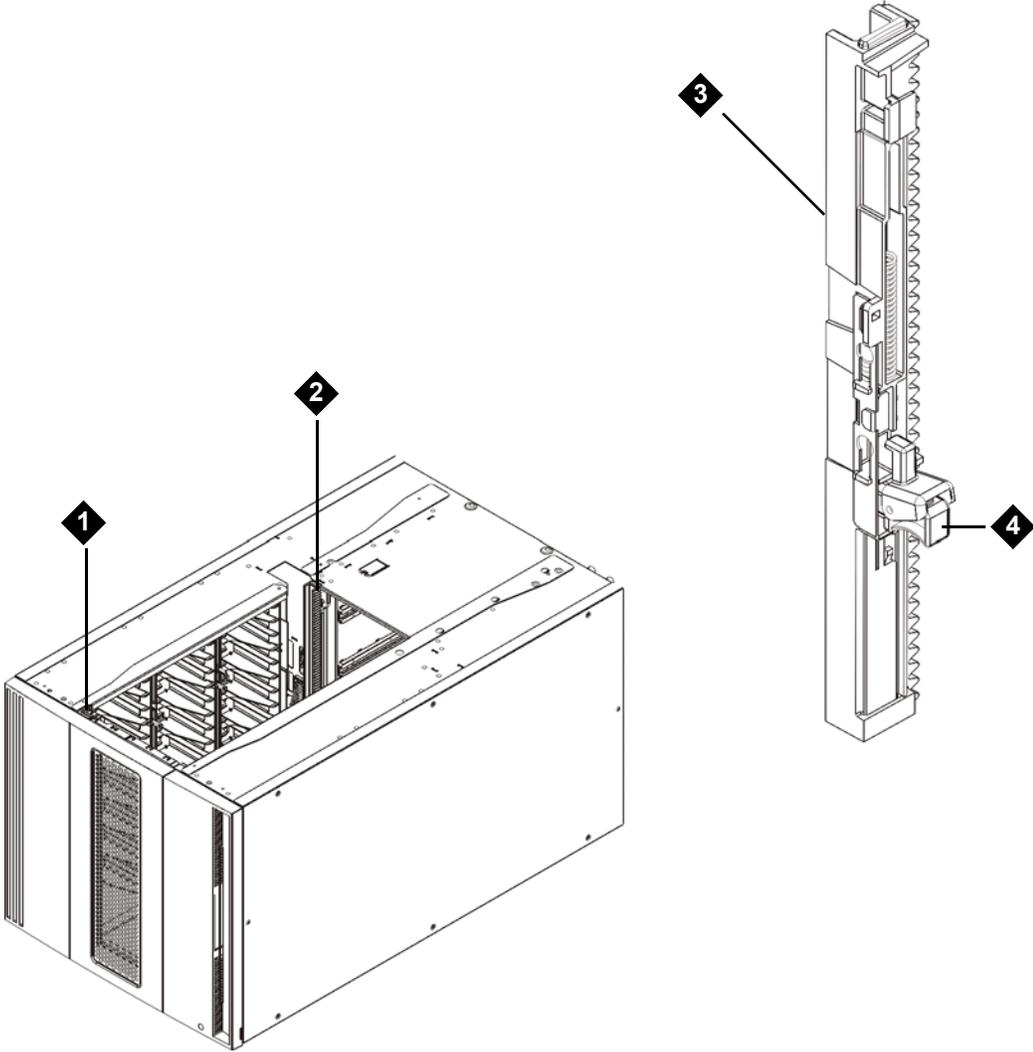
1 Ensure that the Y-rails are properly aligned and the thumbscrews are tightened.

| 1 Front Y-rail | 3 Y-rail (this end up) |

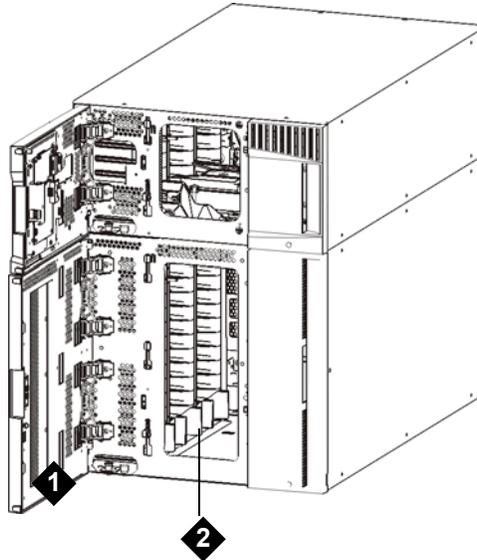
1 access door

2 tape blockers (installed)

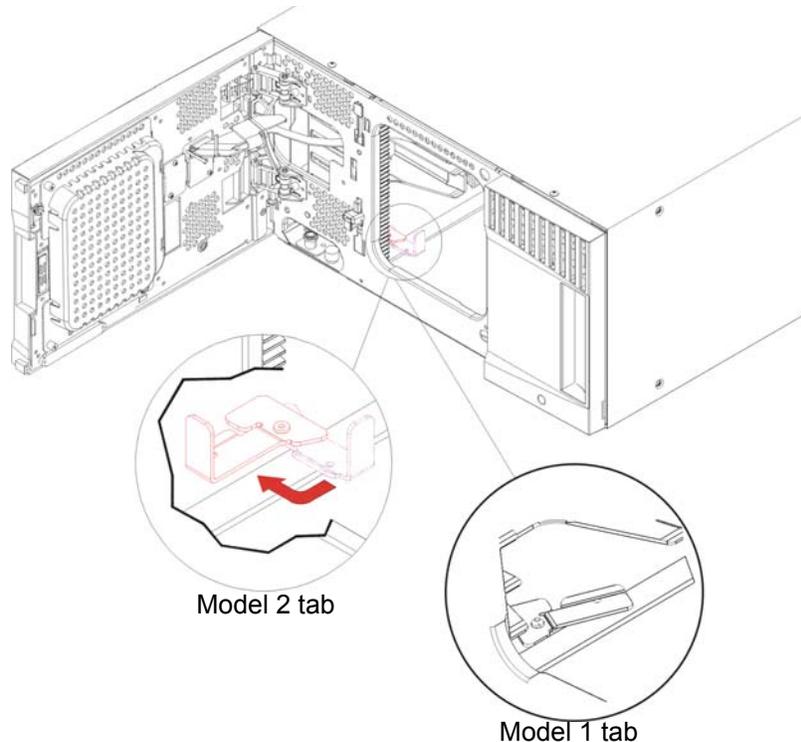
- b. With your free hand, move the parking tab to the "unparked" position so that it is removed completely from the interior of the module (**Model 1 parking tab**: swivel the parking tab away from you; **Model 2 parking tab**: move in a clockwise direction). When replaced correctly, the parking tab will not accidentally swivel into the path of the robot.
- c. Gently release the robot assembly. It will lower to the bottom module of the library.

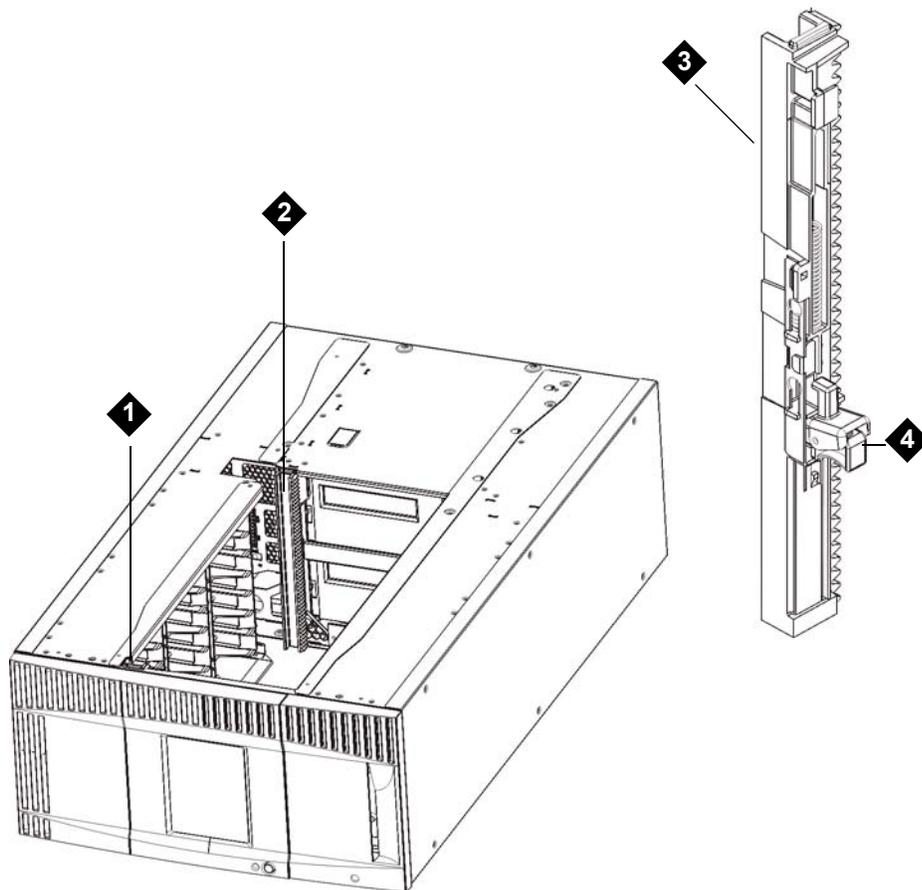
**Note** The rear Y-rail is impossible to lift up with the tape drives installed.

1 Front Y-rail	3 Y-rail (this end up)
2 Rear Y-rail	4 Squeeze here to release

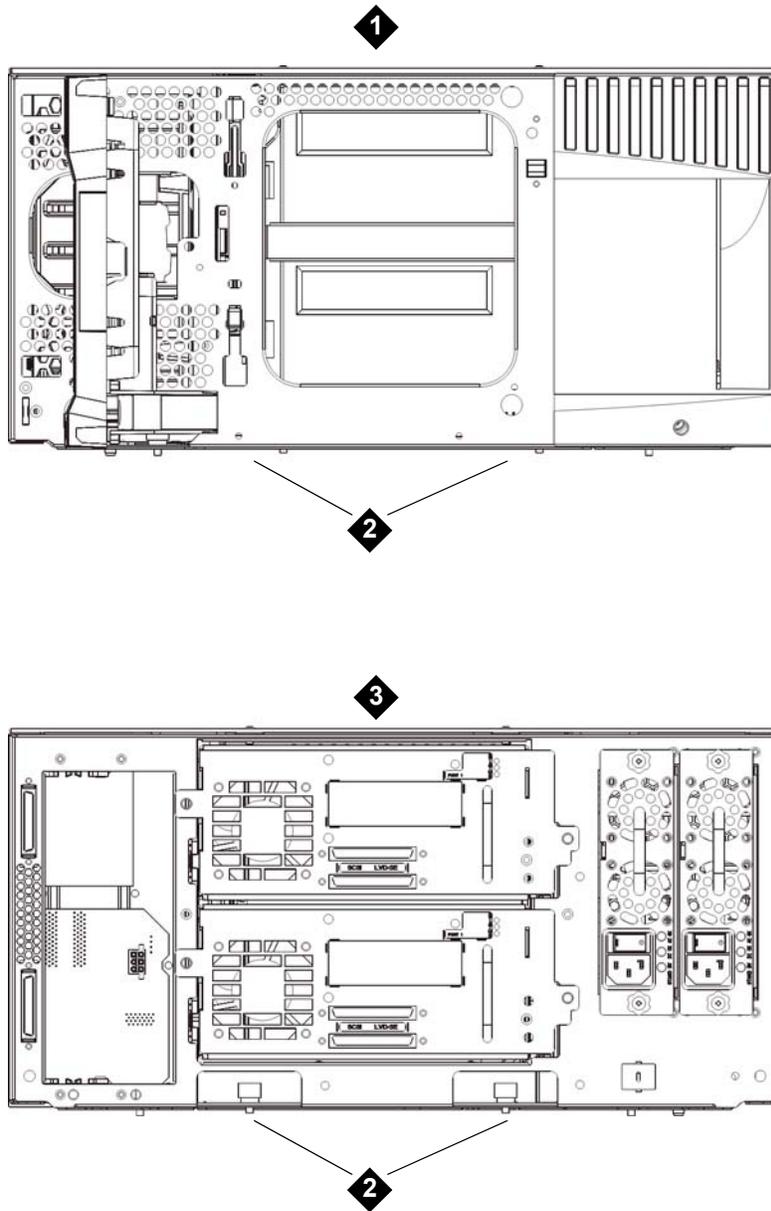
- 5 Loosen the thumbscrews located at the base of the front and rear of the module.

-
- 1 5U Library Control Module (front)
 - 2 Thumbscrews
 - 3 5U Library Control Module (rear)
-

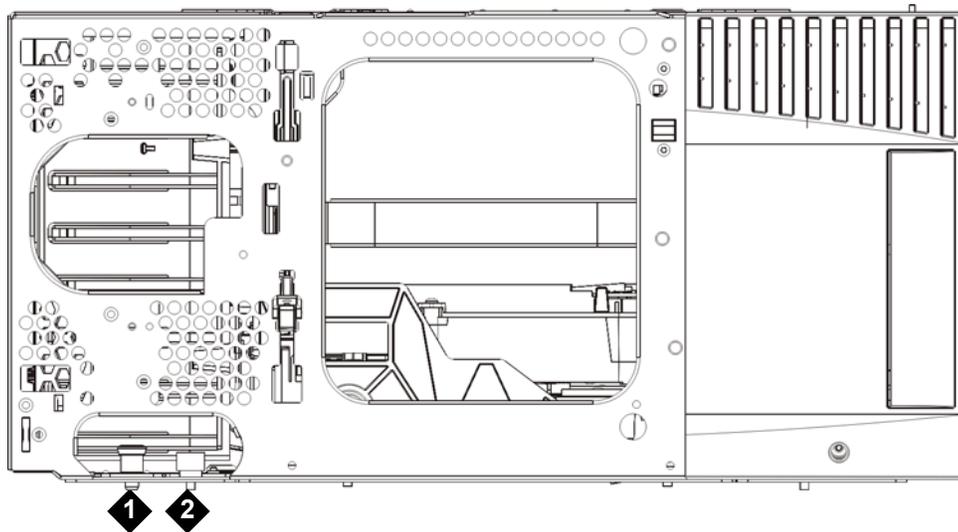
- 6 Open the module's access door and raise the guide pin by pulling it up and turning it slightly, as if it were a screw. Otherwise, the guide pin may scratch the front doors of the module beneath it.

-
- 1 Guide pin
 - 2 Thumbscrew
-

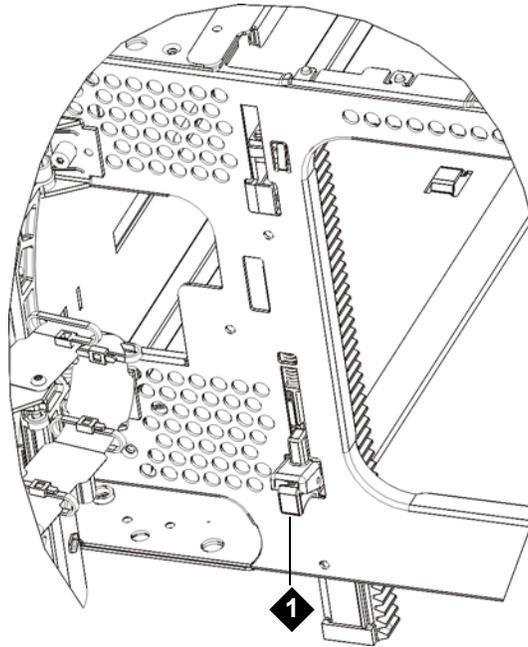
- 9 Engage the Y-rails. Tighten the thumbscrews and lower the guide pin. Doing this aligns the Y-rail with the Y-rail of the module beneath it.
 - a. From the front of the library, open the I/E station and access doors of the 5U Library Control Module. Squeeze the handle of the Y-rail release mechanism, lift it out of its locked position, and slide it downward as far as it will go.

1 Y-rail in unlocked, functional position

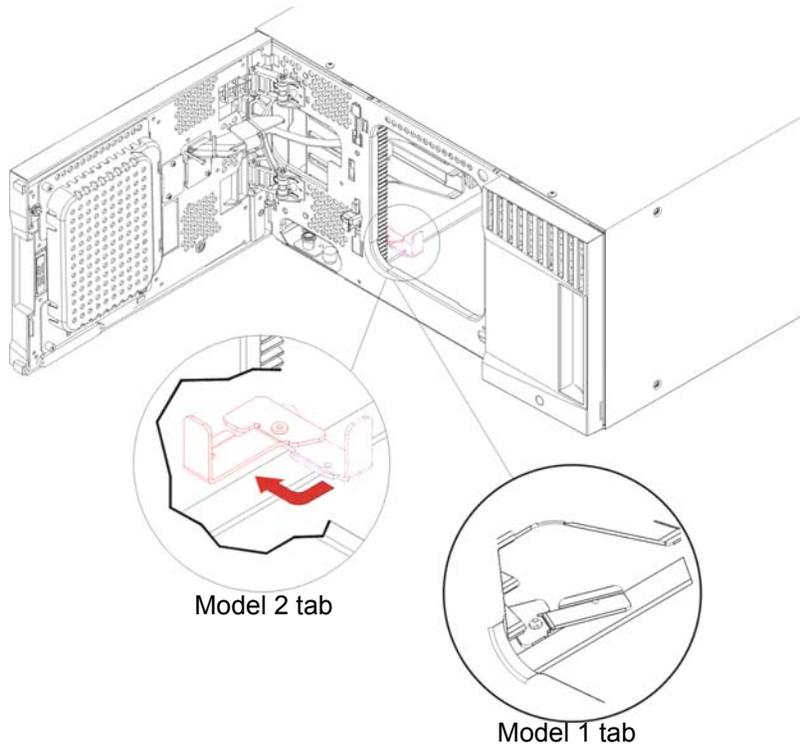
- b. With your free hand, move the parking tab to the "unparked" position so that it is removed completely from the interior of the module (**Model 1 parking tab**: swivel the parking tab away from you; **Model 2 parking tab**: move in a clockwise direction). When replaced correctly, the parking tab will not accidentally swivel into the path of the robot.

c. Gently release the robot assembly. It will lower to the bottom module of the library.

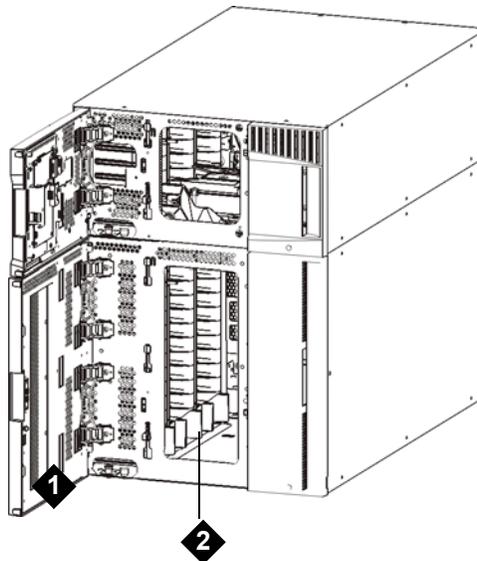
- 11 If tape blockers are required, make sure they are installed in the bottom two rows of the library. The tape blockers block slots in the bottom two rows of the library. You can insert the tape blockers through the open access door.

1 access door

2 tape blockers (installed)

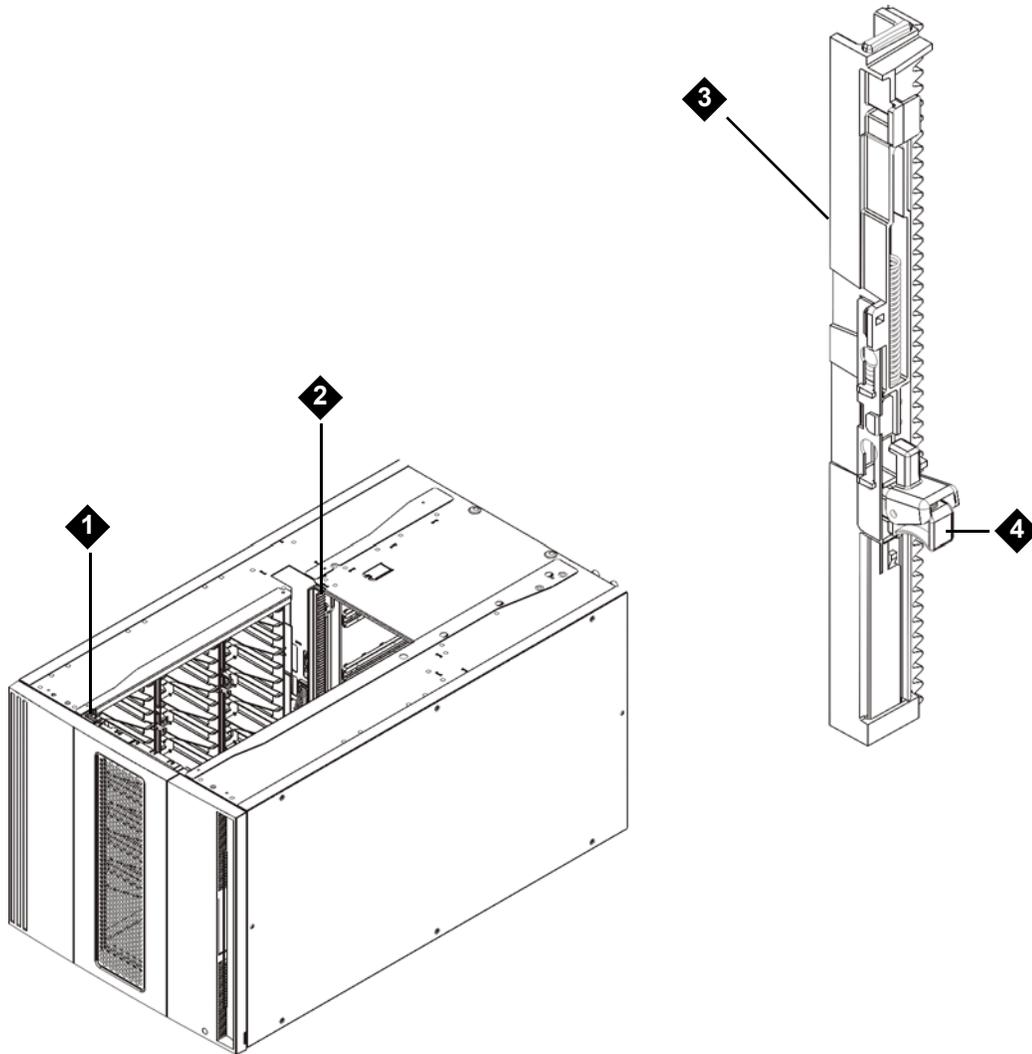
- 3 Disengage the Y-rails so the modules can be unstacked safely.

| 1 Front Y-rail | 3 Y-rail (this end up) |

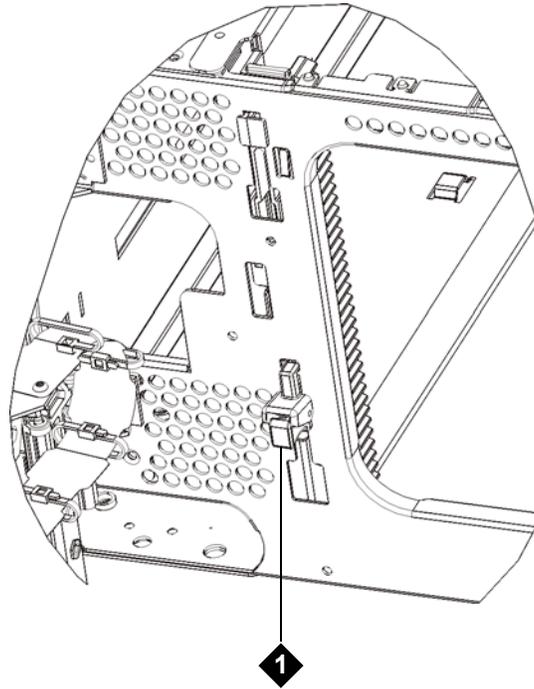
- a. From the front of the library, find the Y-rail release mechanism, which is located on the left side of the 5U Library Control Module. Squeeze the handle of the Y-rail release mechanism, lift it, and release it so that it locks into place.

1 Y-rail in locked, non-functional position

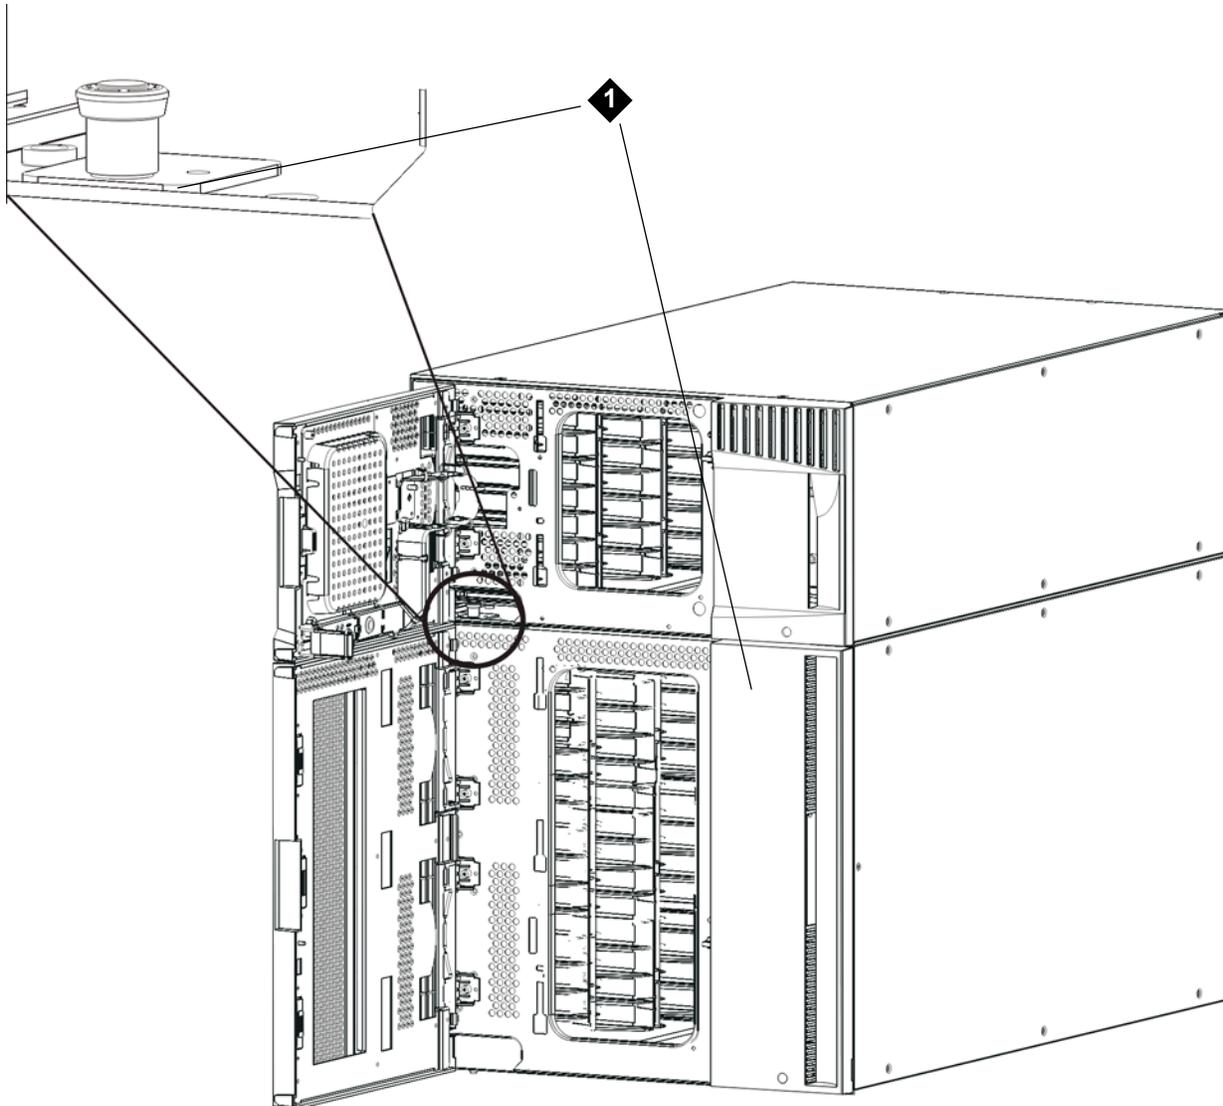
- b. From the rear of the library, find the rear Y-rail release mechanism located in the interior of the right side of the module. Squeeze the handle of the Y-rail release mechanism, lift it, and release it so that it locks into place.
- 4** Remove the rack ears that fasten the module to the rack. See [Using the Rack-mount Kit to Install a Library in a Rack](#) on page 108 for detailed instructions on using the rack ears.
- 5** Loosen the thumbscrews located at the base of the front of the module.

1 Thumbscrews (behind doors)

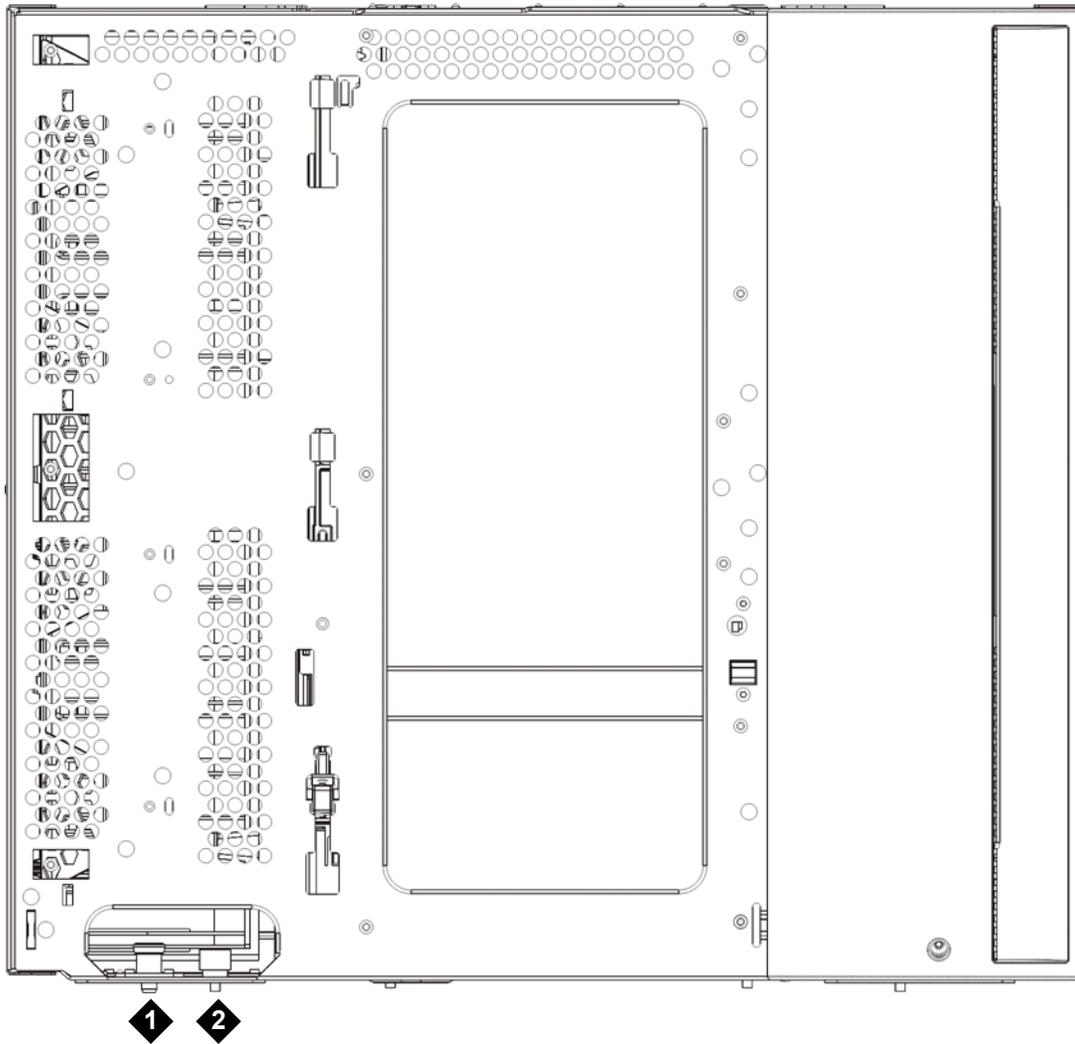
- 1 Remove all tape drives from the 9U Library Expansion Module that you are adding. See [Adding, Removing, and Replacing Tape Drives](#) on page 127 for instructions on removing tape drives.
- 2 Remove the power supplies from the 9U Expansion Module that you are adding. See [Adding, Removing, and Replacing Power Supplies](#) on page 106 for instructions on removing power supplies.
- 3 Open the 9U Expansion Module's access door and raise the guide pin by pulling it up and turning it slightly, as if it were a screw. Otherwise, the guide pin may scratch the front doors of the module on which you are stacking it.

-
- 1 Guide pin
 - 2 Thumbscrew
-

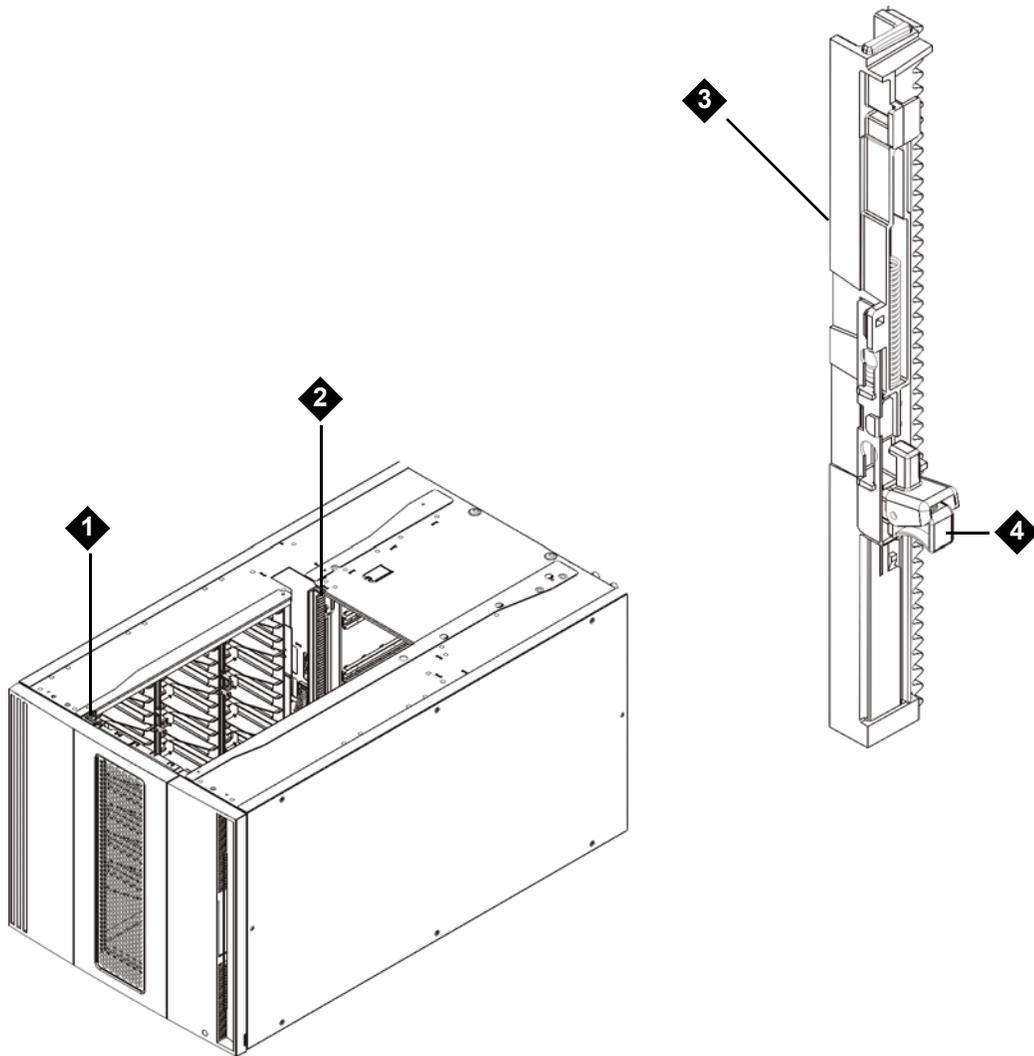
- 8 Engage the Y-rails of each module in your library configuration. Ensure that the Y-rails are properly aligned and the thumbscrews are tightened.

| 1 | Front Y-rail | 3 | Y-rail (this end up) |

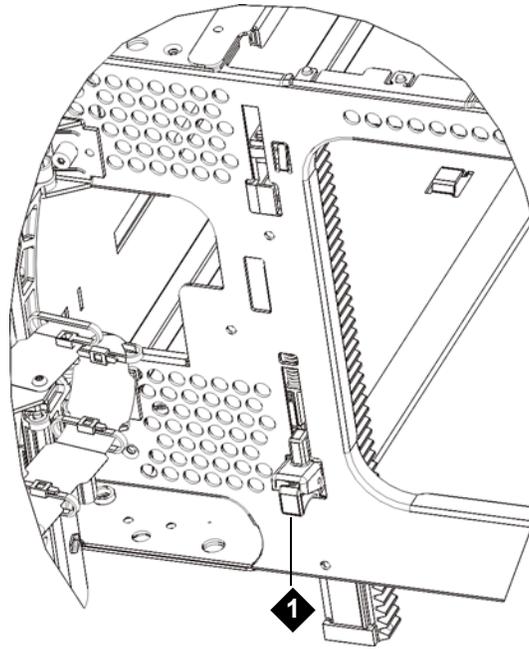
- a. From the front of the library, open the I/E station and access doors of the 9U Expansion Module. Squeeze the handle of the Y-rail release mechanism, lift it out of its locked position, and slide it downward as far as it will go.

1 Y-rail in unlocked, functional position

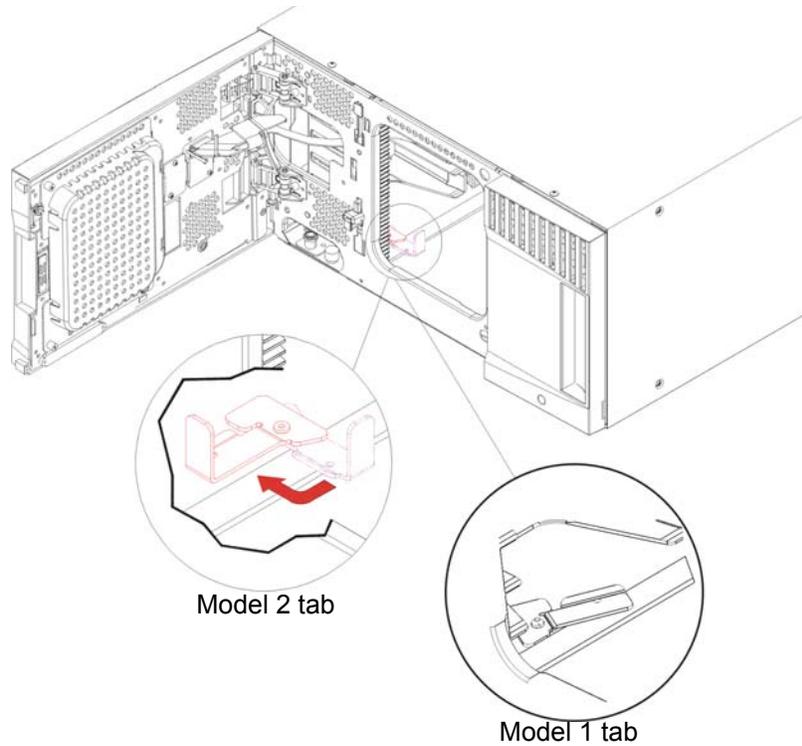
- b. With your free hand, move the parking tab to the "unparked" position so that it is removed completely from the interior of the module (**Model 1 parking tab**: swivel the parking tab away from you; **Model 2 parking tab**: move in a clockwise direction). When replaced correctly, the parking tab will not accidentally swivel into the path of the robot.
- c. Gently release the robot assembly. It will lower to the bottom module of the library.

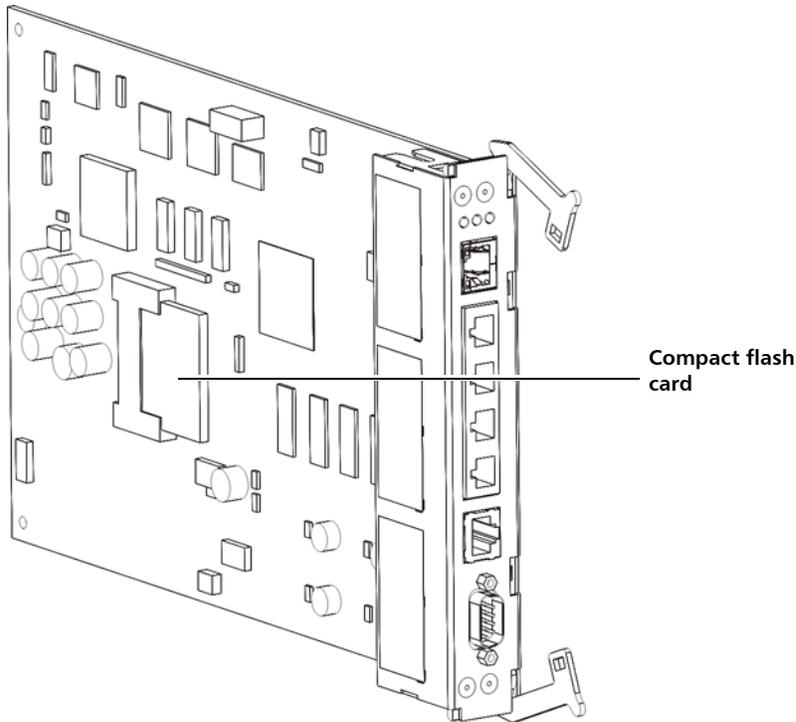
Figure 18 LCB and Compact Flash Card

To remove the existing LCB, release both of the LCB latch hooks, and using the latch hooks as handles, pull the entire LCB toward you (see [Figure 18](#) on page 103).
- 5 If the new LCB and compact flash card came in separate packages, insert the new compact flash card into the new LCB (or, if replacing the compact flash card only, remove the existing compact flash card and install the new one in the existing LCB). See [Figure 18](#) on page 103.

- 6 Insert the new LCB/compact flash card assembly into library using the internal card guides to properly align the assembly with the backplane connector. Be sure that the LCB LEDs are located at the top of the LCB, and that the latch hooks are on the right side of the LCB. When sliding the new LCB into the slot, there should be no resistance.

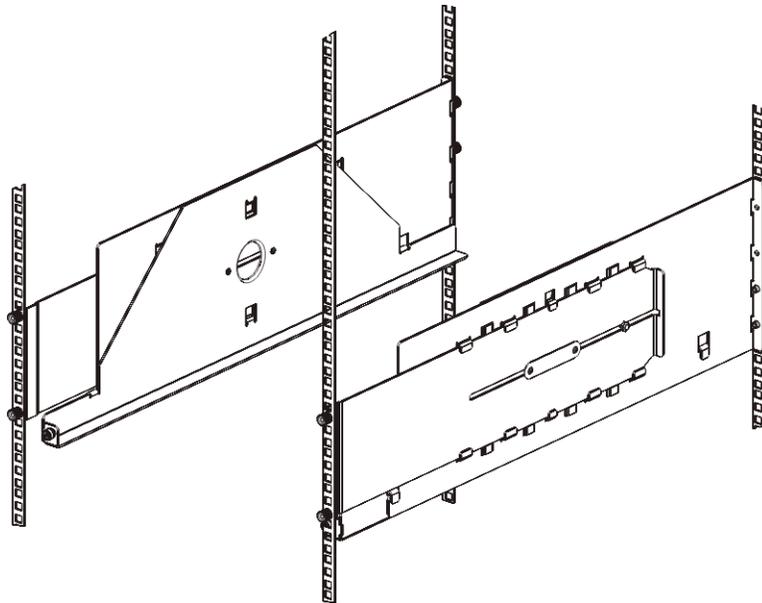
- 3 Install the rack-mount shelves into the rack so that they are level with one another.
 - a. Position the shelf to the appropriate side of the rack (right or left) and align the shelf at the desired height.
 - b. Install the shelf's rear studs in the rack's rear mounting holes.

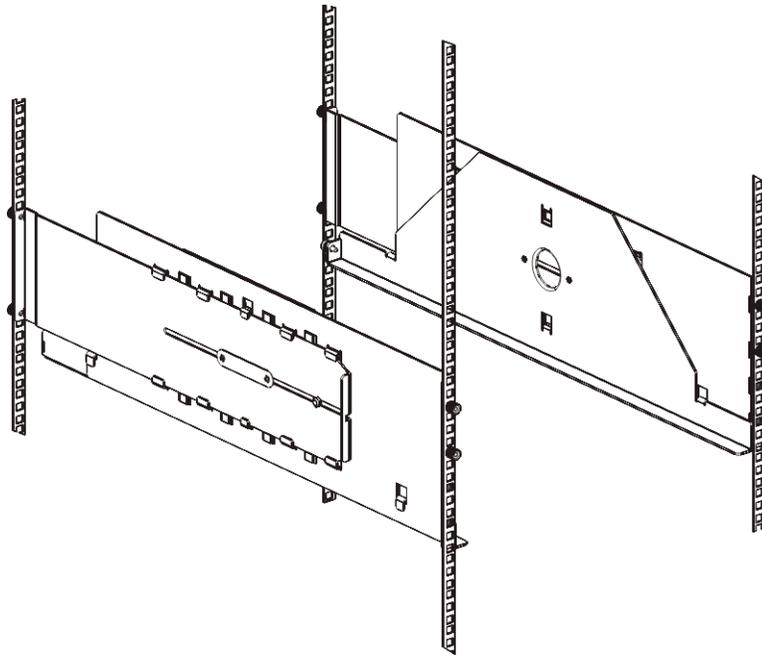
- d. Next, install the shelf's front studs in the rack's front mounting holes.

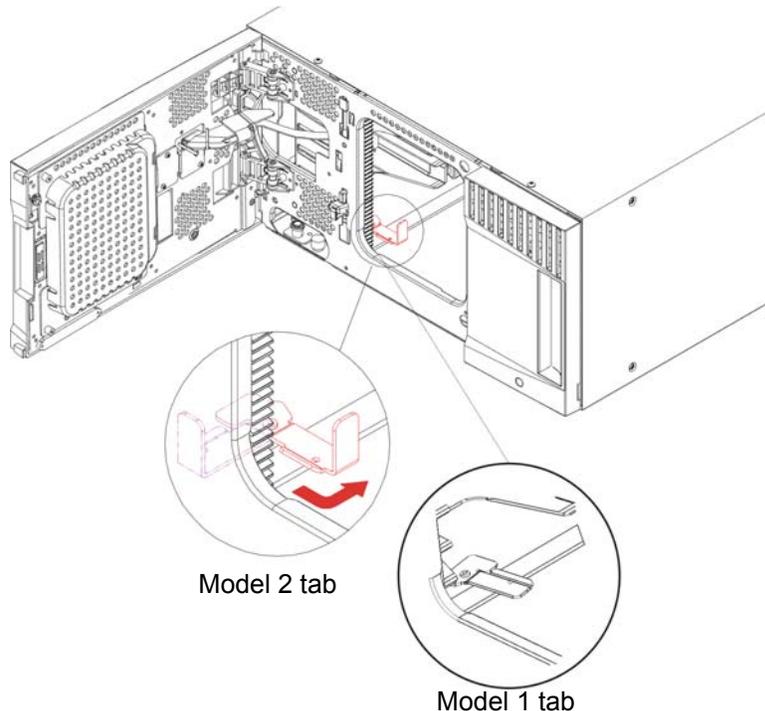
- c. After raising the robot assembly to the approximate middle of the 5U Library Control Module, hold it in place with one hand and, using your other hand, move the parking tab to the "parked" position (**Model 1 parking tab**: swivel toward you; **Model 2 parking tab**: move in a counter-clockwise direction). The metal parking tab is located at the bottom of column 1.
- d. Gently release the robot assembly to rest on the parking tab.

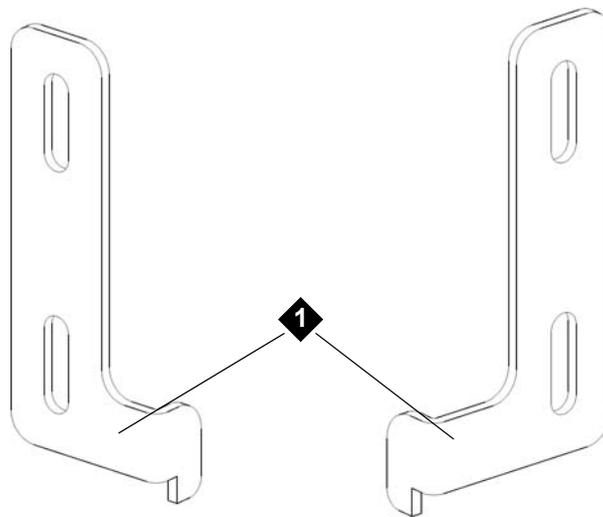
- 1 Place the desired module (whichever module you want to be the bottom module of the library) onto the rack-mount shelves. From the front of the rack, lift the module onto the shelf and gently slide it into the rack. Slide the module to the back of the rack, so that the front of the module is flush with the mounting holes.
- 2 From the back of the rack, secure the module to the rack-mount shelves by tightening the two silver thumbscrews that are attached to the rear of the rack-mount shelves.
- 3 Install the right rack ear. At the front of the library:
 - a. Open the I/E station door. At the lower right corner of the module is a vertical slot. Insert the hinge of the right rack ear into the slot, and then position the holes of the rack ear flush with the rack rail.

1 Hinge of rack ears

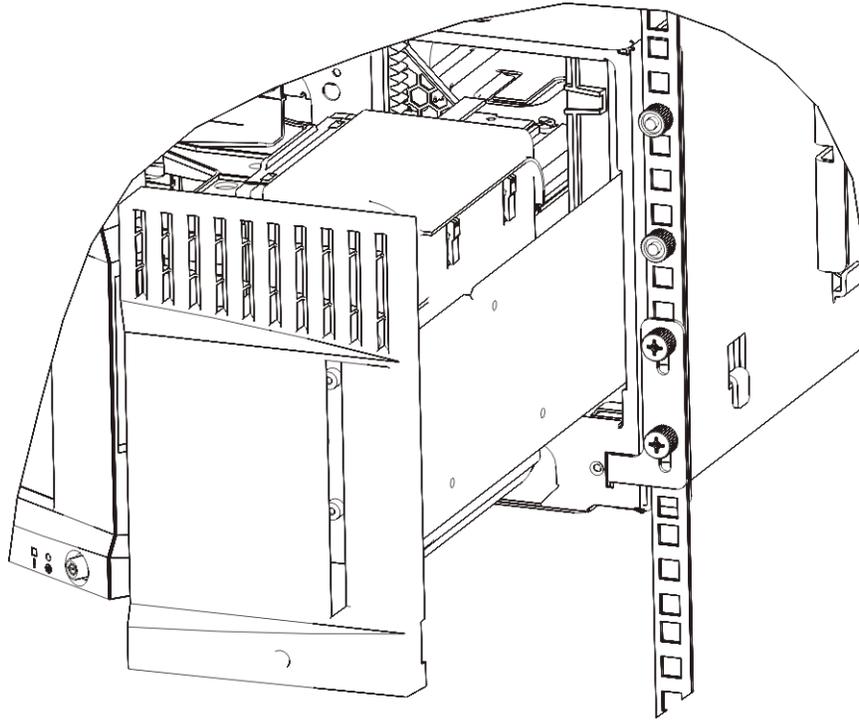
- b. Using two M5 thumbscrews, fasten the rack ear to the rack. The thumbscrews should fasten completely and evenly.
