Dell™ PowerVault™ ML6000 Maintenance Guide

Document Number: 6-01367-10 Rev A

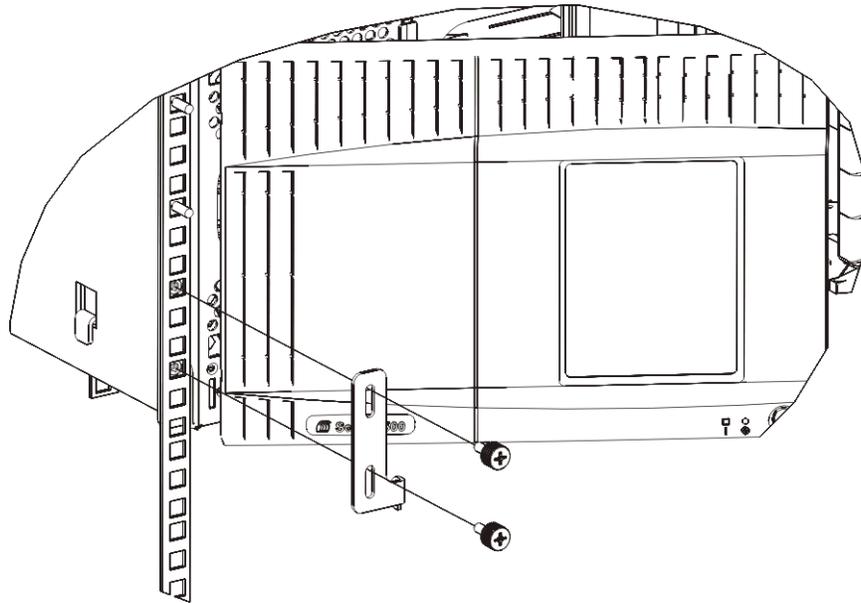
- b. Install the left rack ear in the same manner as the right rack ear.
- c. Using two M5 thumbscrews, fasten the rack ear to the rack. The thumbscrews should fasten completely and evenly.

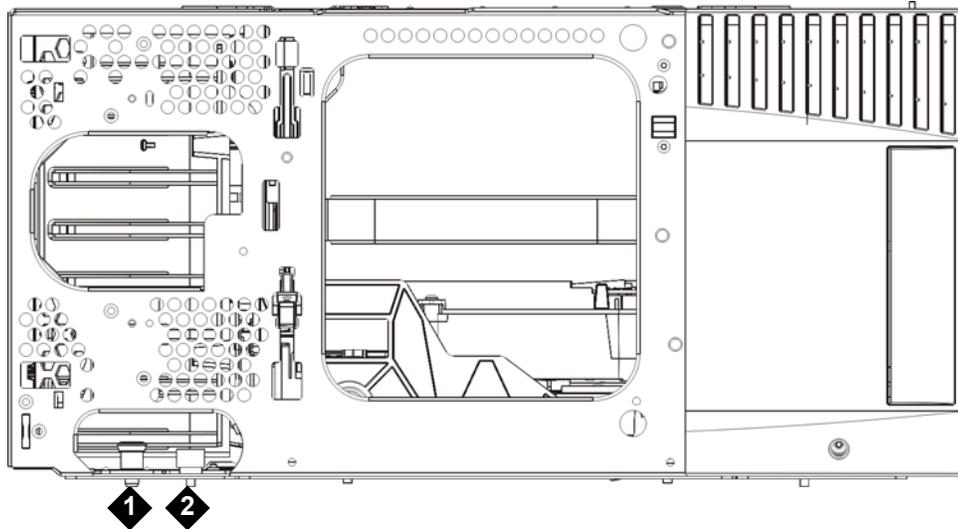
- c. Open the module's access door and raise the guide pin by pulling it up and turning it slightly, as if it were a screw. Otherwise, the guide pin may scratch the front doors of the module on which you are stacking it.

-
- 1 Guide pin
 - 2 Thumbscrew
-

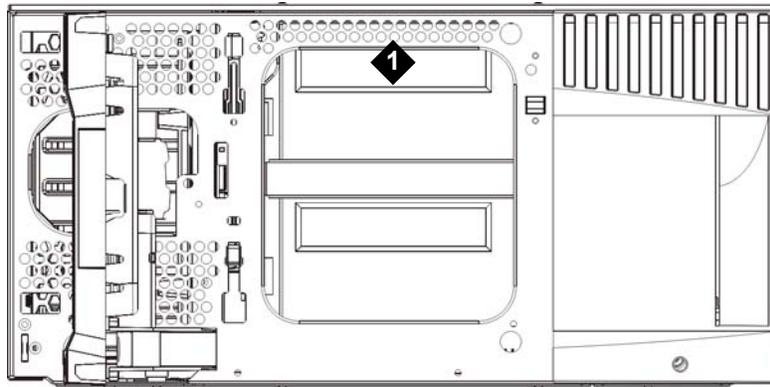
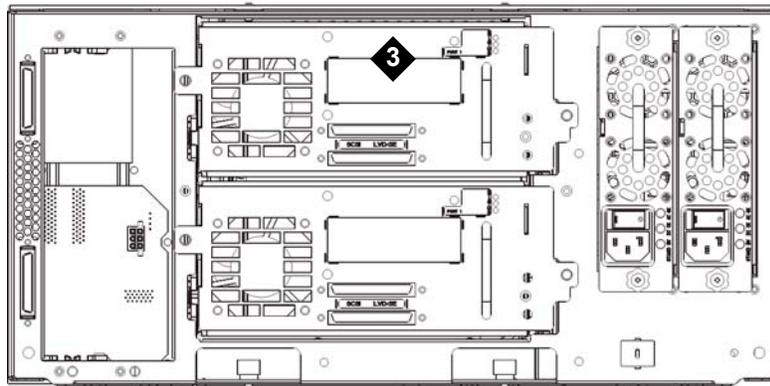
- 7 Secure the module to the module beneath it by tightening the thumbscrews located at the base of the front and back of the module. Press down the thumbscrew, and then tighten it.

-
- 1 5U Library Control Module (front)
 - 2 Thumbscrews
 - 3 5U Library Control Module (rear)
-

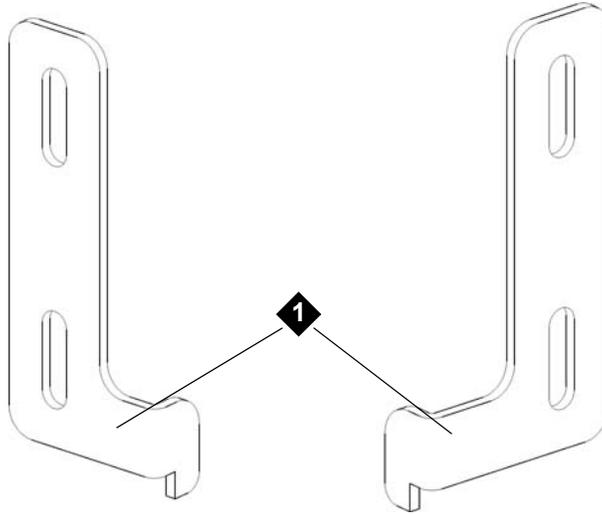
- a. Open the I/E station door. At the lower right corner of the module is a vertical slot. Insert the hinge of the right rack ear into the slot, and then position the holes of the rack ear flush with the rack rail.

1 Hinge of rack ears

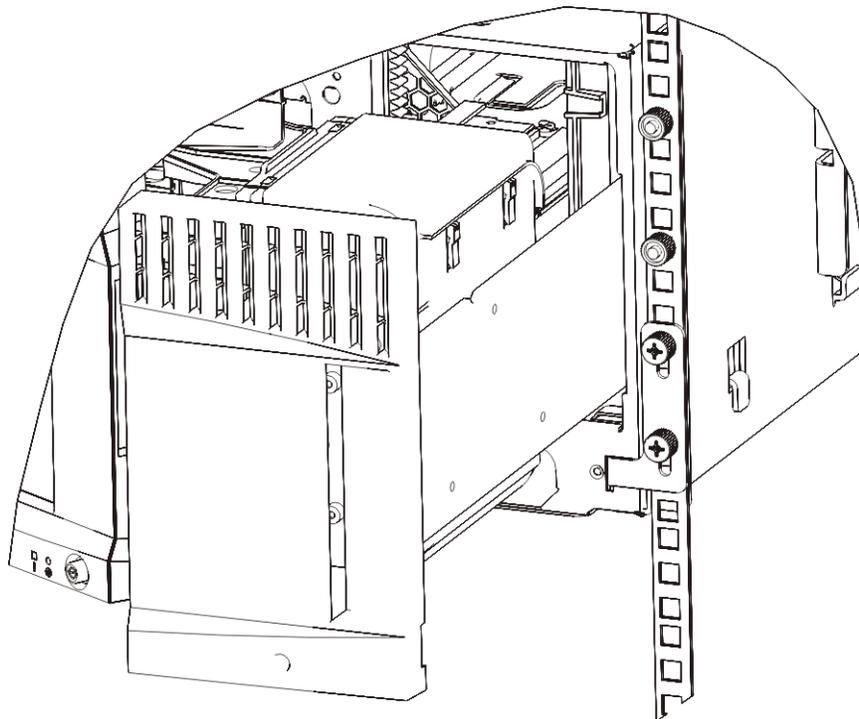
- b. Using two M5 thumbscrews, fasten the rack ear to the rack. The thumbscrews should thread through the nut clips (or cage nuts) and fasten completely and evenly.

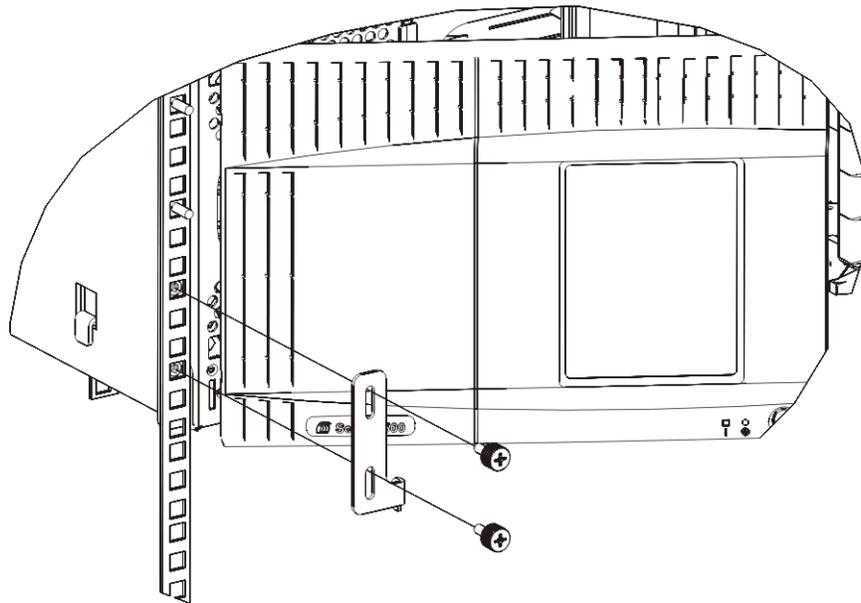
- b. Install the left rack ear in the same manner as the right rack ear.
- c. Using two M5 thumbscrews, fasten the rack ear to the rack. The thumbscrews should thread through the nut clips (or cage nuts) and fasten completely and evenly.

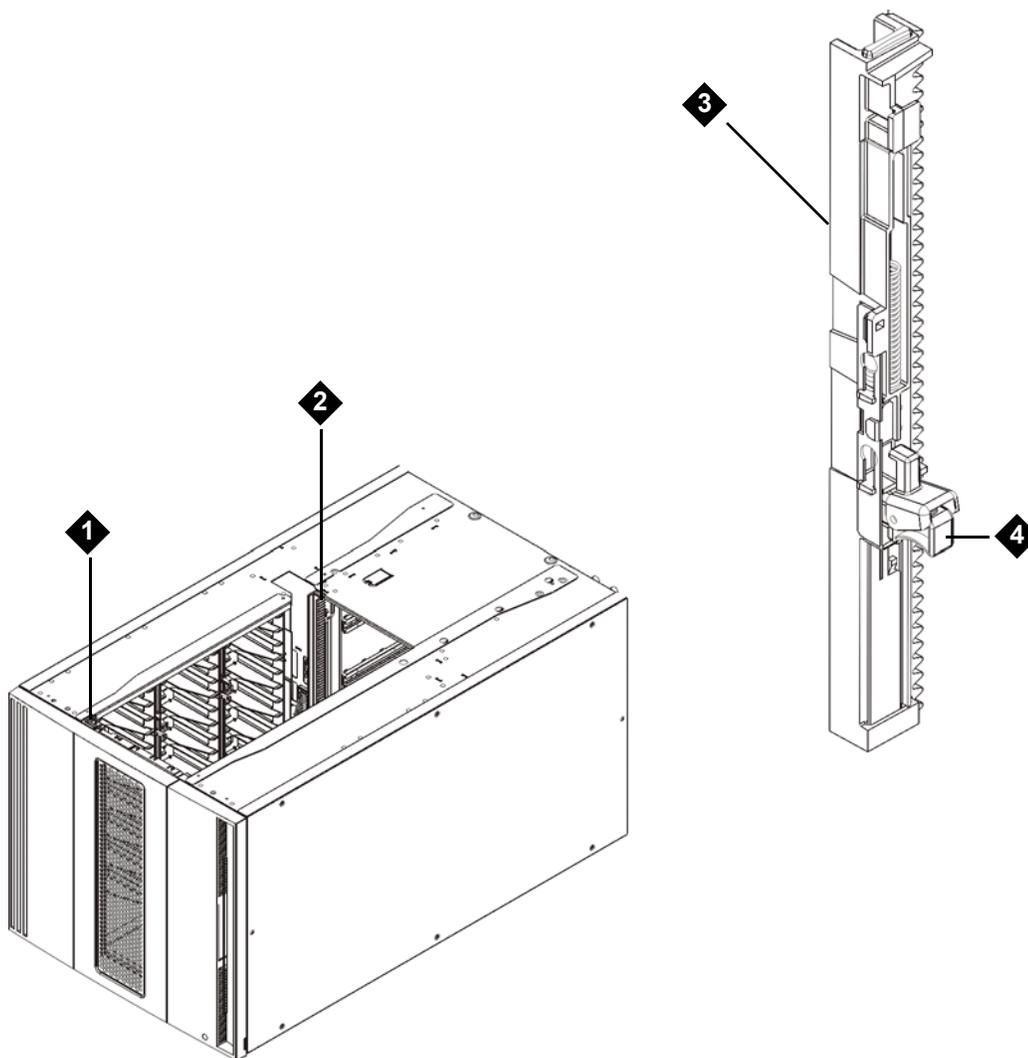
10 If the module you are installing is an expansion module, engage the Y-rails of the new module in your library configuration. Ensure that the Y-rails are properly aligned, and the thumbscrews are tightened.

1 Front Y-rail

2 Rear Y-rail

Check to make sure that there is no gap between the top and bottom Y-rails on both the front and back of the library. If a gap exists, the library cannot mechanically initialize.

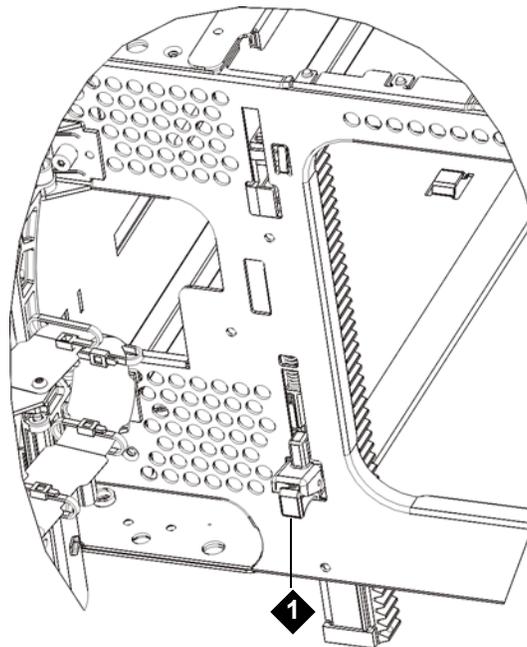
Doing this aligns the Y-rails with the Y-rails of the module beneath it.

1 Y-rail in unlocked, functional position

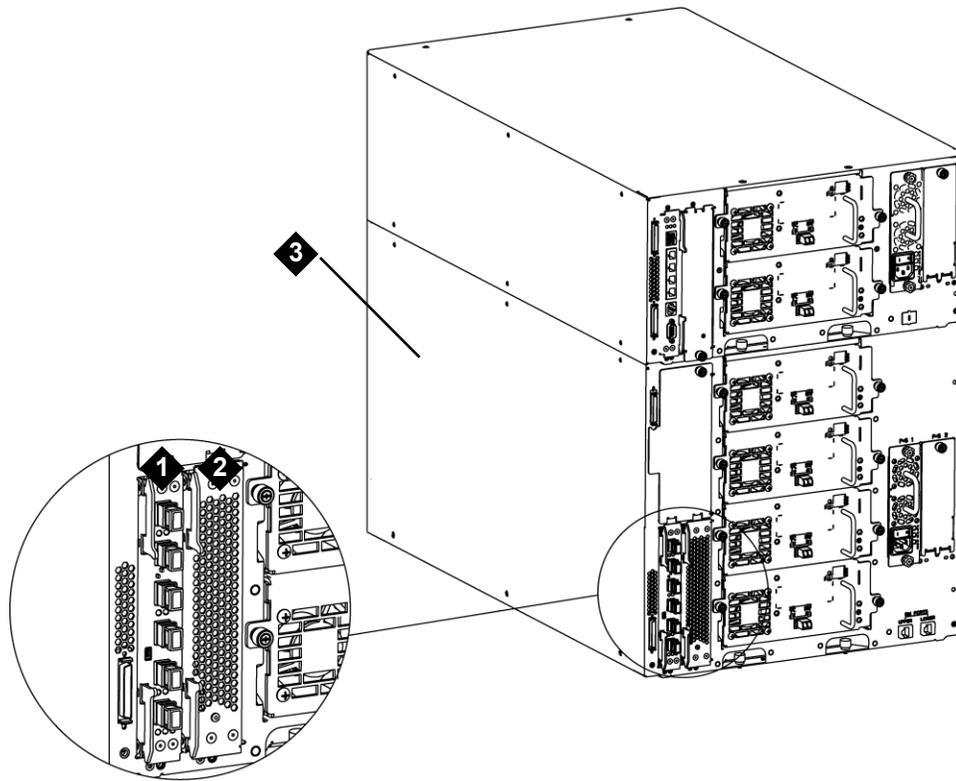
Figure 19 FC I/O Blade and Fan Blade Bays in Expansion Module

- Each FC I/O blade is accompanied by a fan blade that cools the blade. The fan blade is installed to the right of the FC I/O blade in the expansion module. Each expansion module has four bays and can accommodate two FC I/O blades and two fan blades. [Figure 19](#) shows the FC I/O blade and fan blade installed in the expansion module. For instructions on installing the fan blade fan, see [Adding, Removing, and Replacing the FC I/O Fan Blade](#) on page 137.

-
- 1 FC I/O blade
 - 2 Fan blade
 - 3 Expansion module
-

[Figure 19](#) on page 131 shows the FC I/O blade and I/O blade fan installed side-by-side in the expansion module.

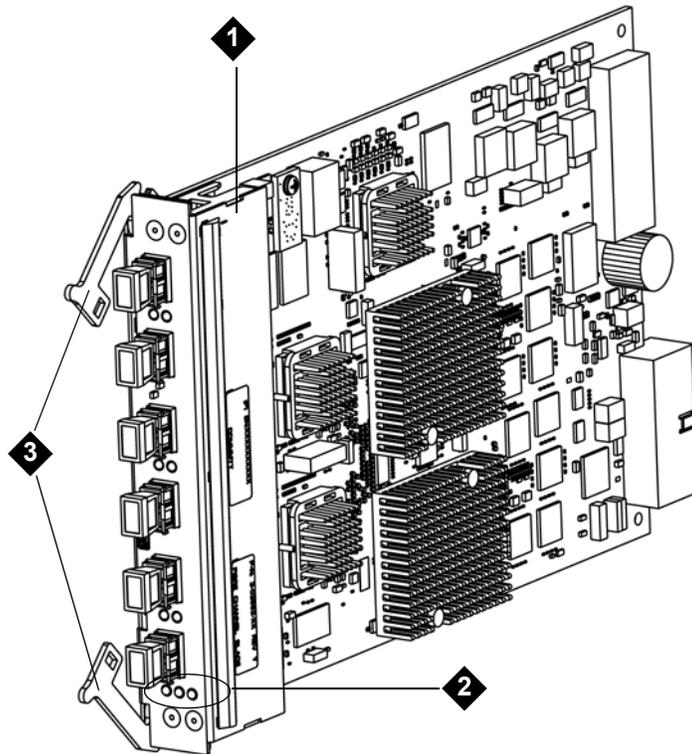
- 2 Remove the cover plate from the appropriate bay.
- 3 Press up and out to open the latch hooks on each side of the I/O blade.

-
- 1 I/O blade
 - 2 LEDs
 - 3 Latch hooks, open
-

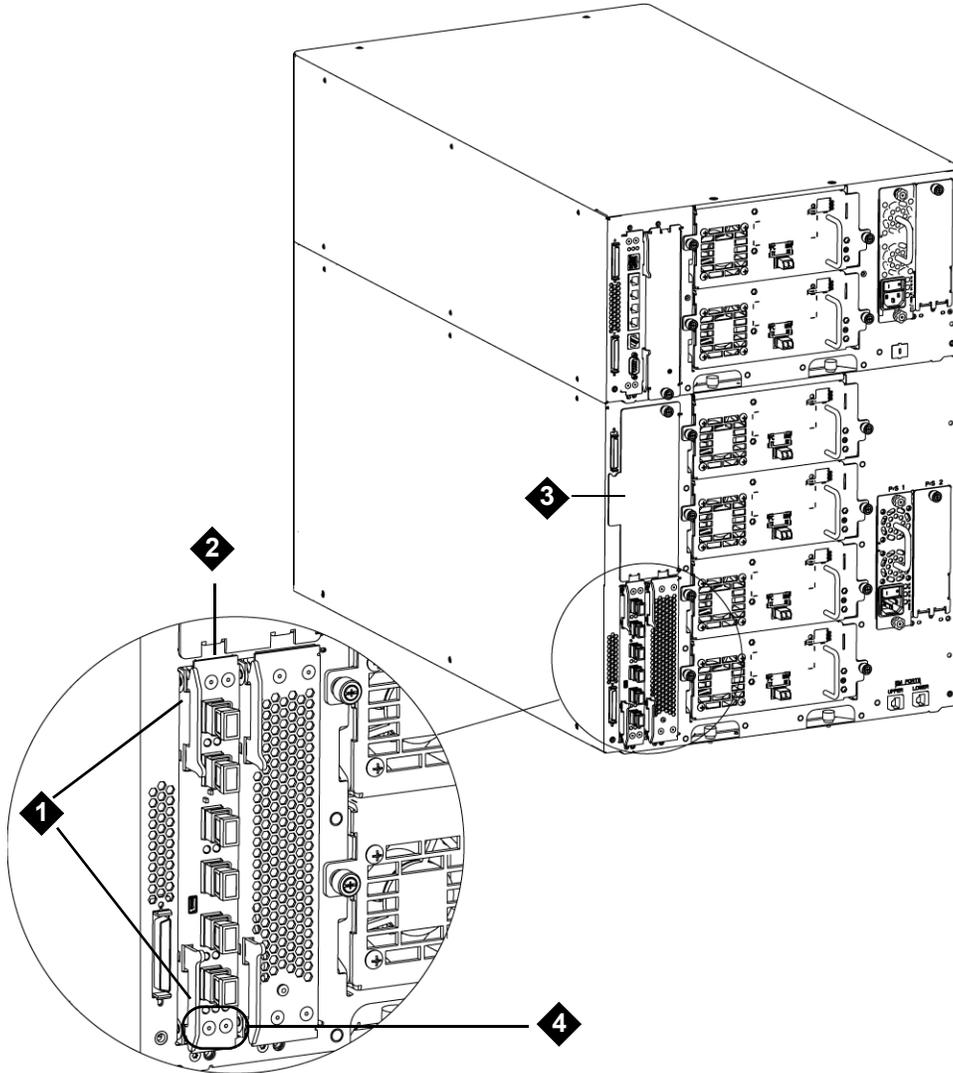
- 6 When you are ready to cable the blade, remove the necessary number of the black rubber protective covers from the ports on the FC I/O blades.

1 Latch hooks, locked

3 Cover plate on empty bay

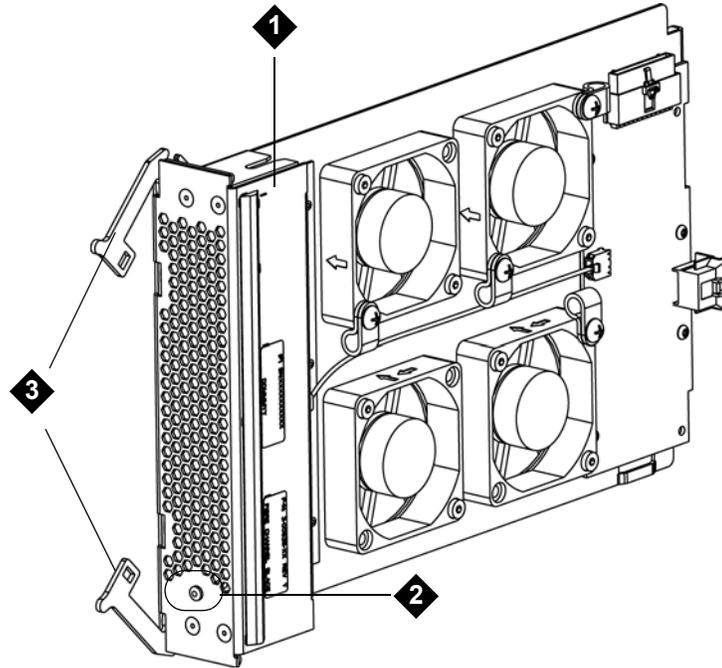
- 3 Press up and out to open the latch hooks on each side of the fan blade. The LED must be at the bottom of the blade.

| 1 | Fan blade |

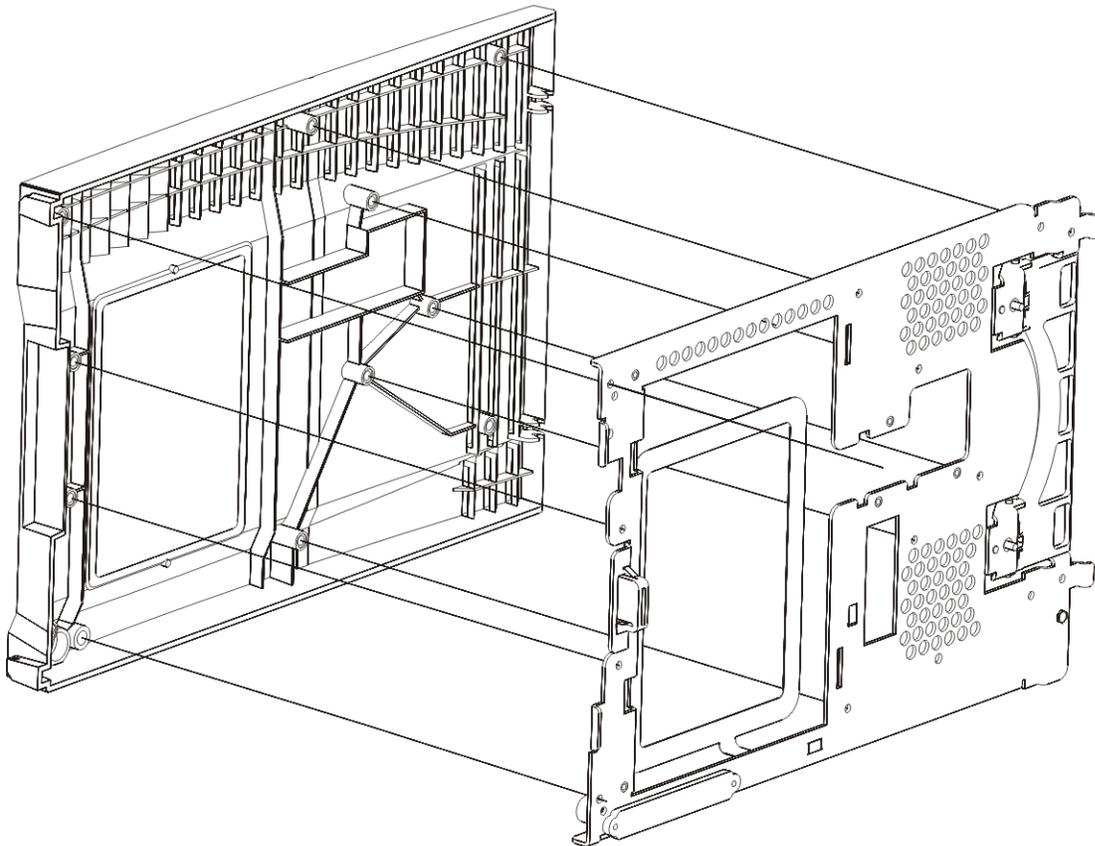
- 2 Remove the operator panel. For details, see [Removing and Replacing the Operator Panel \(LCD\)](#) on page 162.
- 3 Using the screwdriver, remove the screws located on the back of the access door. Set the screws aside.

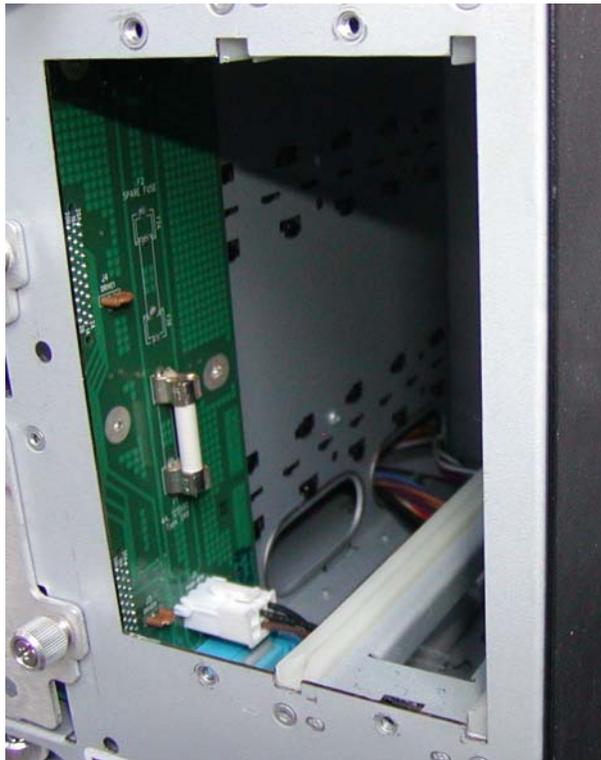
Figure 20 DSIB Fuse Location, Control Module

- 4 Remove all power supplies from the affected module and set aside.
- 5 Remove any cover plates from empty power supply slots and set aside.
- 6 Using a socket wrench or Torx screwdriver, reach through the power supply opening and remove the two screws that attach the fuse cover to the DSIB board, removing the fuse cover. If it is not possible to access the screws, you may need to remove the library side cover panel as well.
- 7 Using a fuse puller, carefully pull the failed fuse from its two fuse clips, which are attached to the DSIB board, located to the left of the power supply area of the module. See [Figure 20](#) and [Figure 21](#) for fuse location.
- 8 Replace the drive fuse with one of the same amperage and type for the module (see information above). Firmly press the new fuse into the two fuse clips. The fuse will snap into the fuse clips when it is secured.

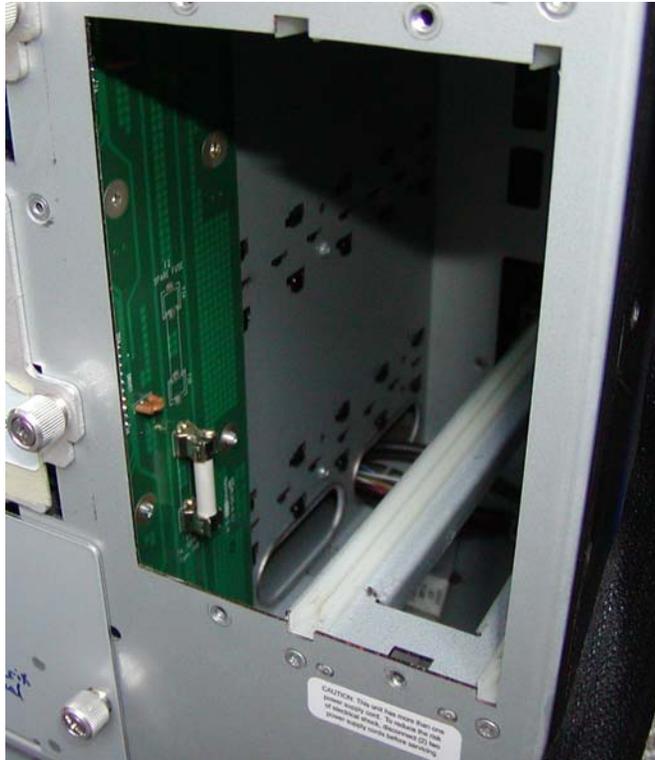
- 9 Reattach the fuse cover to the DSIB board by using a screwdriver to tighten the cover's two screws.
- 10 Replace the side cover panel of the library, if necessary.
- 11 Replace all power supplies and cover plate(s) you removed previously, and reconnect all power supply cord(s).
- 12 Turn on all power supplies in the module in which you replaced the drive fuse.
- 13 Power on the library using the front power switch.

Figure 20	DSIB Fuse Location, Control Module	149
Figure 21	DSIB Fuse Location, Expansion Module	150
Figure 22	Bottom Door	160
Figure 23	Fiducial	190
Figure 24	5U Control Module Fiducial Location	191

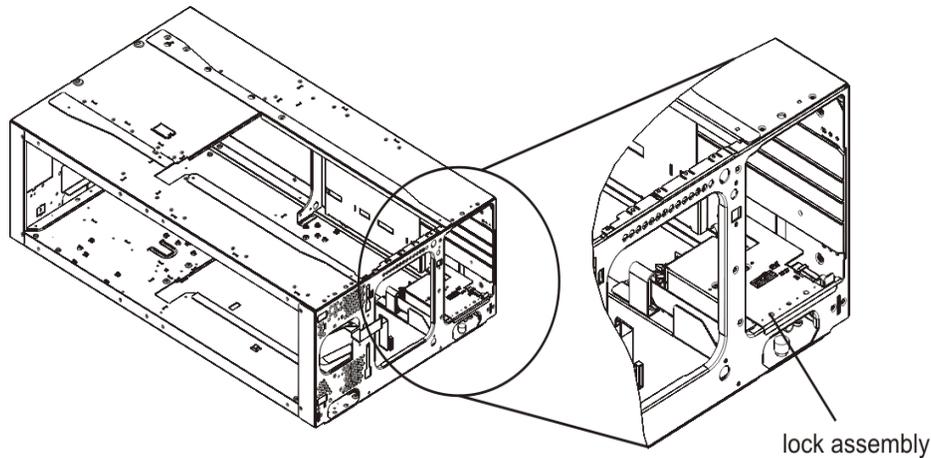
- 1 Take all affected partitions offline. For details about taking partitions offline, see [Taking the Library Online/Offline](#) on page 13.
- 2 Open the I/E station and access doors of the modules.
- 3 Remove the I/E station slide assembly. See [Removing and Replacing the I/E Station Slide Assembly](#) on page 151.
- 4 Remove the mounting screw that attaches the lock assembly to the I/E station, and set it aside. The mounting screw is located at the front of the module, near the I/E station door.
- 5 Disconnect the I/E station cable from the lock assembly.

- 6 Remove the lock assembly and replace it with the new one.
 - 7 Connect the I/E station cable to the new lock assembly.
-

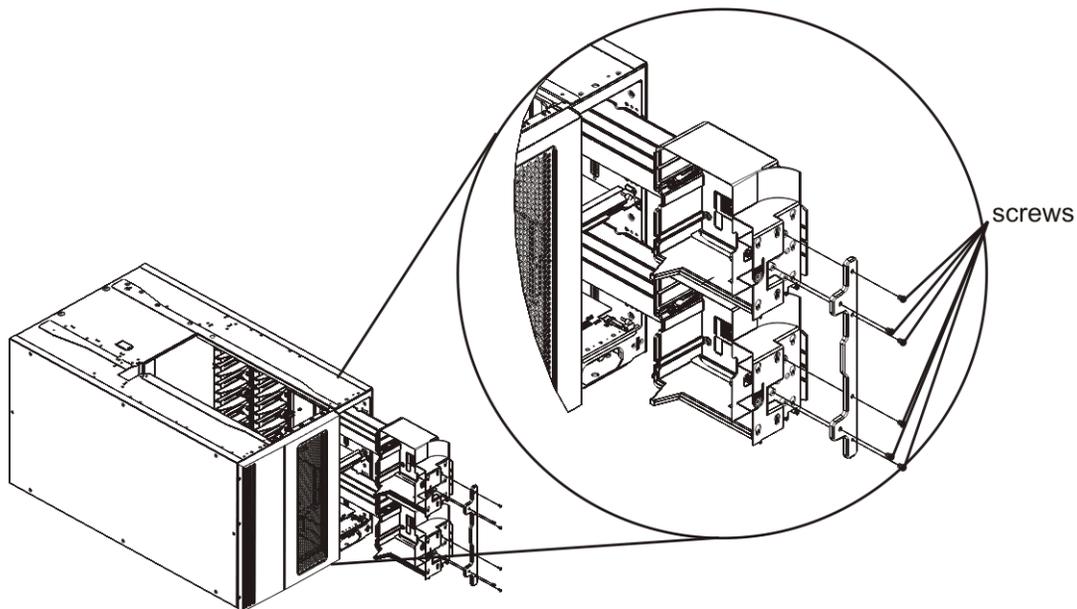
- 9 Secure the metal brace to the two individual slide assembly units.

Using the screwdriver, first install a screw in the bottommost screw hole in the brace. Then install a screw in each remaining screw hole, working from the bottom up.

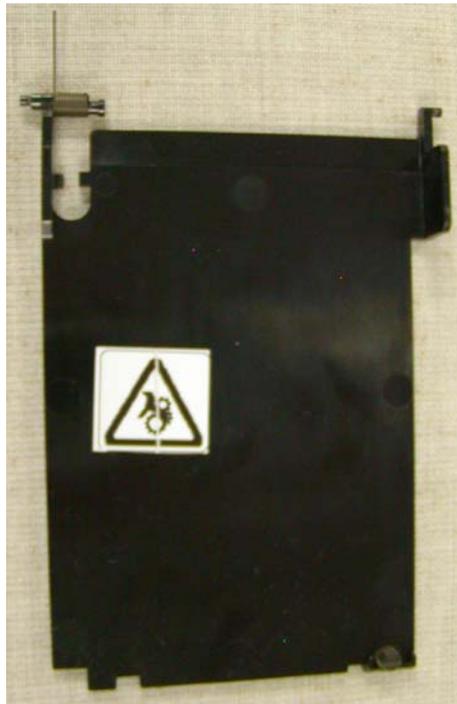
The I/E safety door assembly for the 5U Library Control Module consists of the following parts:

- Plastic door
- Spring

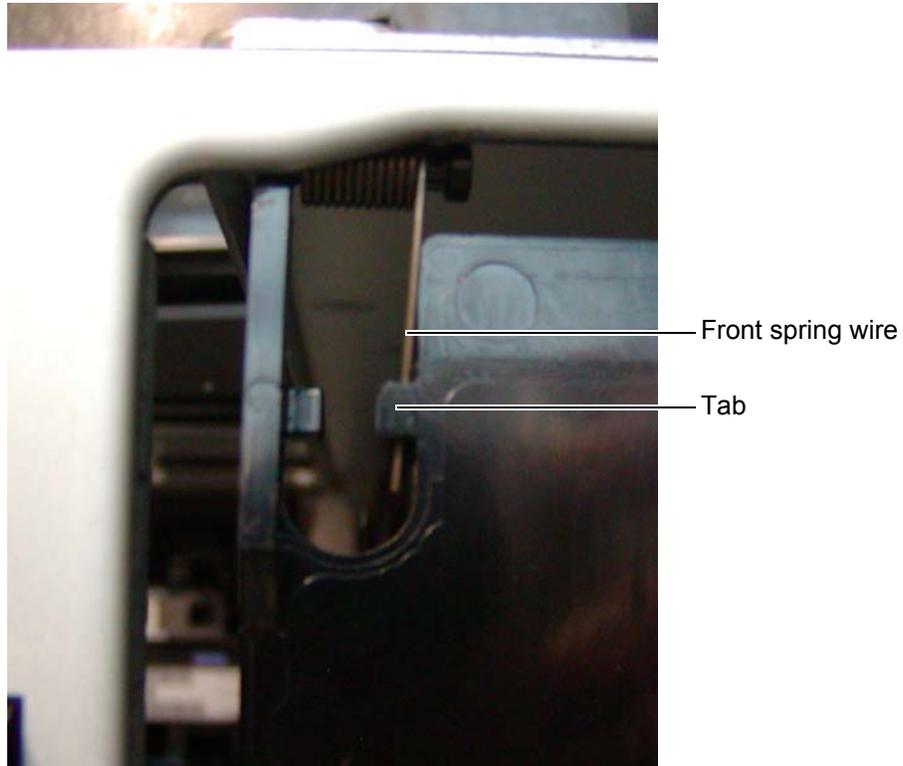
- 3 Unhook the front spring wire from the tab on upper left of the safety door.

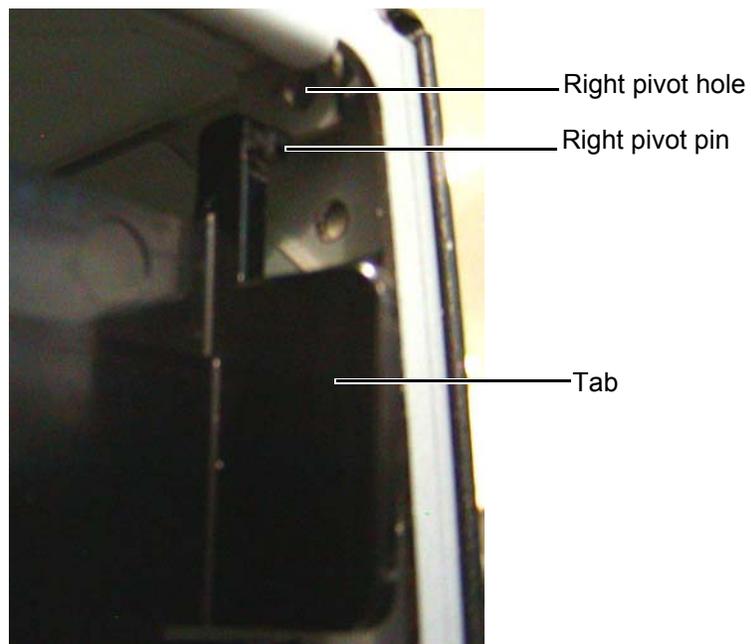
- 4 Remove the right pivot pin from the right pivot hole by pushing the tab to the left. (The tab is located on the upper right of the safety door.)

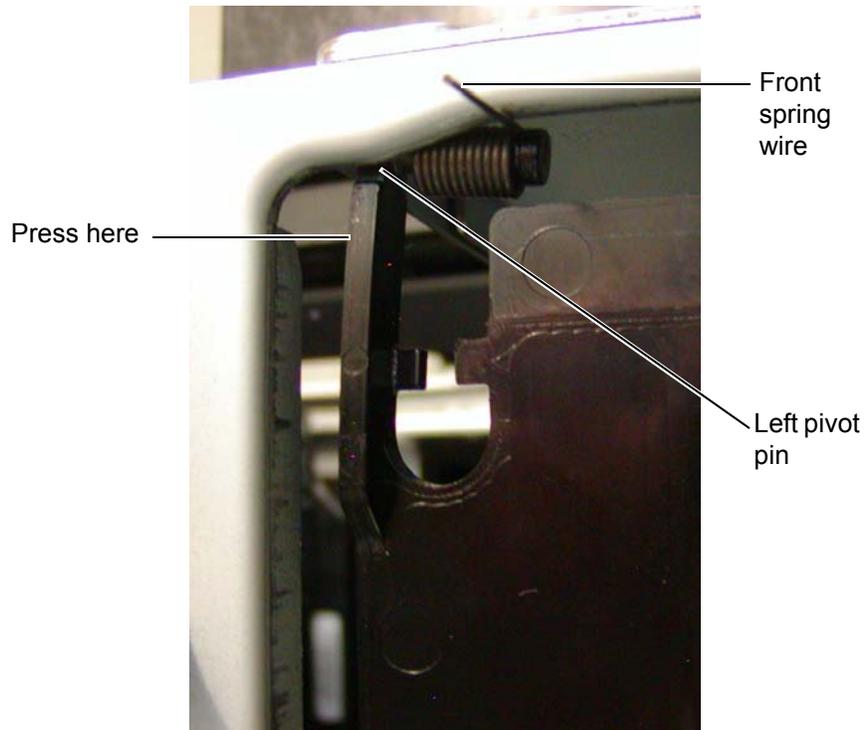
- 5 Remove the left pivot pin from the left pivot hole by pushing the flexible piece of the safety door just beneath the left pivot pin toward the right.

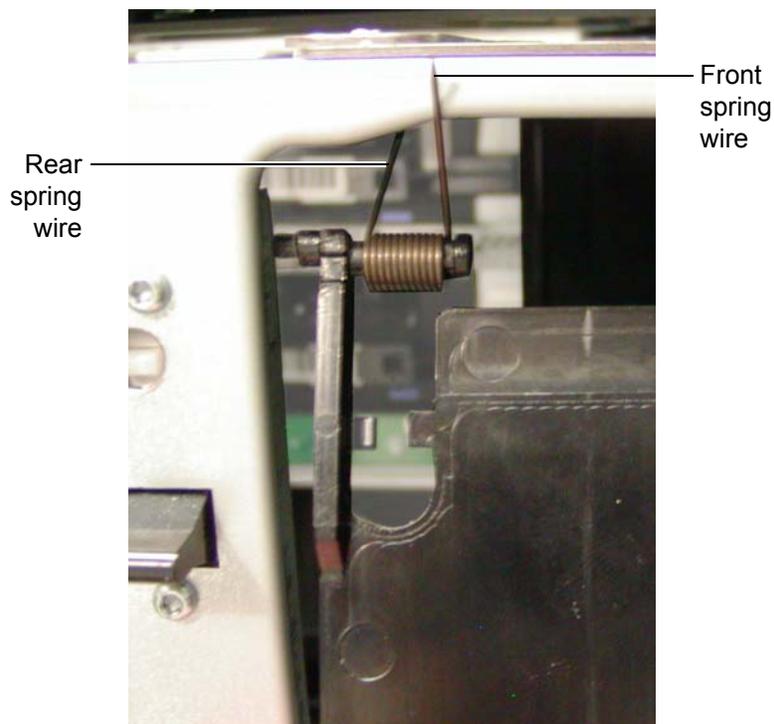
- 6 Remove the safety door from the library.
- 7 To replace the safety door, place the spring on the left pivot pin, and perform the above steps in the reverse order. When installing the safety door, position the spring as shown below.

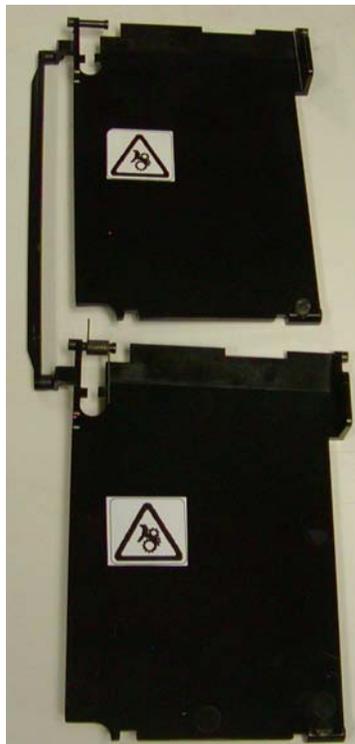
In the most recent version of the library, only the bottom safety door contains a spring. In some older versions of the library, the top door contains a spring; and in other versions, both doors contain a spring. If you have an older version, adjust the instructions accordingly, making sure to unlatch all spring wires from their respective tabs and notches before removing the safety doors, and making sure to secure all spring wires when installing the doors.

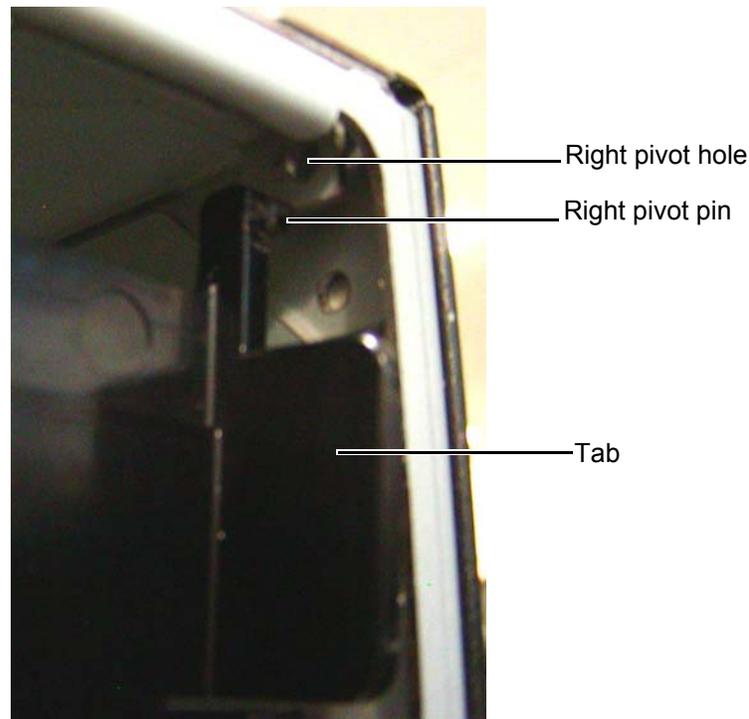
- 3 On the top door, remove the right pivot pin from the right pivot hole by pushing the tab to the left. (The tab is located on the upper right of the safety door.)

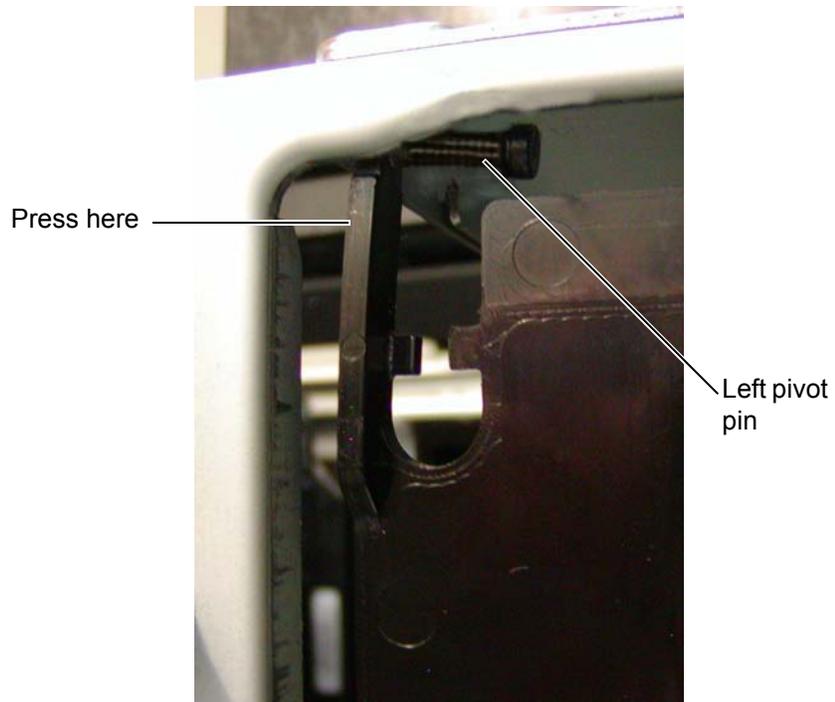
- 4 On the top door, remove the left pivot pin from the left pivot hole by pushing the flexible piece of the safety door just beneath the left pivot pin toward the right.

**Note** If the top door has a spring, remove it as described in steps [Step 6](#) and [Step 7](#) on page 160. On very old libraries, there may not be a notch for the rear spring wire like the one shown in [Figure 22](#) on page 160, but there may be a small hole in the horizontal metal frame which holds the wire. Remove the wire from the hole and make sure, when reinstalling, to push the wire back into the hole.

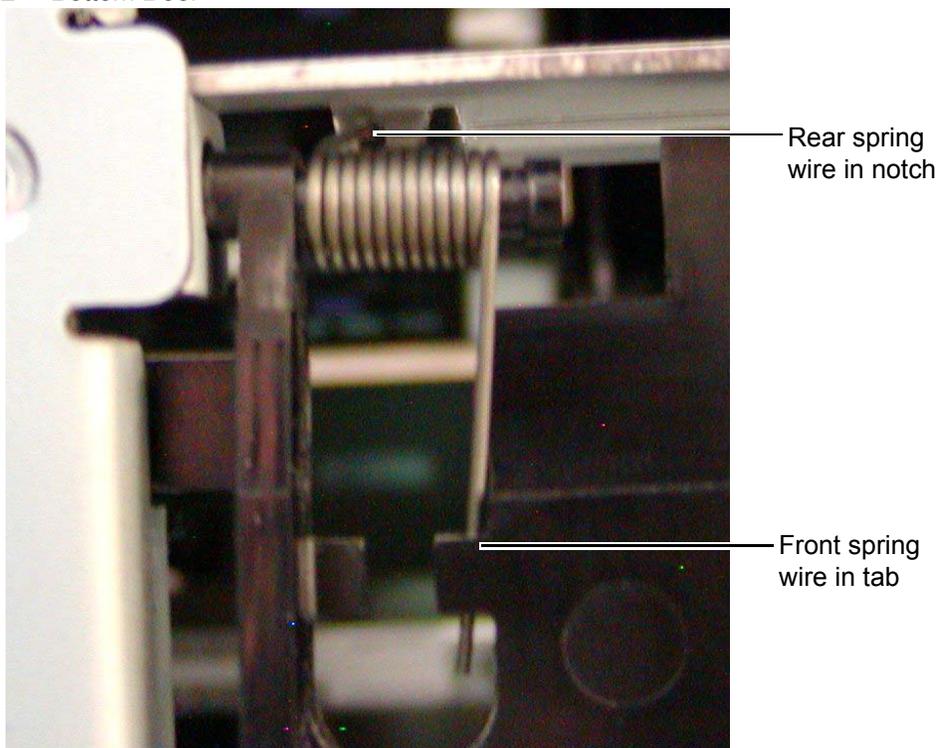
Figure 22 Bottom Door

- 5 Gently set the top door down inside the library, taking care not to damage the plastic link that connects the two doors.
- 6 On the bottom door, unhook the front spring wire from the tab (see [Figure 22](#)).
- 7 Unhook the rear spring wire from the notch in the frame (see [Figure 22](#)).

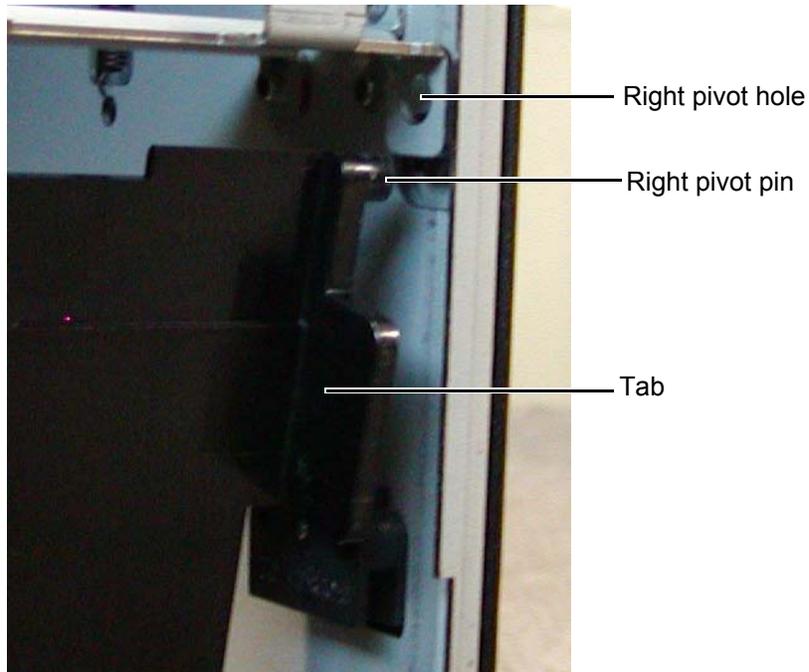
- 8 On the bottom door, remove the right pivot pin from the right pivot hole by pushing the tab to the left. (The tab is located on the upper right of the safety door.)

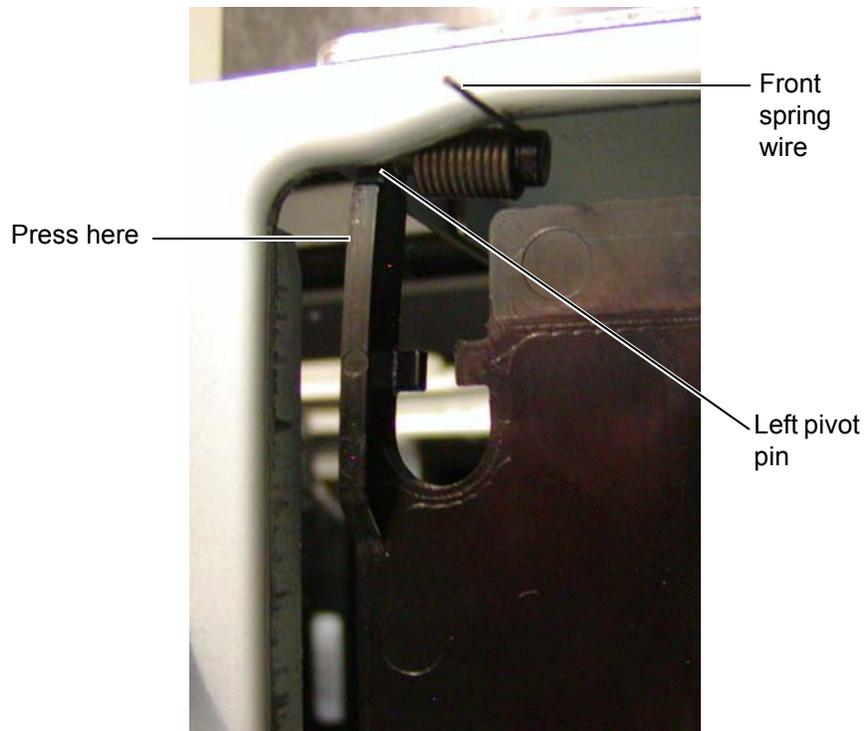
- 9 On the bottom door, remove the left pivot pin from the left pivot hole by pushing the flexible piece of the safety door just beneath the left pivot pin toward the right.

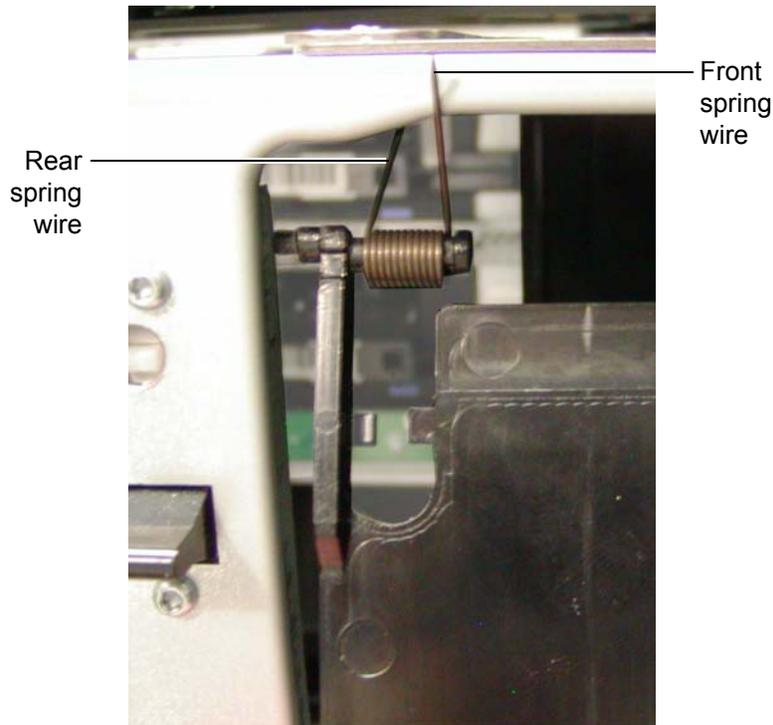
- 11 Build the new safety door assembly to match the one you removed, by snapping the link into position on the left side of each door. Place the spring on the left pivot pin of the bottom door (or whichever pin it was on originally). If your library configuration used two springs, reuse one of the springs from the old door assembly.
- 12 Install the new safety door assembly by following the instructions above in reverse. Install the bottom door first. When installing, position the spring as shown below. When installing the top door, you can push open the bottom door to assist you in placing the top left pivot pin into position.

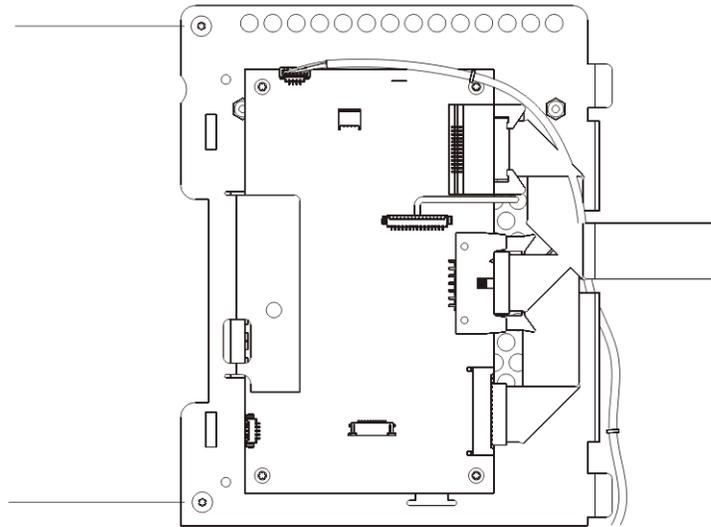
When removing the final screw, hold the operator panel to ensure it doesn't fall and become damaged.

Remove
this
screw...

...and
this
screw

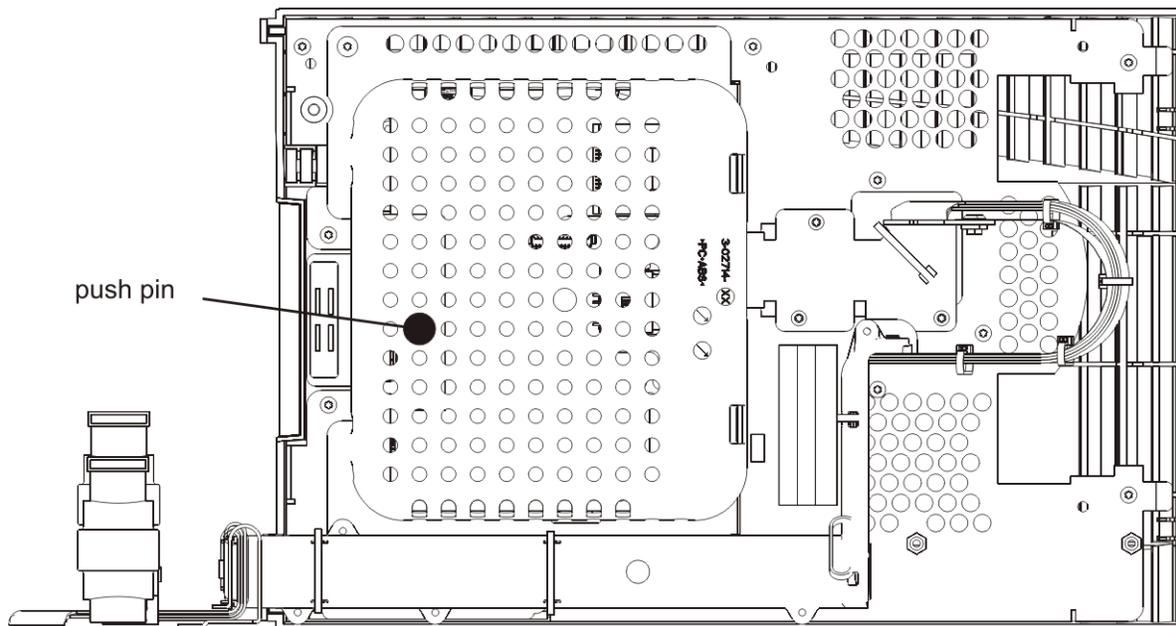
- 10 Replace the black cover that you removed earlier, and using your thumb, push the black push-pin to secure the cover to the access door.

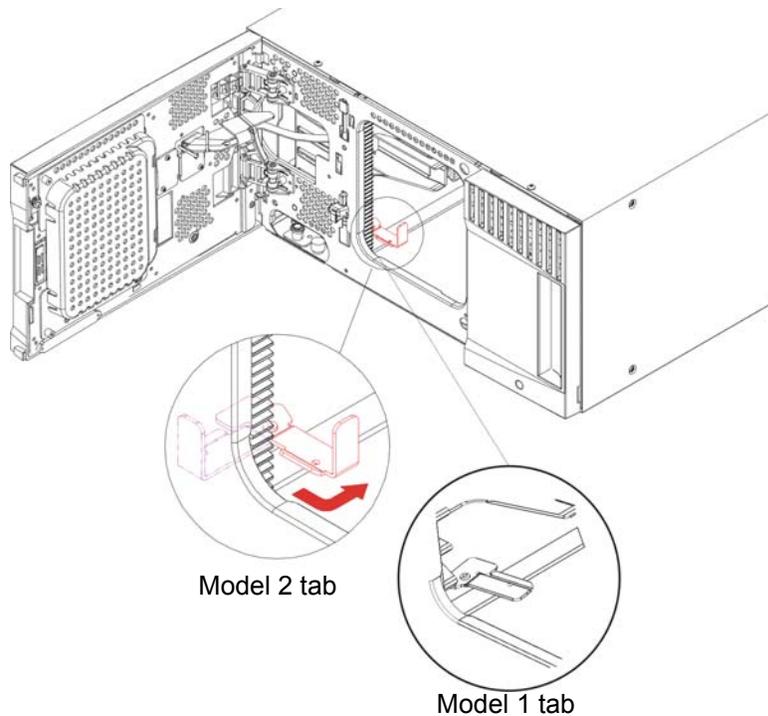
Support the robot assembly by holding onto the broad metal X-axis base plate. Lifting the robot by the thin metal rod will bend the rod. Lifting the robot by the black plastic picker body can damage the robot.

- c. After raising the robot assembly to the approximate middle of the 5U Library Control Module, hold it in place with one hand, and using your other hand, move the parking tab to the "parked" position (**Model 1 parking tab**: swivel toward you; **Model 2 parking tab**: move in a counter-clockwise direction). The metal parking tab is located at the bottom of column 1.
- d. Gently release the robot assembly to rest on the parking tab.

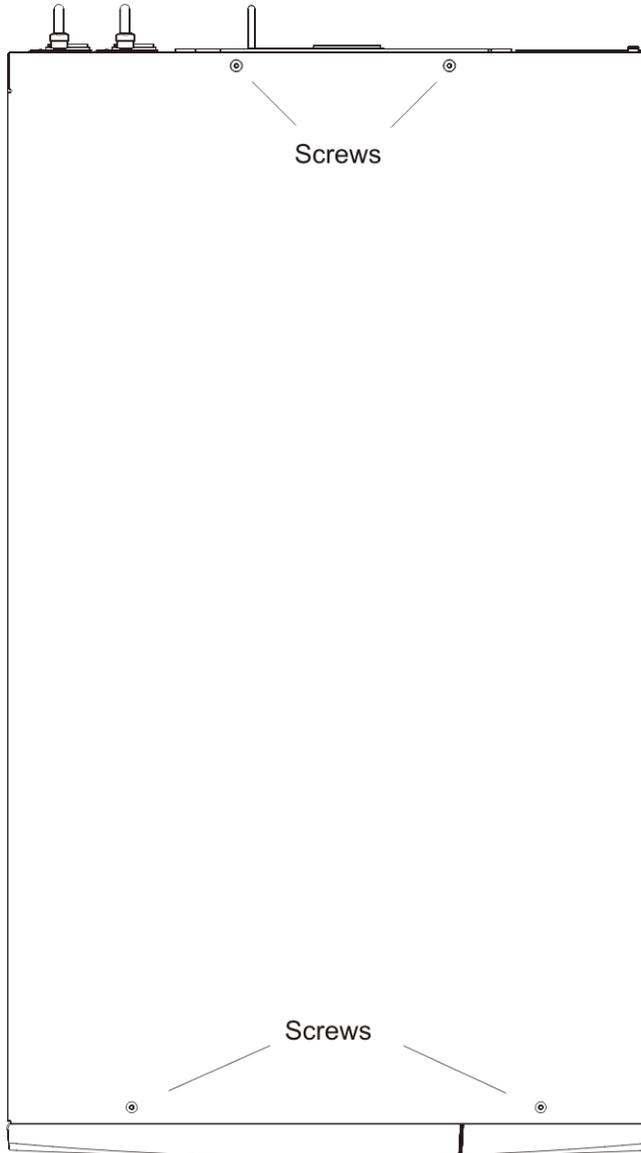
If the 5U Library Control Module's top cover plate is still in place, remove it. Use the Phillips screwdriver to loosen all screws to remove the cover.

On newer versions of the top cover, the screws are retained in the cover. Partially loosen all screws before completely loosening any one screw. Loosening one screw completely while the others are tight can cause the retaining clip of the screw being loosened to come off. In older versions of the top cover, remove the screws and set aside.

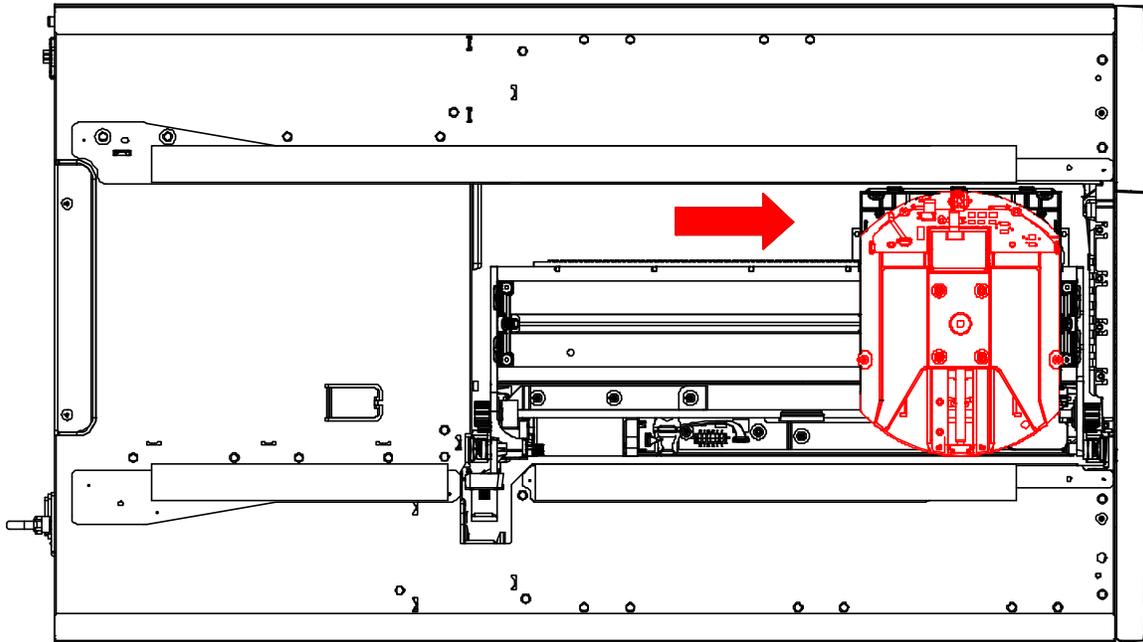
- 5 Carefully grip the picker and pull it toward the front of the library.
