Dell™ PowerVault™ ML6000 Maintenance Guide

Document Number: 6-01367-10 Rev A

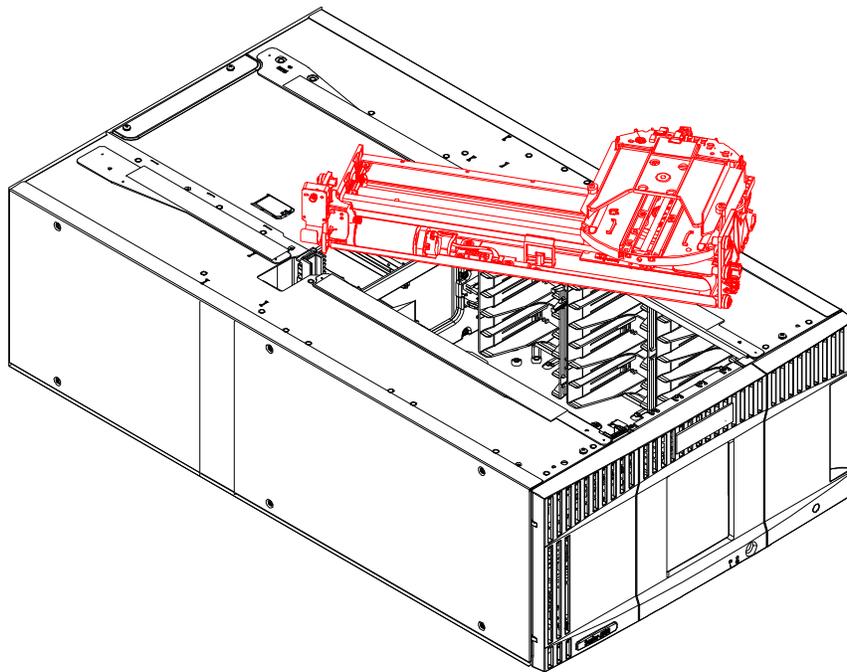
- 6 Grip the robot in the center of the tray.
- 7 Carefully lift the robot out of the 5U Library Control Module and place it at an angle on top of the 5U Library Control Module. Be careful not to pinch the cable spool flex circuit.

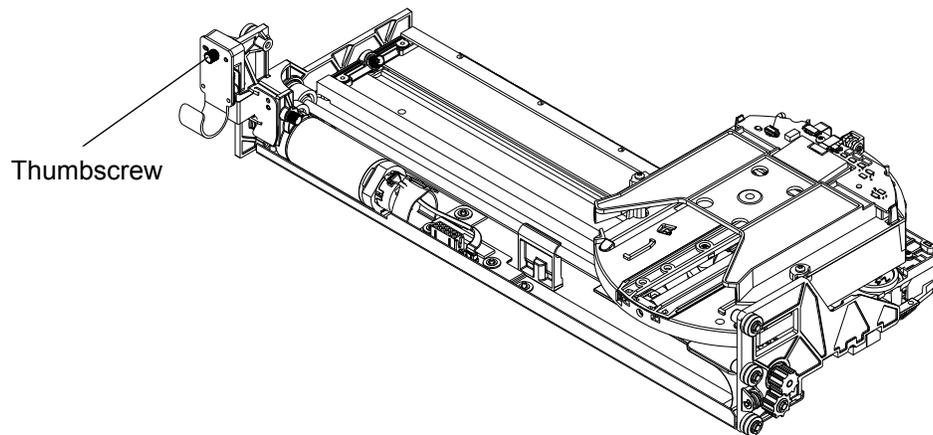
- 8 Unscrew the captive thumbscrew that attaches the cable spool to the robot assembly, and pull the cable spool flex circuit off the assembly.

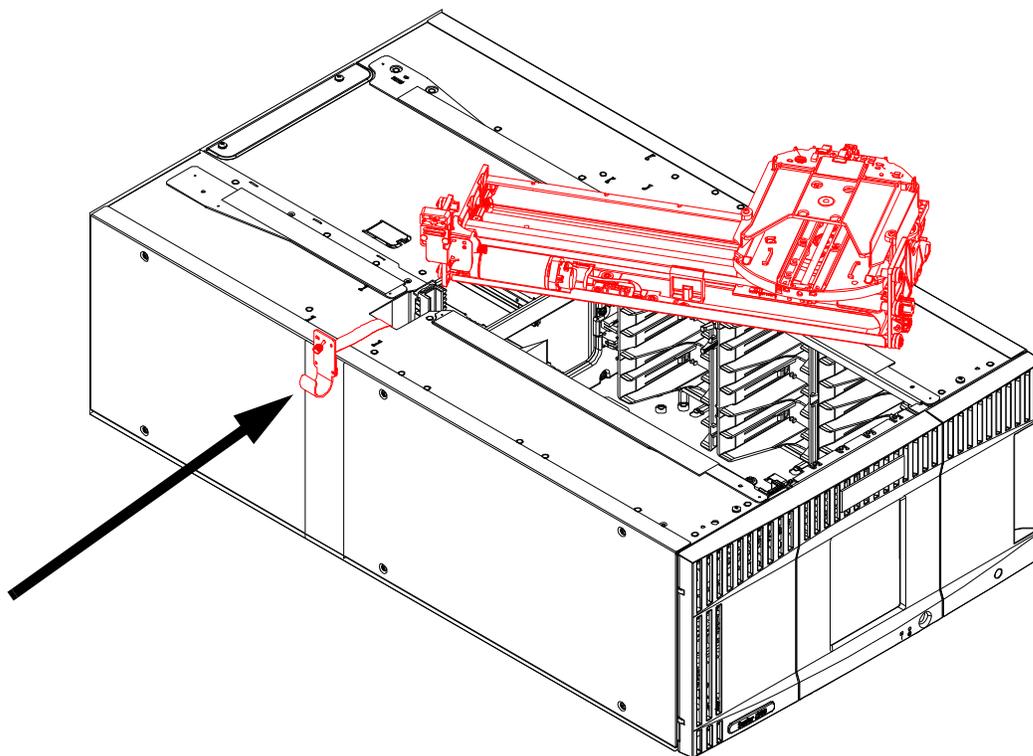
- 9 Lay the cable spool circuit across the library so that it rests on the edge. (This keeps it from falling inside.)

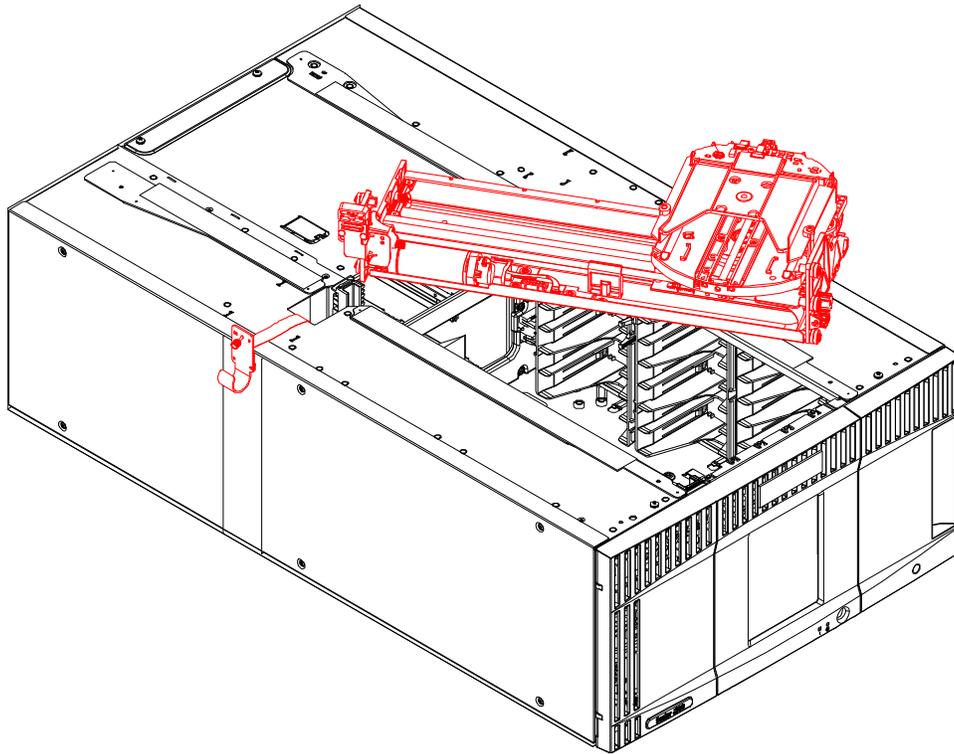
- 1 Place the robot assembly on top of the 5U Library Control Module at an angle, as shown below. This position keeps the cable from kinking when you attach the cable spool in the next step.

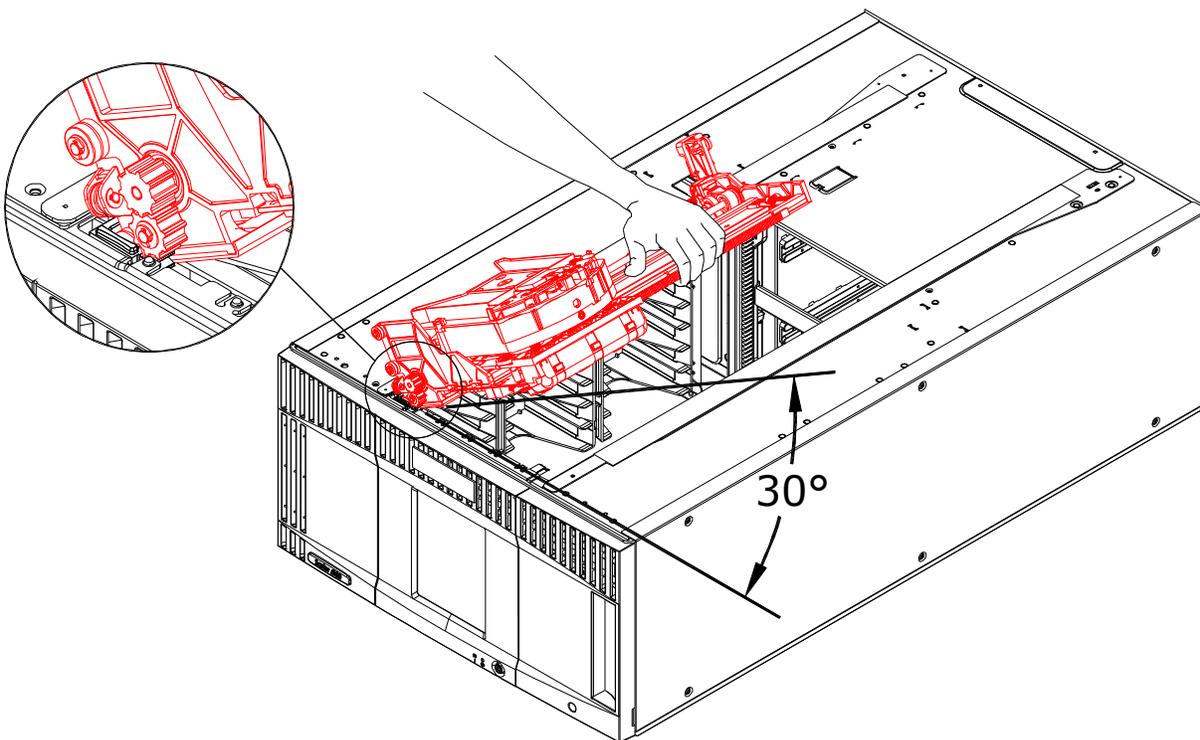
- a. Lift the robot from the center of the tray and hold it at a 30-degree angle to the 5U Library Control Module. Insert the front and rear lower guide rollers into the gear rack on the Y-rail, then lower the robot slightly until both the front and rear gears make contact with the gear rack.

**Note** It is very important to hold the robot at a 30-degree angle until both the front and rear gears contact the gear rack on the Y-rail.

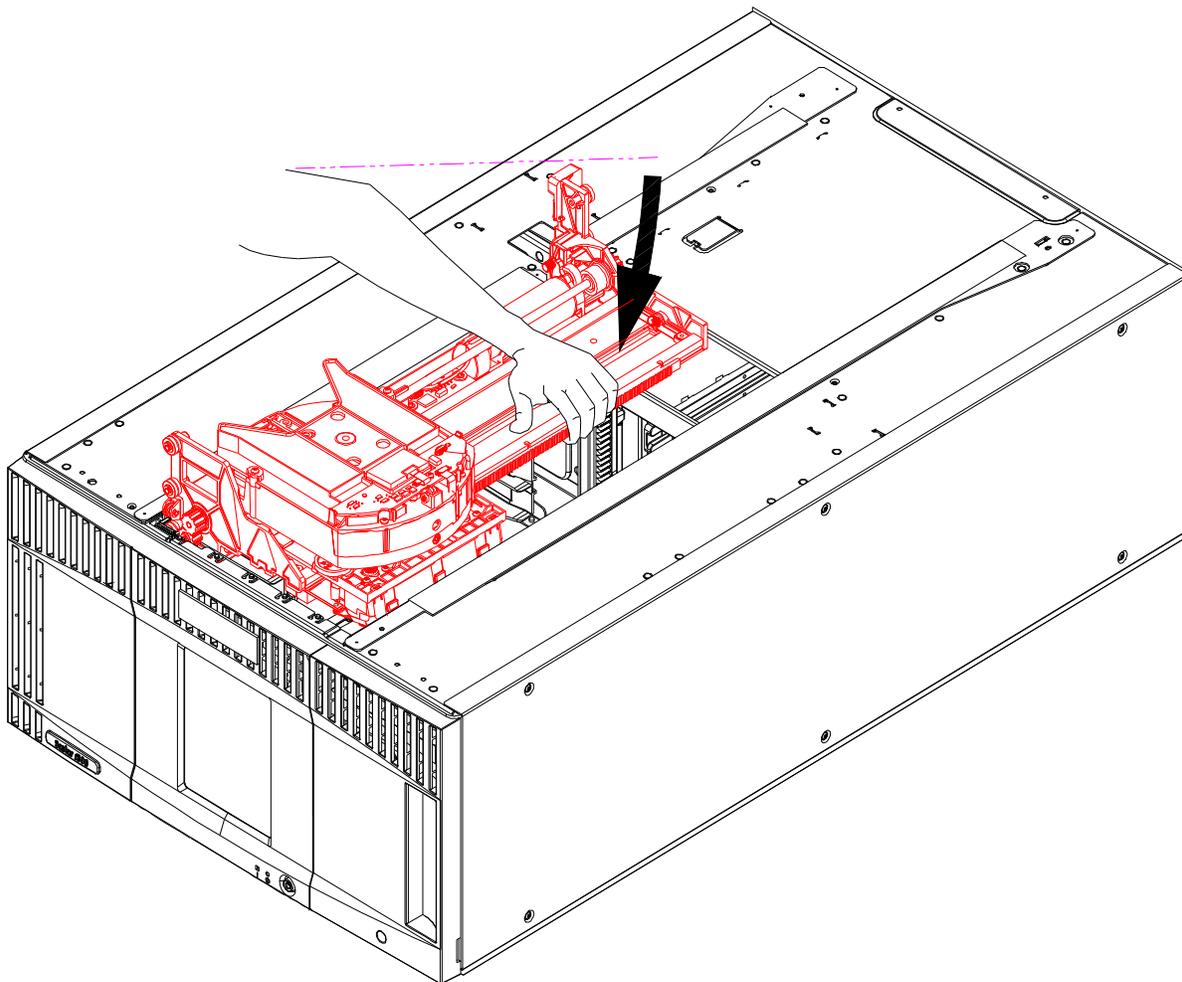
- b. Rotate the robot so that it is level with the library. Do not allow either the front or rear lower guide rollers to exit the gear rack on the Y-rail. As you rotate the robot into the level position, the gears will rotate and engage in the gear rack.

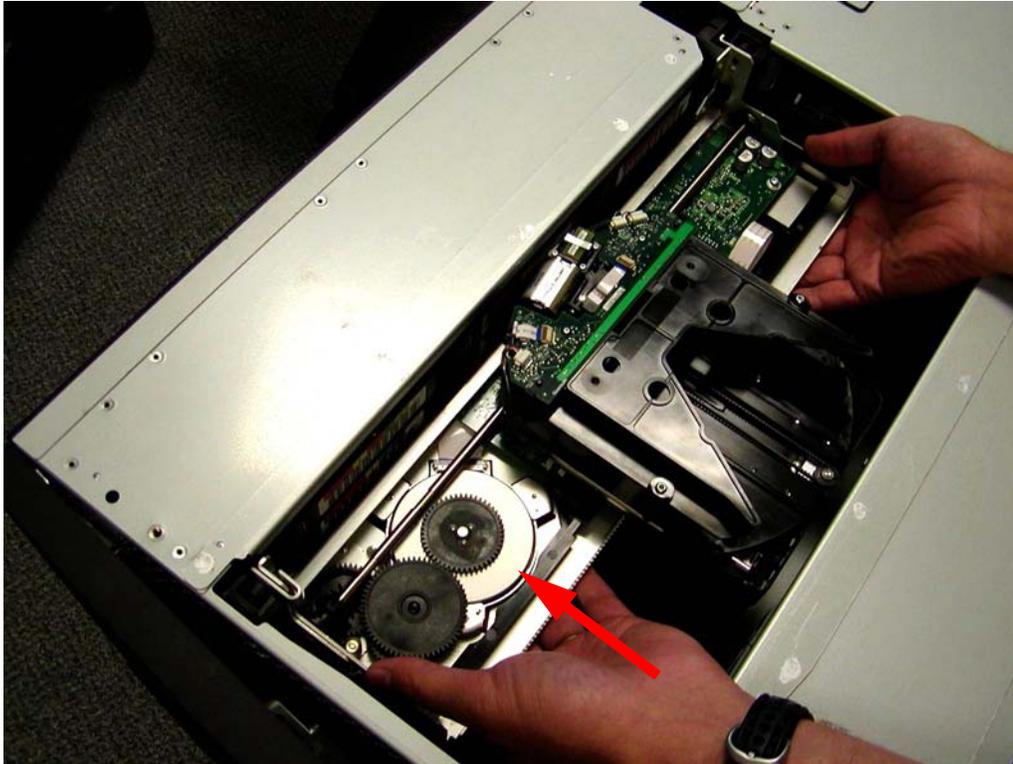
- a. Hold the robot with both hands. Keeping the robot level, insert the front and rear lower guide rollers into the gear rack on the Y-rail, then lower the robot slightly until both the front and rear gears make contact with the Y-gear rack. Do not allow the front and rear rollers to exit the gear rack. Exert slight pressure on the robot toward the left side of the library.

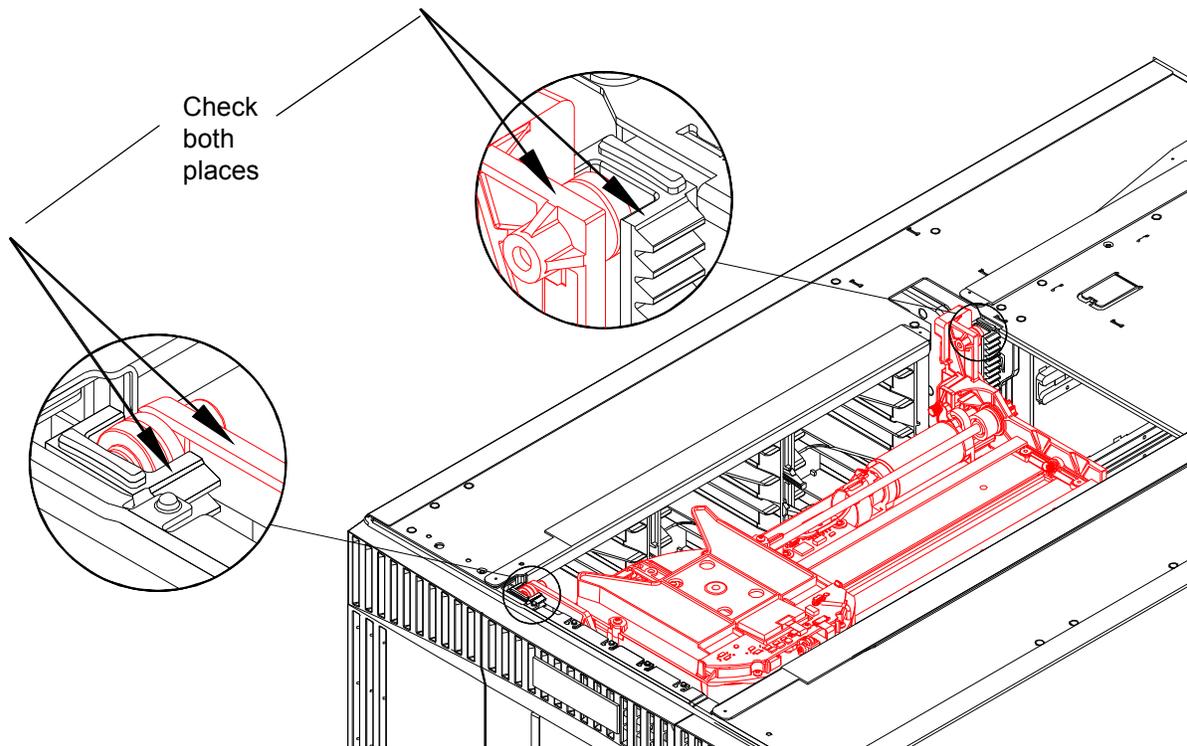
- 5 While supporting the center of the robot tray, slowly lower the robot until the top of the Y-climber front shelf mount is even with the front gear rack on the Y-rail. You may need to exert slight downward pressure on the robot to engage the gears in the gear rack and begin lowering the robot.

While continuing to hold the robot level, verify that the Y climber rear shelf mount is level with the rear gear rack on the Y-rail. Check both places indicated in the figure below. If it is level, continue to the next step. ***If it is off by more than 2 mm, the robot is NOT LEVEL. Disengage the robot from the gear rack and repeat the previous step.***

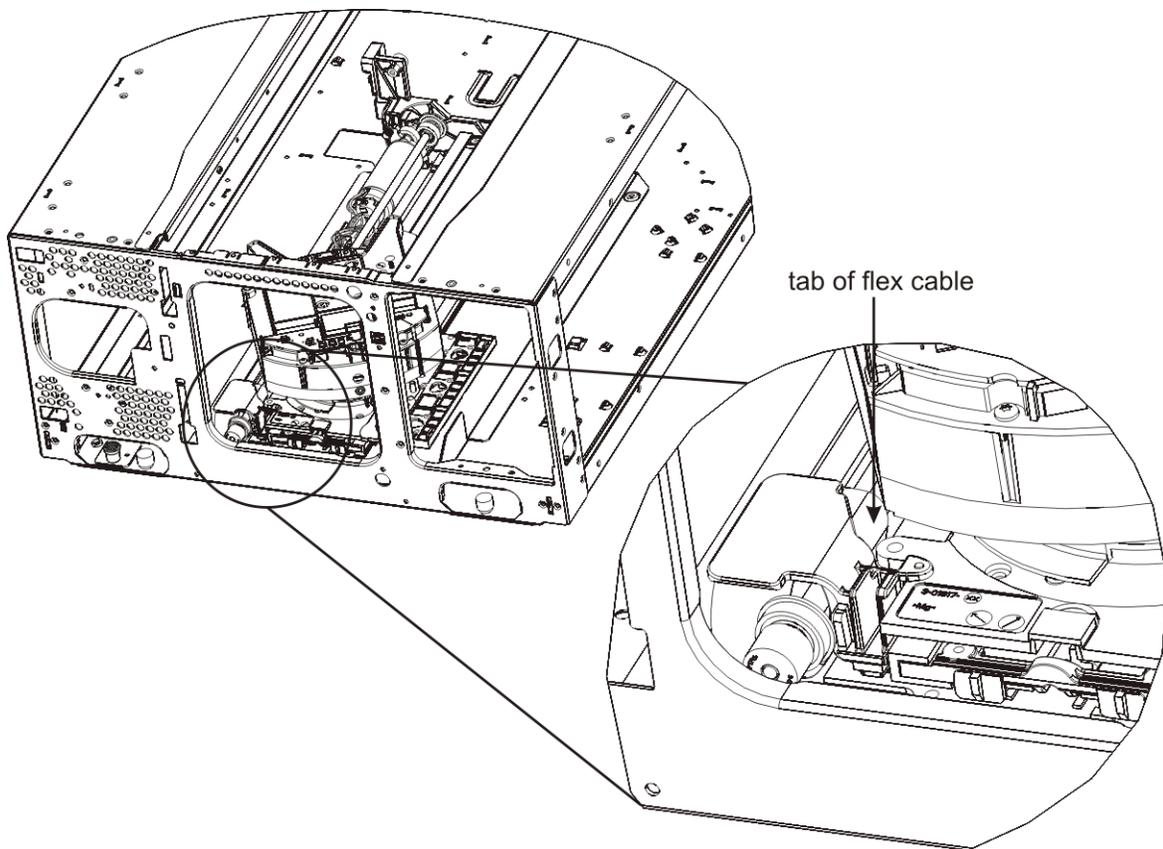
- 4 Disconnect the X-axis flex cable.

Using your hand, squeeze the tab of the flex cable, and then pull the cable out and up. The other end of the flex cable remains attached.

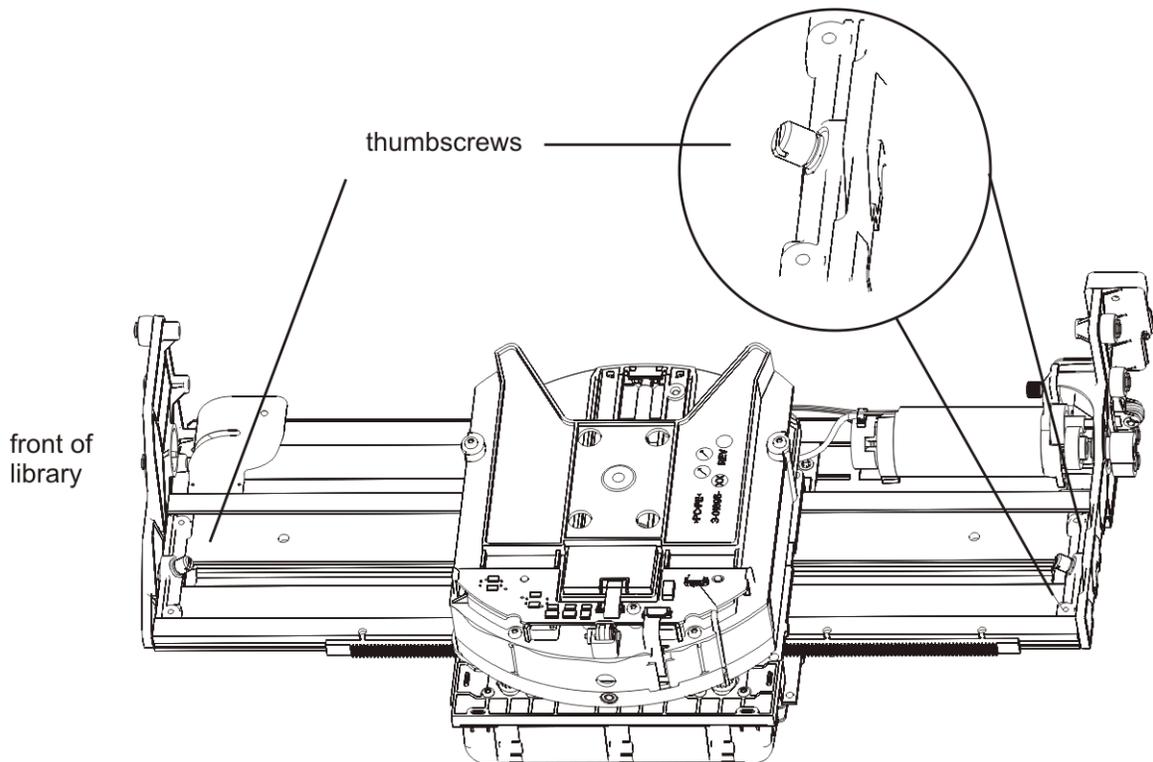
- 5 Using the T10 Torx screwdriver, loosen the thumbscrews located at the front and back of the picker assembly. You may need to slide the picker to access the thumbscrews.

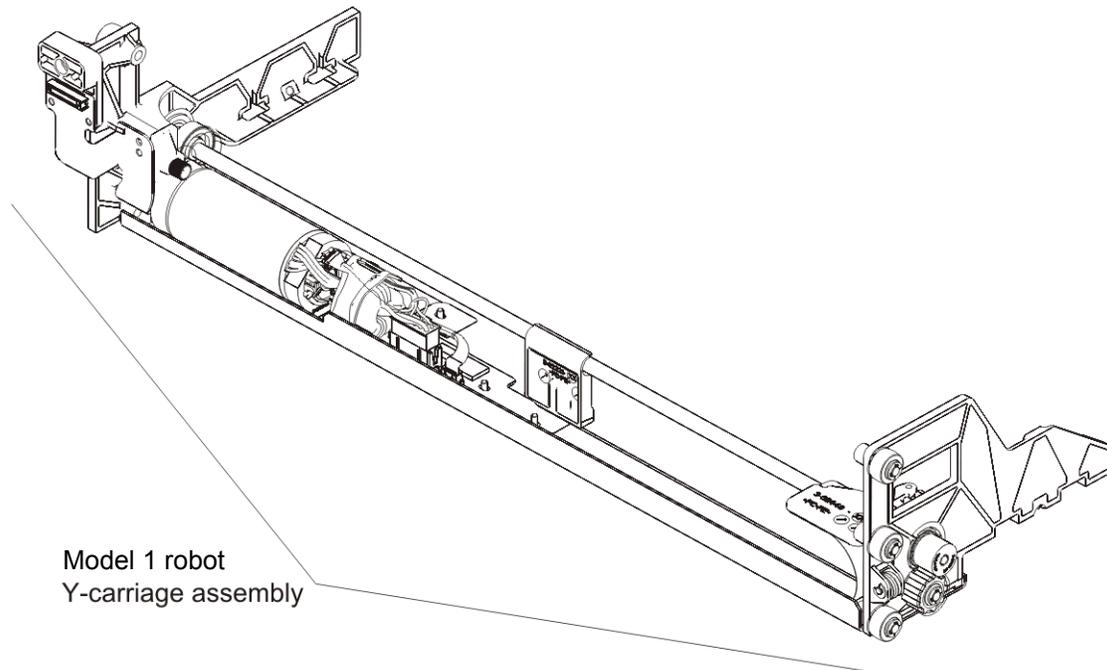
- 2 Separate the robot into the Y-carriage assembly and picker assembly. For details, see [Removing and Replacing the Model 1 Picker Assembly from the Y-Carriage Assembly Inside the Library](#) on page 176. (The instructions for removal are the same whether inside or outside of the library.)

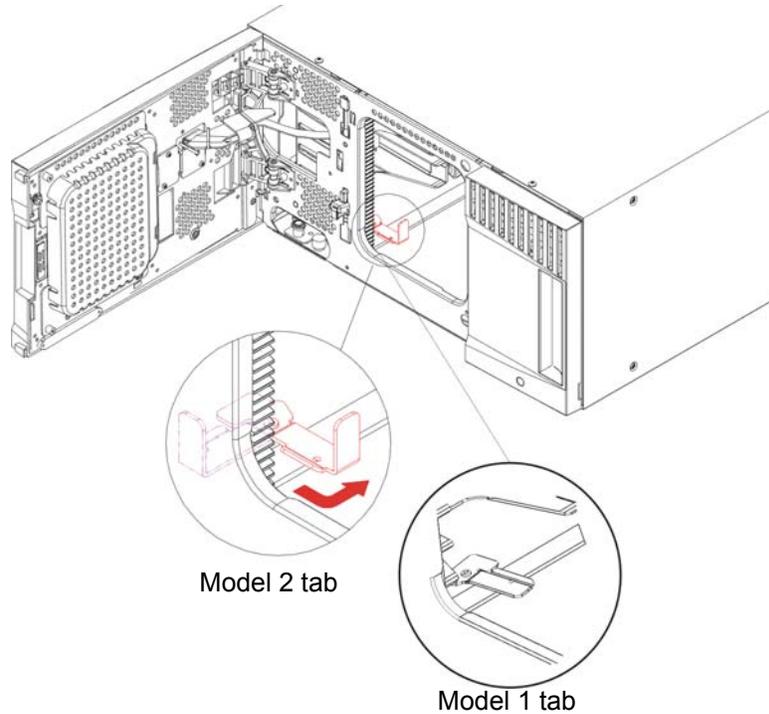
- c. After raising the robot assembly to the approximate middle of the 5U Library Control Module, hold it in place with one hand, and using your other hand, move the parking tab to the "parked" position (**Model 1 parking tab**: swivel toward you; **Model 2 parking tab**: move in a counter-clockwise direction). The metal parking tab is located at the bottom of column 1.

- d. Gently release the robot assembly to rest on the parking tab.

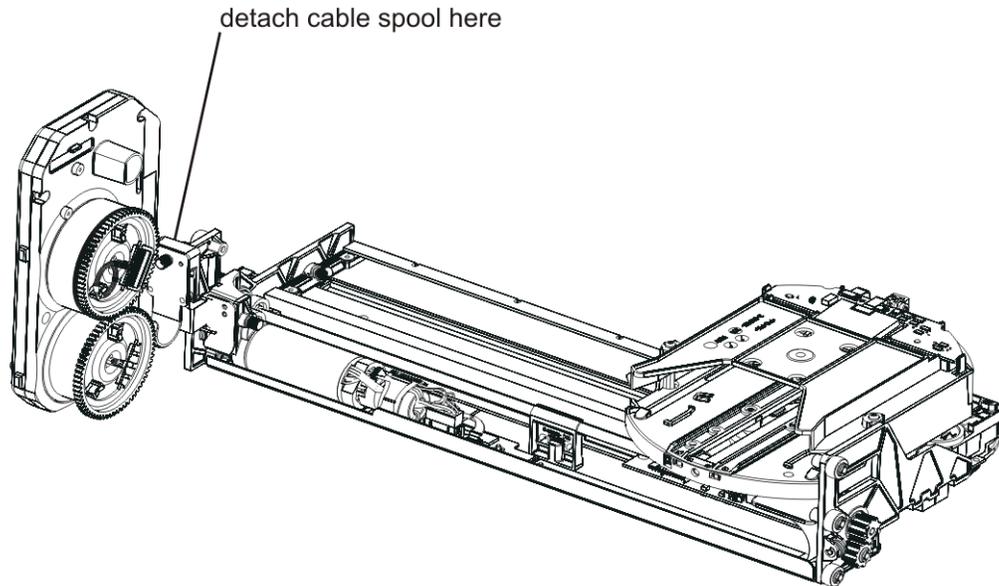
**Note** The figure below shows the Model 1 robot assembly and cable spool. If you are working on a Model 2 robot assembly and cable spool, they will look slightly different, but the way they attach together is the same.

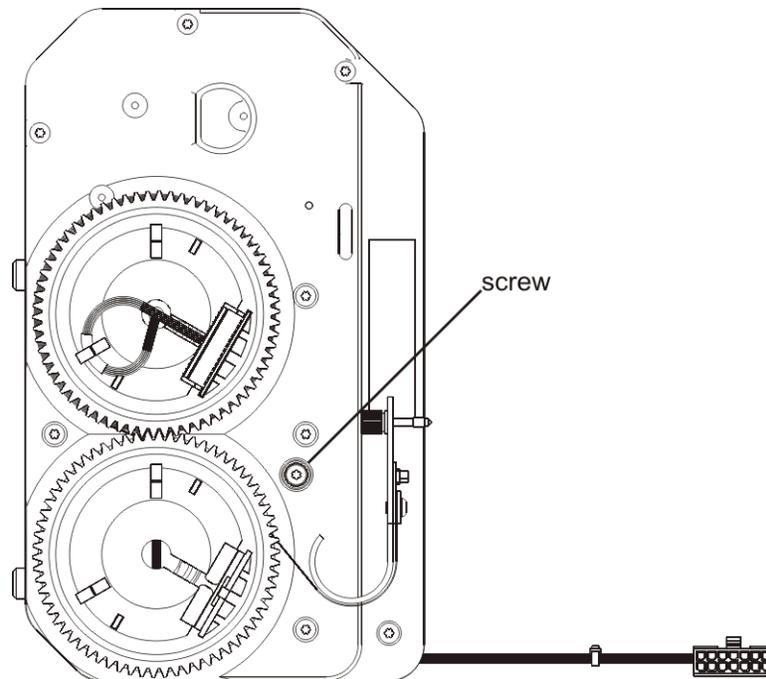
The external appearance of the cable spool on your library may differ slightly from the one shown in the figure below. However, the fit, function, and location of the screw and cable are the same.

- 5 Remove the cable spool.
 - a. Disengage the cable spool from the side of the module.
 - b. Remove the zip tie that secures the cable spool's cables to the chassis.
 - c. Reach through the drive bay to disconnect the cable spool cable that is attached to the rear of the module, behind the area where the picker assembly is usually positioned.
 - d. Remove the cable spool from the module.

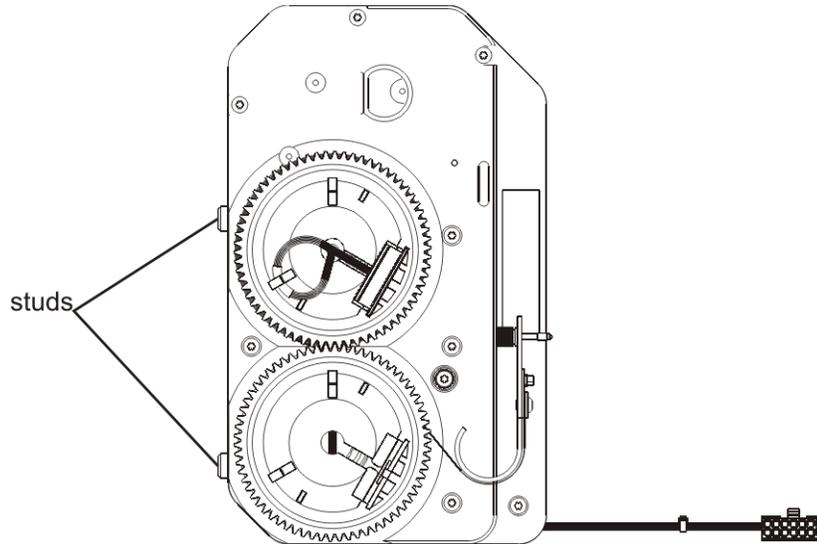
**Note** The external appearance of the cable spool on your library may differ slightly from the one shown in the figure below. However, the fit, function, and location of the studs, screw, and cable are the same.

- 2 Tighten the screw (which you loosened earlier) to secure the cable spool into place.
- 3 Reconnect the cable spool cable.
- 4 Attach a new zip tie to secure the cable spool's cables to the chassis. Securing the zip tie ensures that the cables are not accidentally damaged when you remove the tape drives and power supplies.
- 5 Replace the tape columns in their proper locations.

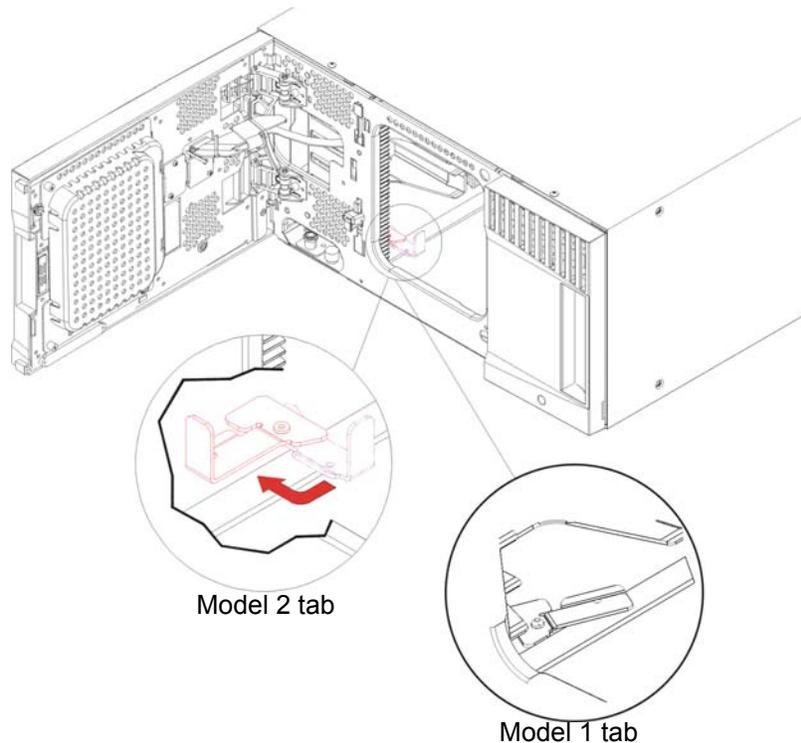
- b. With your free hand, move the parking tab to the "unparked" position so that it is removed completely from the interior of the module (**Model 1 parking tab**: swivel the parking tab away from you; **Model 2 parking tab**: move in a clockwise direction). When replaced correctly, the parking tab will not accidentally swivel into the path of the robot.
- c. Gently release the robot assembly. It will lower to the bottom module of the library.

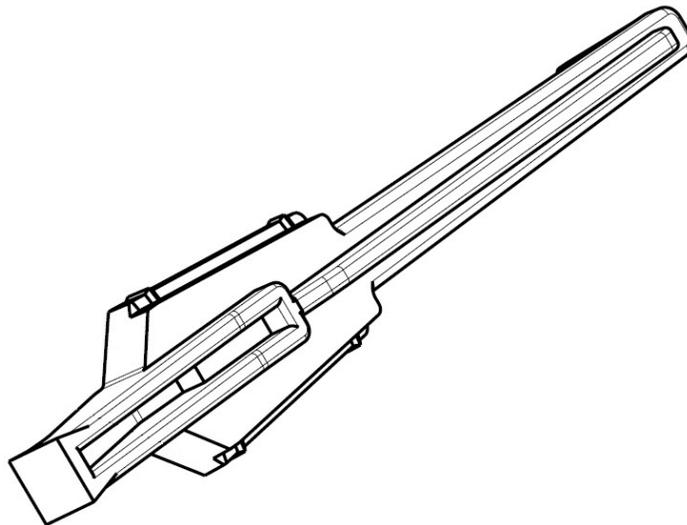
Figure 23 Fiducial

The fiducial is a removable white plastic part that snaps on to the column in a specific location. The robot scans the fiducials during initialization and other move operations so that it "knows" where tape cartridges belong. If there is a problem with a fiducial, you may need to replace the fiducial. To do this, you need to first remove the column (see [Removing and Replacing Columns](#) on page 189).

- 1 To place a fiducial on a column, slide it into the appropriate slot, and snap the tail of the fiducial over the post on the column.
- 2 See [Figure 24](#) for a drawing of a fiducial. See [Figure 24](#) for the locations of the fiducials in a 5U tape column. See [Figure 25](#) for the location of the fiducials in a 9U tape column.

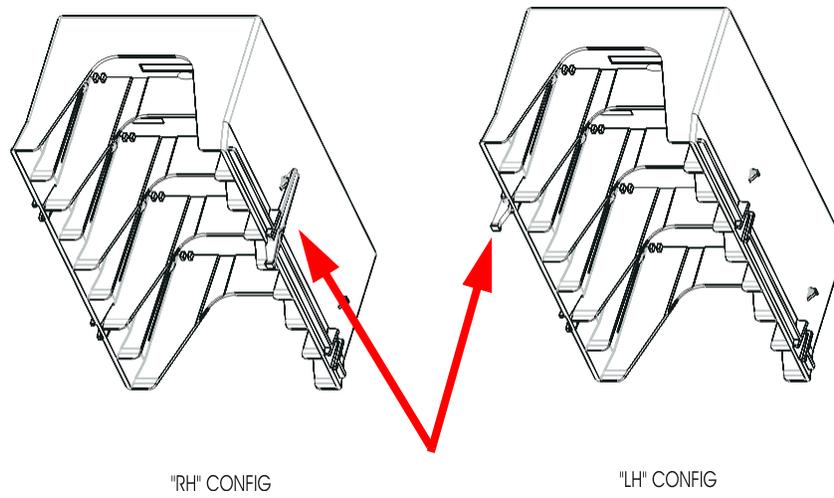
Figure 24 5U Control Module Fiducial Location

The location of the fiducial on a column is based entirely upon the location of the column in the library. Mis-application of these instructions will cause the robotic mechanism to be unable to put and get tape cartridges from the columns.

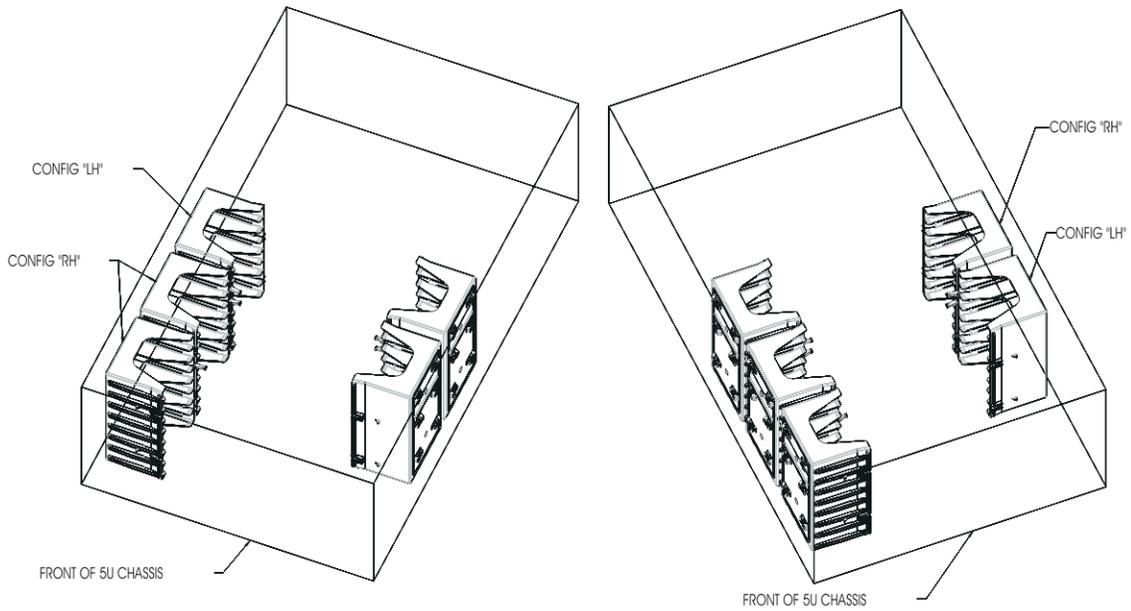
Figure 26 5U Control Module Column Location

- 3 See [Figure 26](#) for the locations of the columns in a 5U Library Control Module. See [Figure 27](#) for the locations of the columns in a 9U Library Expansion Module.

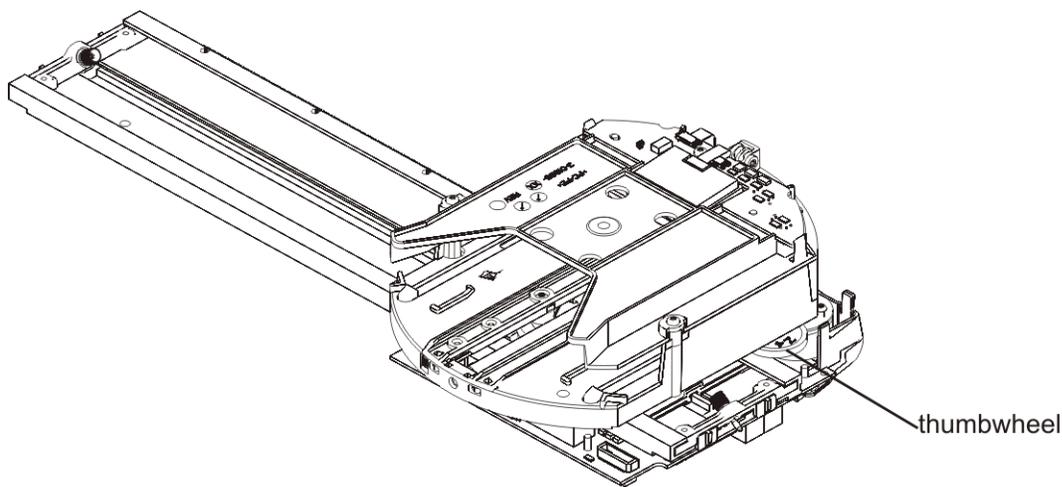
- 1 Take all library partitions offline.
- 2 Open the library main access doors.
- 3 Rotate the picker assembly by hand, so that the opening faces the drives.
- 4 Use the gear thumbwheel in the rear of the picker assembly base to manually slide the tape cartridge out of the picker assembly toward the tape drives.

Problem: The library has a tape in the Picker Assembly, but cannot recover without user intervention to remove the tape cartridge.

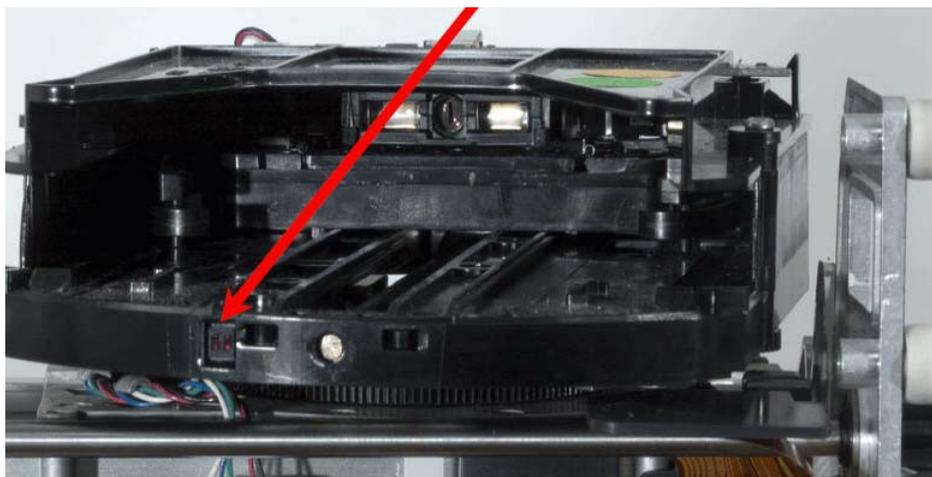
- c. Open and fully extend the bottom I/E station door, then reach through the main access door and locate the picker assembly's recessed calibration sensor in the picker base, just slightly to the right of the picker's center line. Gently wipe the surface of the calibration sensor, using a soft, lint-free cloth.

Note to Service: The picture below shows the location of the calibration sensor. If you are guiding a customer by phone, you may want to copy the picture and e-mail it to them.

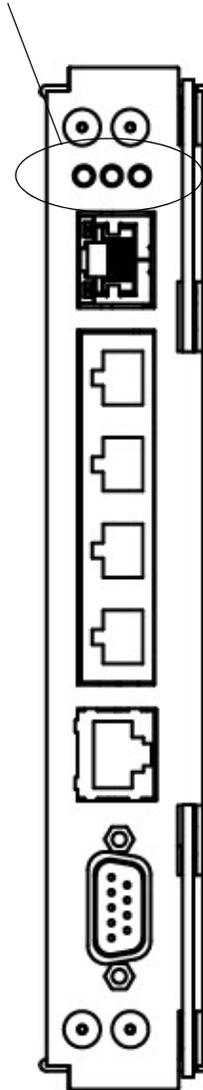
Library Control Blade
Status LEDs

- Left = Blue
- Middle = Amber
- Right = Green

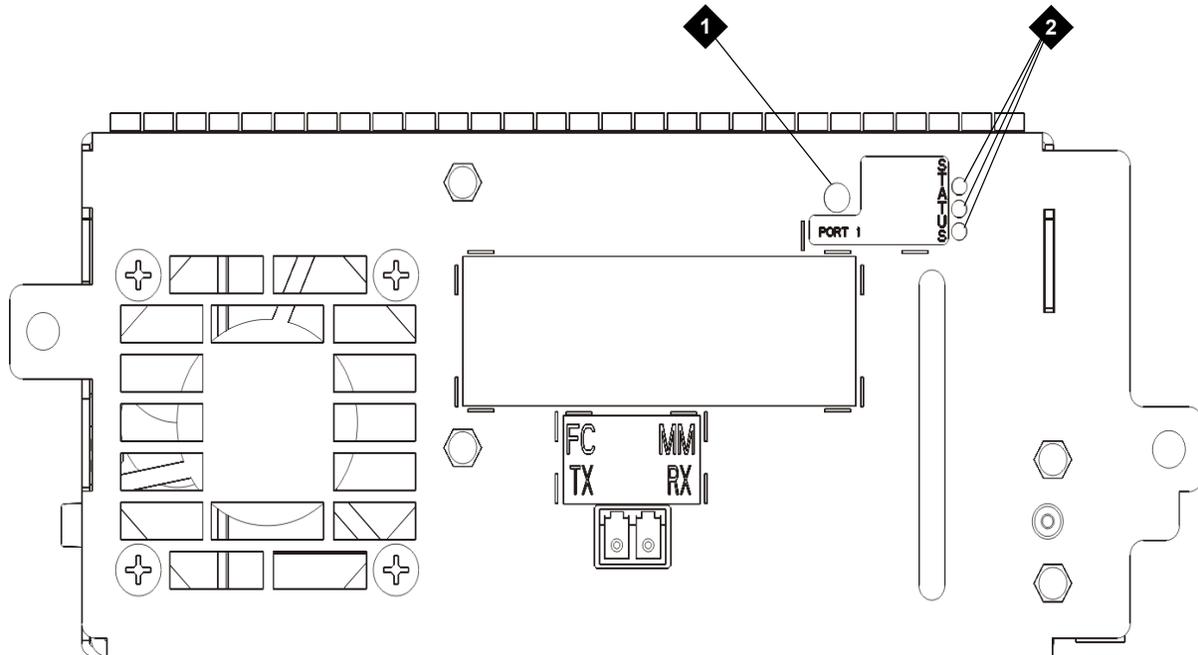
Figure 29 Location of Tape Drive LEDs

[Figure 29](#) shows where the tape drive LEDs and the FC port link LED are located.

1 FC port link LED

2 Tape drive LEDs

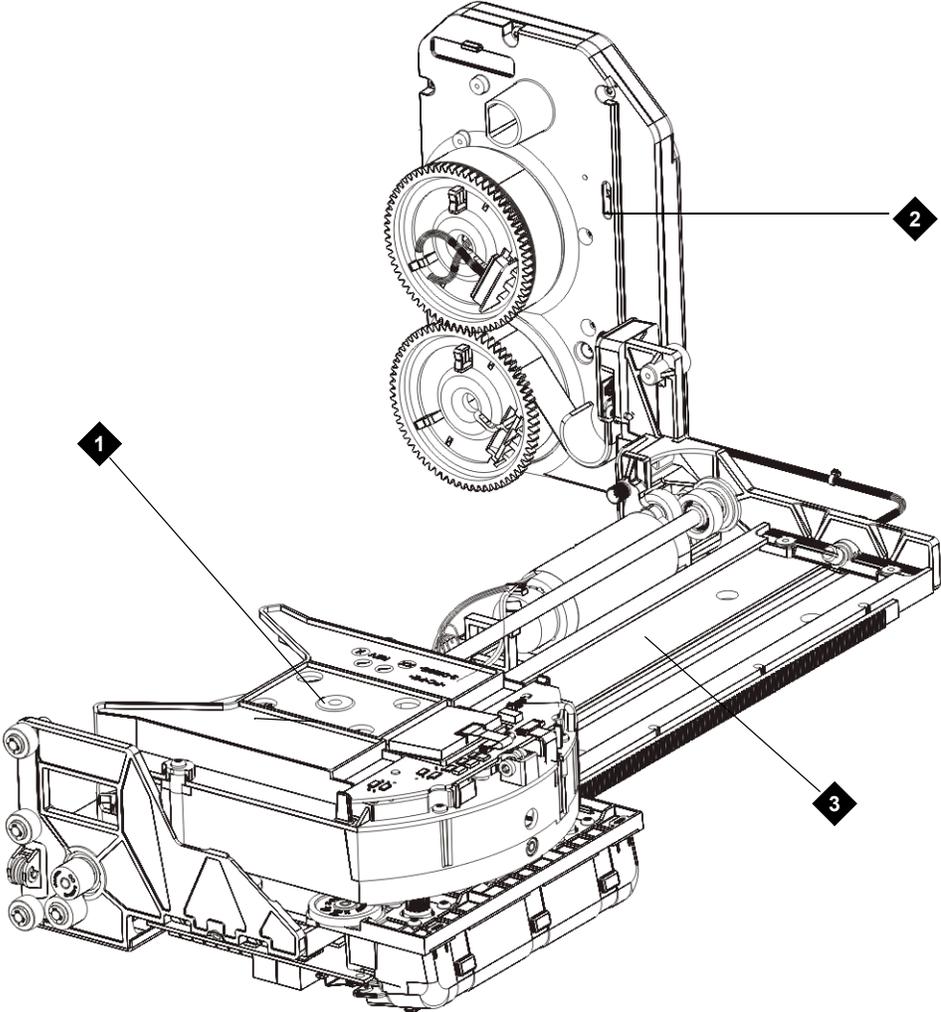
Figure 40 Model 1 Robot Assembly with Original Cable Spool

Both robot assemblies are shown below. Note that the actual cable spool may look slightly different from the one shown in [Figure 40](#).

| 1 | Picker | 3 | Y-carriage assembly |

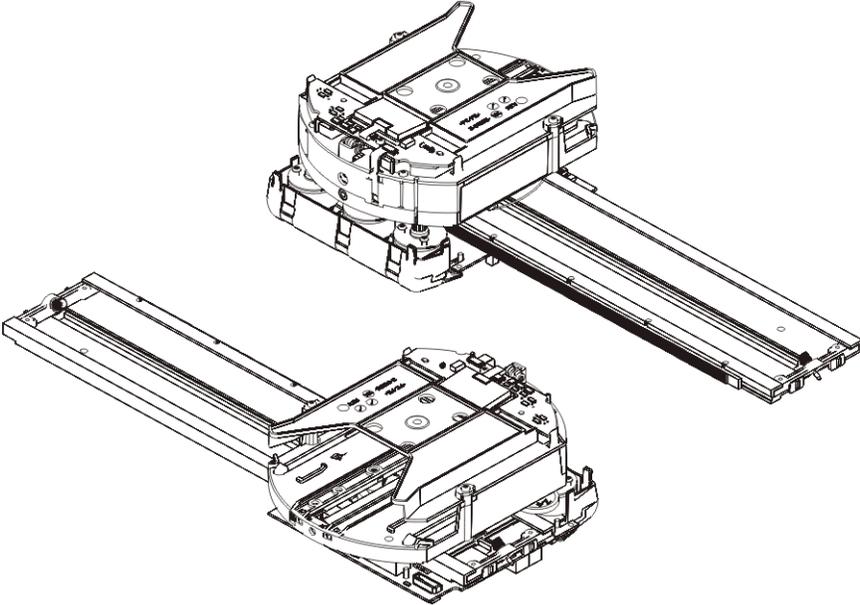
Figure 42 Model 1 Picker Assembly

As of November 2008, the picker assembly changed as part of the robot change. The two pickers are identified as follows:

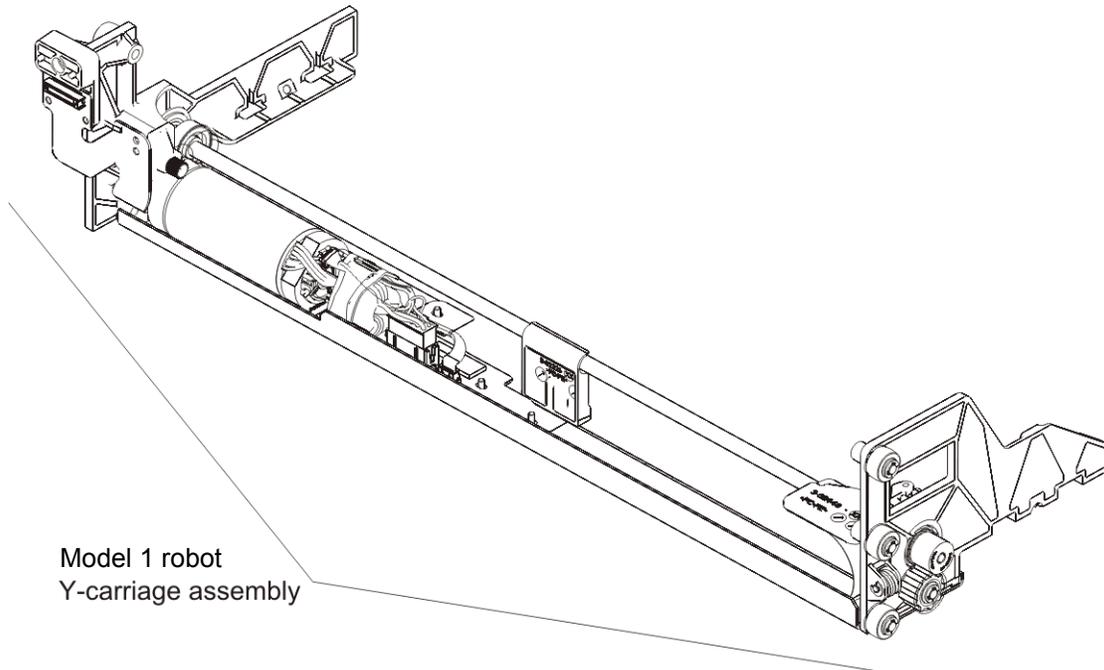
Model 1 Y-carriage Assembly

As of November 2008, the Y-carriage assembly changed as part of the robot change. The Model 2 Y-carriage assembly is included as part of the Model 2 Robot Assembly (see [Figure 41](#) on page 444).

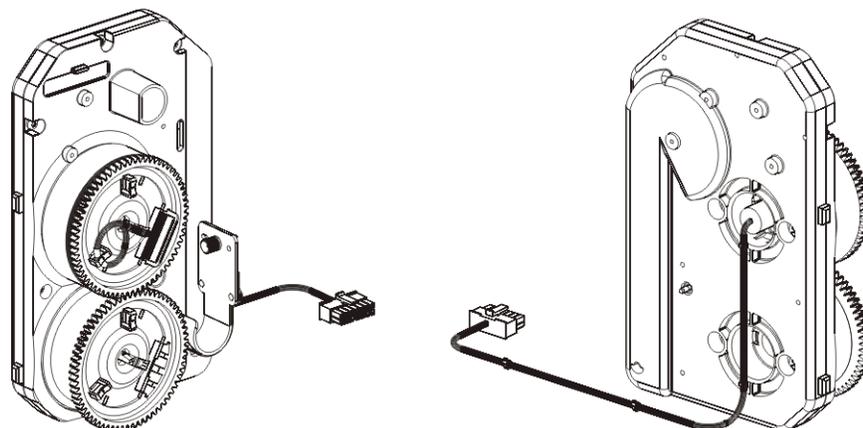
Figure 44 Original Cable Spool.

On August 27, 2007, the cable spool changed. The cable spools look very similar to each other and function exactly the same way. The gears are different sizes, but the location of the components is the same.

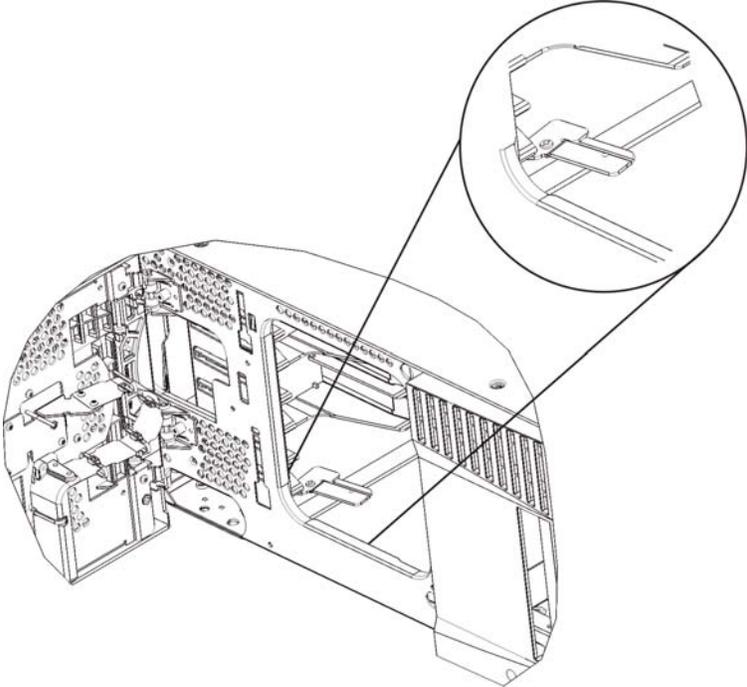
Figure 46 Model 1 Parking Tab, Parked

As of November 2008, the robot assembly was changed. This change affected the parking tab. The Model 2 robot has spring-loaded roller sliders that extend below the Y-carriage assembly and which could be caught and bent on the lower chassis when removing the control module if the old parking tab was used. The new parking tab sticks up 1 inch vertically and holds the robot up high enough that the roller sliders will not get caught. Also, the tab swivels in the opposite direction. The two parking tabs are identified as follows:

Feature	Model 1 Parking Tab	Model 2 Parking Tab
Color	Grey	Black
Shape	Flat	Vertical
Movement	Clockwise to hold-robot position	Counter-clockwise to hold-robot position

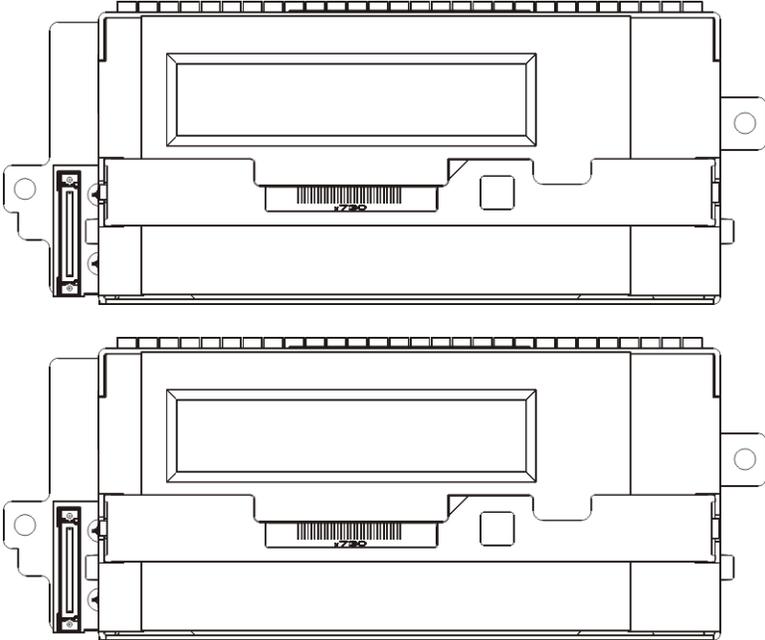
Figure 51 Tape Drive, Front View

In this document, *tape drive* is used as a collective term to describe the universal drive sled (UDS) and the tape drive itself. The UDS houses the tape drive. The tape drive itself is also sometimes called the *drive brick* to differentiate it from the *drive sled*.

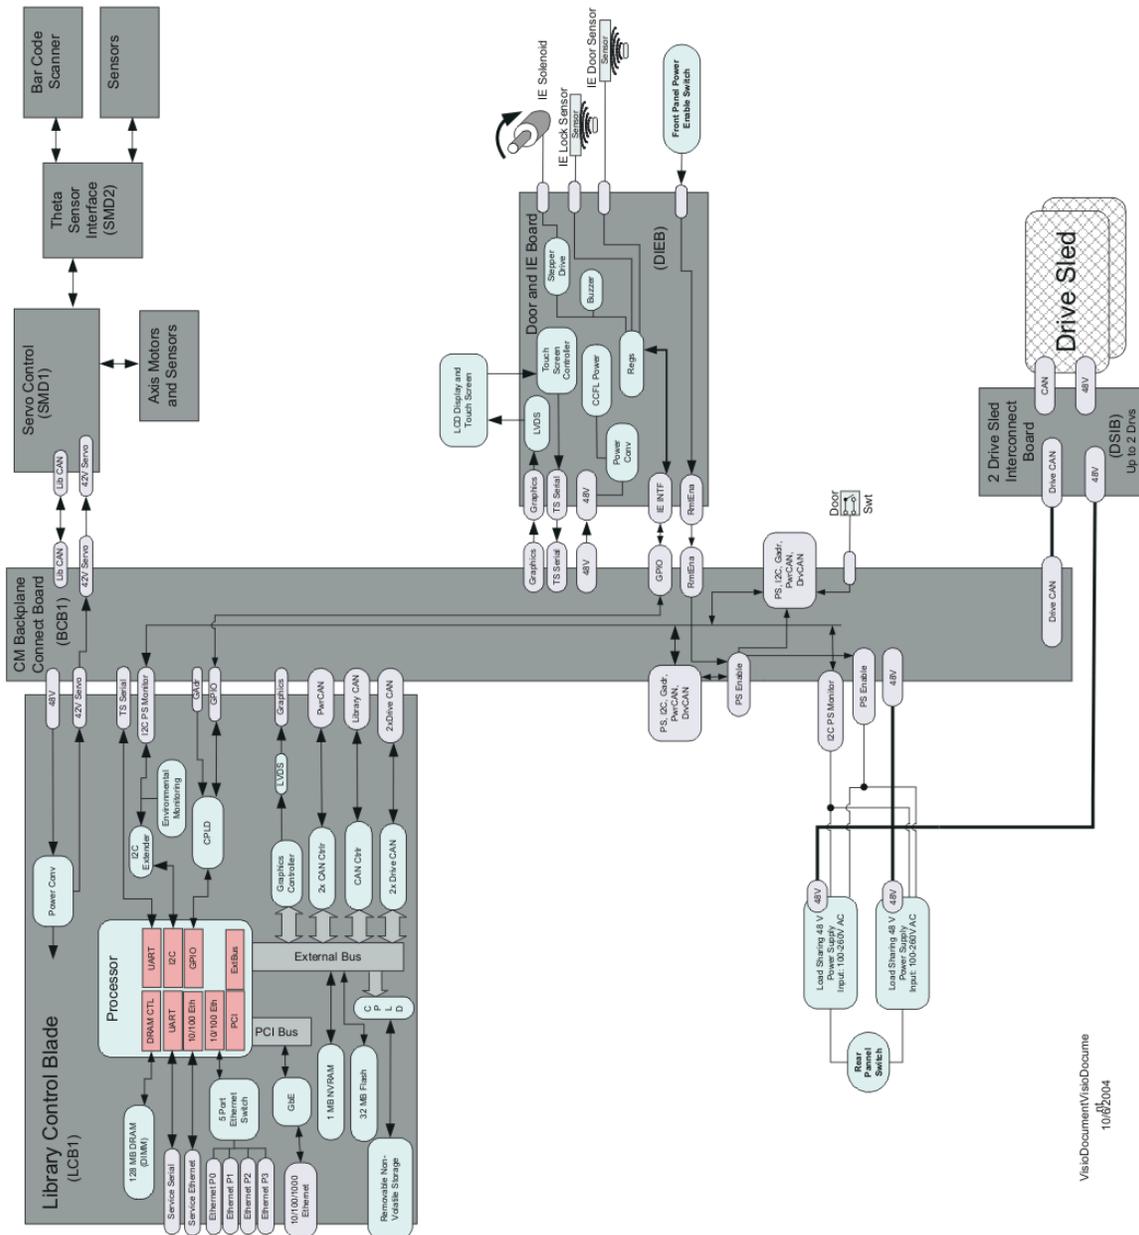
Figure 58 Electrical System, 5U Library Control Module

The following diagrams illustrate the library's main connection points, which enable the library to communicate with components within the library, and with other servers on the SAN. Become familiar with the location of each of these connection points, and how they may be configured for use.
