BladeCenter JS23 and BladeCenter JS43  
Type 7778  
Problem Determination and Service Guide

BladeCenter JS23 and BladeCenter JS43

Type 7778

Problem Determination and Service Guide

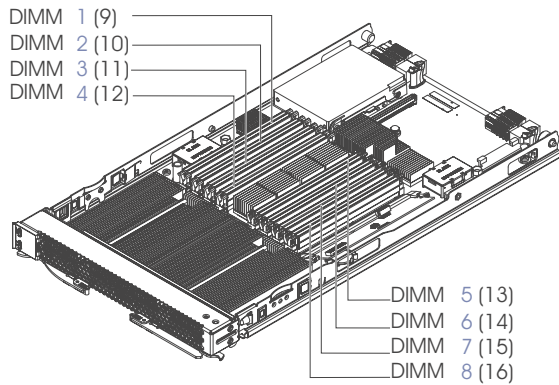
Figure 1. DIMM connectors. Base unit connectors (followed by expansion unit connectors in parentheses)

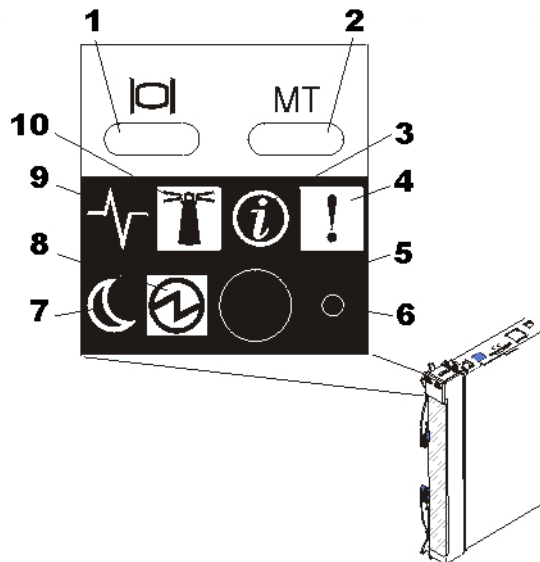
**Note:** Figure 2 shows the control-panel door in the closed (normal) position. To access the power-control button, you must open the control-panel door.

Figure 2. Blade server control panel buttons and LEDs

**1 Keyboard/video select button:** When you use an operating system that supports a local console and keyboard, press this button to associate the shared BladeCenter unit keyboard and video ports with the blade server.

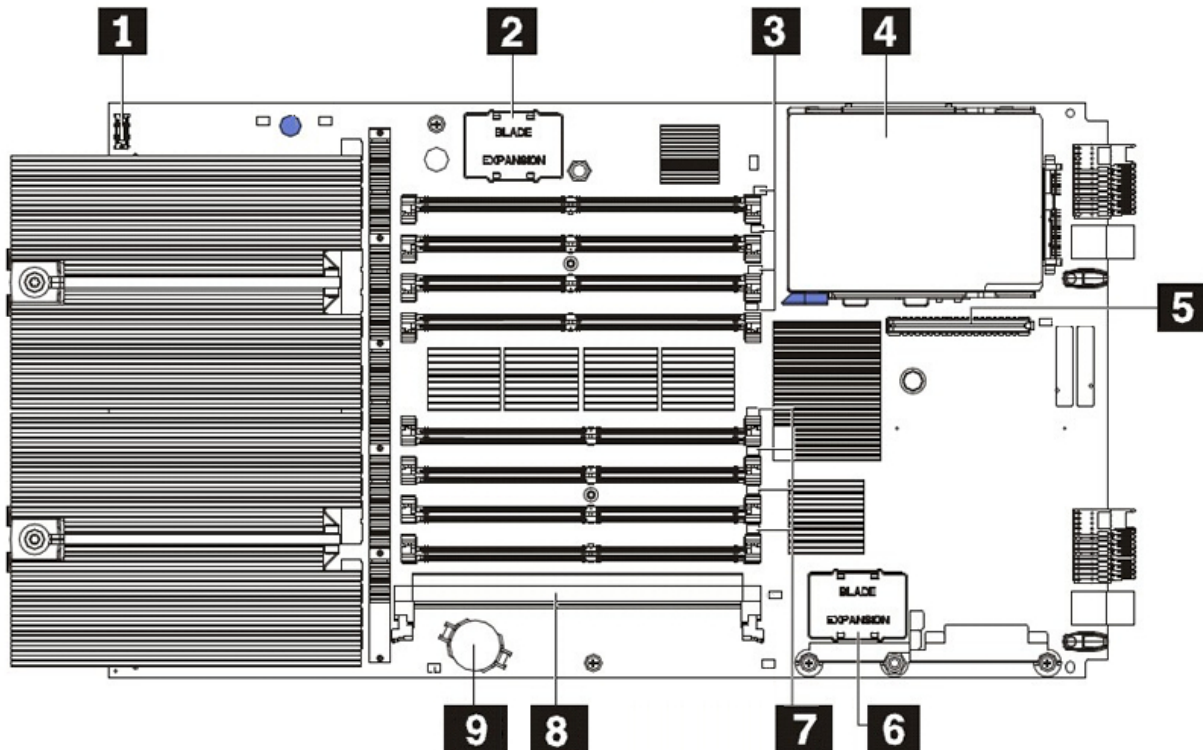
Figure 3 shows the connectors on the base unit system board in the blade server.

Figure 3. JS23 system-board connectors, which are also the JS43 base unit system-board connectors

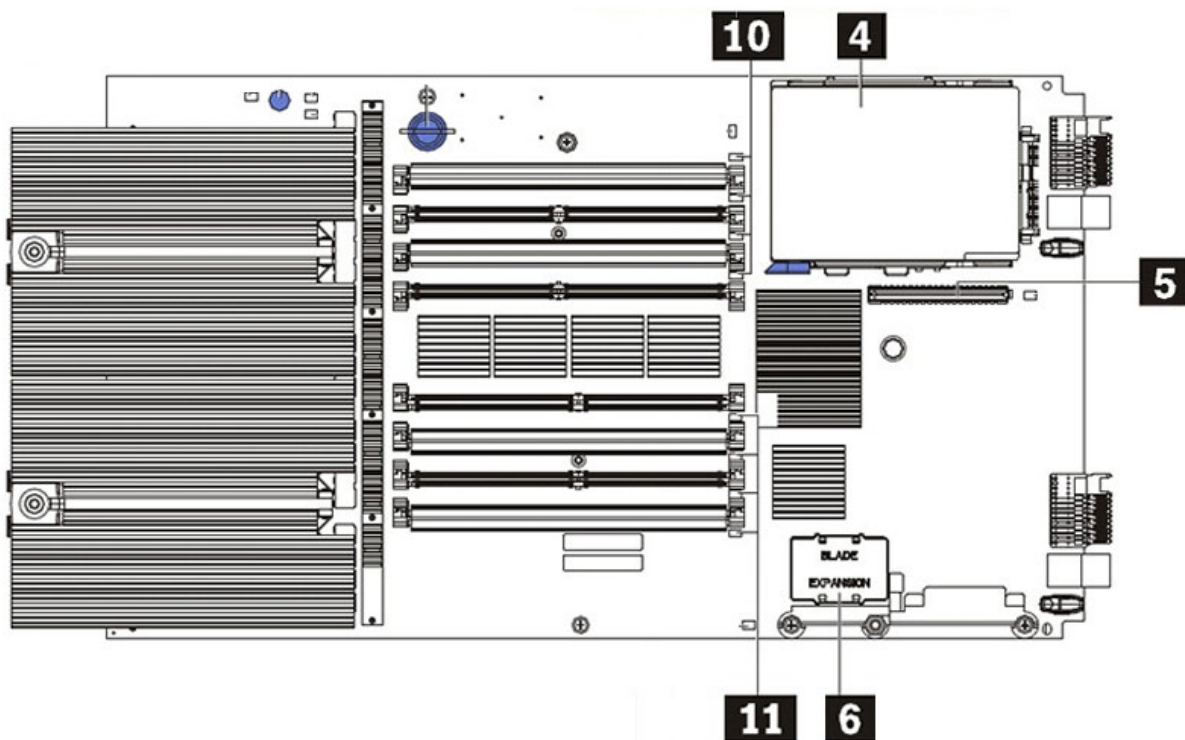
Figure 4 on page 12 shows the connectors on the expansion unit system board in the blade server.

Figure 4. JS43 expansion unit system-board connectors

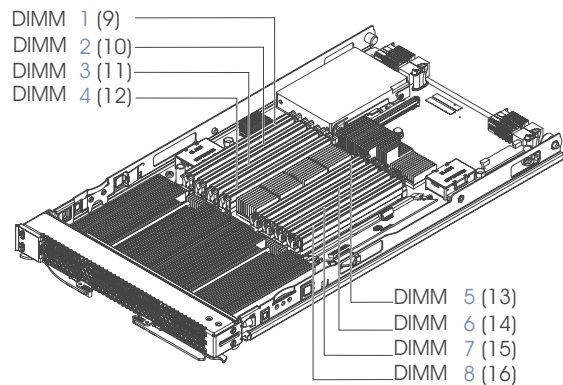
Figure 5 on page 13 shows individual DIMM connectors. DIMM connectors 1-8 are in the JS23 blade server and in the base unit planar of the JS43 blade server. DIMM

connectors 9-16 are in the expansion unit.

Figure 5. DIMM connectors. Base unit connectors (followed by expansion unit connectors in parentheses)

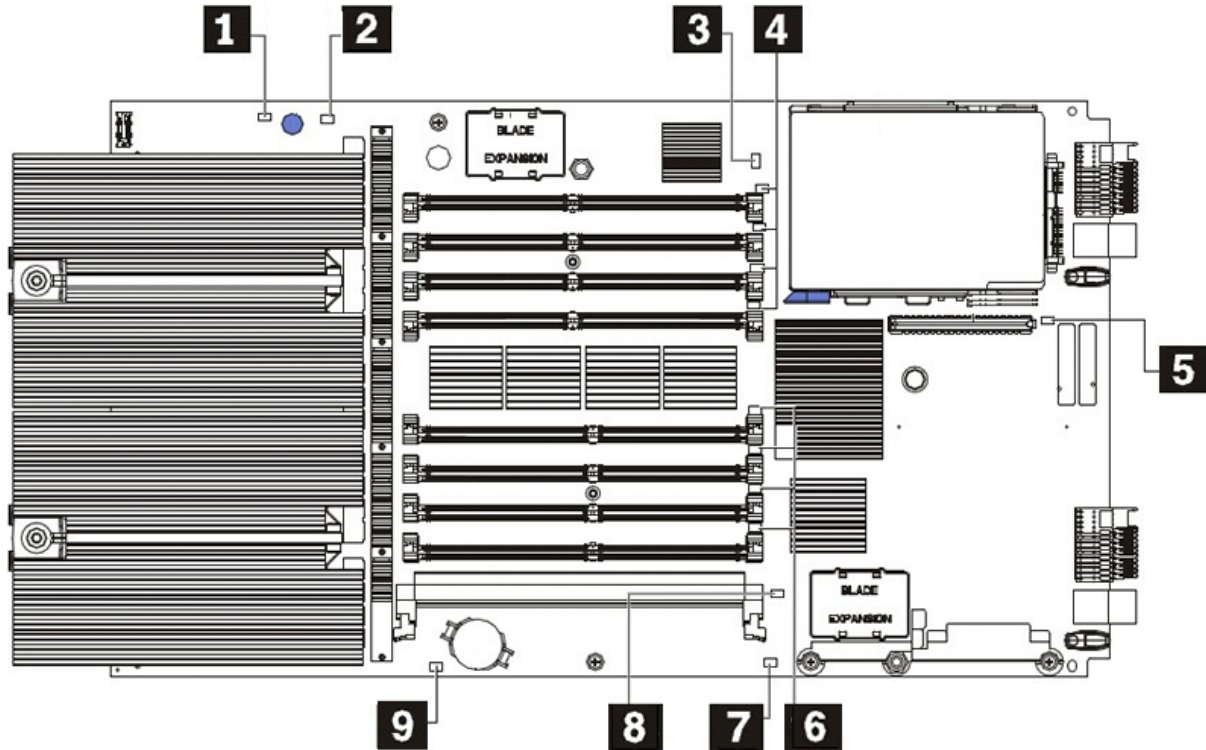
Figure 6 on page 14 shows LEDs on the base planar.

Figure 6. LED locations on the system board of the JS23 blade server, which is also the base system board of the JS43 blade server

Remove the blade server from the BladeCenter unit, open the cover, press the blue button to see any error LEDs that were turned on during error processing, and use Figure 6 on page 14 to identify the failing component.

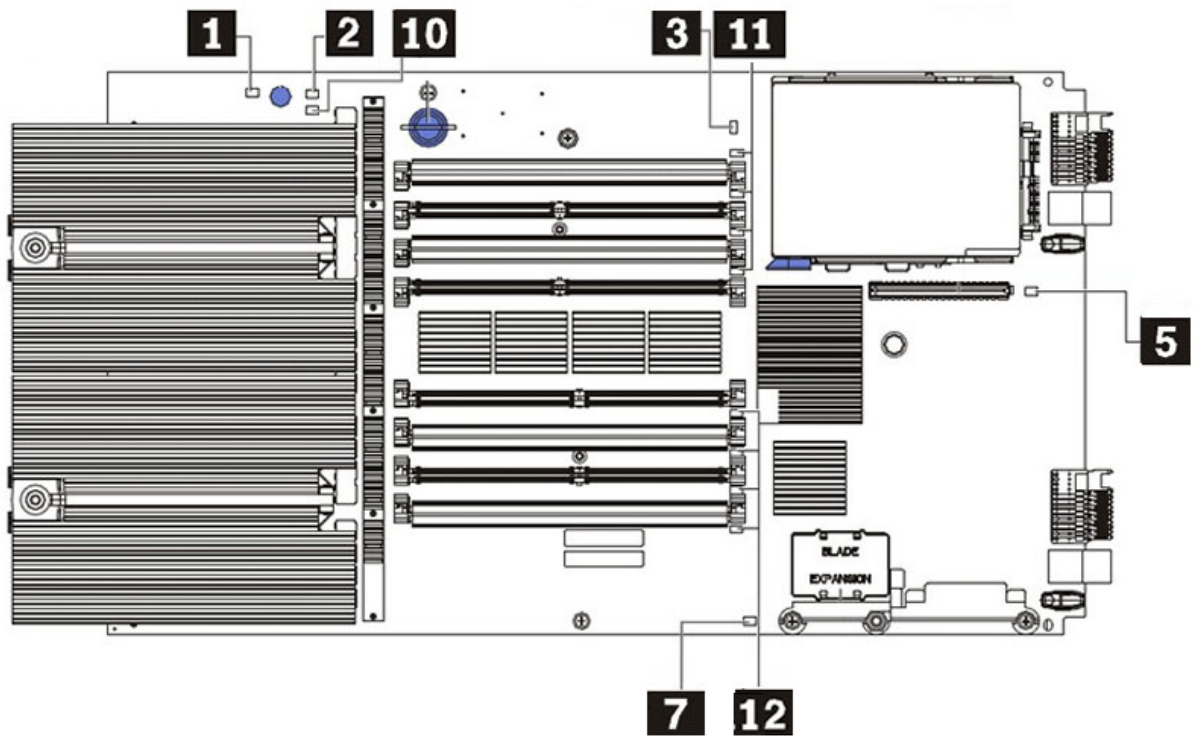
Figure 7 on page 15 shows LEDs on the base planar.

Figure 7. LED locations on the system board of the JS43 expansion unit

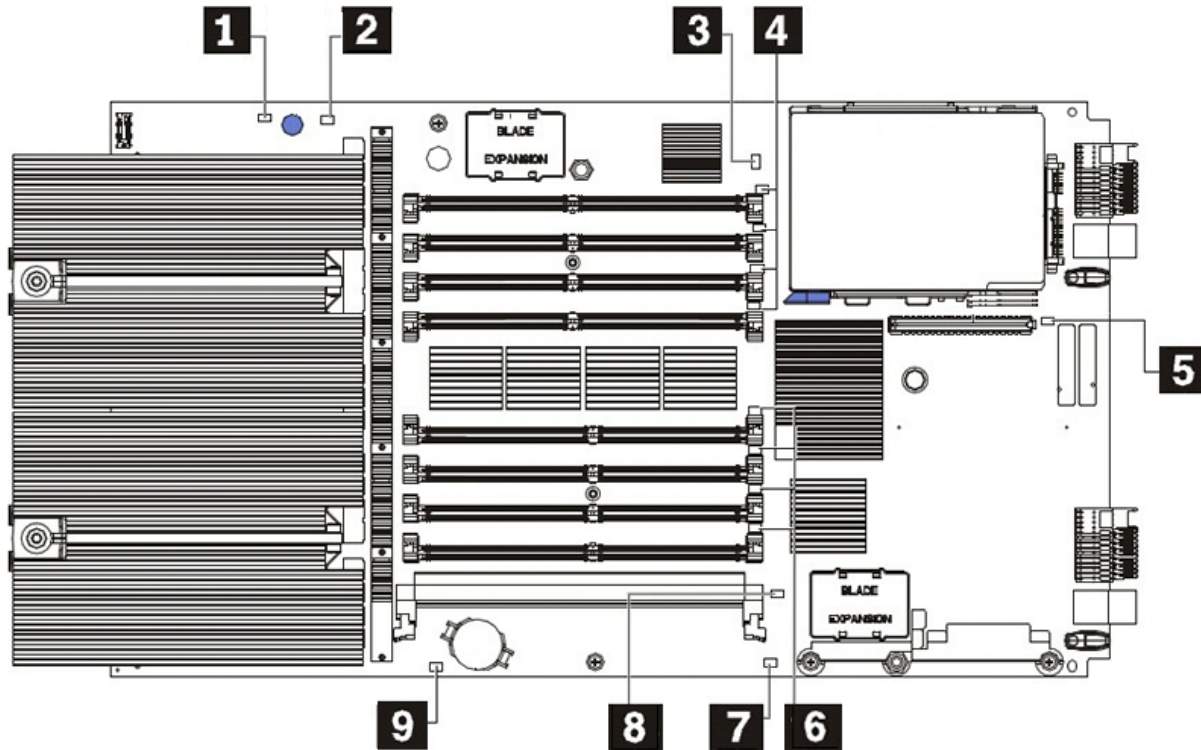
Figure 8 shows the locations of error LEDs on the base unit system board:

Figure 8. Light path diagnostic LEDs on the base unit system board

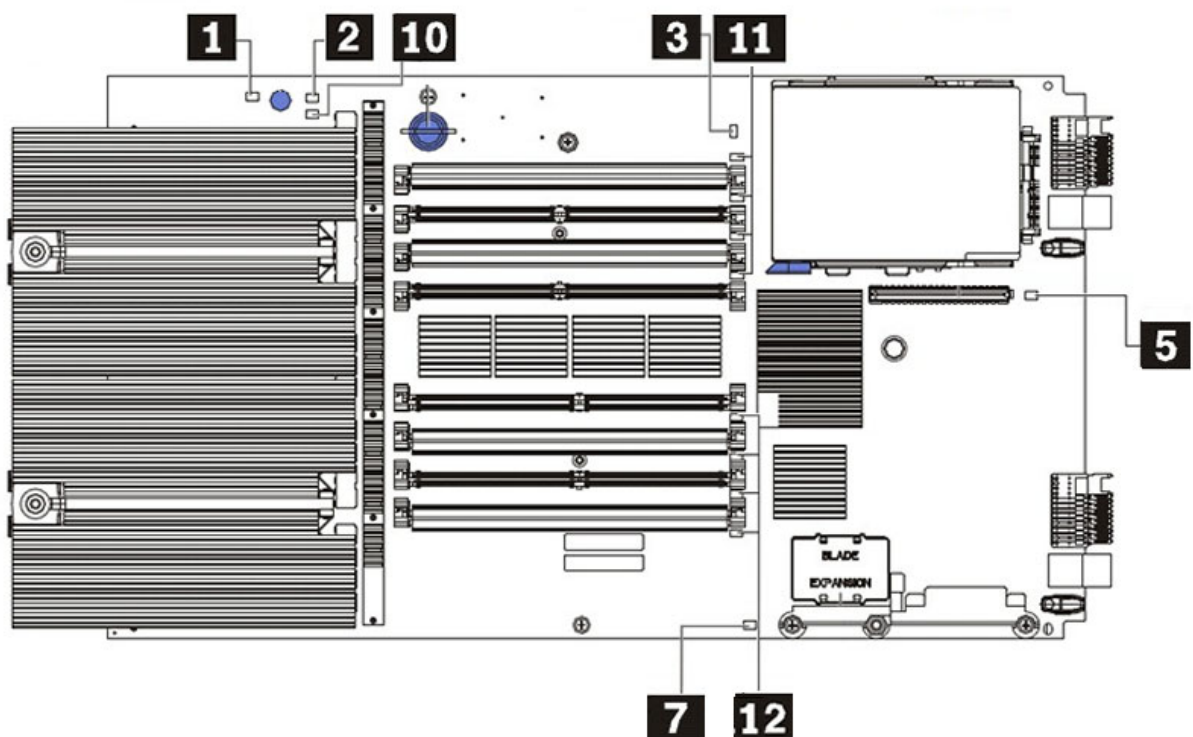
Figure 9 on page 231 shows the locations of error LEDs on the expansion unit system board:

Figure 9. Light path diagnostic LEDs on the expansion unit system board

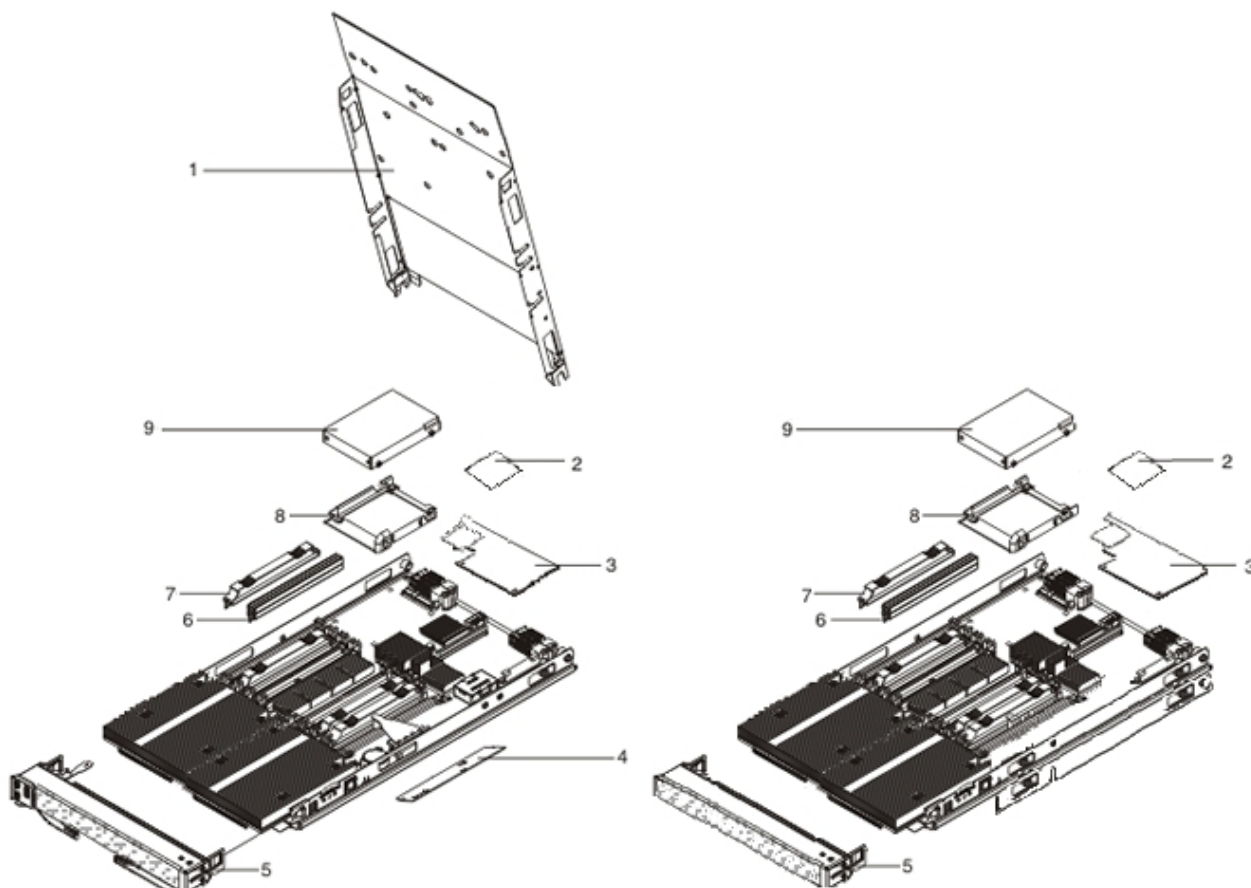
Figure 10 shows replaceable components that are available for the JS23 or JS43 blade server.

Figure 10. Parts illustration, Type 7778. JS23 base unit with cover, followed by JS43 expansion unit

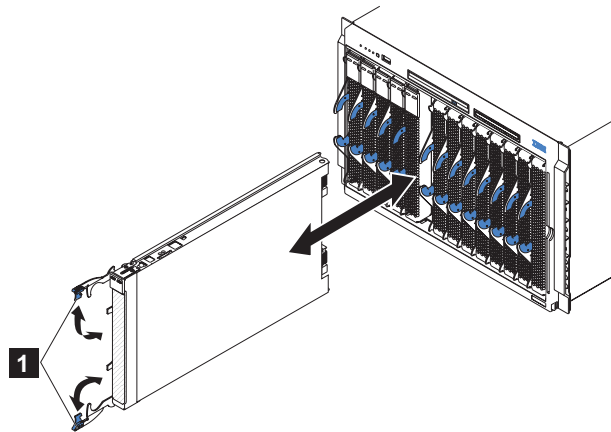
Figure 11. Removing the blade server from the BladeCenter unit

4. Wait at least 30 seconds for the hard disk drive to stop spinning.
5. Open the two release handles, as shown by **1** in Figure 11 on page 255. The blade server moves out of the bay approximately 0.6 cm (0.25 inch).
6. Pull the blade server out of the bay. Spring-loaded doors farther back in the bay move into place to cover the bay temporarily.
7. Carefully lay the blade server on a flat, static-protective surface, with the cover side up.
8. Place either a blade filler or another blade server in the bay within 1 minute. The recessed spring-loaded doors move out of the way as you insert the blade server or filler blade.

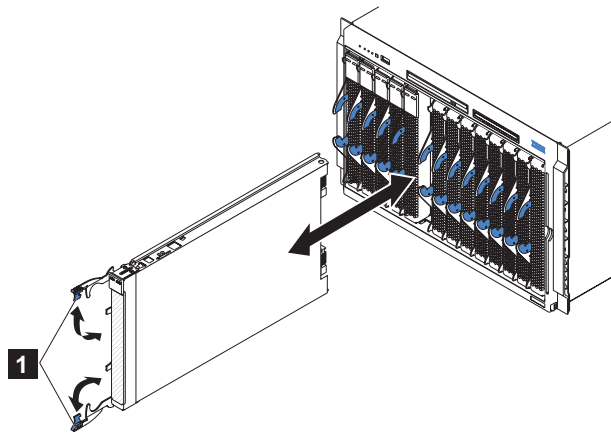
Figure 12. Installing the blade server in a BladeCenter unit

5. Verify that the release handles on the blade server are in the open position (perpendicular to the blade server, as shown in **1** in Figure 12 on page 256).

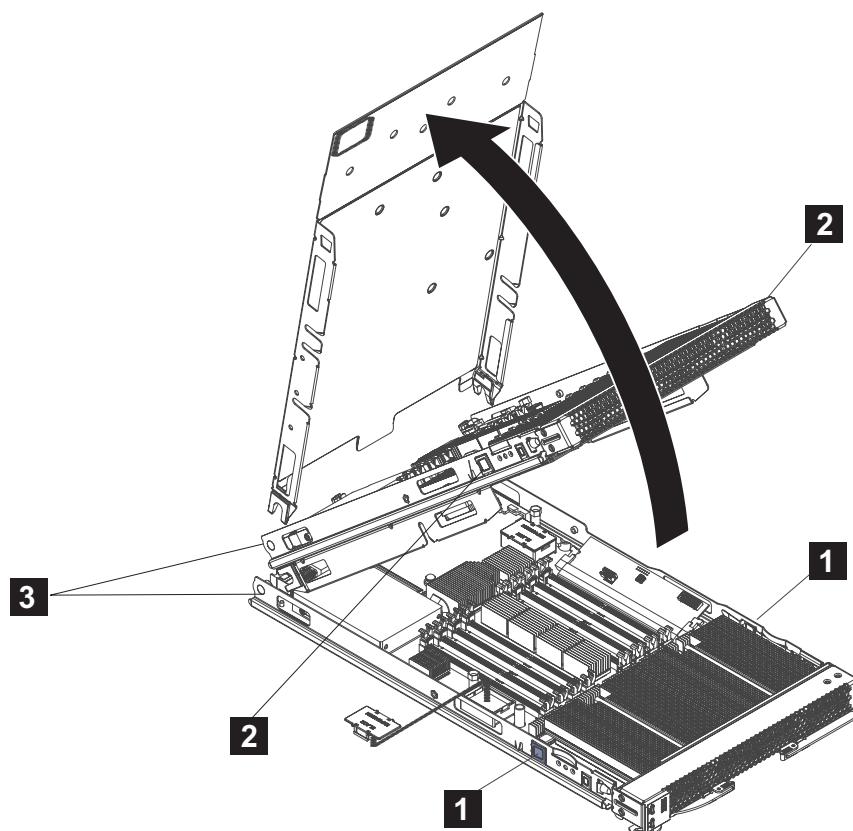
Figure 13. Removing the cover

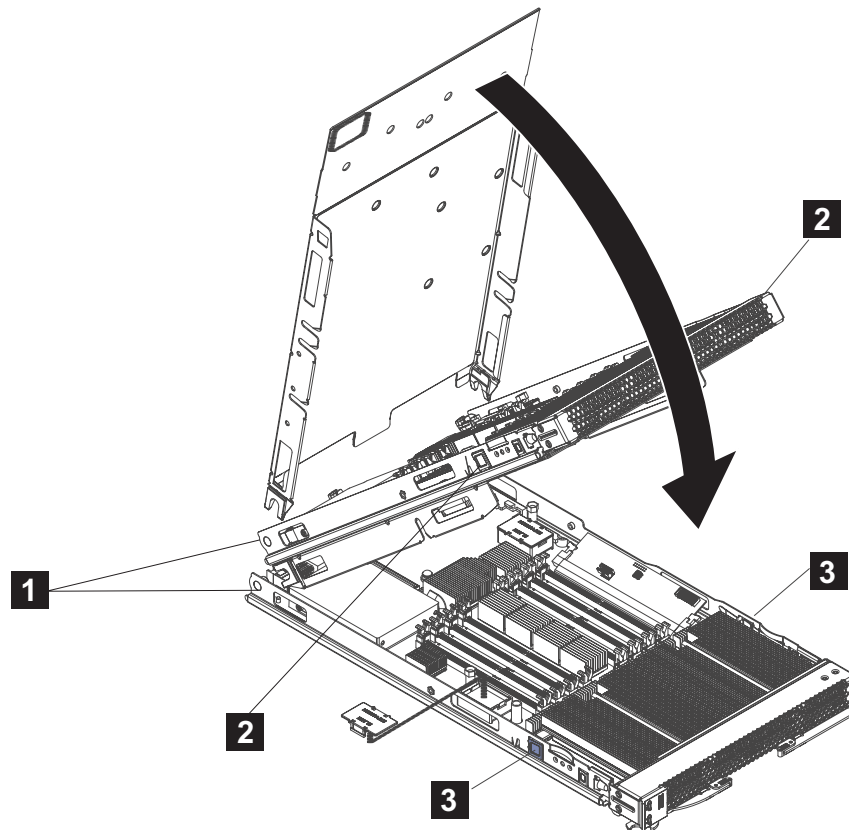
Figure 14. Installing the cover

1. Read “Safety” on page v and the “Installation guidelines” on page 253.
2. Lower the cover so that the slots at the rear slide down onto the pins ( **1** in Figure 14 on page 260) at the rear of the blade server. Before you close the cover, verify that all components are installed and seated correctly and that you have not left loose tools or parts inside the blade server.
3. Pivot the cover to the closed position until the releases (as shown by **2** in the expansion unit and by **3** in the base unit) click into place in the cover.
4. Install the blade server into the BladeCenter unit. See “Installing the blade server in a BladeCenter unit” on page 256.

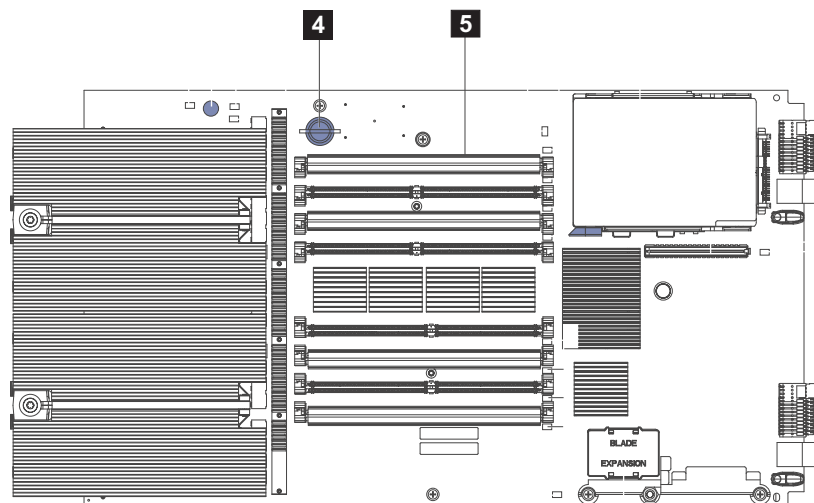
1. Read “Safety” on page v and the “Installation guidelines” on page 253.
2. Shut down the operating system, turn off the blade server, and remove the blade server from the BladeCenter unit. See “Removing the blade server from a BladeCenter unit” on page 255.
3. Carefully lay the blade server on a flat, static-protective surface, with the cover side up.
4. Open and remove the blade server cover. See “Removing the blade server cover” on page 258.
5. To access the expansion blade retention thumb screw (shown by **4** in Figure 15), remove the DIMM in DIMM slot 1 ( **5** ), as described in “Removing a memory module” on page 269.

Figure 15. Expansion blade DIMM 1 slot and the expansion blade retention screw

6. Use your thumb to back out the expansion blade retention thumb screw ( **4** ) by rotating the screw counterclockwise until the connection between the expansion unit and the base unit is loose and the expansion unit is fully separated from the base unit.
7. Pivot the expansion unit ( **1** in Figure 16) up on the cover pins of the base unit ( **2** ).

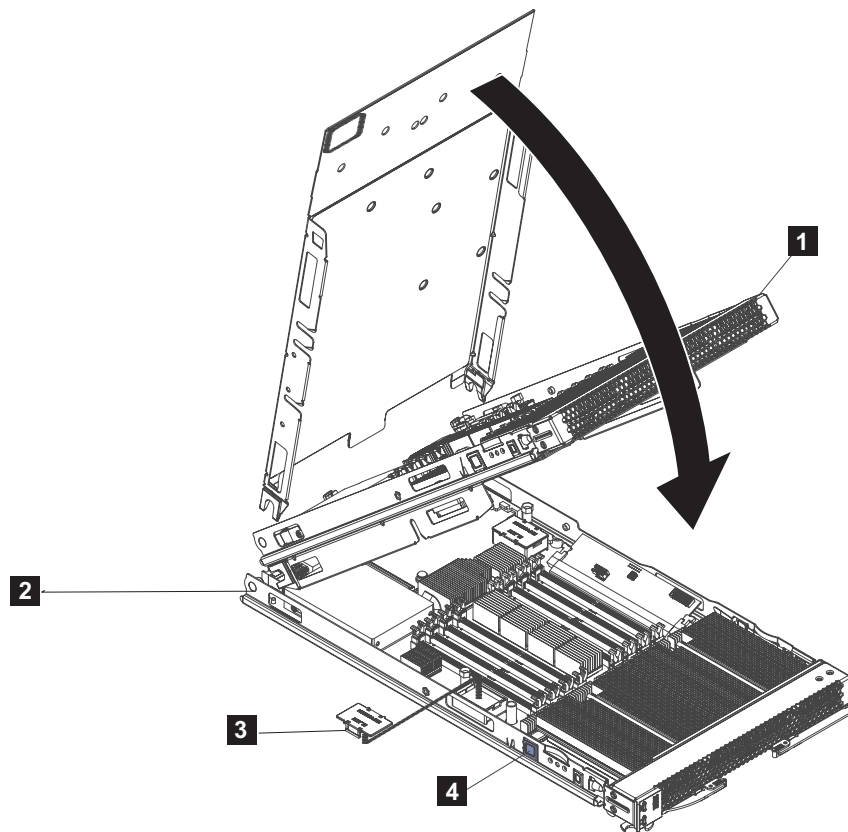
Figure 17. Installing the expansion unit

**Attention:** Install the expansion unit (**1**) at an angle of 40 degrees or less when there is a CFFh card installed on the base planar.

1. Read “Safety” on page v and the “Installation guidelines” on page 253.
2. Shut down the operating system, turn off the blade server, and remove the blade server from the BladeCenter unit. See “Removing the blade server from a BladeCenter unit” on page 255.
3. Carefully lay the blade server on a flat, static-protective surface, with the cover side up.
4. Open and remove the blade server cover. See “Removing the blade server cover” on page 258.
5. Remove the expansion connector cover, as shown by **3** in Figure 17.

6. Lift the expansion unit above the blade server base unit and engage the circular pivot bearings onto the cover pins ( **2** ) of the base unit.  
The expansion unit of the JS43 blade server fits on top of the base unit, with the DIMM slots and expansion card slots on top.
7. Pivot the expansion unit on the cover pins of the base unit and lower the expansion unit until it lies flat on the base unit.
8. To access the expansion blade retention thumb screw (shown by **4** in Figure 18), remove the DIMM in DIMM slot 1 ( **5** ), as described in "Removing a memory module" on page 269.

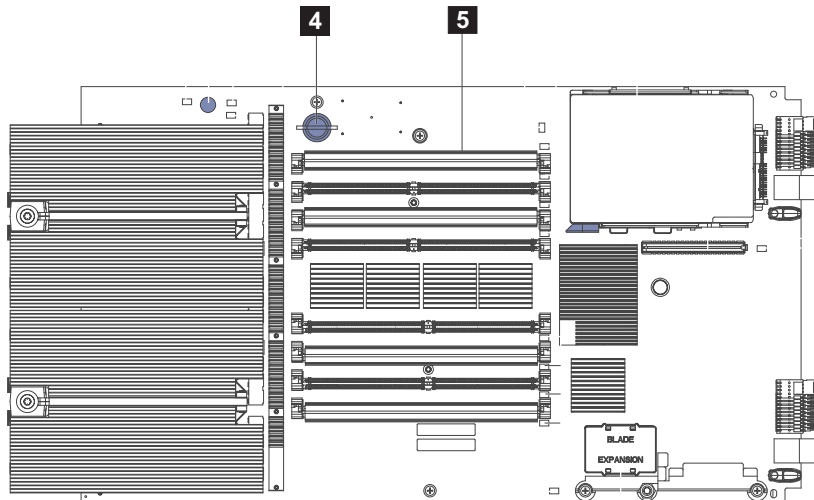
Figure 18. Expansion blade DIMM 1 slot and the expansion blade retention screw

9. Tighten the thumb screw ( **4** ) by rotating the screw clockwise until the connection between the expansion unit and the base unit is secure. Stop tightening when firm resistance is detected.
10. Replace the DIMM in DIMM slot 1, as described in "Installing a memory module" on page 270.
11. Install and close the blade server cover. See "Installing and closing the blade server cover" on page 260.

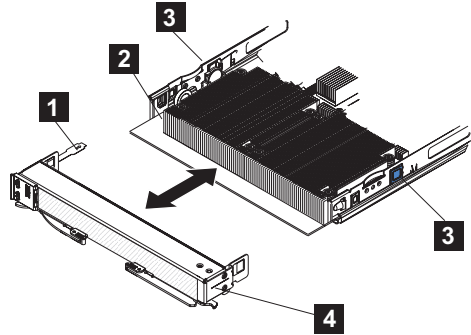
Figure 19. Removing the bezel assembly

5. Press the bezel-assembly release (as shown by **3** in Figure 19) on each side of the blade server and pull the bezel assembly (**4**) away from the blade server approximately 1.2 cm (0.5 inch).

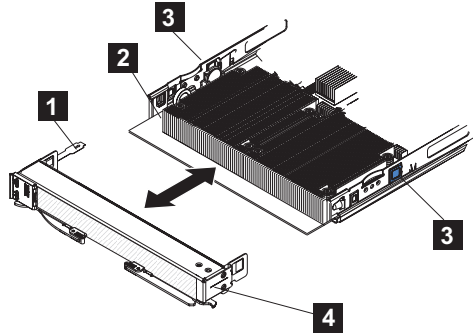
Figure 20. Installing the bezel assembly

1. Connect the control-panel cable ( **1** in Figure 20) to the control-panel connector ( **2** ) on the system board.
2. Carefully slide the bezel assembly ( **4** ) onto the blade server until the two bezel-assembly releases ( **3** ) click into place in the bezel assembly.
3. Install and close the blade server cover. See “Installing and closing the blade server cover” on page 260.

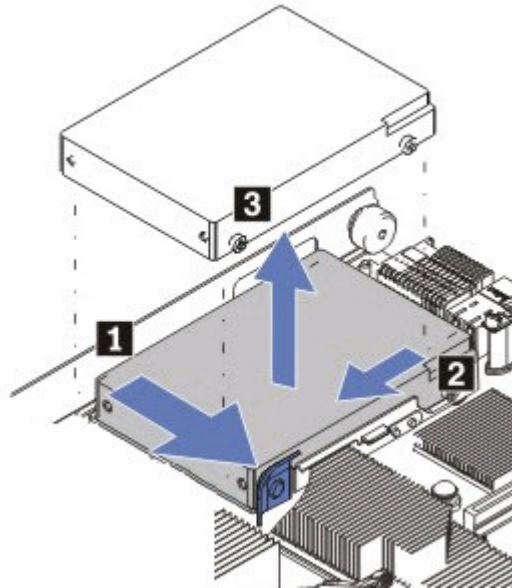
Figure 21. Removing a drive

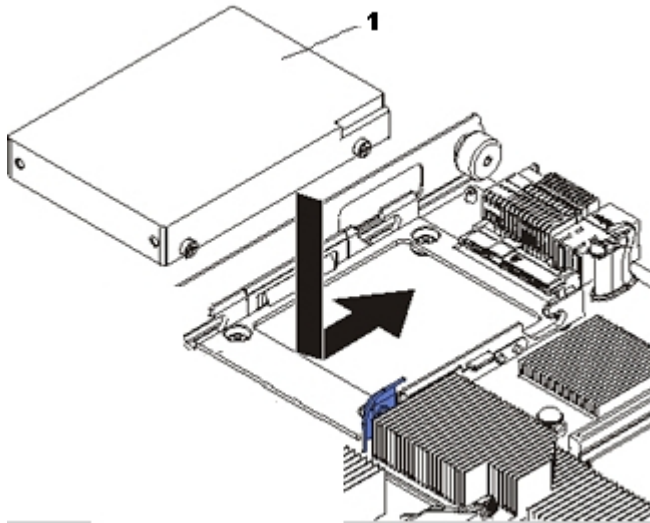
Figure 22 shows how to install the disk drive.

Figure 22. Installing a drive

All drive connectors are on the same bus. Depending on the blade server model, at least one drive might already be installed. If the JS43 blade server is equipped with one drive, you can install an additional drive in the expansion unit. If the two drives are both SAS hard disk drives or both solid state drives, you can use them to implement and manage a redundant array of independent disks (RAID) level-1 array. See “Configuring a RAID array” on page 293 for information about RAID configuration.

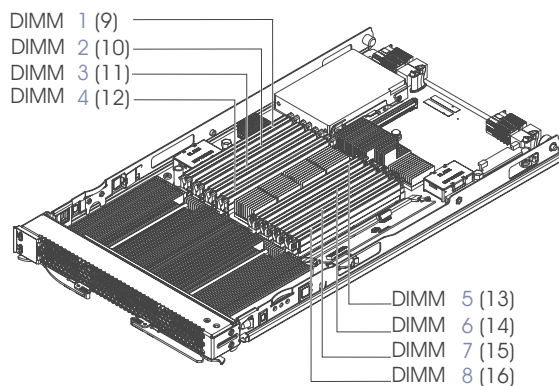
Figure 23. DIMM connectors. Base unit connectors (followed by expansion unit connectors in parentheses)

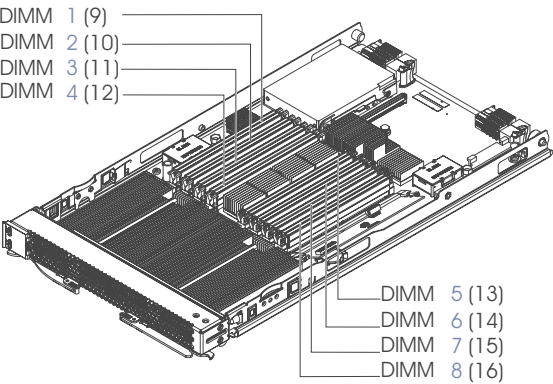
Figure 24. DIMM connectors. Base unit connectors (followed by expansion unit connectors in parentheses)

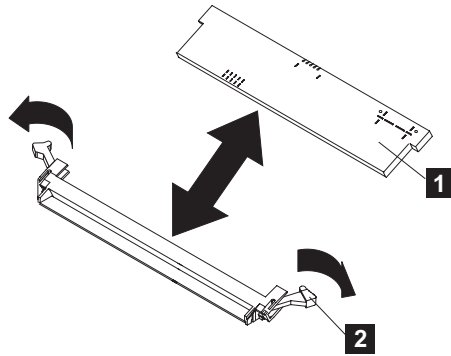
Figure 25. Removing the management card

Perform the following procedure to remove the management card, which is shown by **1** in Figure 25.

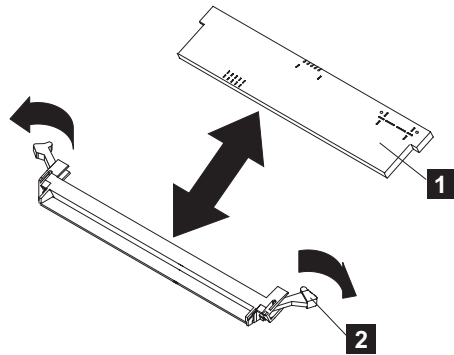
Figure 26. Installing the management card

3. Touch the static-protective package that contains the management card to any *unpainted* metal surface on the BladeCenter unit or any *unpainted* metal surface on any other grounded rack component; then, remove the management card (as shown by **1** in Figure 26) from its package.

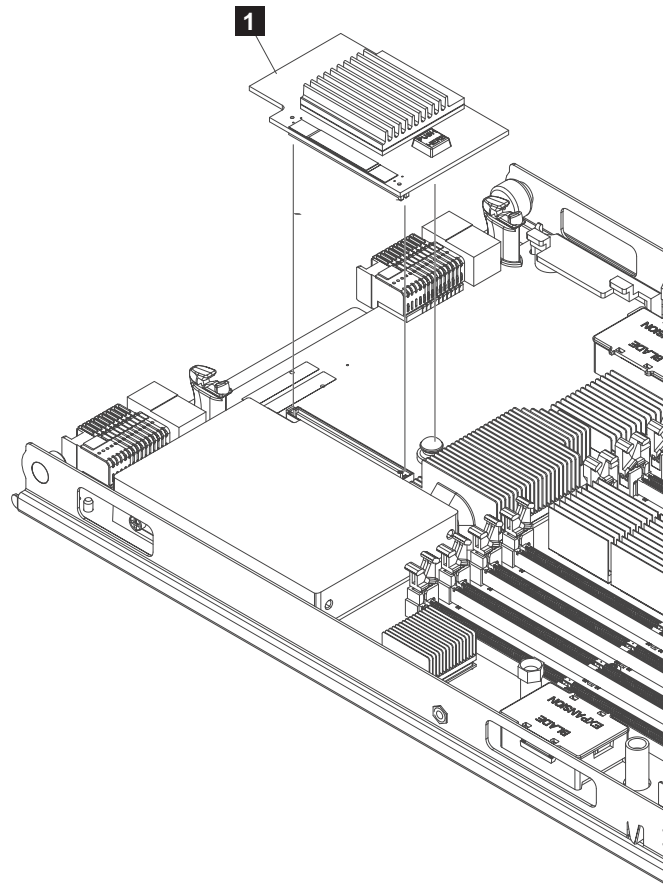
Figure 27. Removing a CIOv form factor expansion card from the 1Xe connector

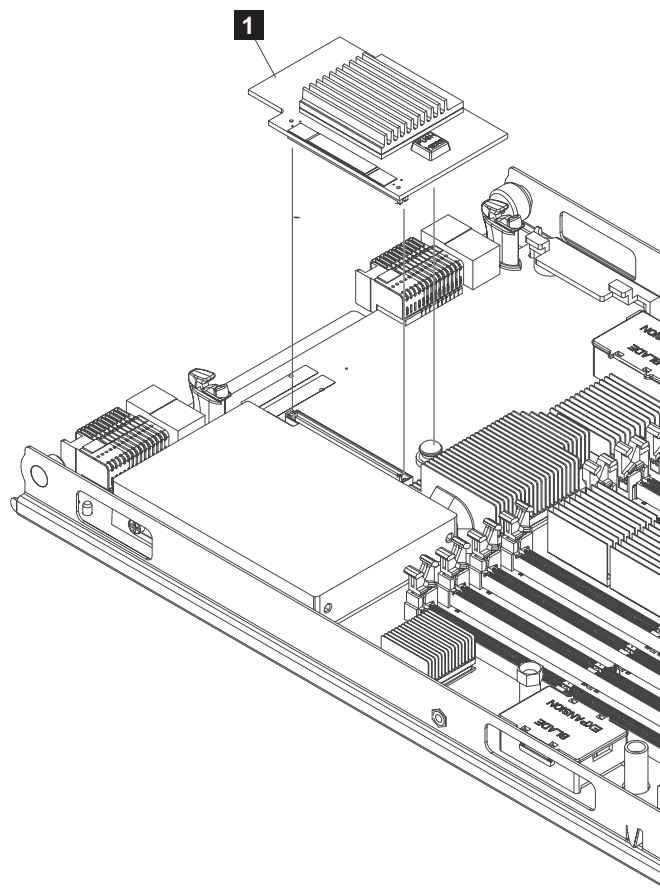
Figure 28. Installing a CIOv form-factor expansion card on the 1Xe connector

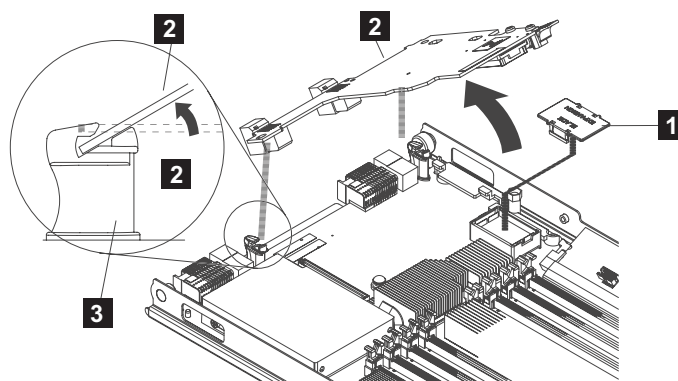
Figure 29. Removing a combination-form-factor expansion card

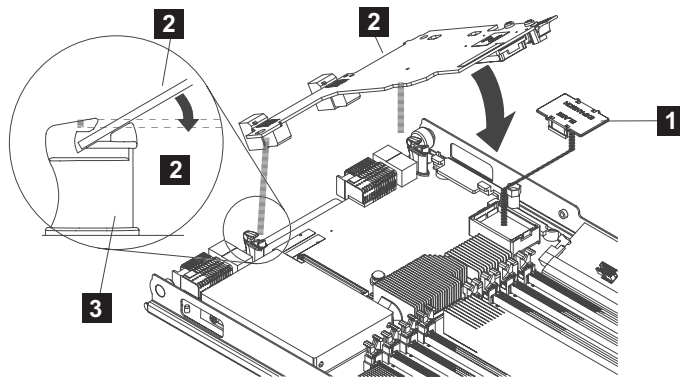
Figure 30. Installing a combination-form-factor expansion card

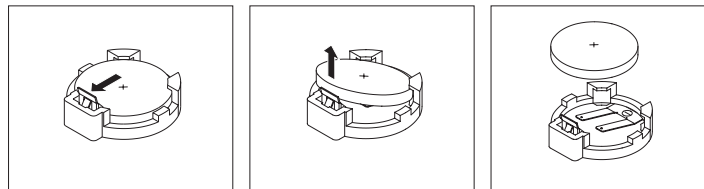
Figure 31. Removing the battery

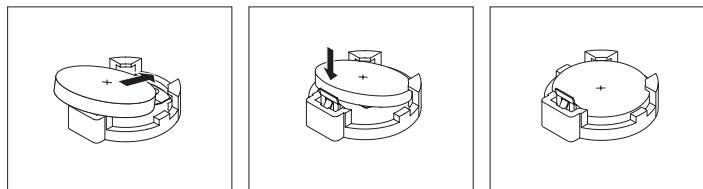
Figure 32. Installing the battery

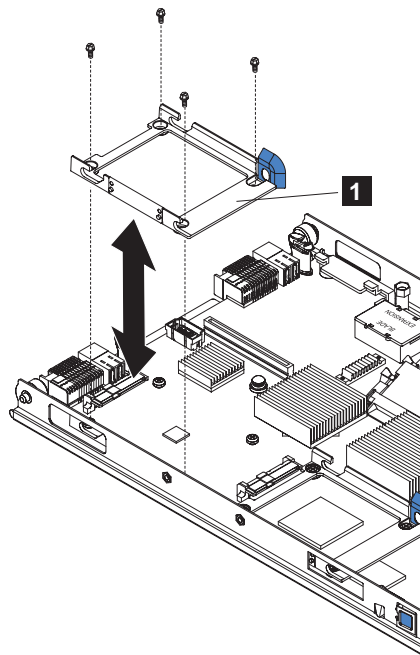
Figure 33. Removing the disk drive tray

1. Read "Safety" on page v and the "Installation guidelines" on page 253.
2. Shut down the operating system, turn off the blade server, and remove the blade server from the BladeCenter unit. See "Removing the blade server from a BladeCenter unit" on page 255.
3. Carefully lay the blade server on a flat, static-protective surface, with the cover side up.
4. Open and remove the blade server cover. See "Removing the blade server cover" on page 258.
5. Remove the disk drive if one is installed. See "Removing a drive" on page 267.
6. Remove the four screws that secure the drive tray ( **1** in Figure 33) to the system board and remove the drive tray.

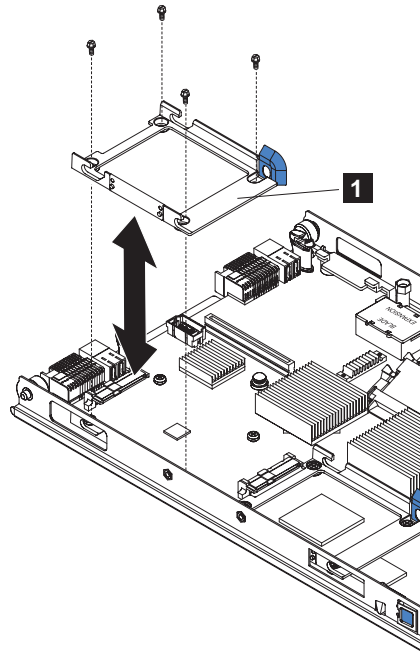
Figure 34. Installing the disk drive tray
