**Power Systems**

# IBM Flex System p24L Compute Node Installation and Service Guide

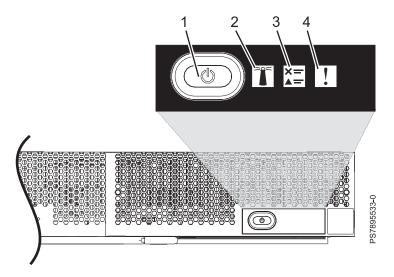
Figure 1. Compute node control panel button and LEDs

1. **Power-control button and light path LED**: Press this button to turn on or turn off the compute node or to view light path diagnostic LEDs.

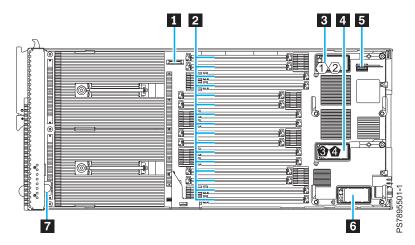
The following figure shows the connectors on the base-unit system board in the IBM Flex System p24L Compute Node.

Figure 2. System-board connectors for the IBM Flex System p24L Compute Node

Callout	IBM Flex System p24L Compute Node connectors
1	3 V lithium battery connector (P1-E1)
2	DIMM connectors (See Figure 3 on page 13 for individual connectors.)
3	I/O expansion card top connector for chassis bays 1 and 2 (P1-C18)
4	I/O expansion card bottom connector for chassis bays 3 and 4 (P1-C19)
5	Management card connector (P1-C21)
6	Everything-to-Everywhere (ETE) connector (P1-C20)
7	Light path card

**Note:** See **5** in Figure 2 on page 12 for the location of the management card on the system board.

**Note:** See **7** in Figure 2 on page 12 for the location of the light path panel on the system board.

- 5. Locate the connector on the currently installed system board into which the light path panel will be installed. See 7 in Figure 2 on page 12 for the location of the light path panel on the system board.

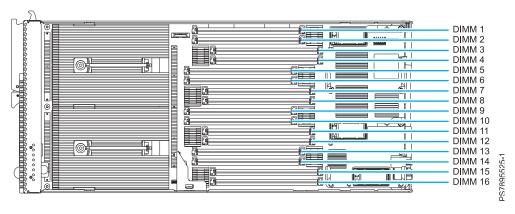
The following figure shows individual DIMM connectors for the IBM Flex System p24L Compute Node system board.

Figure 3. DIMM connectors for the IBM Flex System p24L Compute Node

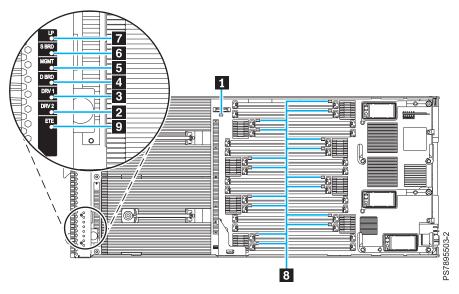
Press and hold the front power-control button to see any light path diagnostic LEDs that were turned on during error processing. Use the following figure to identify the failing component.

The following figure shows LEDs on the IBM Flex System p24L Compute Node. The following figures and table shows the system-board LEDs.

Figure 4. LED locations on the system board of the IBM Flex System p24L Compute Node

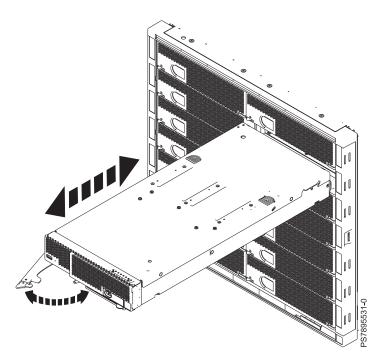
Figure 5. Removing the compute node from the IBM Flex System Enterprise Chassis

- 3. Press the power-control button to turn off the compute node. See "Turning off the compute node" on page 11.
- 4. Wait at least 30 seconds for the hard disk drive to stop spinning.
- 5. Open the release handles, as shown in Figure 5 on page 29. There is one release handle. The compute node can be moved out of the bay approximately 0.6 cm (0.25 inch).
- 6. Pull the compute node out of the bay.
- 7. Carefully lay the compute node on a flat, static-protective surface, with the cover side up.
- 8. Place either a compute node filler or another compute node in the bay.

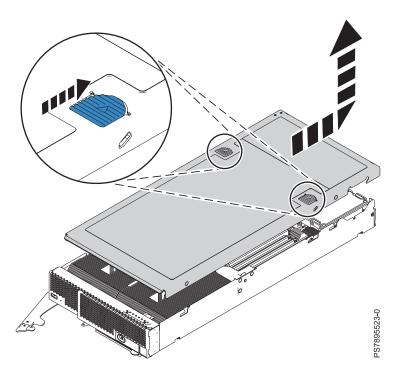
Figure 6. Removing the cover from an IBM Flex System p24L Compute Node

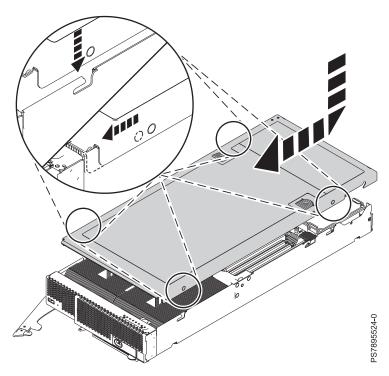
Figure 7. Installing the cover for an IBM Flex System p24L Compute Node

- 1. Read the Safety topic and the "Installation guidelines" on page 27.
- 2. Lower the cover so that the pins on the sides of the cover slide down into the slots (as shown in the preceding figures) at the front and rear of the compute node. Before you close the cover, verify that all components are installed and seated correctly and that you have not left loose tools or parts inside the compute node.
- 3. Slide the cover forward to the closed position until the releases click into place in the cover.

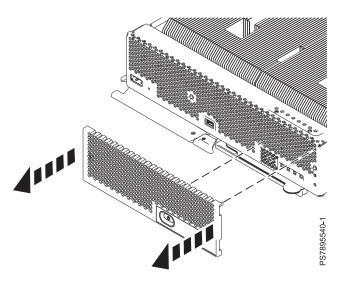
Figure 8. Removing the bezel assembly from an IBM Flex System p24L Compute Node

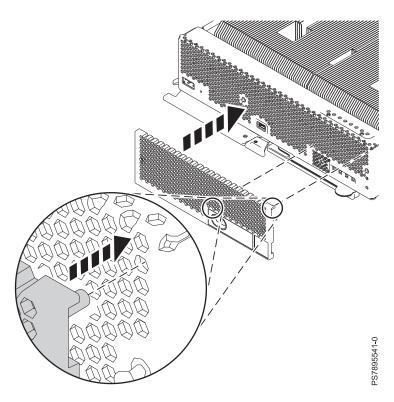
Figure 9. Installing the bezel assembly in an IBM Flex System p24L Compute Node

- 1. Align the bezel with the compute node according to the circled locations indicated in Figure 9.
- 2. Align the bezel assembly with the front of the compute node. Firmly press the bezel at the sides where the two pins protrude from the face of the compute node until the assembly clicks into place.
- 3. Install the compute node into the IBM Flex System Enterprise Chassis. See "Installing the compute node in an IBM Flex System Enterprise Chassis" on page 76.

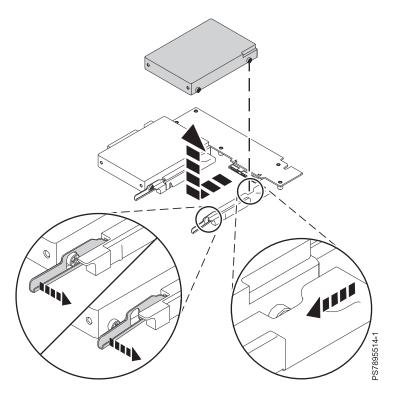
Figure 10. Removing a hard disk drive

- a. Move and hold the blue release lever at the front of the drive tray, as indicated in Figure 10.
- b. Slide the drive forward to disengage the connector.
- c. Lift the drive out of the drive tray.

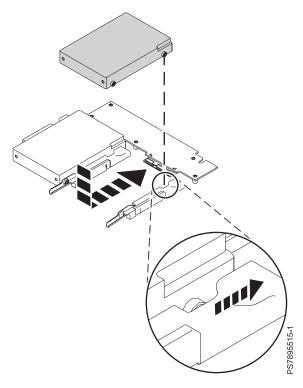
Figure 11 shows how to install the hard disk drive.

Figure 11. Installing a hard disk drive

- a. Move and hold the blue release lever at the front of the drive tray.
    - b. Slide the filler forward and lift it out of the drive tray.
- 6. Place the drive into the drive tray and push it toward the rear of the compute node, as indicated in Figure 11 on page 37. When the drive moves past the lever at the front of the tray, it snaps in place.

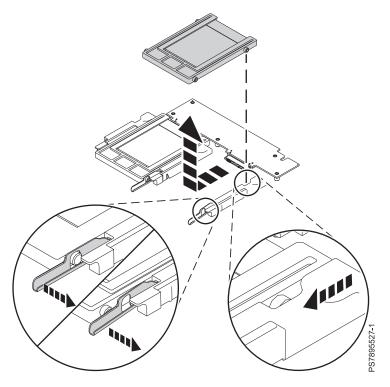
Figure 12. Removing an SSD carrier

- a. Pull and hold the blue release lever at the front of the drive tray, as indicated in Figure 12.
- b. Slide the carrier case forward to disengage the connector.
- **c**. Lift the carrier case out of the drive tray.

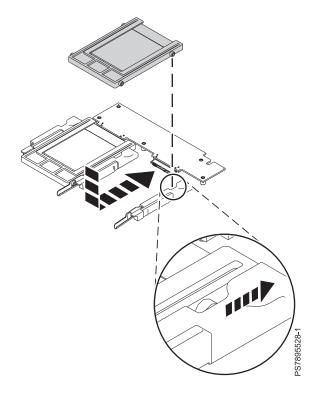
Figure 13 shows how to install the disk drive.

Figure 13. Installing an SSD carrier

- 6. If you are replacing an SSD carrier, continue to the next step. If you are installing a new SSD carrier, remove the filler to vacate the space for the new SSD carrier:
  - a. Pull and hold the blue release lever at the front of the drive tray.
  - b. Slide the filler forward to disengage the connector.
  - c. Lift the filler out of the drive tray.
- 7. Remove the SSD carrier case that you want to replace from the drive tray. See "Removing a solid-state drive carrier" on page 38.
- 8. Install SSDs into the new carrier case. See "Installing a SATA solid-state drive" on page 43.
- 9. Place the carrier case into the drive tray and push it toward the rear of the compute node, as indicated in Figure 13 on page 40. When the SSD carrier moves past the lever at the front of the tray, it snaps in place.

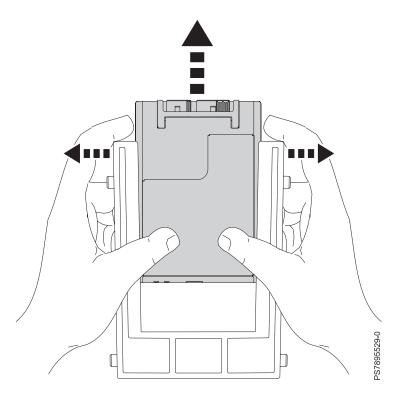
Figure 14. Removing a SATA SSD

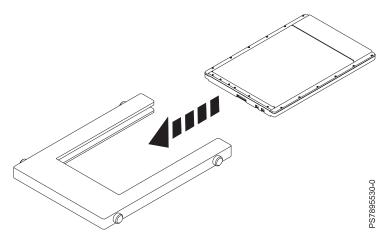
Figure 15 shows how to install the SATA SSD.

Figure 15. Installing a SATA SSD

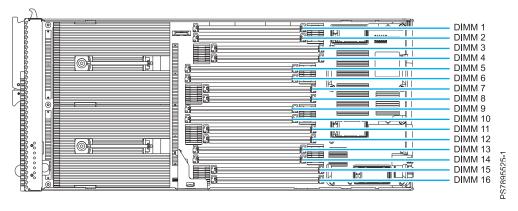
Figure 16. DIMM connectors for the IBM Flex System p24L Compute Node

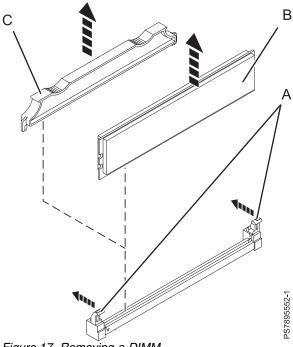
**6.** Carefully open the retaining clips **(A)** on each end of the DIMM connector by pressing them in the direction of the arrows. Remove the DIMM **(B)**.

Figure 17. Removing a DIMM

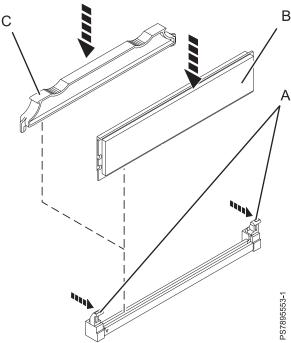
10. Insert the DIMM (B) by pressing the DIMM along the guides into the connector.

Figure 18. Installing a DIMM

Verify that each retaining clip (A) snaps into the closed position.

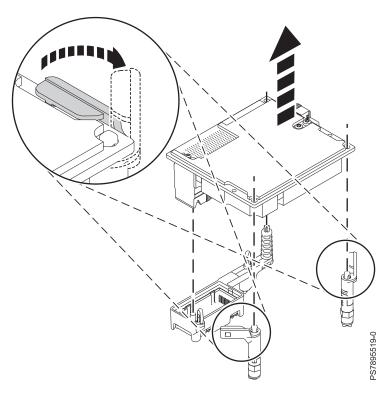
Figure 20. Removing a network adapter from its connector

- 3. Carefully lay the compute node on a flat, static-protective surface, with the cover side up.
- 4. Open and remove the compute node cover. See "Removing the compute node cover" on page 31.
- 5. Pull the slot's two blue release tabs open, as indicated in Figure 20 on page 49.
- 6. Lift the network adapter up and away from its connector and out of the compute node.
- 7. If you are instructed to return the expansion card, follow all packaging instructions, and use any packaging materials for shipping that are supplied to you.
- 8. Install and close the compute node cover. See "Installing and closing the compute node cover" on page 32.

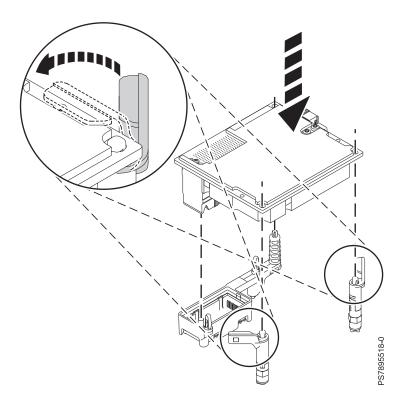
Figure 21. Installing a network adapter on its connector

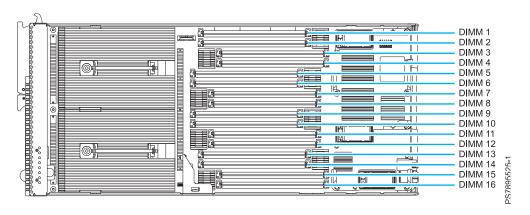
Figure 24. DIMM connectors for the IBM Flex System p24L Compute Node

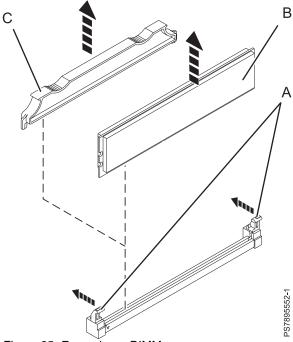
6. Carefully open the retaining clips **(A)** on each end of the DIMM connector by pressing them in the direction of the arrows. Remove the DIMM **(B)**.

Figure 25. Removing a DIMM

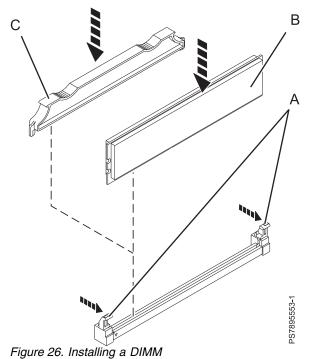
Attention: To avoid breaking the DIMM retaining clips or damaging the DIMM connectors, handle the clips gently.
- 10. Insert the DIMM (B) by pressing the DIMM along the guides into the connector.

Verify that each retaining clip (A) snaps into the closed position.

**Important:** If there is a gap between the DIMM and the retaining clips, the DIMM is not correctly installed. Open the retaining clips to remove and reinsert the DIMM. Install a DIMM filler **(C)** in any location where a DIMM is not present to avoid machine damage.

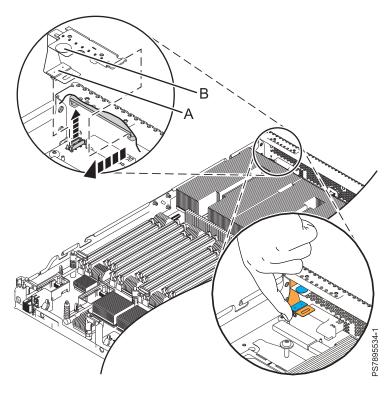
Figure 29. Removing the light path diagnostics panel

To remove the light path diagnostics panel, which is shown in Figure 29, complete the following steps.

- 5. Grasp the light path diagnostics panel by its pull tab (B) and pull it horizontally out of its bracket.
- 6. Disconnect the cable (A) from the system board. For best maneuverability, orient yourself in front of the compute node. Use your index finger to reach under the cable connection and pull it up, as shown in Figure 29 on page 65.

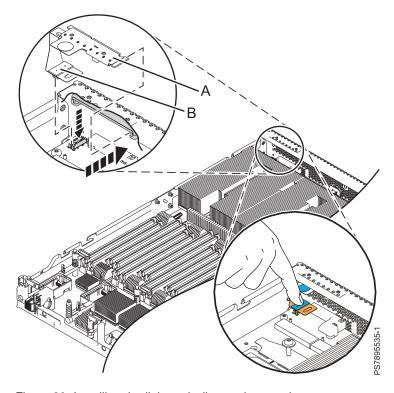
Figure 30. Installing the light path diagnostics panel

To install the light path diagnostics panel, which is shown in Figure 30, complete the following steps:

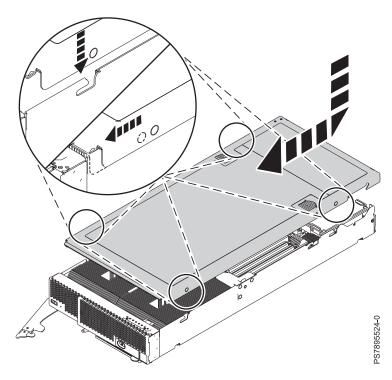
Figure 31. Installing the cover for an IBM Flex System p24L Compute Node

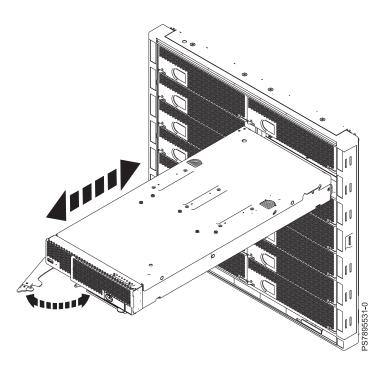
Figure 32. Installing the compute node in an IBM Flex System Enterprise Chassis

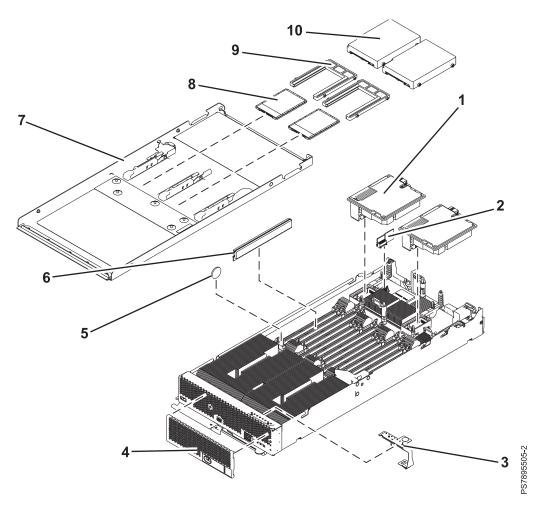
Figure 33. IBM Flex System p24L Compute Node parts

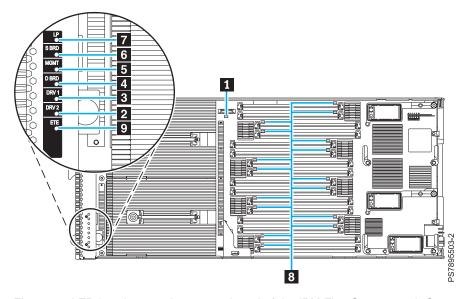
The following figure shows LEDs on the IBM Flex System p24L Compute Node. The following figures and table shows the system-board LEDs.

Figure 34. LED locations on the system board of the IBM Flex System p24L Compute Node
