# Troubleshooting Video Toaster [2]

*Revised October 15, 2002*

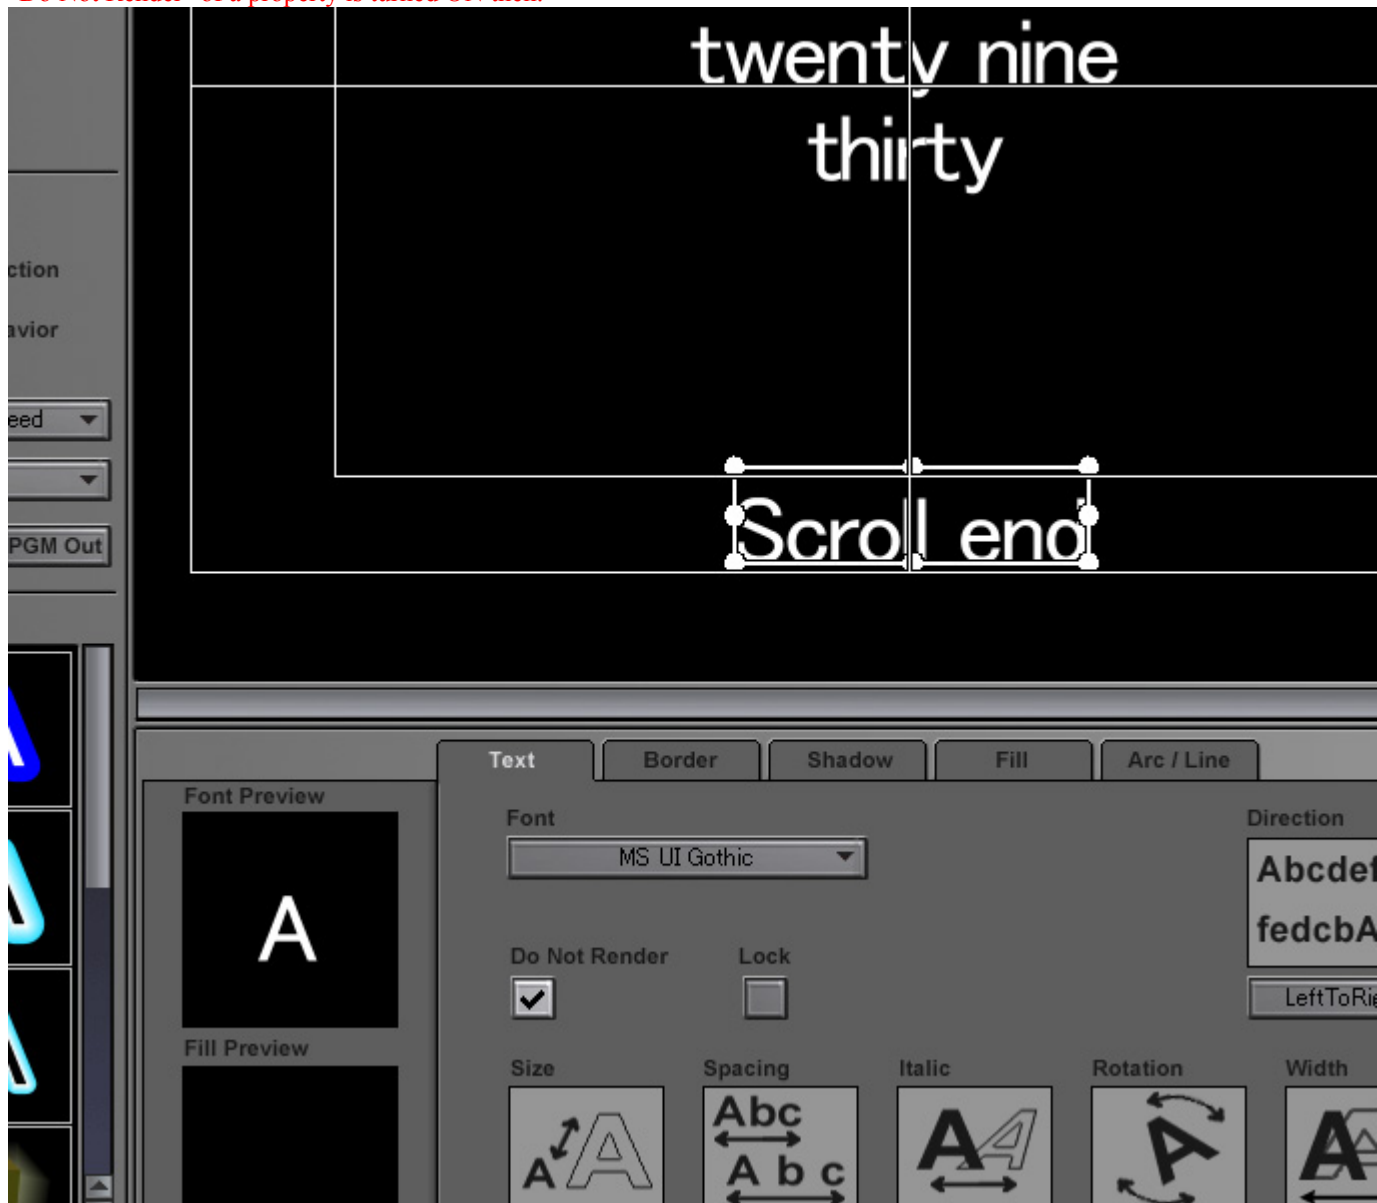
You have to make "Scroll End."

"Do Not Render" of a property is turned ON then.
