BALDOR MN422 Spring-Set Disc Brakes Manual

Installation and Service Instructions for 1-056-X00* Series (all revisions) Manual Adjust Brakes

*This sheet includes Series 1-056,000; 1-056,100; 1-056,200; 1-056,300; 1-056,400; 1-056,500; 1-056,600 and 1-056,900. For other series consult factory.

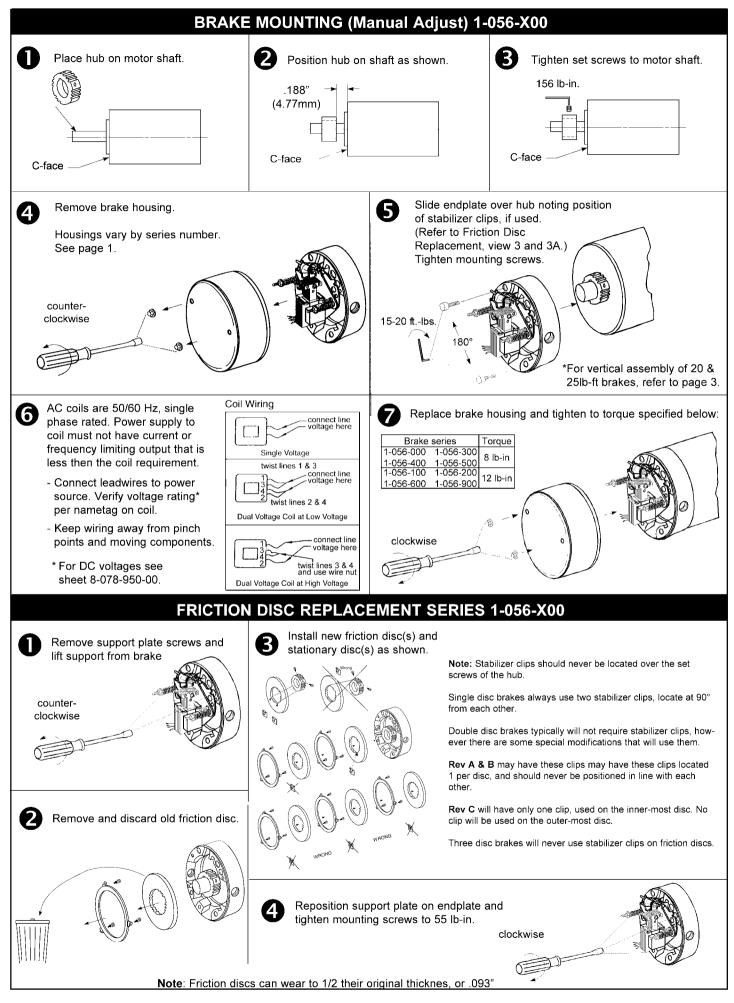
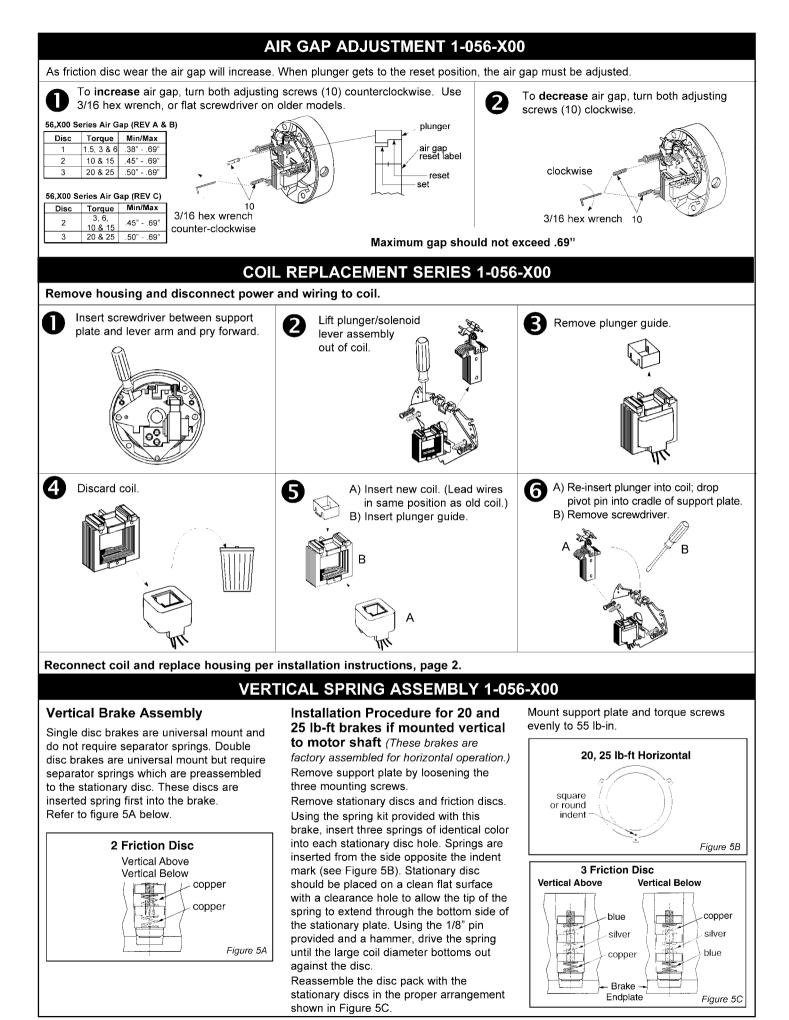
Brake sets and torque is produced when electric current to the solenoid coil is interrupted, thereby collapsing the solenoid magnetic field. The solenoid plunger returns to its original de-energized position allowing the lever arm to move forward by virtue of the compressed torque springs. This action compresses the disc pack components which applies a retarding torque to the brake hub and ultimately restores the brake to a spring-set static condition.
