Released in November 2005, the Brother HL-5200 printer engine is based on a new 30ppm, true 1200 DPI laser engine. While these cartridges are similar to the Brother HL-2030 (TN-350) engines, there are enough differences that warrant it's own instructions. The first section of this article covers the theory behind these cartridges . The first three paragraphs have some interesting information on the reset gears and how they work. The rest is standard Brother theory. If you are not familiar with brother cartridges, it would be best to read through this entire section. It may save you a few very frustrating hours.

Toner-Refill-Instructions.com

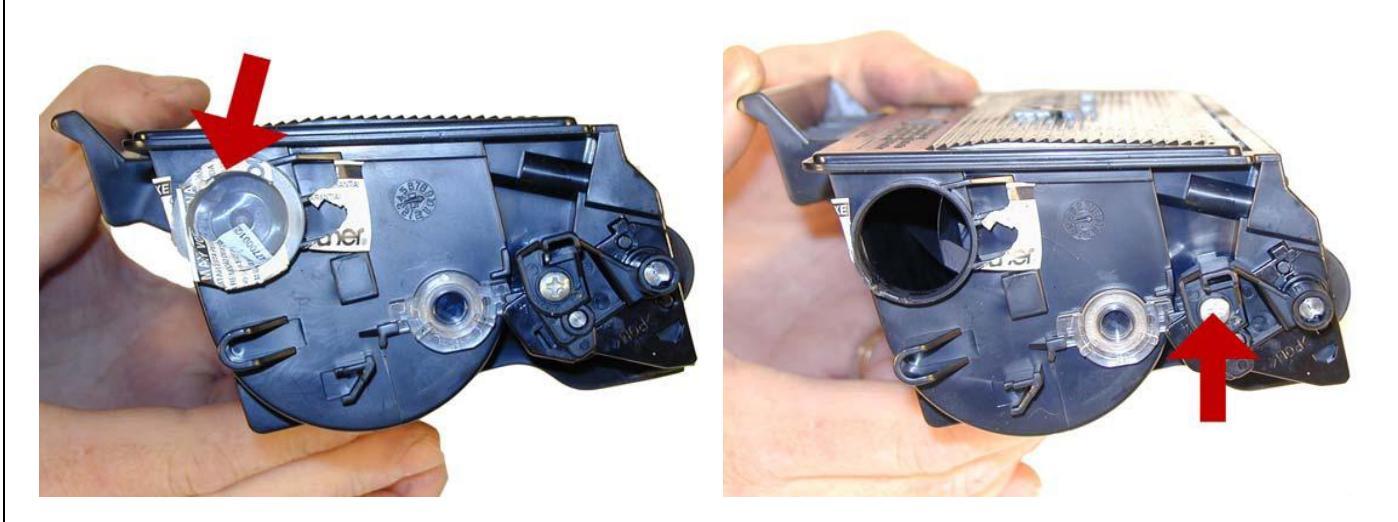
1. Remove the fill plug from the toner cartridge. Dump the remaining toner and vacuum/blow out the cartridge. Make sure that the gear area is clean. Leaving any toner in the teeth of the gears may cause a tooth to be damaged and cause a clicking noise. We have found it best to use compressed air to clean them out, but to also keep one hand over the gears to protect them

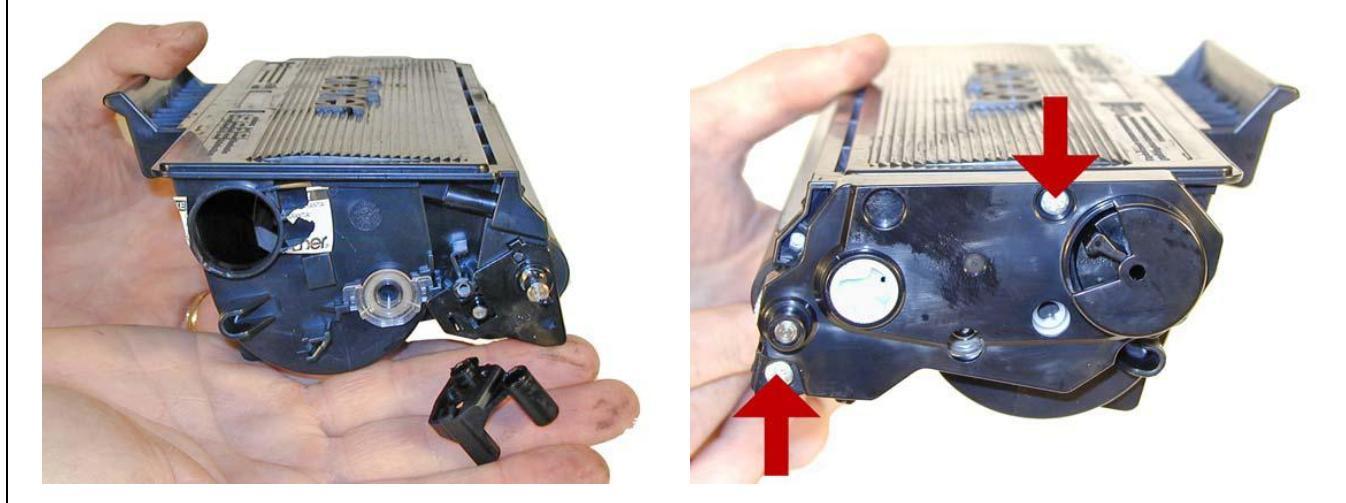
2. On the NON GEAR side of the developer roller, remove the screw.

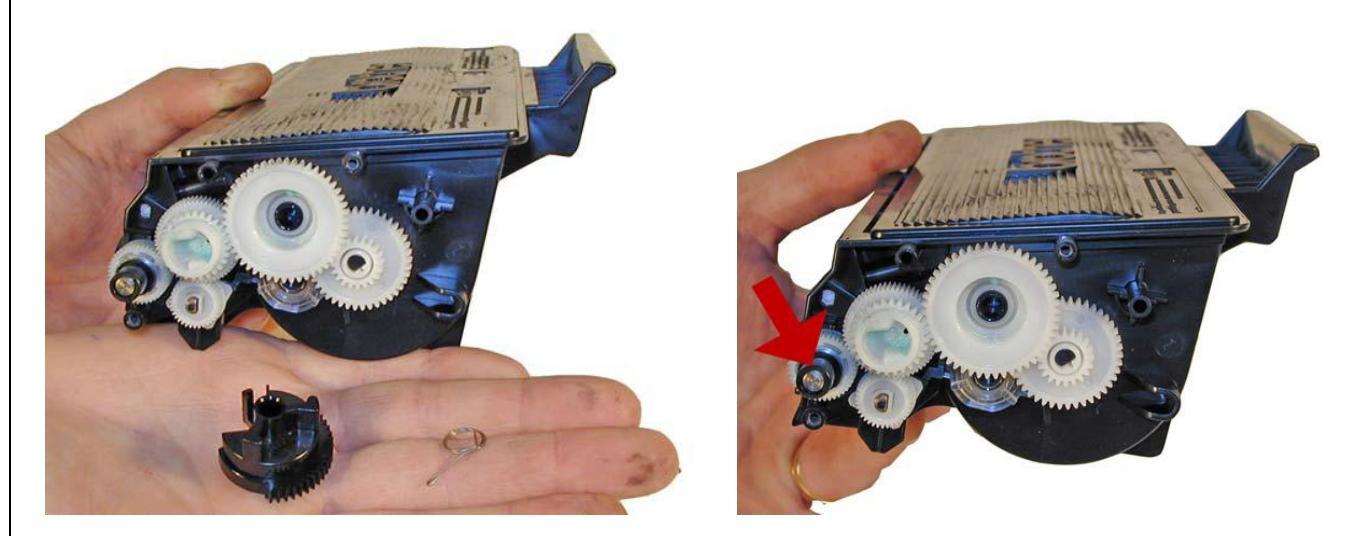
- 1. Remove the drum axle plate.
- 2. On the GEAR SIDE, remove the two screws and cover plate.

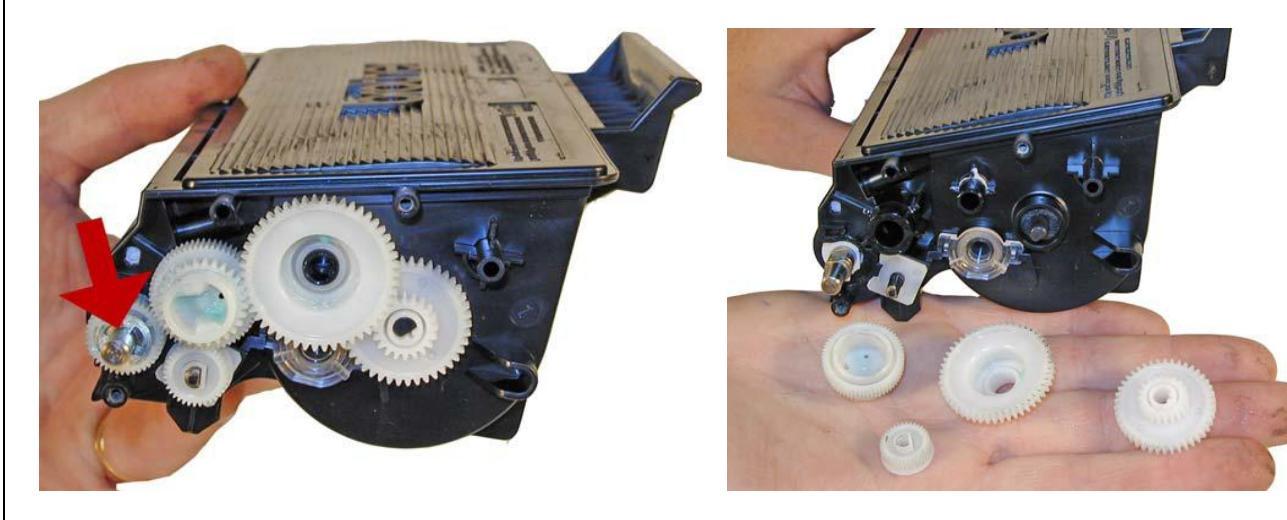
5. The black spring loaded reset gear may fall off as the plate is removed. This gear resets the printer when the cartridge is installed. New starter cartridges do not have this reset gear. Until they are available, the starter cartridges cannot be remanufactured.

6. Remove the black plastic spacer from the developer roller shaft.

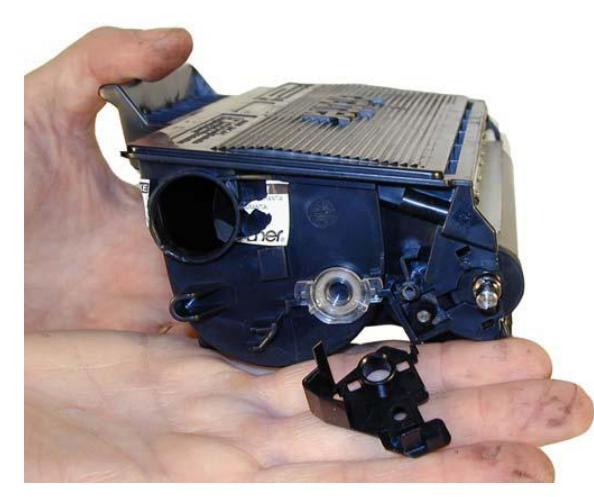
- 7. Remove the E-Ring, and small gear.
- 8. Remove all the remaining gears.

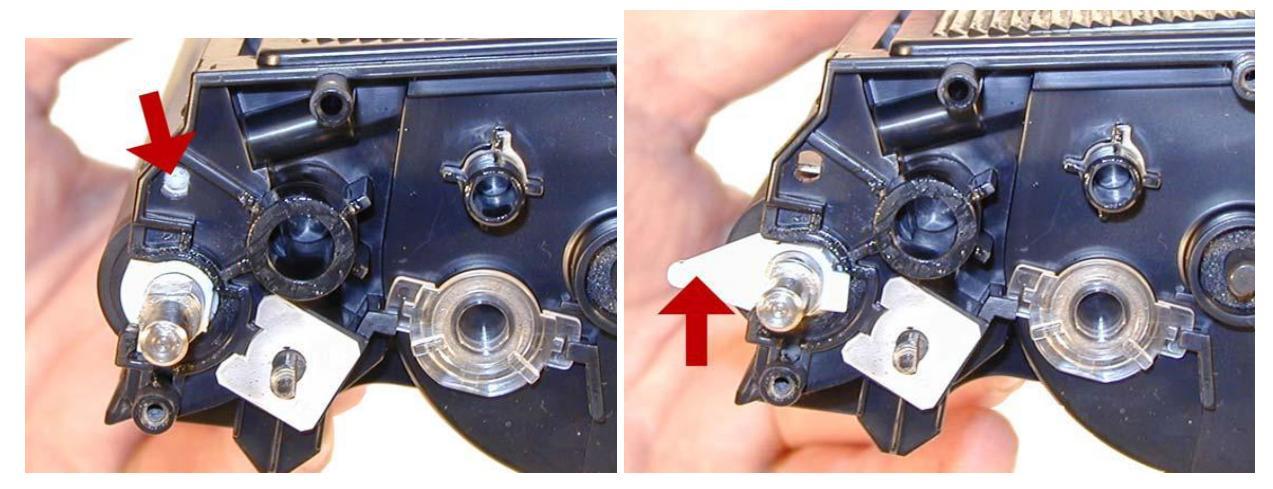
9. Remove the non-gear side end cap by gently prying it off.

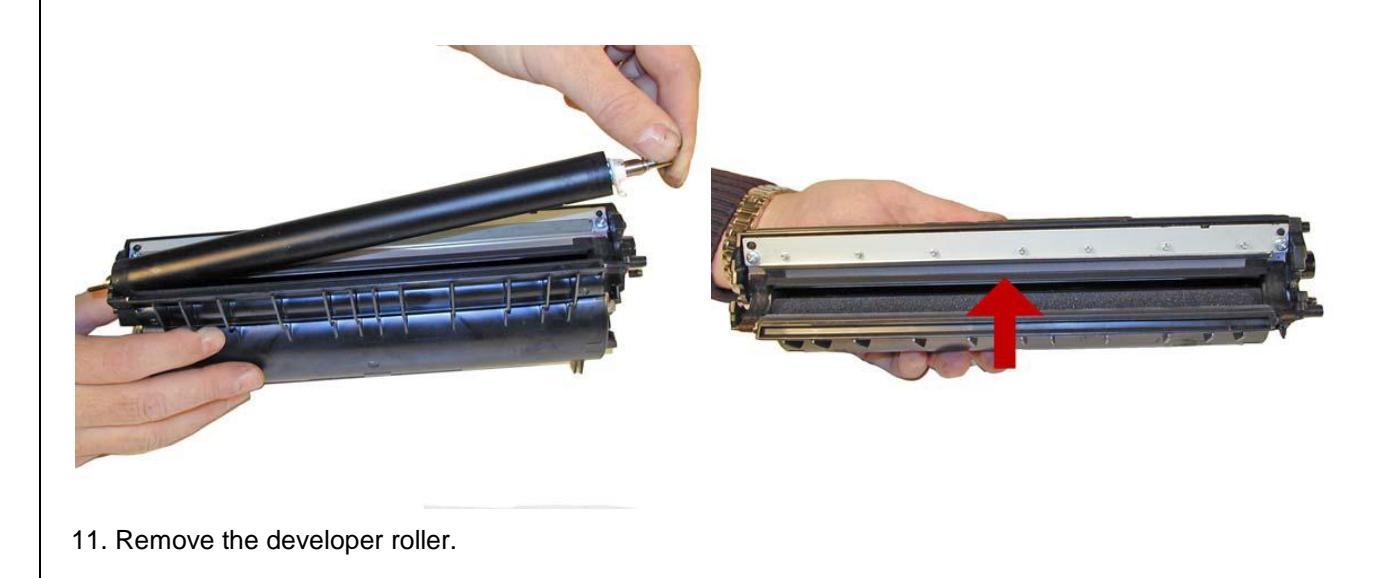
10. On the gear side of the developer roller, press in on the locking tab, and rotate the developer roller lock up.

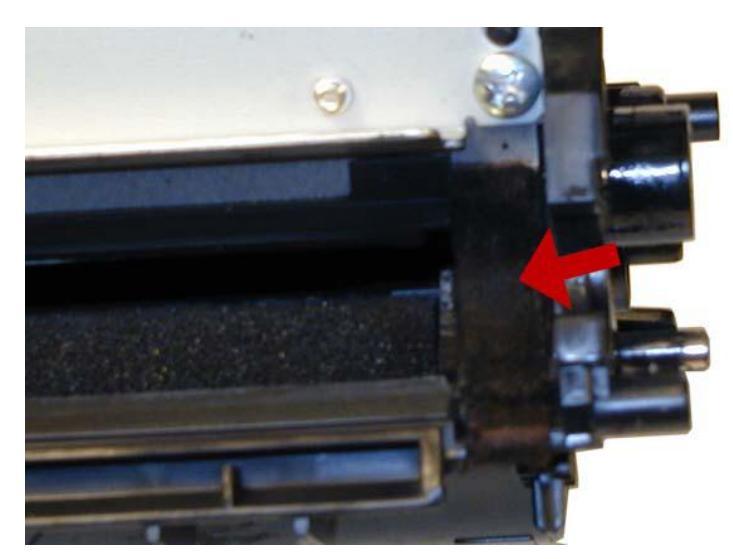
12. Vacuum the doctor blade and foam feed roller clean. We do not recommend that the doctor blade be removed and the developer roller felt seals will be disturbed. Once a new blade is available, great care will have to be taken not to tear the seals, causing a leak. The doctor blade can be easily cleaned by blowing the excess toner off, and wiping down with a lint free cloth. Be very careful not to leave any lint behind!

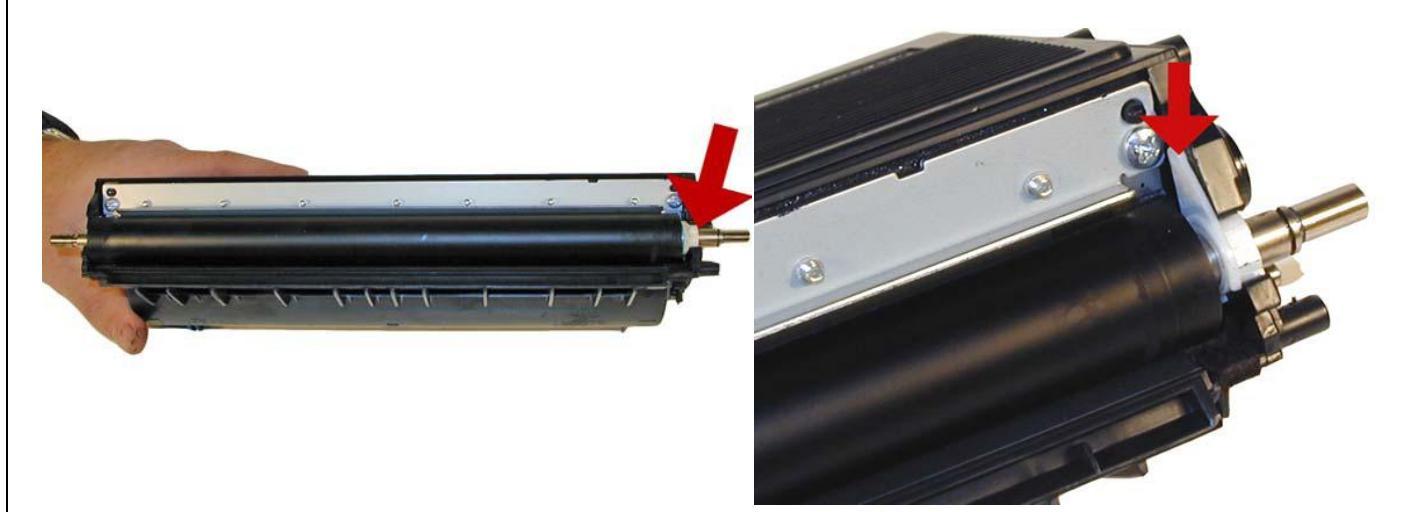
13. Inspect the magnetic roller felts. If they are compressed, (shinny) rough them up with a small screwdriver.

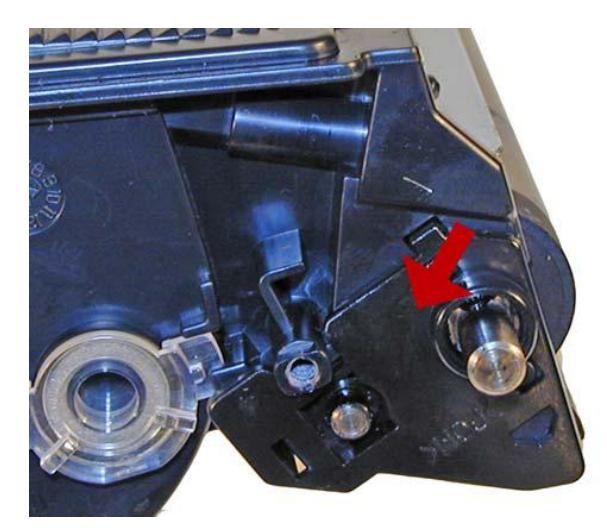
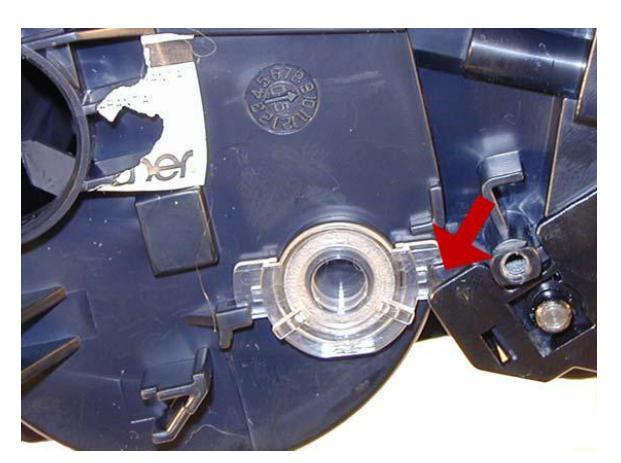
14. Clean the developer roller with a lint free cloth. Do not use any chemicals other than a dedicated cleaner for Brother rollers to clean the roller. A dry clean cloth will work fine.

Re-install the developer roller long shaft side to the gear side, and white lock pointing up. Turn the lock towards the doctor blade until it locks in place.

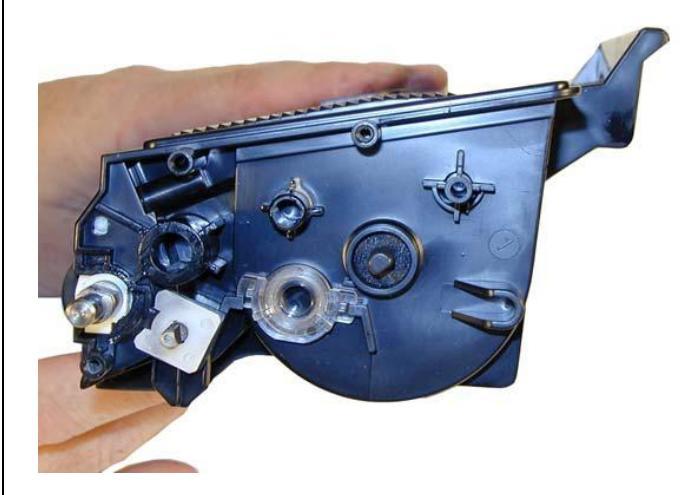
15. Install the small outside end plate on the non-gear side. Make sure the clear plastic plug for the optical sensor is locked in the proper position.

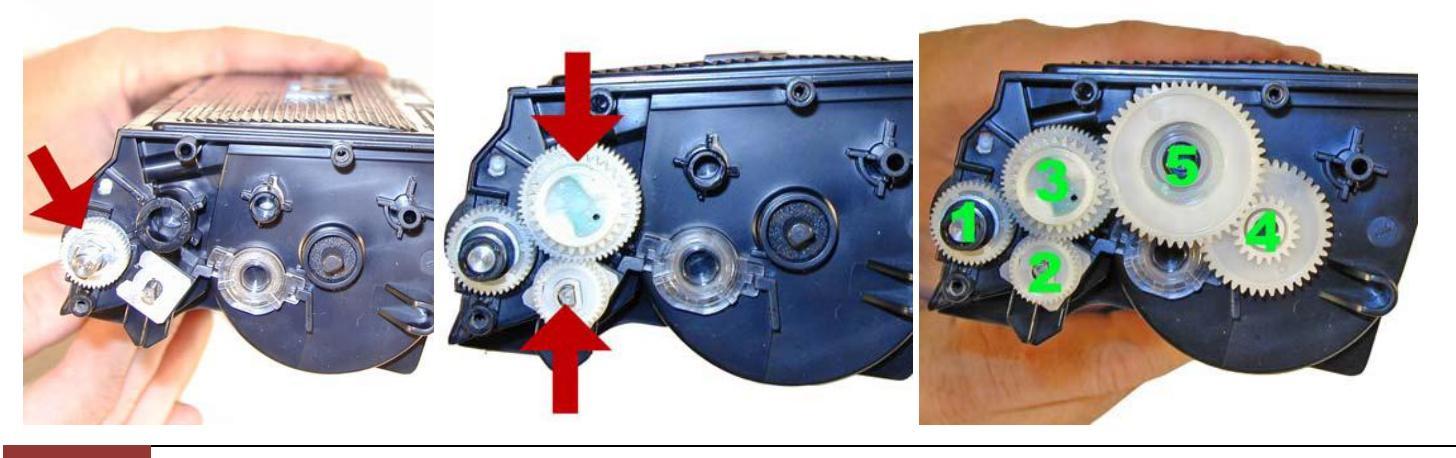
16. Clean the gears, making sure that they have no toner on them. This is a good time to also check the gear shafts to make sure there is enough grease. If the shafts appear dry, or the grease is contaminated with toner, clean the shaft and inside of the gear. Replace the grease with white lithium grease.
