Power Systems  
Isolation procedures

This edition applies to IBM Power Systems™ servers that contain the POWER6® processor and to all associated models.

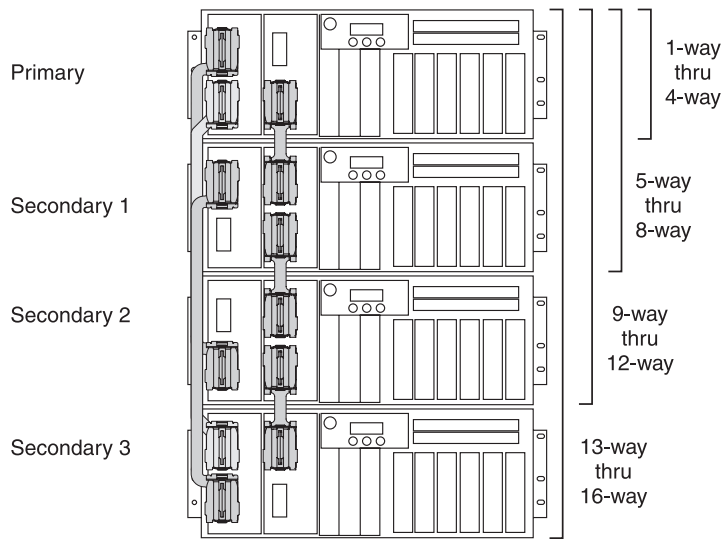
Table 15. Converting the loop number to port location labels for a 9117-MMA, and 9406-MMA

**Note:** If you are working on a Model MMA with multiple processor enclosures, exchange the FRU on the correct unit (primary or secondary) by matching the serial number (if available in the FRU list on the serviceable event view) or by matching the loop number to the correct unit.

**Note:** To simplify this information, secondary units on the Model MMA server are numbered 1 through 3-secondary unit 1 being nearest to the primary unit and secondary unit 3 being furthest.

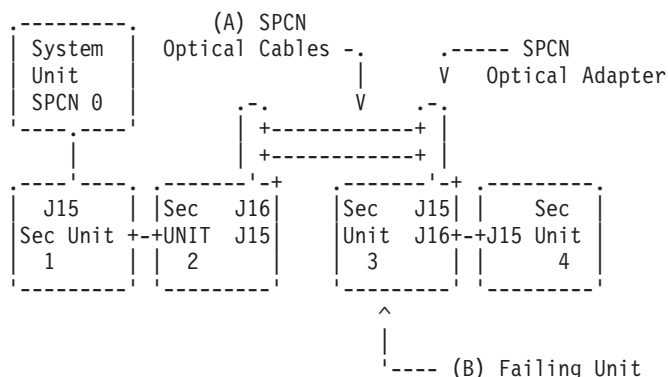
14. Do the SPCN optical cables (A) connect the failing unit (B) to the preceding unit in the chain or loop?

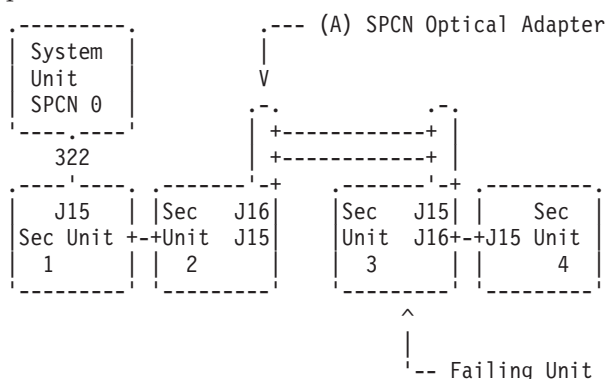
15. Remove the SPCN optical adapter (A) from the preceding frame in the string that cannot become powered on.

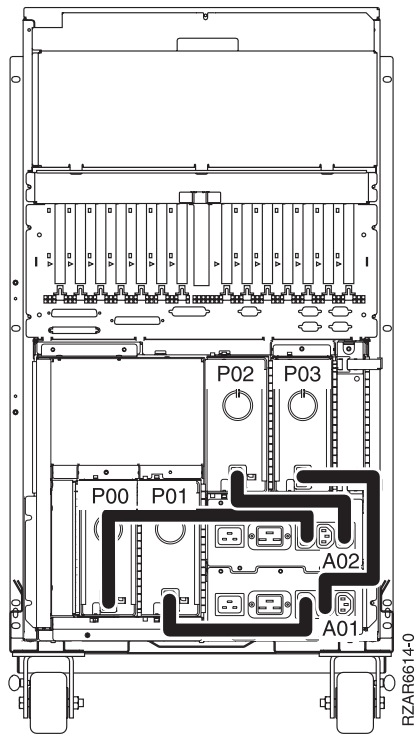
Figure 1. Dual line cord drawing for 5094, 5096, 5294, 5296

- b. Locate the ac line cord or the ac jumper cable for the reference code you are working on.
  - c. Go to step 10.
9. Is the reference code 1xxx 1500 or 1xxx 1530?
  - **No:** Perform Problem Analysis using the reference code.  
**This ends the procedure.**
  - **Yes:** Locate the ac jumper cables for the reference code you are working on (see Table 40 on page 156), and then continue with the next step:
    - If the reference code is 1xxx 1500, determine the locations of ac jumper cables that connect to power supply P00 (see the preceding figures).
    - If the reference code is 1xxx 1530, determine the locations of ac jumper cables that connect to power supply P03 (see the preceding figures).
10. Perform the following:

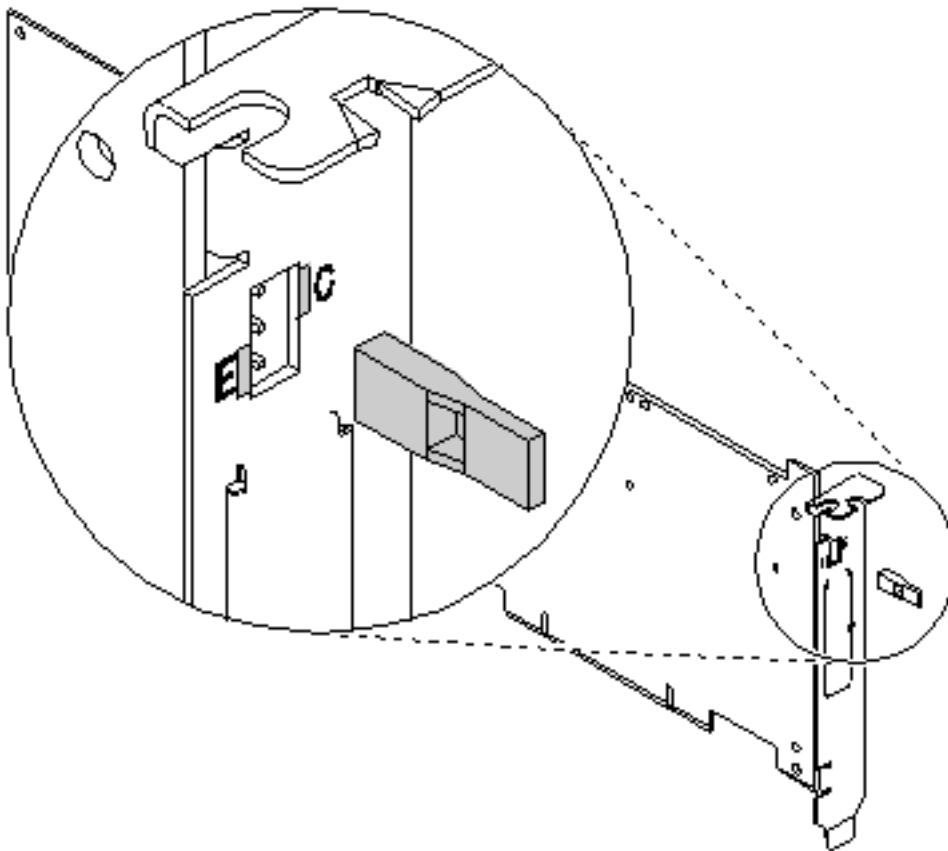
Reclaim adapter cache storage. See Reclaiming IOP cache storage.

The 2748 and 2778 I/O cards support two modes: compression and enhanced. The rear of the I/O card is marked with a **C**, indicating compression mode, and an **E**, indicating enhanced mode. Three pins on the rear of the I/O card determine the mode of the card, depending on which of the pins have a jumper placed on them.

The jumper may be moved at any time, but changes only take effect during a system IPL. Refer to the illustration below while changing the mode jumper.

1. Power off the system, ensuring that no jobs are currently processing (see Powering on and powering off the system ).
2. Choose from the following options:
  - To set the mode of the card to compressed (C), place the jumper on the top and middle pins.
  - To set the mode of the card to enhanced (E), place the jumper on the middle and bottom pins.

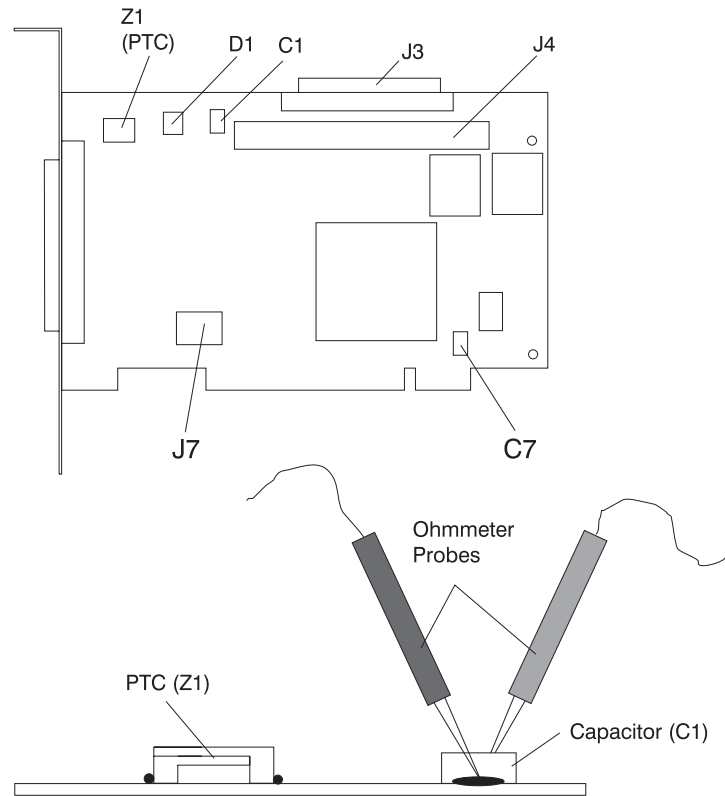
SCSI-2 Fast/Wide PCI Single-Ended Adapter

2. Disconnect any internal and external cables from the adapter, then remove the adapter from the system.
3. Verify with a digital ohmmeter, that the internal PTC resistor, labeled Z1, is cool and in a low resistance state, typically less than 1/2 Ohm. Measuring across, be sure to probe both sides of the PTC where the solder joints and board come together. The polarity of the test leads is not important. If necessary, allow the PTC to cool and measure again. Refer to the following illustration.

**Note:** Ensure that only the probe tips are touching the solder joints. Do not allow the probes to touch any other part of the component.

4. Locate capacitor C1 and measure the resistance across it using the following procedure:
  - a. Connect the positive lead to the side of the capacitor where the + is indicated. Be sure to probe at the solder joint where the capacitor and board come together.
  - b. Connect the negative lead to the opposite side of the capacitor. Be sure to probe at the solder joint where the capacitor and board come together.
  - c. If there is no short-circuit present, the resistance reading is high, typically hundreds of Ohms.

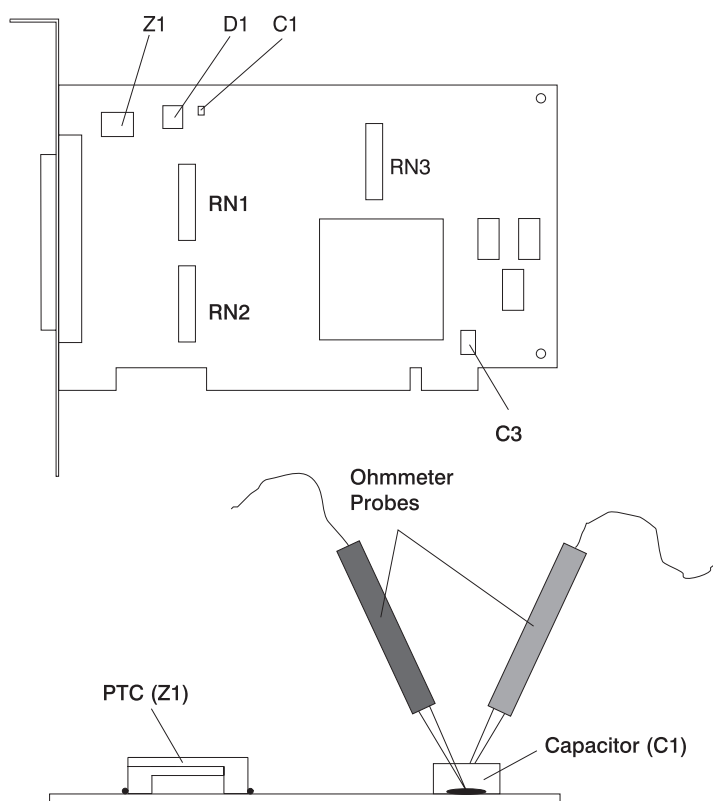
SCSI-2 Differential Fast/Wide PCI Adapter

3. Disconnect the external cables from the adapter and remove the adapter from the system.
4. Verify with a digital ohmmeter that the internal PTC resistor, labeled Z1, is cool and in a low resistance state, typically less than 1/2 Ohm. Refer to the following illustration. Measuring across, be sure to probe both sides of the PTC resistor where the solder joints and board come together. The polarity of the test leads is not important. If necessary, allow the PTC resistor to cool and measure again.

5. Locate capacitor C1 and measure the resistance across it using the following procedure:
  - a. Connect the negative lead to the side of the capacitor marked "GND". Be sure to probe at the solder joint where the capacitor and board come together.
  - b. Connect the positive lead to the side of the capacitor marked "Cathode D1" on the board near C1. Be sure to probe at the solder joint where the capacitor and board come together.
    - If there is no fault present, then the resistance reading is 25 to 35 Ohms. The adapter is not faulty. Continue to the next step.
    - If the resistance measured is higher than 35 Ohms, check to see if RN1, RN2, and RN3 are plugged into their sockets. If these sockets are empty, you are working with a Multi-Initiators or High-Availability system. With these sockets empty, a resistive reading across C1 cannot be

verified other than it measures a high resistance (not a short-circuit). If the resistance measurement is not low enough to be suspected as a fault (lower than 10 Ohms), continue to the next step.
