## Optical lens cleaning using compressed air.

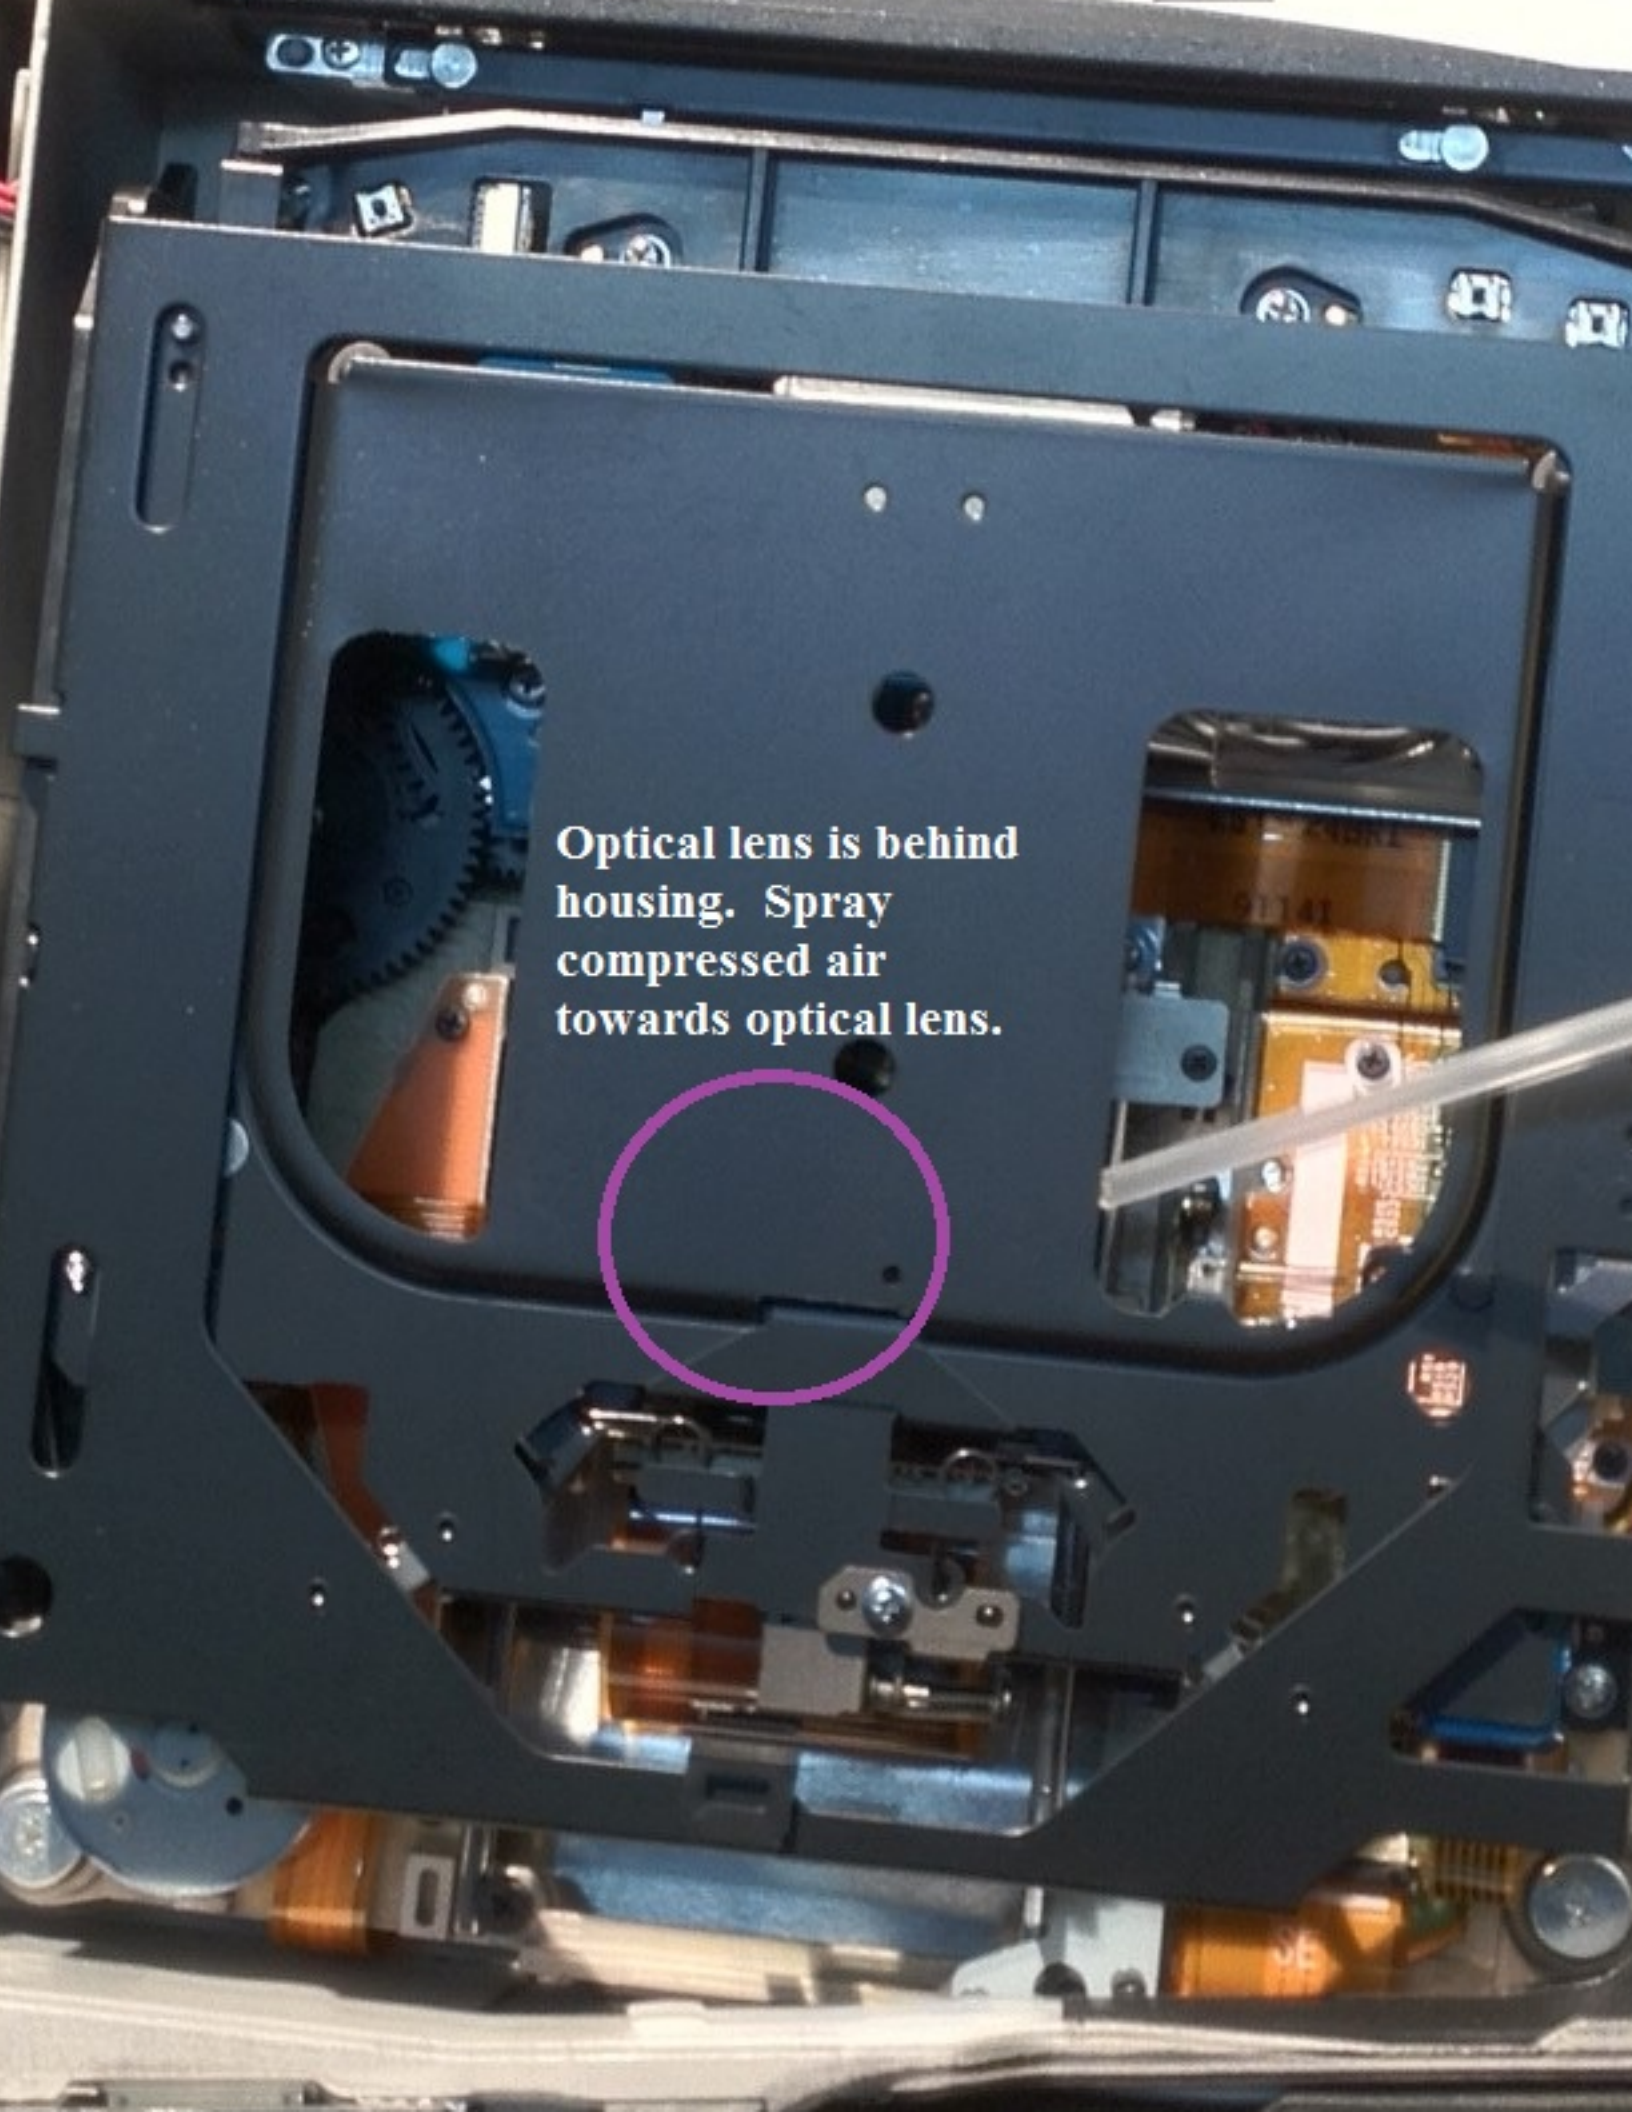
The image shows the interior of a black plastic housing. On the left, a blue gear is visible. On the right, there is a complex assembly with yellow and orange components, possibly a sensor or camera module. A clear tube is positioned to spray air towards a small hole in the housing, which is highlighted by a purple circle. The text "Optical lens is behind housing. Spray compressed air towards optical lens." is overlaid on the image.

**Optical lens is behind housing. Spray compressed air towards optical lens.**

Optical lens is behind housing in circled area.  
Spray compressed air towards the optical lens.

1. Power Camera.
2. Eject Disc compartment.
3. Remove power from camera.
4. Open side panel by loosening 5 screws. Fig.1
5. Spray compressed air into optical lens area. Fig.2 and Fig.3
6. Close side panel by tightening screws from step 4. Fig.1
7. Test and resume normal operation.
